NATIONAL TRANSPORTATION SAFETY BOARD

Specialist's Factual Report

METEOROLOGY

ERA22FA014

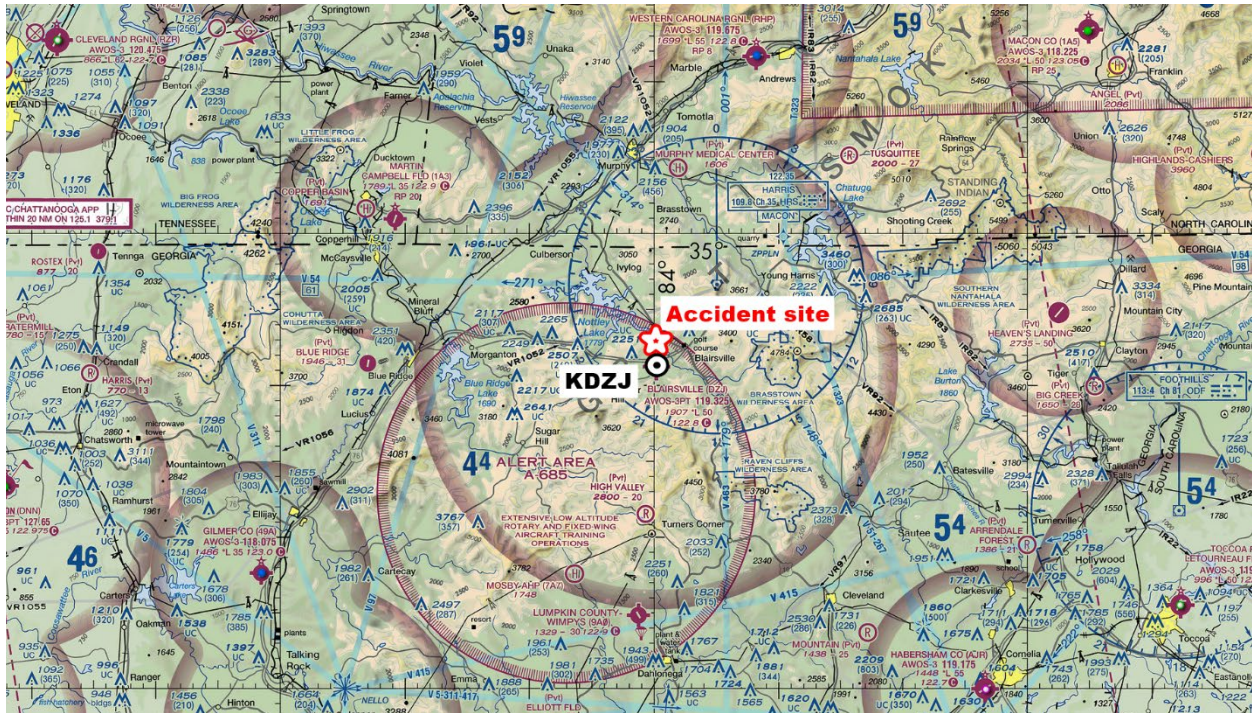
Figure 2 – Sectional map of the accident area with the locations of the accident site and surface observation site.

The area surrounding the accident site was documented using official Aviation Routine Weather Reports (METARs) and Specials (SPECIs). The following observations were taken from standard code and are provided in plain language. Figure 2 is a local sectional chart with the accident site and the closest weather reporting location marked.

Blairsville Airport (KDZJ) was the departure airport and also had the closest official weather station to the accident site. KDZJ had an Automated Weather Observing System (AWOS²) whose longline³ reports were not augmented. The KDZJ AWOS was located 2 miles south of the accident site, at an elevation of 1,907 ft, and had a 6° westerly magnetic variation⁴ (figure 2). KDZJ AWOS observations surrounding the accident time are shown below:⁵

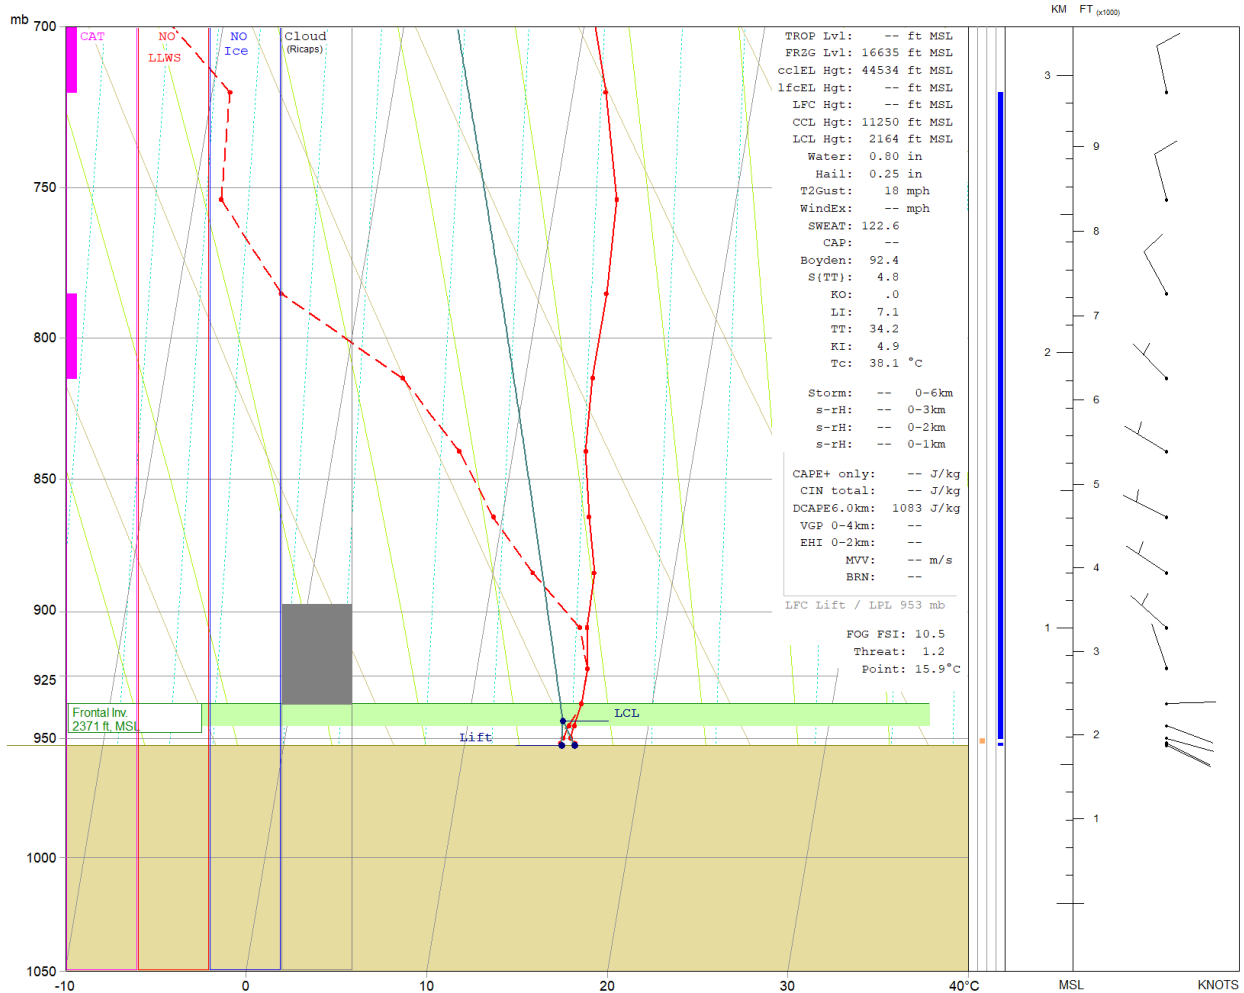
Figure 3 – 0800 EDT HRRR sounding.

A High-Resolution Rapid Refresh (HRRR)⁸ model sounding was created for the accident site for 0800 EDT which provided a surface elevation of 1,867 ft.⁹ The 0800 EDT HRRR sounding was plotted on a standard Skew-T Log P diagram¹⁰ with the derived stability parameters included in figure 3 with data from the surface to 700-hPa (or approximately 10,000 ft above msl). These data were analyzed using the RAOB¹¹ software package. The sounding depicted the lifted condensation level (LCL)¹² at 297 ft agl (2,164 ft above msl) and the convective condensation level (CCL)¹³ at 11,250 ft above msl. The freezing level was located at 16,635 ft above msl. The precipitable water value was 0.80 inches.

The 0800 EDT HRRR sounding for the accident site indicated a stable environment from the surface through 10,000 ft above msl. Clouds were indicated by RAOB to be present from 2,400 ft above msl (~500 ft agl) through 4,000 ft above msl. A frontal inversion¹⁴ was noted at 2,371 ft above msl. No icing potential was indicated by RAOB below 10,000 ft above msl.

The 0800 EDT HRRR sounding wind profile indicated a near surface wind from 117° at 1 knot with the wind remaining light and variable at 5 knots or less below 7,000 ft above msl. RAOB did not indicate the possibility of low-level wind shear (LLWS) or clear-air turbulence below 6,000 ft above msl.

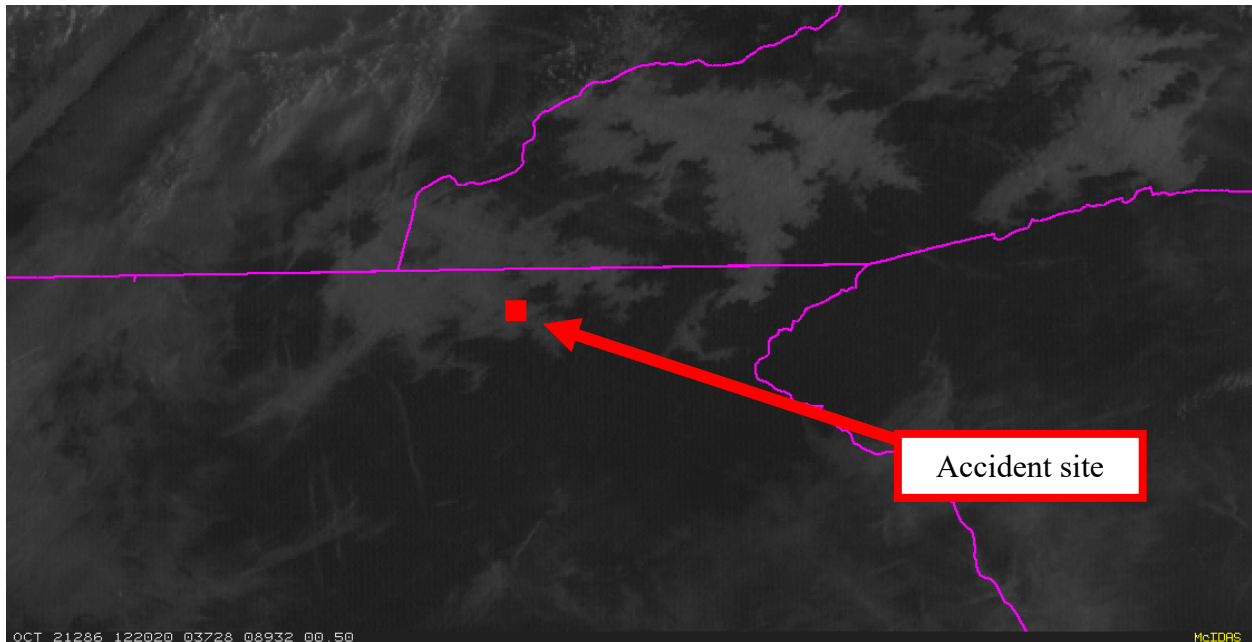
Figure 4 – GOES-16 visible image at 0820 EDT.

Figure 4 presents the GOES-16 visible imagery from 0820 EDT at 2X magnification with the accident site highlighted with a red square. There was cloud cover above the accident site and in the valleys across the mountainous terrain of northern Georgia, western North Carolina, and eastern Tennessee. Figure 5 presents the GOES-16 infrared imagery from 0820 EDT at 6X magnification with the accident site highlighted with a red square. The lower brightness temperatures (red and yellow colors; higher cloud tops) were located northwest of the accident site in Tennessee. The brightness temperature of about 285 Kelvin above the accident site would have been near 6,000 ft based on the vertical temperature profile provided by the 0800 EDT HRRR sounding. It should be noted these figures have not been corrected for any parallax error.
