# National Transportation Safety Board

### ERA22FA338

# **ELECTRONIC DEVICES**

Specialist's Factual Report

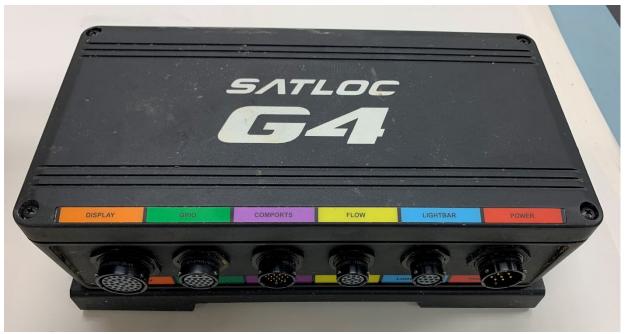
The SATLOC G4 was in good condition as shown in figure 1. Data were extracted normally from the internal SATA drive.

Figure 1. SATLOC G4 as received.

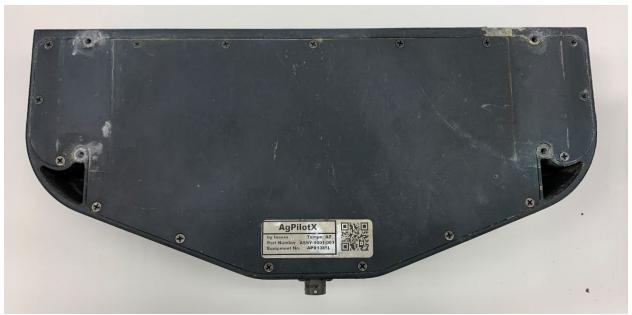
The AgPilotX Lightbar was in good condition upon arrival at the Vehicle Recorder Laboratory. The device contained an internal 8 GB microSD card. The contents of the card were examined and the historical data associated with the accident flight were extracted normally.

Figure 2. AgPilotX Lightbar as received.

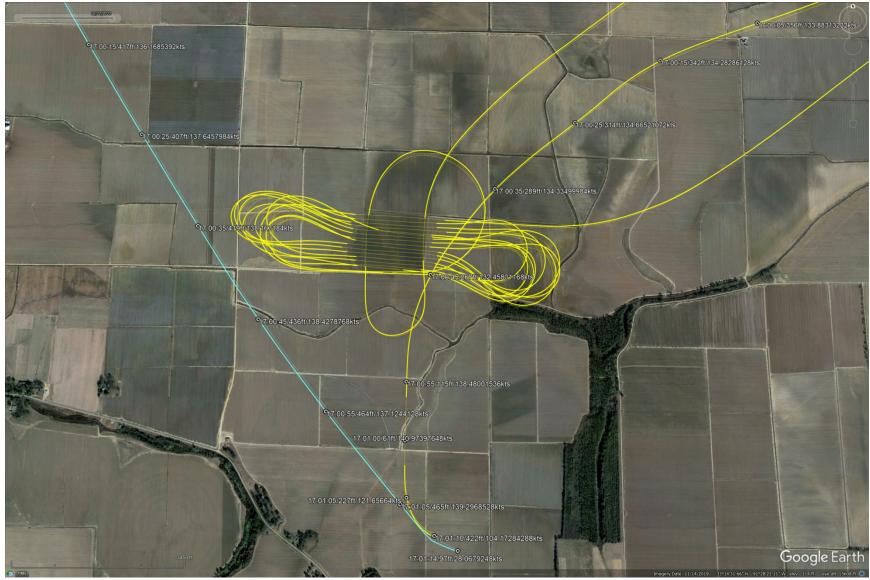
Figure 3 shows approximately the final minute of recorded data on both the SATLOC and the AgPilotX.

**Figure 3.** Google Earth overlay showing approximately the final minute of recorded data from the SATLOC G4 (N749LA, in yellow) and AgPilotX (N214RL, in cyan).

Figures 3 through 5 are Google Earth overlays of the accident flight recorded on both the SATLOC G4 and AgPilotX. The weather and lighting conditions in Google Earth are not necessarily the weather and lighting conditions present at the time of the accident flight. The SATLOC flight track from N749LA is shown in Yellow and the AgPilotX flight track from N214RL is shown in Cyan. Recorded GPS Altitude and Ground Speed are depicted for the SATLOC and GNSS Altitude and Speed over Ground are depicted for the AgPilotX.

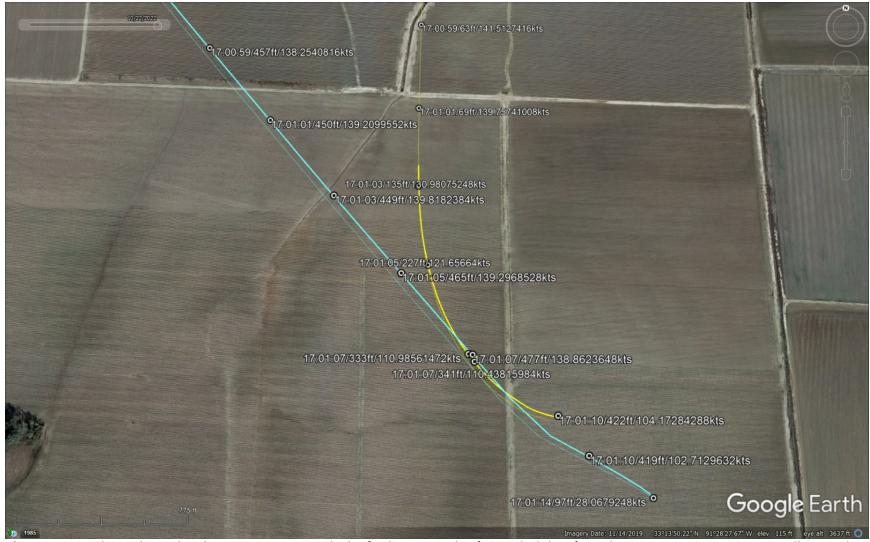
Figure 4 shows approximately the final 15 seconds of recorded data on both the SATLOC and the AgPilotX.

**Figure 4.** Google Earth overlay showing approximately the final 15 seconds of recorded data from the SATLOC G4 (N749LA, in yellow) and AgPilotX (N214RL, in cyan).

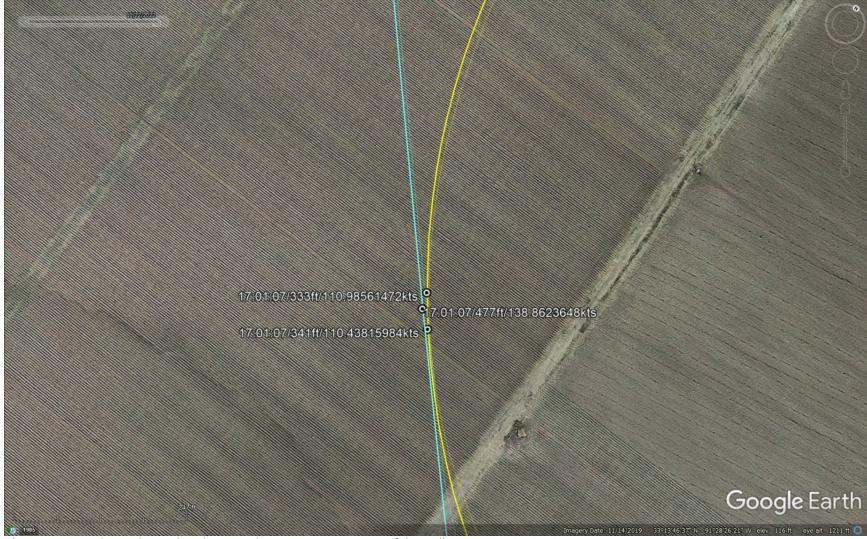
Figure 5 shows the approximate time of collision of the two aircraft at approximately 17:01:07 CDT. The overlay shows the point at which time and position data are aligned.

**Figure 5.** Google Earth overlay showing the approximate time of the collision at 17:01:07 CDT.

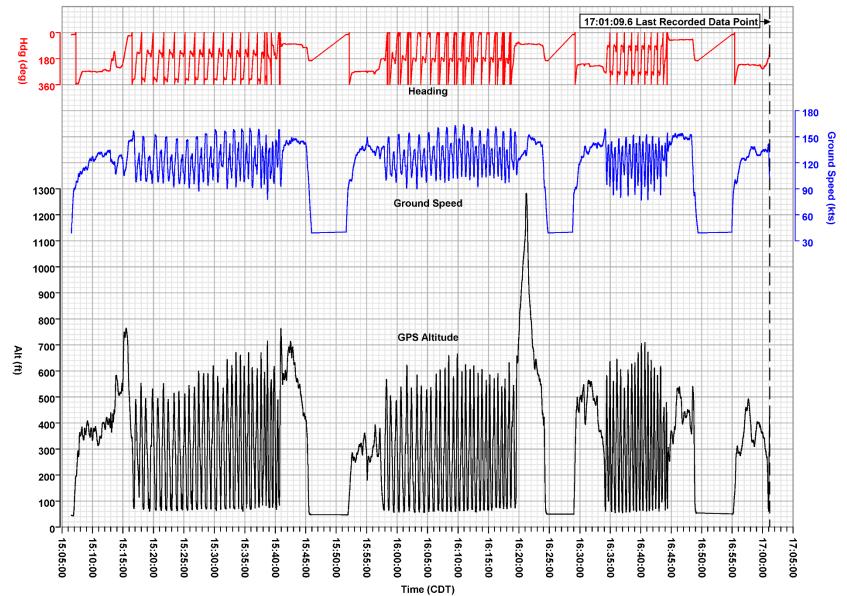
Figure 6 is a plot of SATLOC G4 basic parameters from the last session recorded. The time interval shown is 15:05:00 to 17:05:00 CDT.

Figure 6. Plot of SATLOC G4 parameters from the last session recorded.
