# National Transportation Safety Board

ERA24FA003

## **ONBOARD IMAGE RECORDER**

Location: Croydon, New Hampshire  
Date: October 8, 2023  
Time: 1932 eastern daylight time (EDT)  
2332 coordinated universal time (UTC)  
Helicopter: Bell 407, N802JR

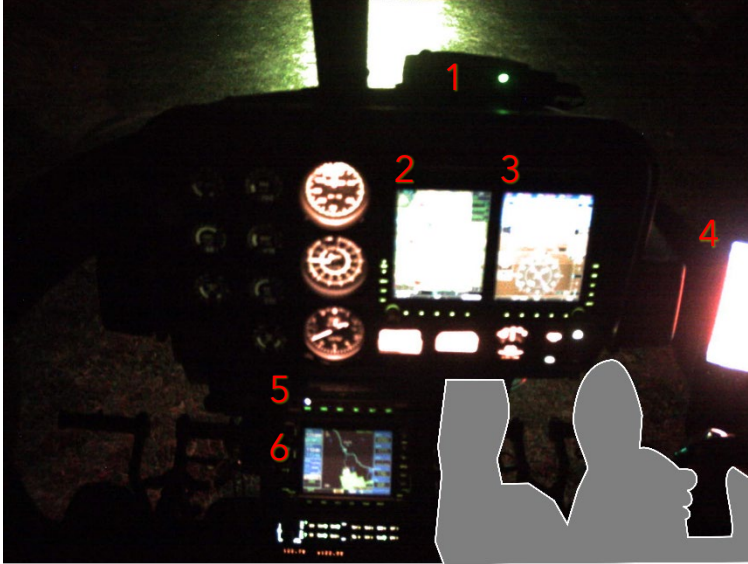
**Figure 2.** Field of view identifying select instruments on the panel (pilot redacted in gray).

The accident recording was made at a resolution of 1600x1200 pixels at a frame rate of 4 frames per second (fps). Both ambient and line-in audio were recorded. The camera was mounted in the overhead of the helicopter's cockpit and was oriented to show a forward-facing field of view (FOV) that included a view of the instrument panel, rudder pedals, and cyclic. The collective stick was not visible. Figure 2 is a still frame image showing the camera's FOV with select instruments and indicators labeled.

| 1. | SkyTrac |
| 2. | Multi-function Display (MFD) |
| 3. | Primary Flight Display (PFD) |
| 4. | Garmin 696 |
| 5. | HeliSAS Control Panel (HCP) |
| 6. | Garmin 530 |

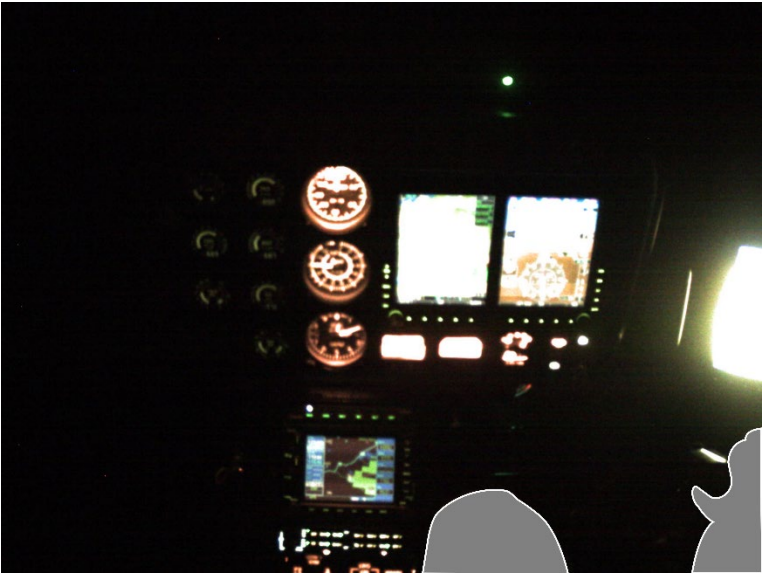
Time Start (EDT)	Time End (EDT)	Transcript
19:30:46		<p>The helicopter took off. All values observed on the instrument panel appeared nominal:</p> <ul style="list-style-type: none"> <li>• The stand-by altimeter was about 1700 ft.</li> <li>• The stand-by airspeed was 0 kts.</li> </ul>
19:31:01		A light from the barn was visible on the right side of the FOV.
19:31:07		A house was visible in the upper left of the FOV.
19:31:18		<p>The altitude was about 1850 ft. The trim ball indicated full left deflection.</p> <p>The pilots said, "Ah [expletive], it's too dark."</p>
19:31:33.75		<p>The following were observed:</p> <ul style="list-style-type: none"> <li>• Altitude: 2200 ft</li> <li>• Airspeed: 0 kts</li> </ul> <p>The helicopter appeared to be in level uncoordinated flight. The turn coordinator showed right needle deflection and full left ball.</p>

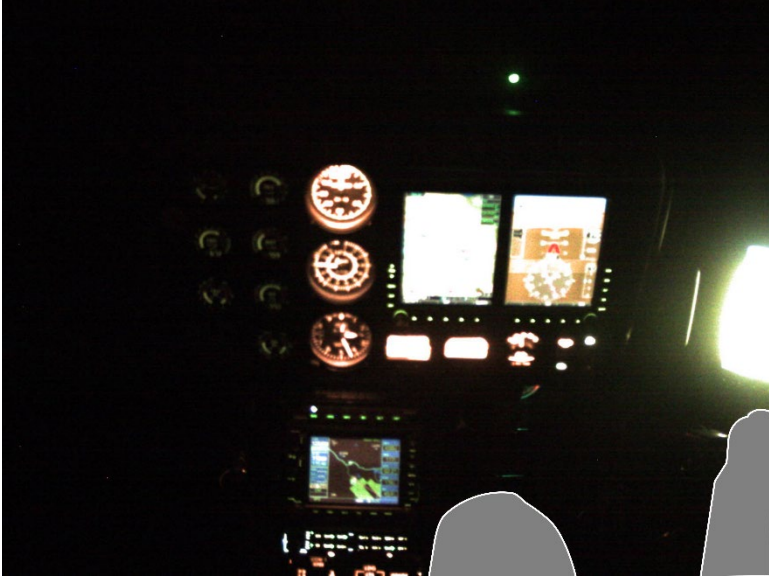
Time Start (EDT)	Time End (EDT)	Transcript
19:31:42.75		<p>The following were observed:</p> <ul style="list-style-type: none"> <li>• Altitude: 2450 ft</li> <li>• Airspeed: 20 kts</li> </ul> <p>The pilot said, "Ah [expletive], [pilot's name]."</p> <p>A red chevron indicating extreme nose down attitude appeared on the PFD.<sup>2</sup> The helicopter appeared to be in a right bank with full turn needle deflection and ball centered.</p>

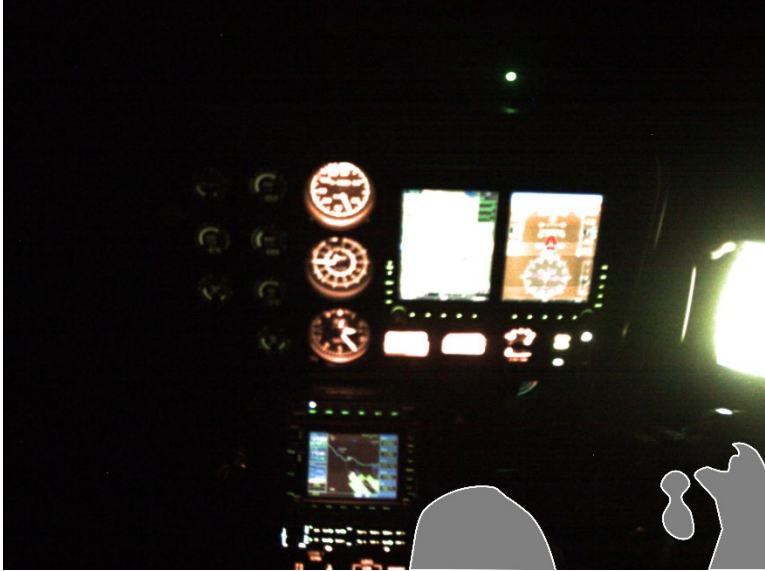
Time Start (EDT)	Time End (EDT)	Transcript
19:31:49.50		<p>The following were observed:</p> <ul style="list-style-type: none"> <li>• Altitude: 2400 ft</li> <li>• Airspeed: 70 kts</li> </ul> <p>A double red chevron indicating extreme nose down attitude appeared on the PFD for approximately 3 seconds. The helicopter appeared to be in uncoordinated flight with full right needle deflection and full left ball.</p> <p>Large rapid cyclic movements were observed: predominantly forward and right cyclic inputs, which were followed by two full left cyclic inputs.</p>

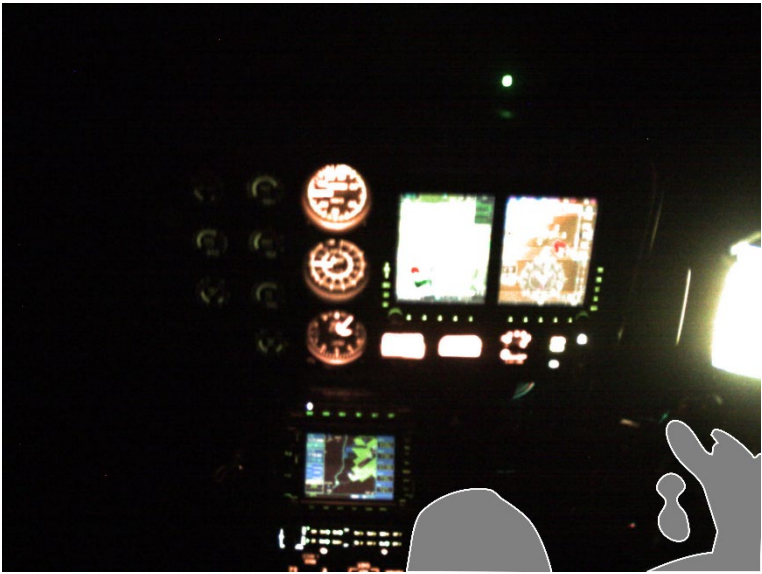
Time Start (EDT)	Time End (EDT)	Transcript
19:32:00		The pilot momentarily reached his left arm across his body towards the Garmin 696.
19:32:03.25		<p>The following were observed:</p> <ul style="list-style-type: none"> <li>• Altitude: 2100 ft</li> <li>• Airspeed: 120 kts</li> </ul> <p>A red chevron indicating extreme nose down attitude reappeared on the PFD. The helicopter appeared to be in uncoordinated flight, extreme right bank, with full right needle deflection and full left ball. The torque gauge appeared to be near the maximum allowable value.</p> <p>Large rapid cyclic movements continued.</p>
