NTSB No. PLD22FR002

# Marathon Pipe Line LLC Hazardous Liquids Pipeline Release

Edwardsville, Illinois

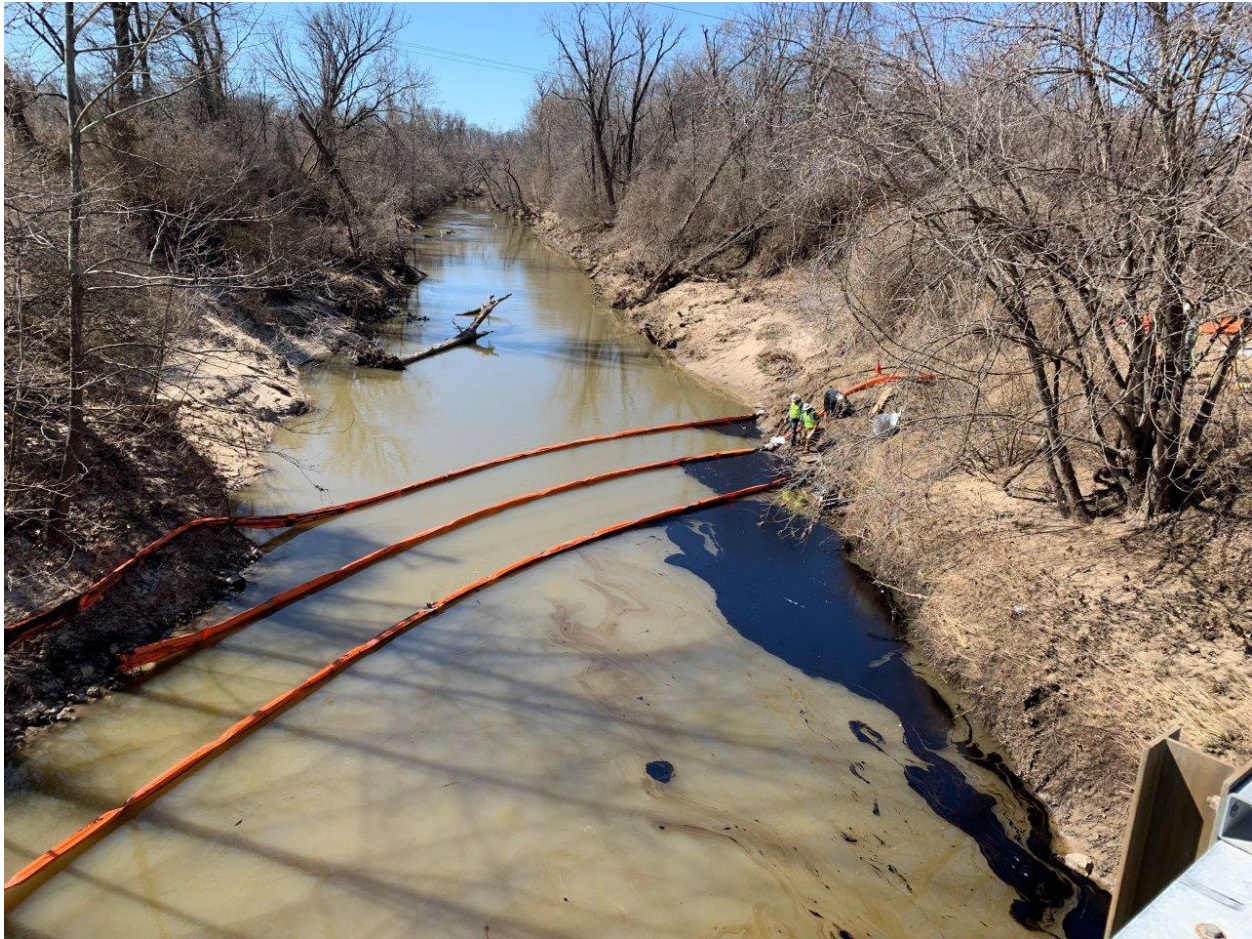
**Figure.** Containment booms on Cahokia Creek.

Following the rupture, Marathon and its contracted oil spill response organizations deployed containment booms, vacuum trucks, and personnel at 10 locations along the creek. ([See figure.](#)) Remediation and clean-up work is ongoing.
