National Transportation Safety Board

RRD22MR010

ELECTRONIC CONTROL MODULE

Specialist's Factual Report

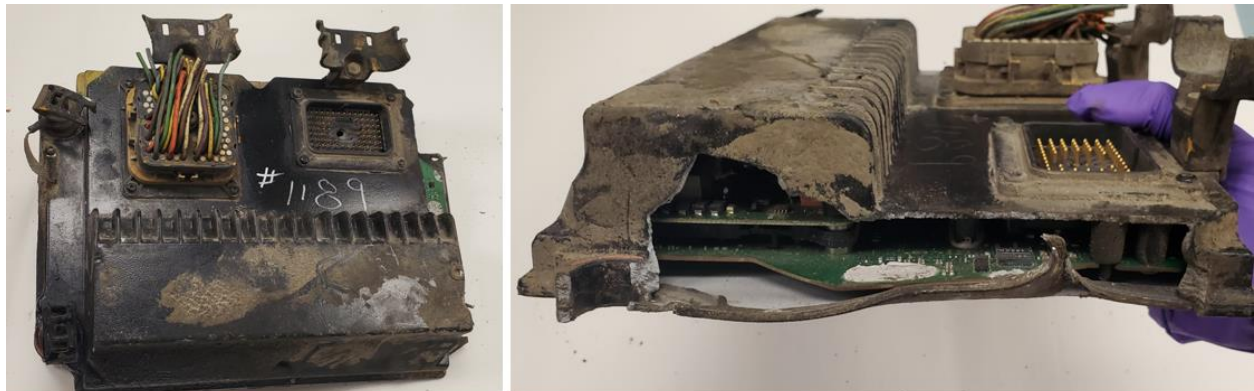
Upon arrival at the Vehicle Recorder Division, an exterior examination revealed the device had sustained impact damage, as shown in figure 1. The device was identified as a Caterpillar ECM based on the marked part number, as shown in figure

Figure 1. Top view and side view of the Caterpillar ECM as Received.

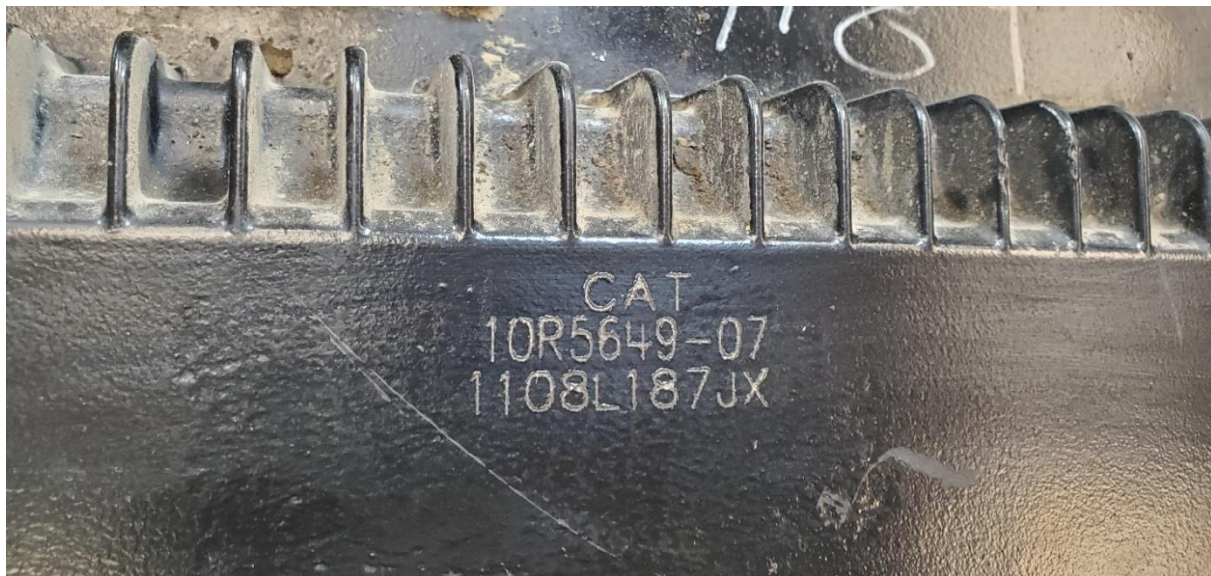
Figure 2. Identification of the Caterpillar ECM as Received.

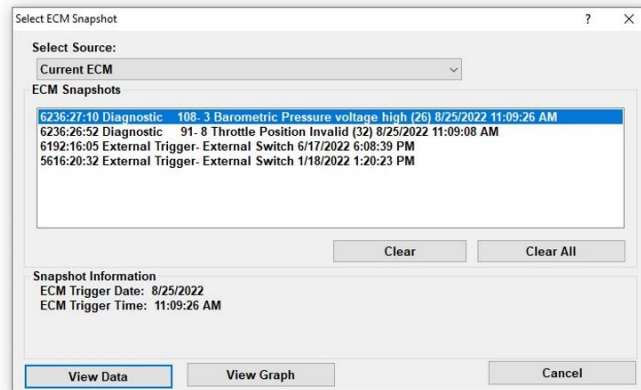
Figure 3. List of events recorded on the Caterpillar ECM.

The device was hand-carried to a Carter Machinery facility for data download, with the supervision of the recorder specialist and a highway accident investigator from the NTSB. The download was successful, and the data indicated that there were no snapshots associated with the accident (occurred on June 27, 2022) recorded on the ECM. Figure 3 shows a list of the snapshots recorded on the ECM. There were two snapshots triggered by events before the accident date; one was recorded on June 17, 2022, and the other one was on January 18, 2022. The two *Diagnostic* snapshots on the top of the list were triggered by the downloading process. The data also indicated that the ECM was installed in a vehicle with Caterpillar C15 engine, and that the internal clock of the ECM was about two hours ahead of the eastern daylight time (EDT) at the time of downloading, as shown in figure 4. All the available data recorded on the ECM was downloaded and provided as attachment 1 to this report.

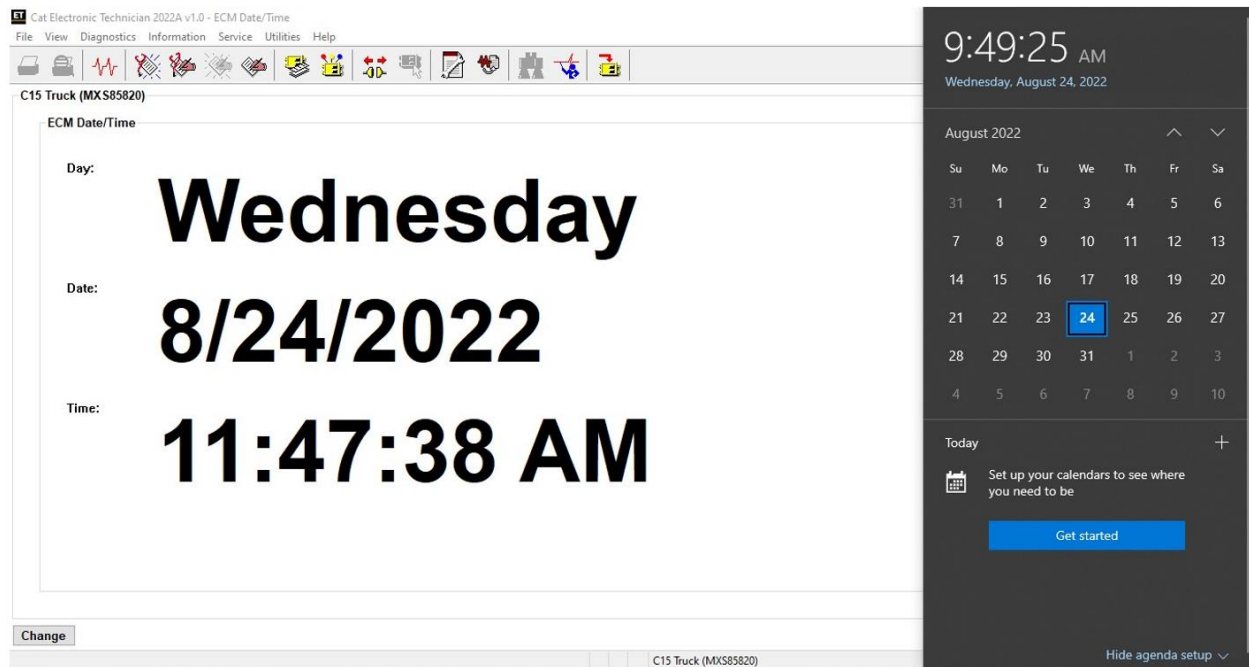
Figure 4. Internal clock of the Caterpillar ECM comparing to EDT at the time of downloading.
