National Transportation Safety Board

CEN23FA353

Specialist's Factual Report

Location: Gilman City, Missouri
Date: August 8, 2023
Time: 1150 central daylight time (CDT)
Airplane: Air Tractor Inc AT-802, Rice Flying LLC, N804AA

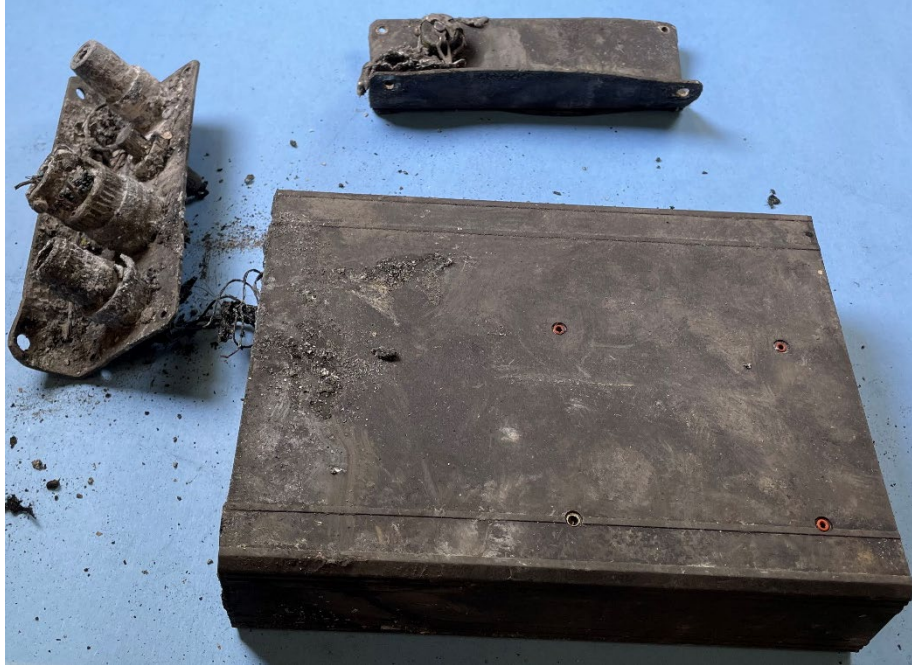
The SATLOC was severely damaged in the event, as shown in figure 1. The internal circuit board was removed from the device and a compact flash card was recovered, as shown in figure 2. The compact flash card showed signs of fire damage as well, as shown in figure 3.

Figure 1. SATLOC as received by the NTSB Vehicle Recorder's Lab.

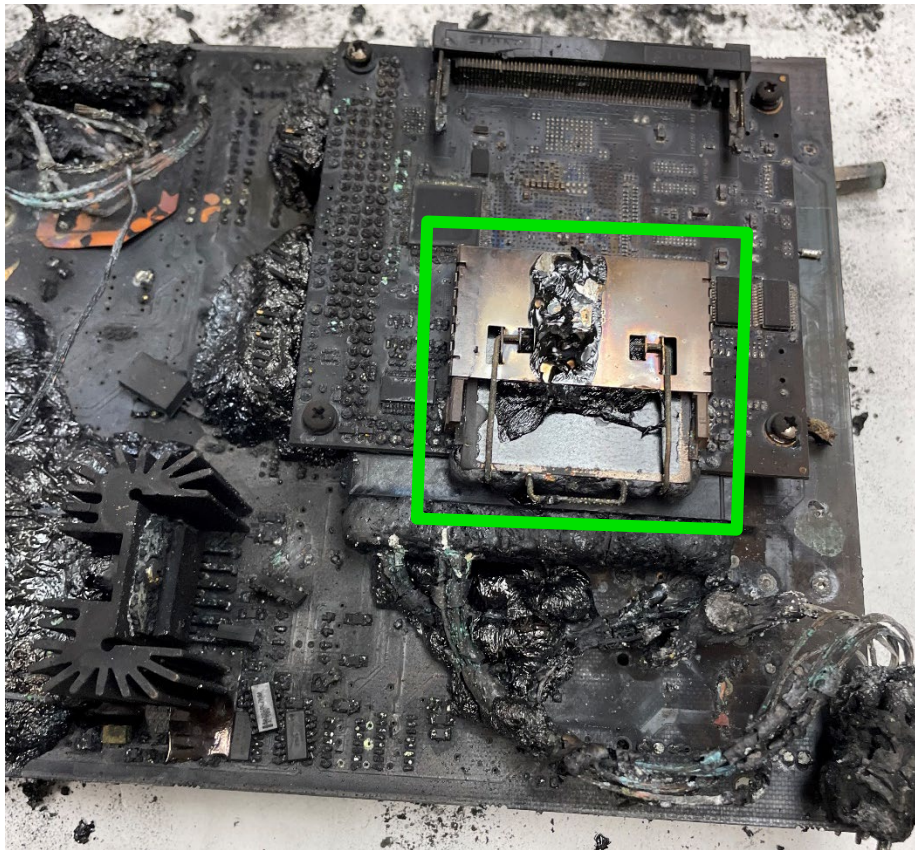
Figure 2. SATLOC internal circuit board with Compact Flash card (green box).

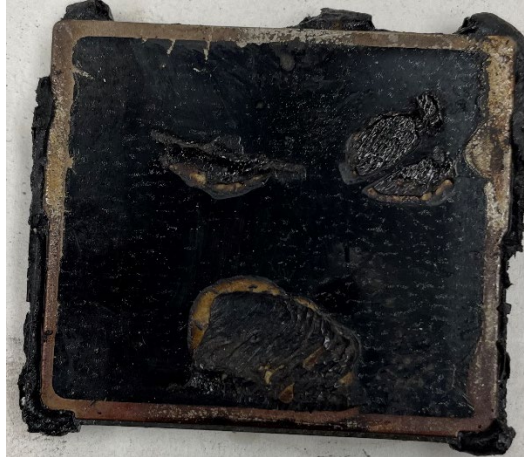
Figure 3. Compact Flash card recovered from the SATLOC.

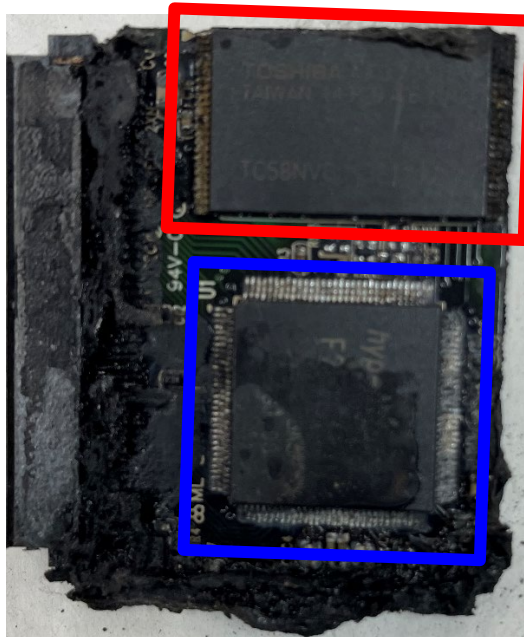
The Compact Flash card's internal components showed signs of fire damage, as shown in figure 4. The Vehicle Recorder's Lab shipped the Compact Flash card to DriveSavers Data Recovery Experts and Service Company. DriveSavers was unable to recover any data from the Compact Flash Card. Therefore, no data were recovered.

Figure 4. Compact Flash card microprocessor (bottom blue box) and Non-Volatile Memory chip (top red box) recovered from the SATLOC.
