NATIONAL TRANSPORTATION SAFETY BOARD

Electronic Device

Specialist's Factual Report by Gerald Kawamoto

Location: New Bedford, MA
Date: November 4, 2019
Aircraft: Cessna 150
Registration: N714LK
Operator: Private
NTSB Number: ERA20FA031

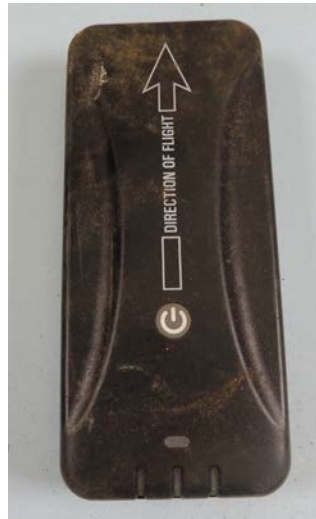
Upon arrival at the Vehicle Recorder Division, the exterior of the device did not exhibit major signs of damage, as shown in Figure 1. However, internal components appeared to be dislodged and could be audibly observed when the device was moved. An interior examination confirmed that internal components had sustained damage, as shown in Figure 1. The non-volatile memory³ chip was removed, read out, and converted to engineering units using laboratory tools.

Figure 1. Exterior of the Appareo Stratus 3i.

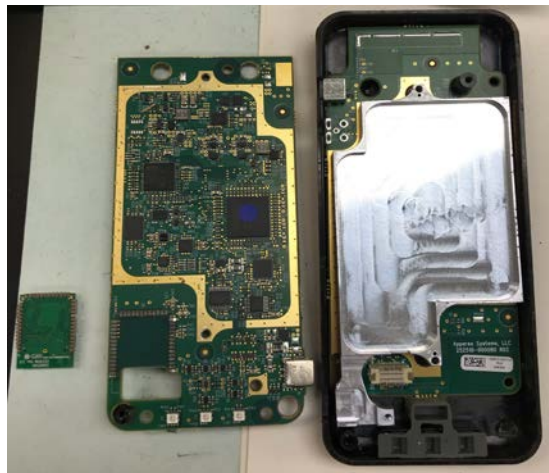
Figure 2. Dislodged and broken internal components of the Appareo Stratus 3i.

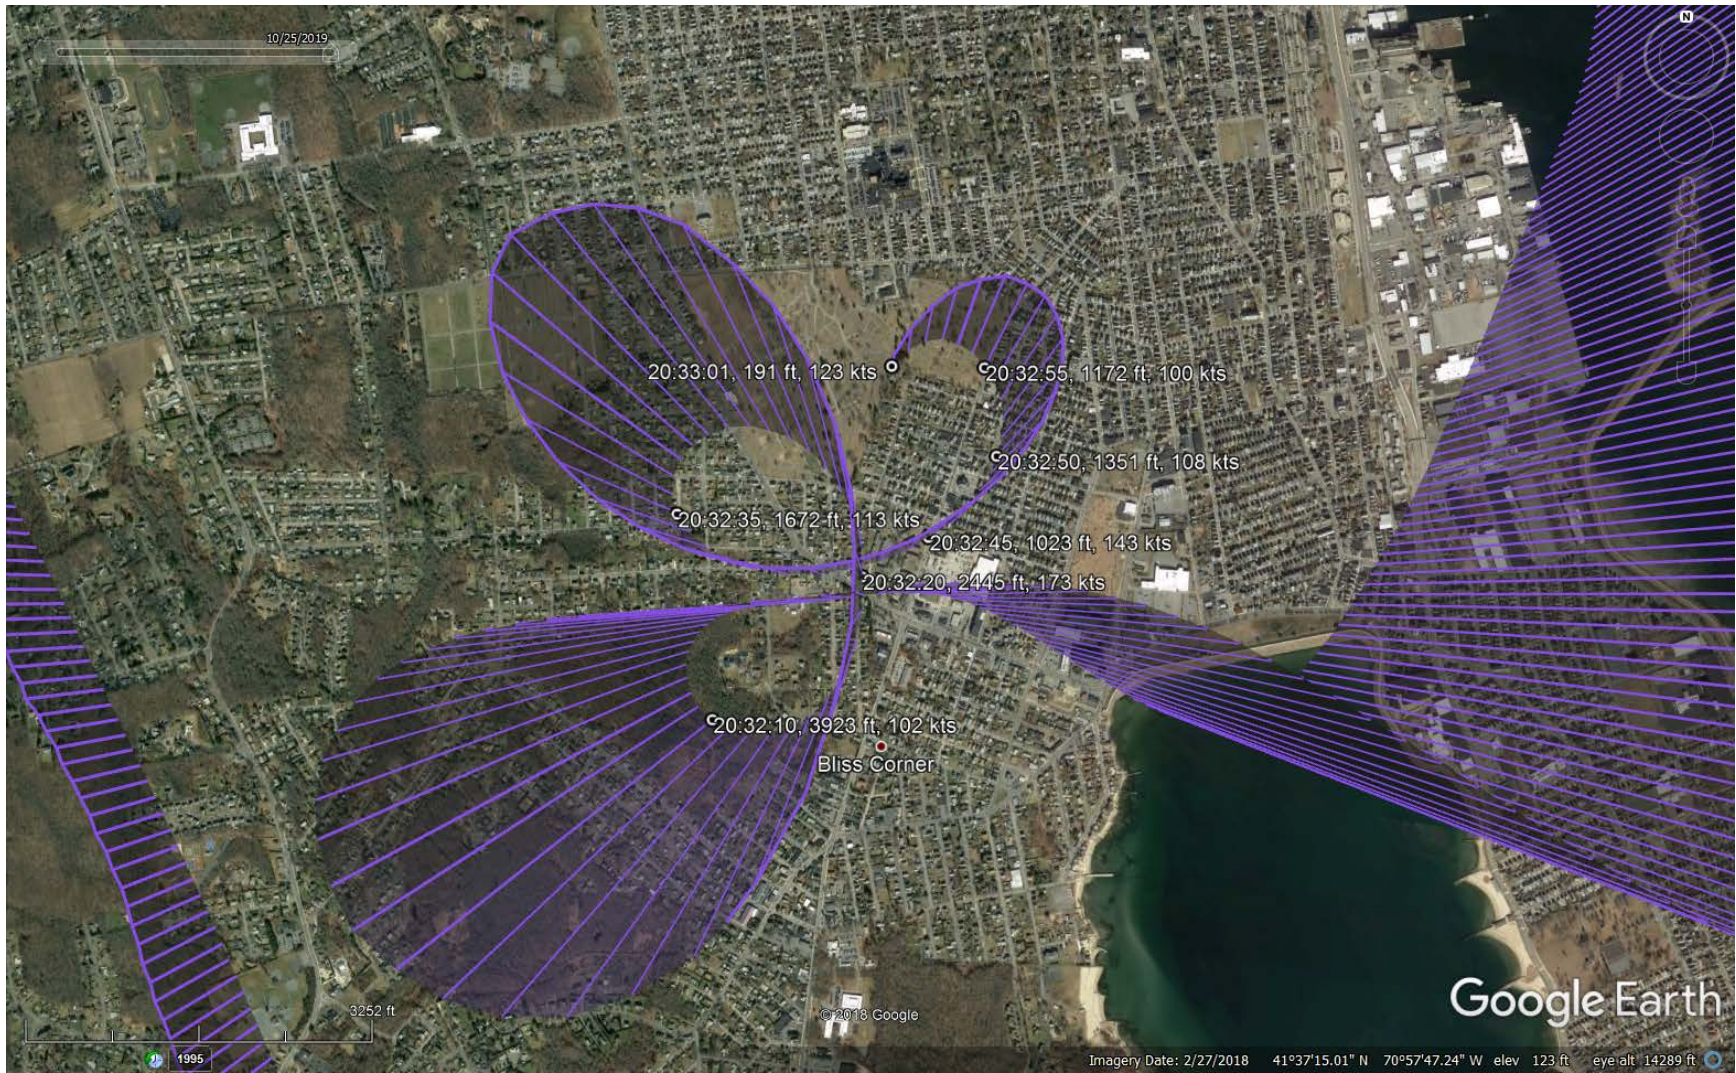
Figure 4 is a graphical overlay generated using Google Earth zoomed in on the end of the recording.

Figure 4. Google Earth overlay of the end of the accident flight.

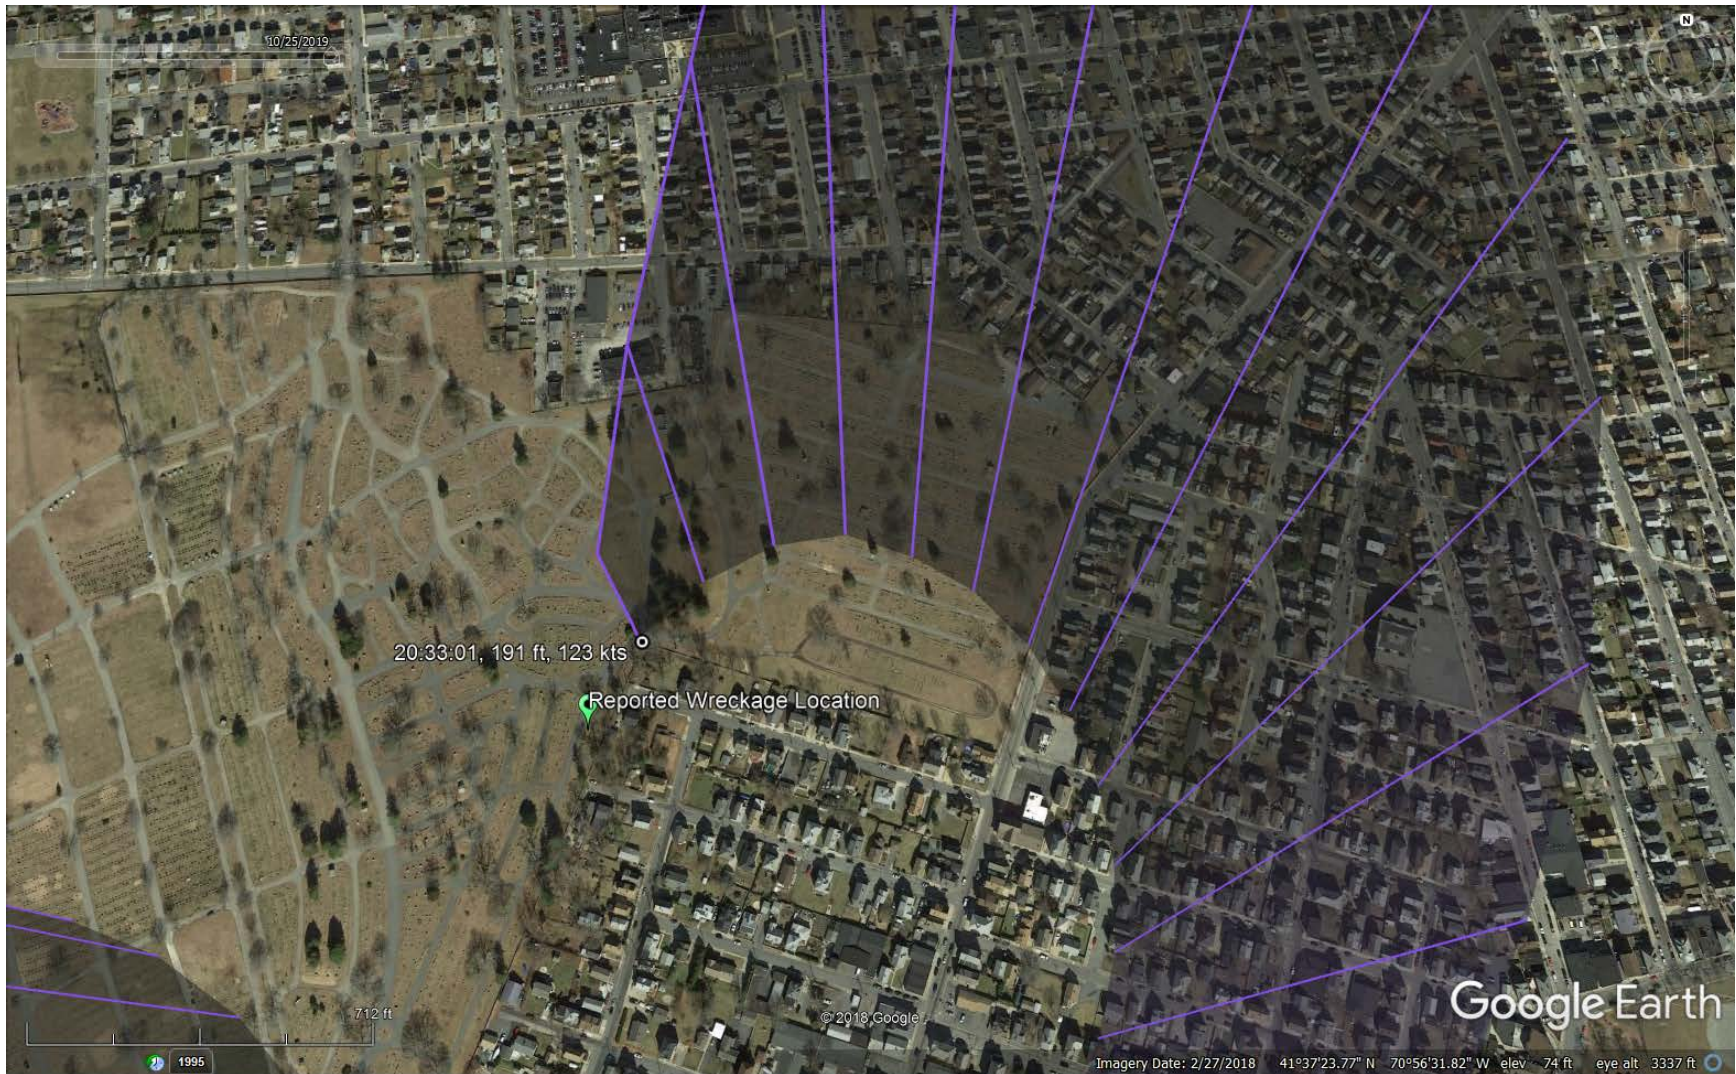
Figure 5 is a graphical overlay generated using Google Earth showing the last recorded data point and the main wreckage location.

Figure 5. Google Earth overlay showing the last data point recorded and the reported wreckage location.

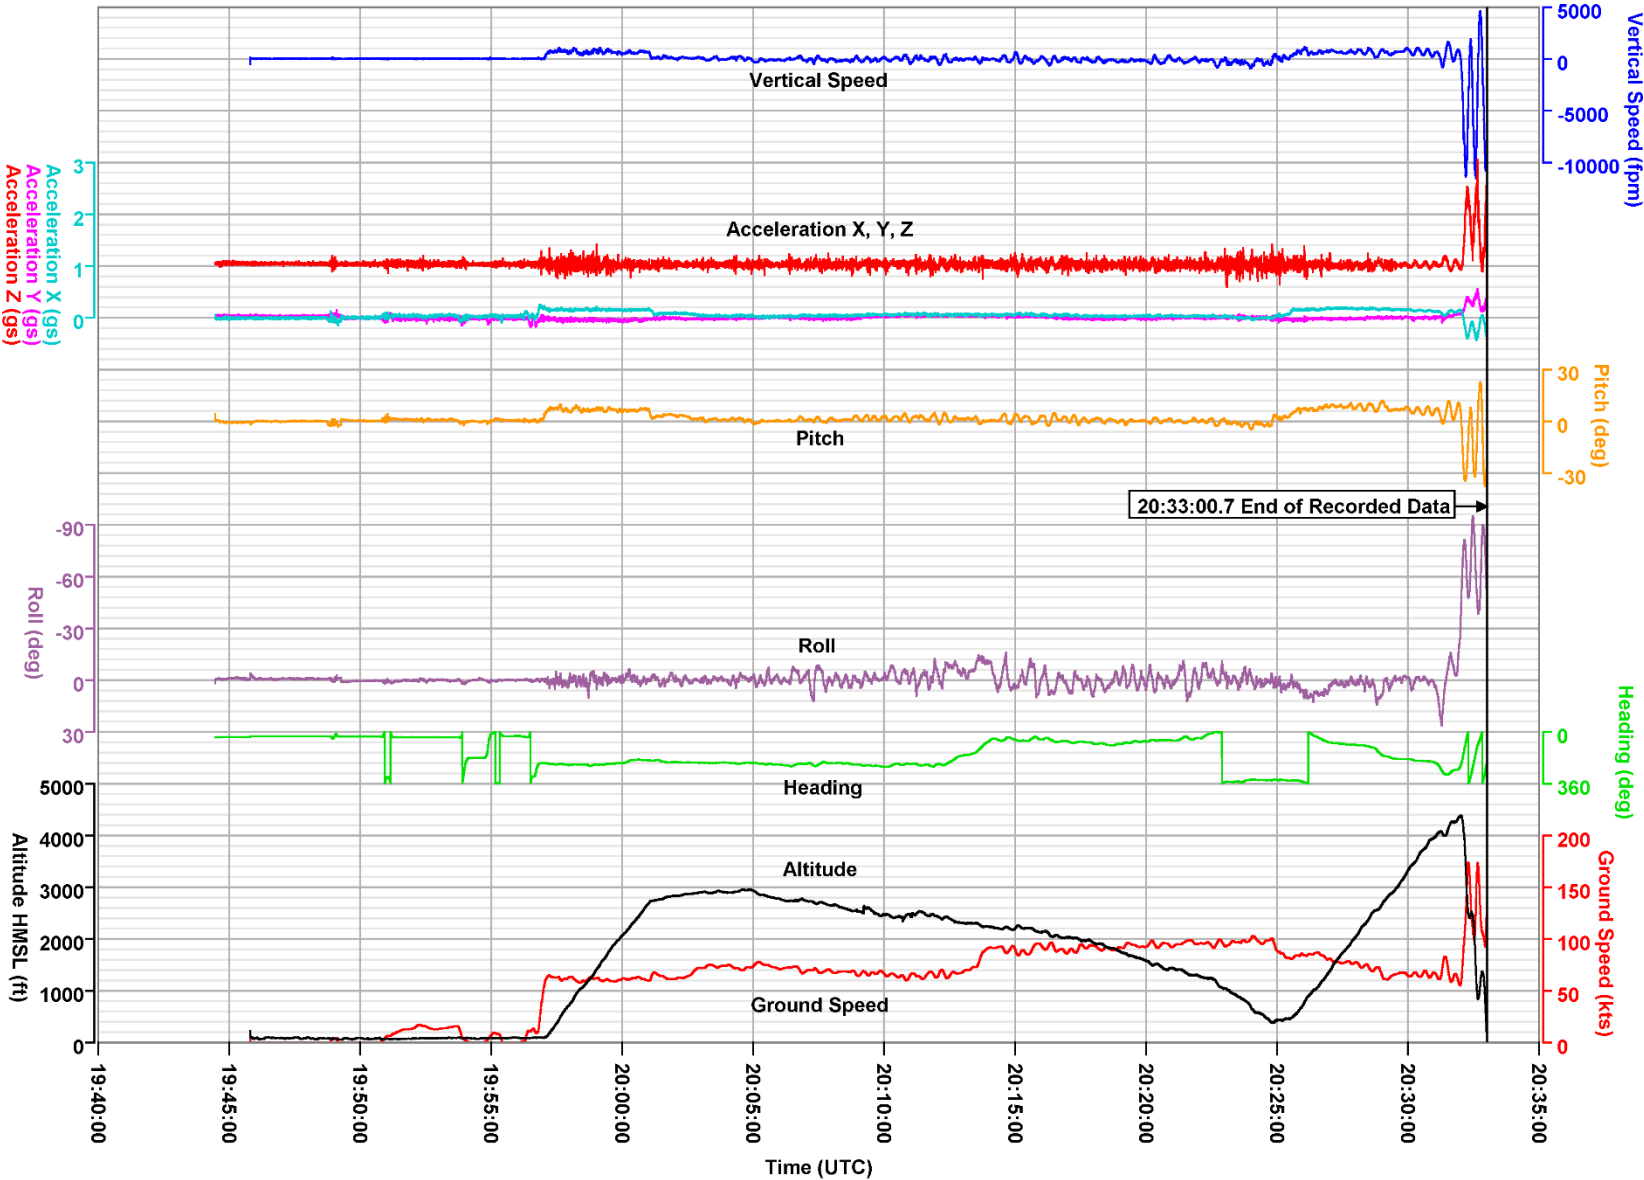
Figure 6 is a plot of parameters from the Appareo Stratus 3i for the entire accident flight. The time interval is 19:40:00 to 20:35:00 UTC.

Figure 6. Plot of Stratus 3i parameters for the entire accident flight.

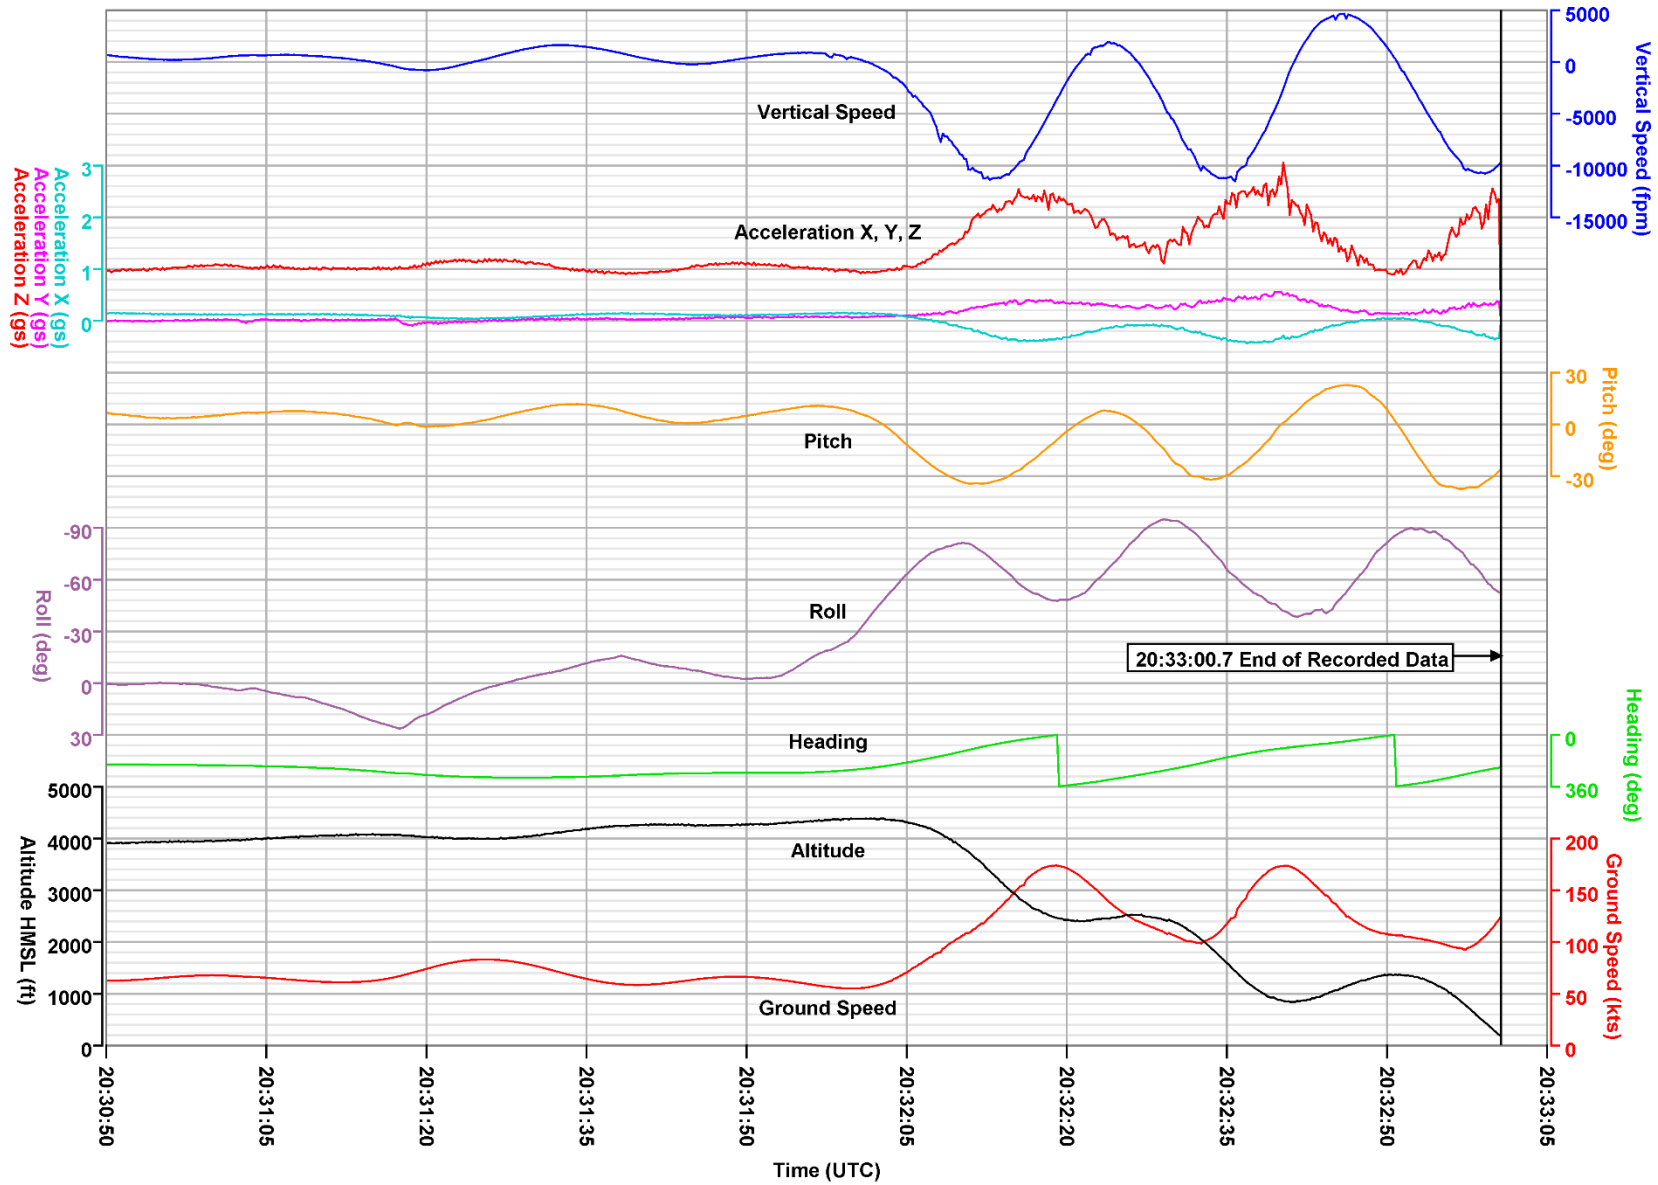
Figure 7 is a plot of parameters from the Appareo Stratus 3i at the end of the accident flight. The time interval is 20:30:50 to 20:33:05 UTC.

Figure 7. Plot of Stratus 3i parameters at the end of the accident flight.
