NATIONAL TRANSPORTATION SAFETY BOARD

Electronic Devices

Specialist's Factual Report

Location: Grover, Utah
Date: May 24, 2019
Aircraft: Cirrus SR22
Registration: N809SR
Operator: Private
NTSB Number: WPR19FA154

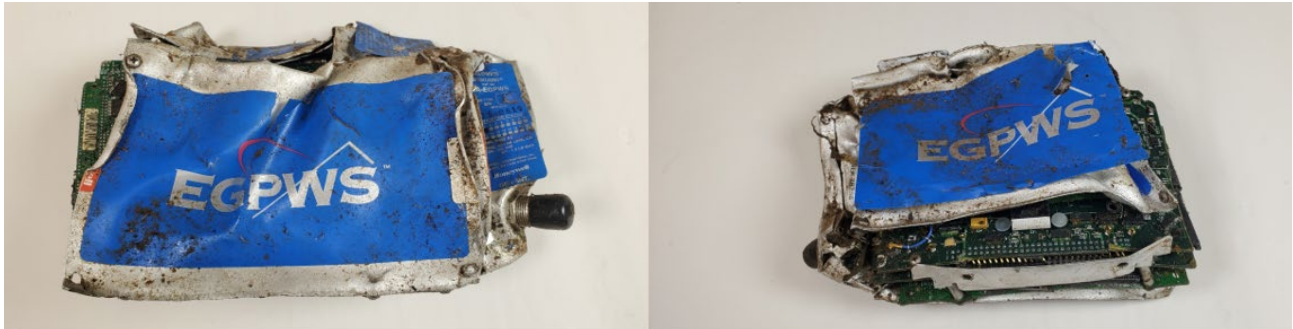
Figure 1: Front and back of Honeywell EGPWS KGP 560 as received.

Upon arrival at the Vehicle Recorder Division, an exterior examination revealed the device sustained severe impact damage, as shown in Figure 1. The NVM chips were damaged and removed from the circuit board, as shown in Figures 2 and 3. The NVM (U24) where the flight data stored was sent to the Integrated Electronic Engineering Center of Binghamton University for damage evaluation. The evaluation results stated that the successful data recovery of the U24 chip was highly unlikely, as shown in Figure 4. Thus, no data were recovered from this device. The full report of the chip damage evaluation is provided as Attachment 1 to this report.

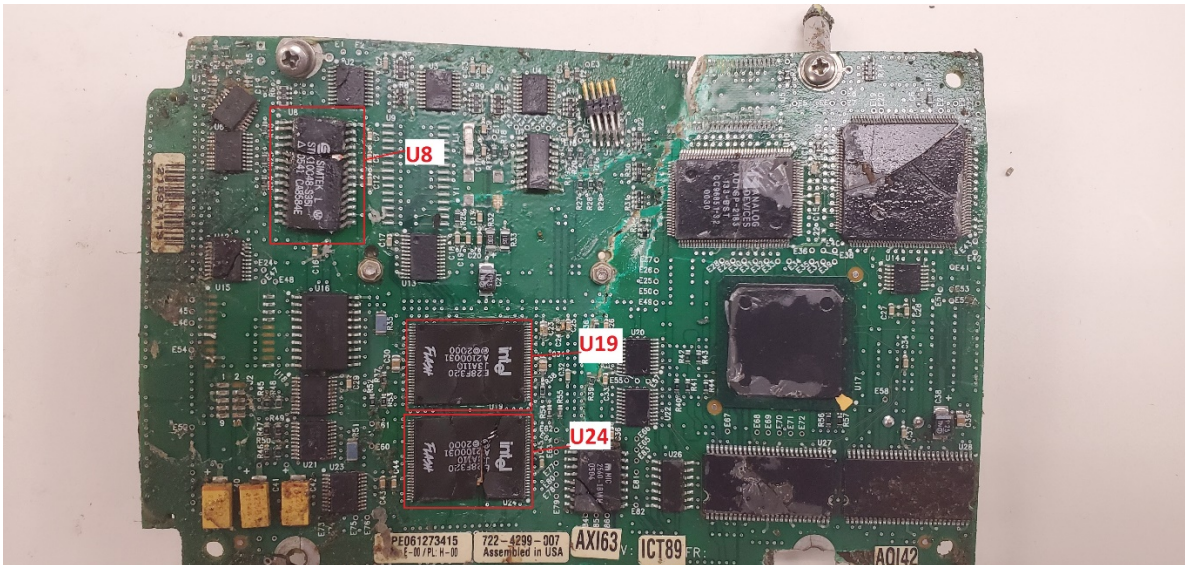
Figure 2: Circuit board containing NVM chips (U8, U19 and U24) of the Honeywell EGPWS.

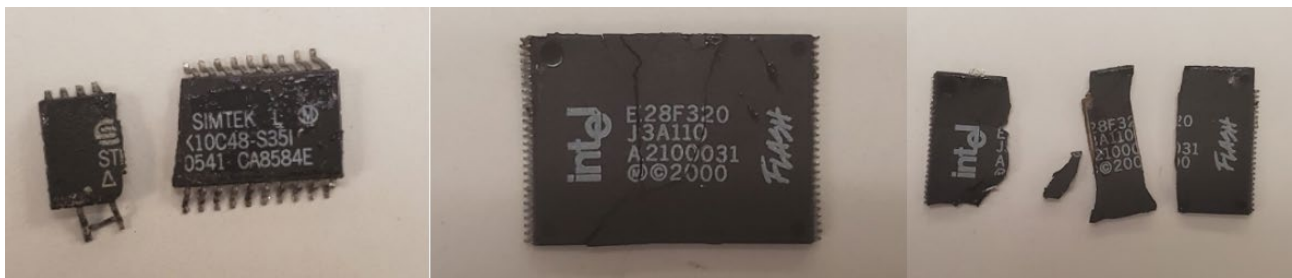
Figure 3: U8 (left), U19 (center) and U24 (right) of the Honeywell EGPWS.

- **One part received for analysis**
 - Accident WPR19A154
 - Honeywell EGPWS KGP-500
 - Intel flash E28F320
- **Analyst**
 - S.R. Cain
- **Analyses**
 - Optical microscopy
 - Acoustic microscopy
 - X-ray has already been done by the NTSB
- **Scope**
 - To determine the level of damage to the chip
 - Evaluate the likelihood of successful data recovery
- **Results**
 - The package as received had suffered severe flex damage
 - There was little if any evidence of thermal damage
 - The package was badly fractured, but the segment containing the chip was whole, although damaged
 - Optical inspection showed that the segment containing the chip was badly bent
 - Inspection of the edge showed multiple fractures
 - Sonic imaging could not be done on the entire part due to the severe flex
 - The portion that could be imaged sonically showed evidence of overmold and chip cracking

Disposition: the chip appears to be cracked, successful data recovery is highly unlikely

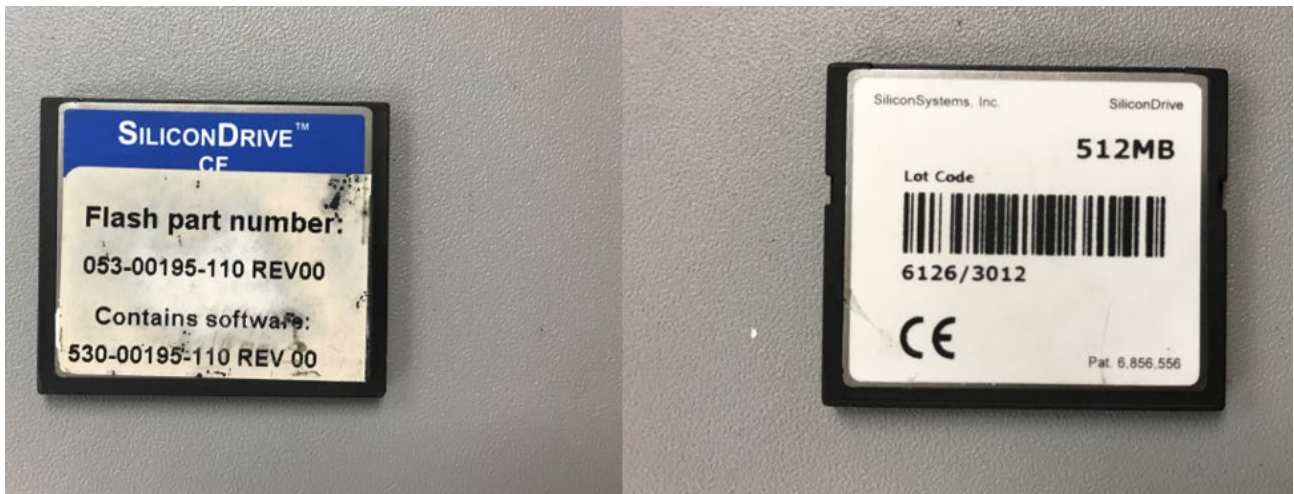
Figure 5: Front and back of Avidyne MFD CF memory card as received.

Upon arrival at the Vehicle Recorder Division, an exterior examination revealed the CF memory card was in good condition, as shown in Figure 5. The data were downloaded using the manufacturer's procedure which involves the use of a surrogate workstation containing a fully functional MFD.

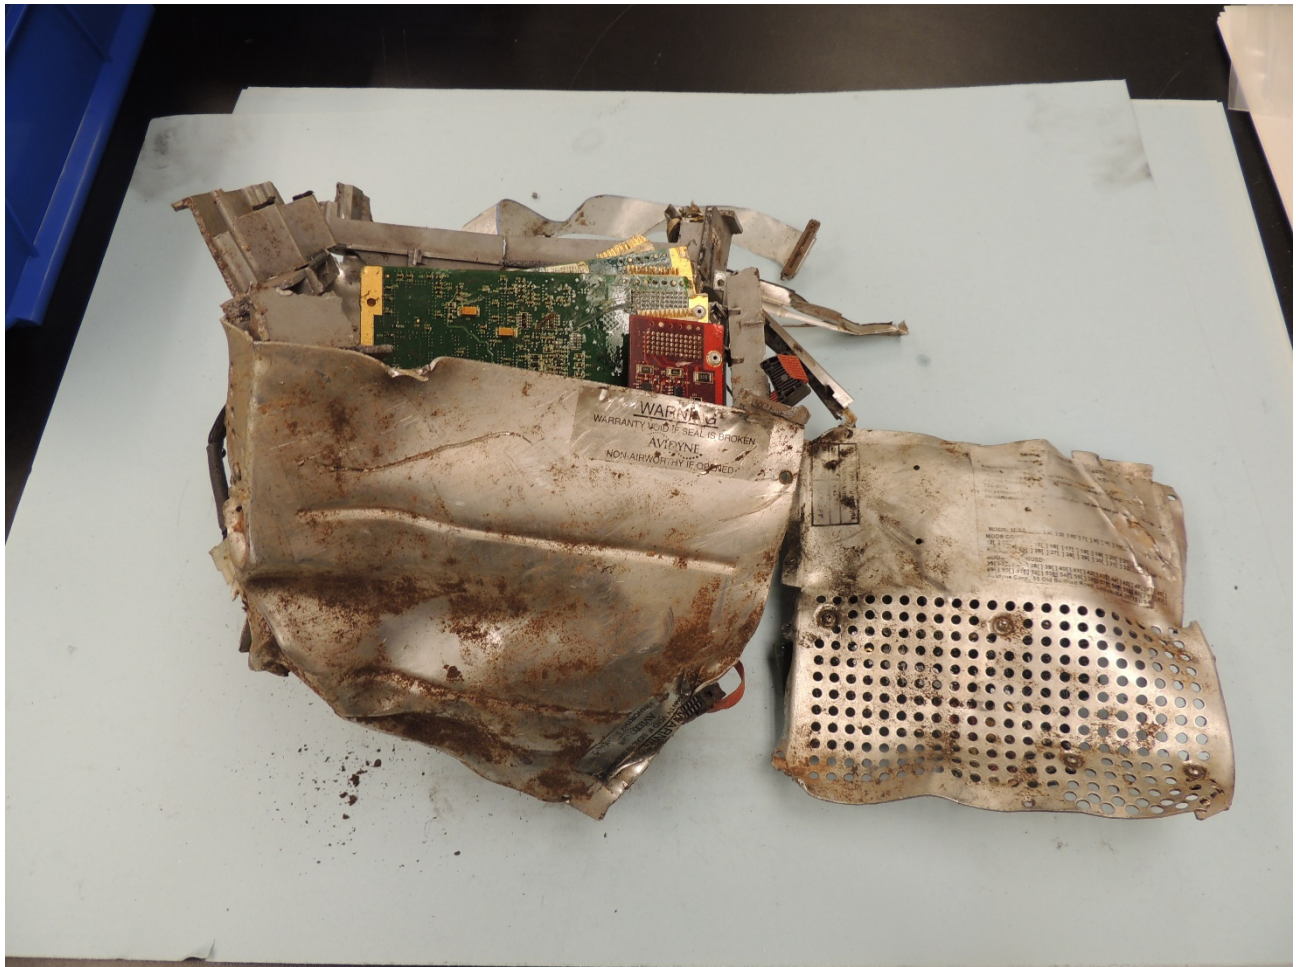
Figure 6: Avidyne PFD as received.

Upon arrival at the Vehicle Recorder Division, an exterior examination revealed the device sustained severe damage, as shown in Figure 6. The circuit board containing NVM were found, but one of the two flash memory chips was missing from the device. As shown in Figure 7, the U102 flash memory chip was on the circuit board while the U101 was missing. The U102 was removed from the circuit board, as shown in Figure 8. The extent of the damage precluded normal and advanced recovery procedures and additional attempts were unsuccessful in yielding usable data. Therefore, no data pertinent to the event were recovered.

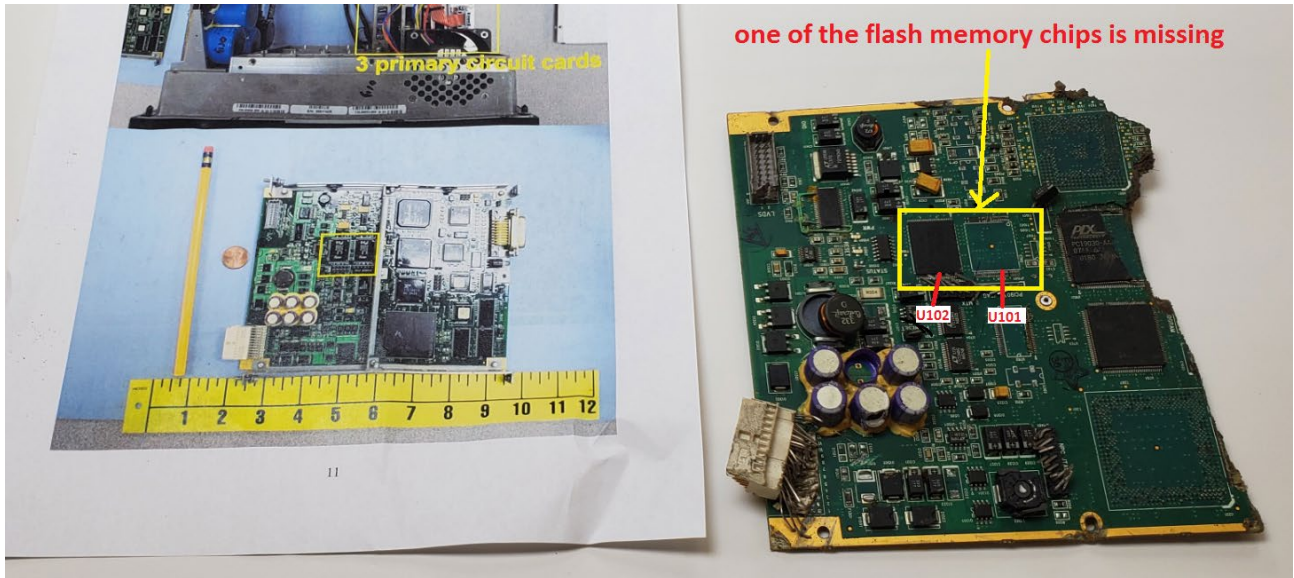
Figure 7: Circuit board containing NVMs of the Avidyne PFD comparing to an undamaged circuit board.

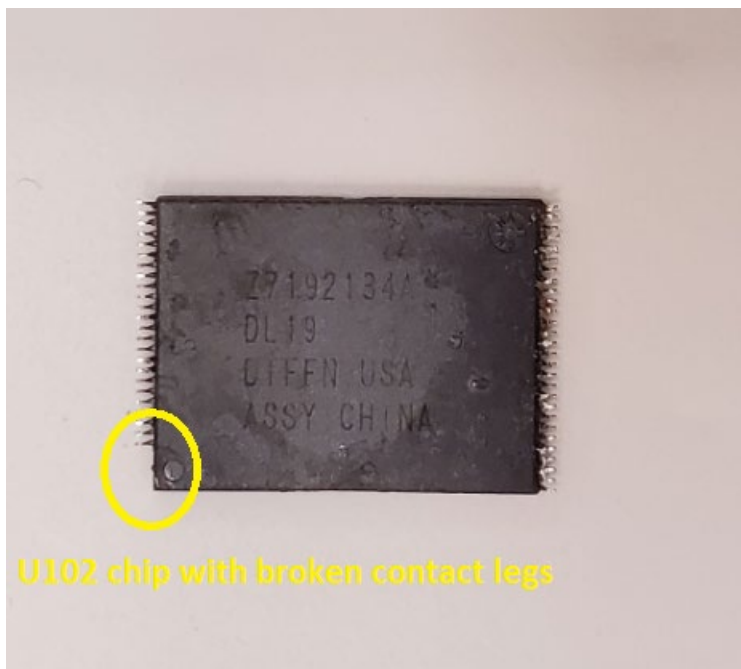
Figure 8: U102 flash memory chip had broken contact legs.

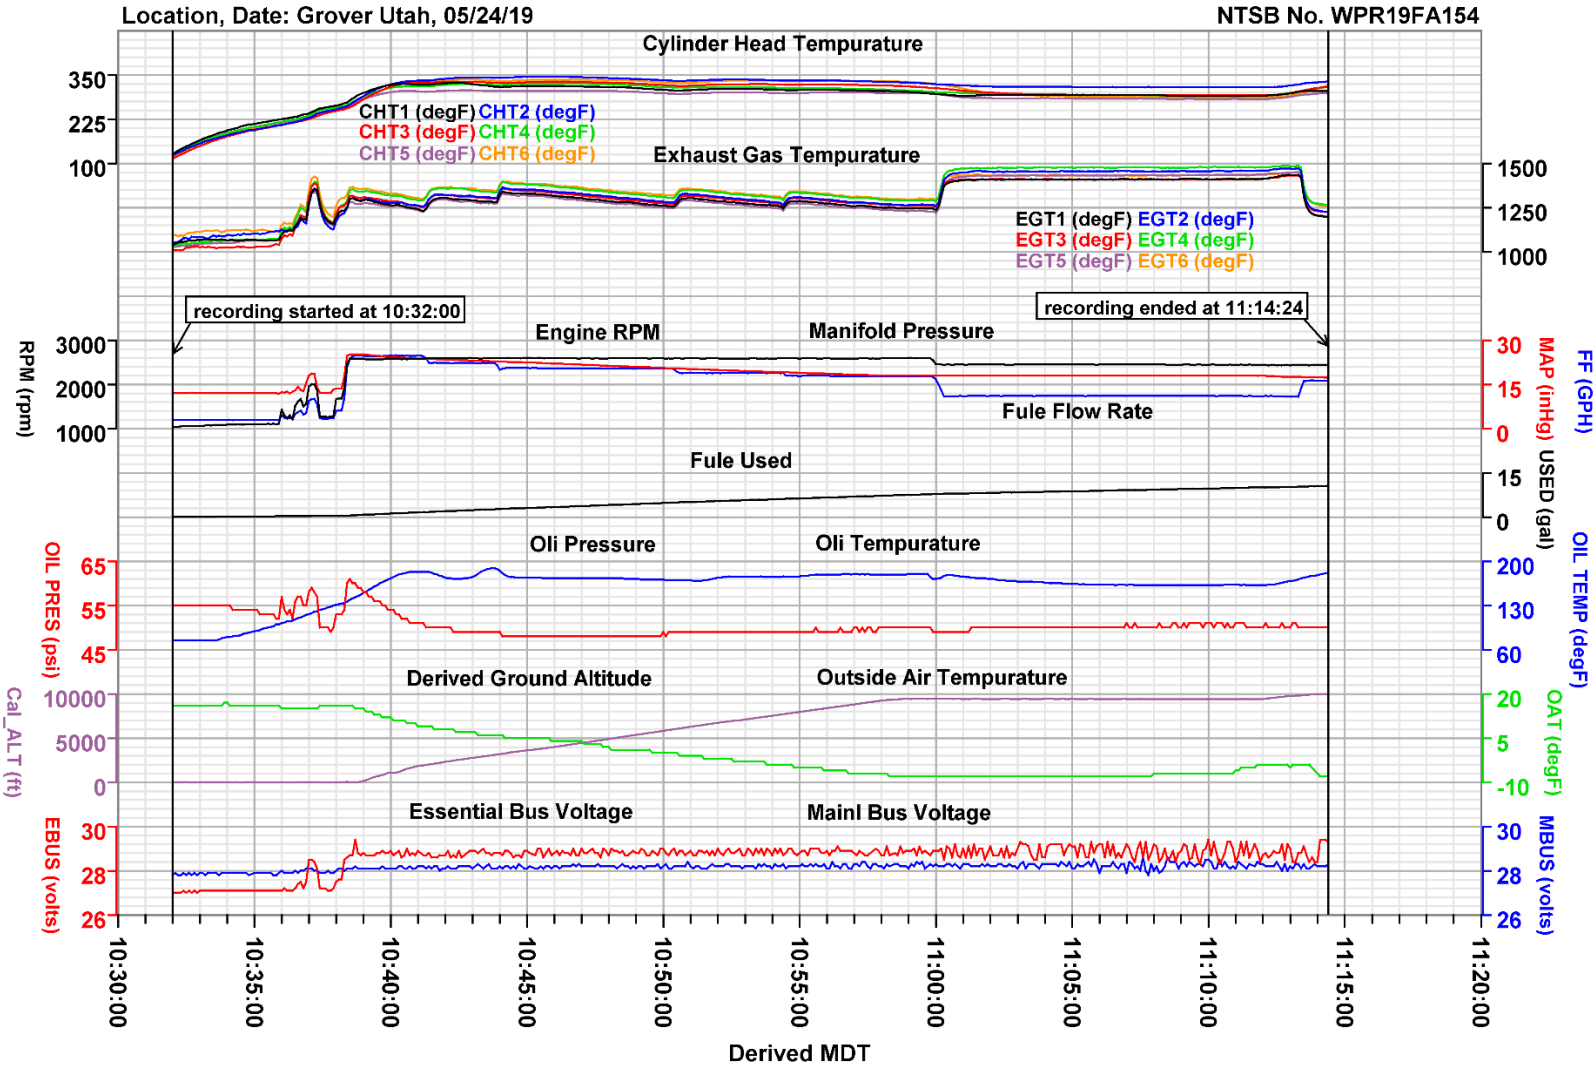
National Transportation Safety Board
 Figure 9: Plot of data parameters from Avidyne MFD CF memory card of the accident flight.

Figure 9 is a plot of the recorded data parameters from the Avidyne MFD CF card of the accident flight, from 10:33:00 to 11:14:24 MDT.

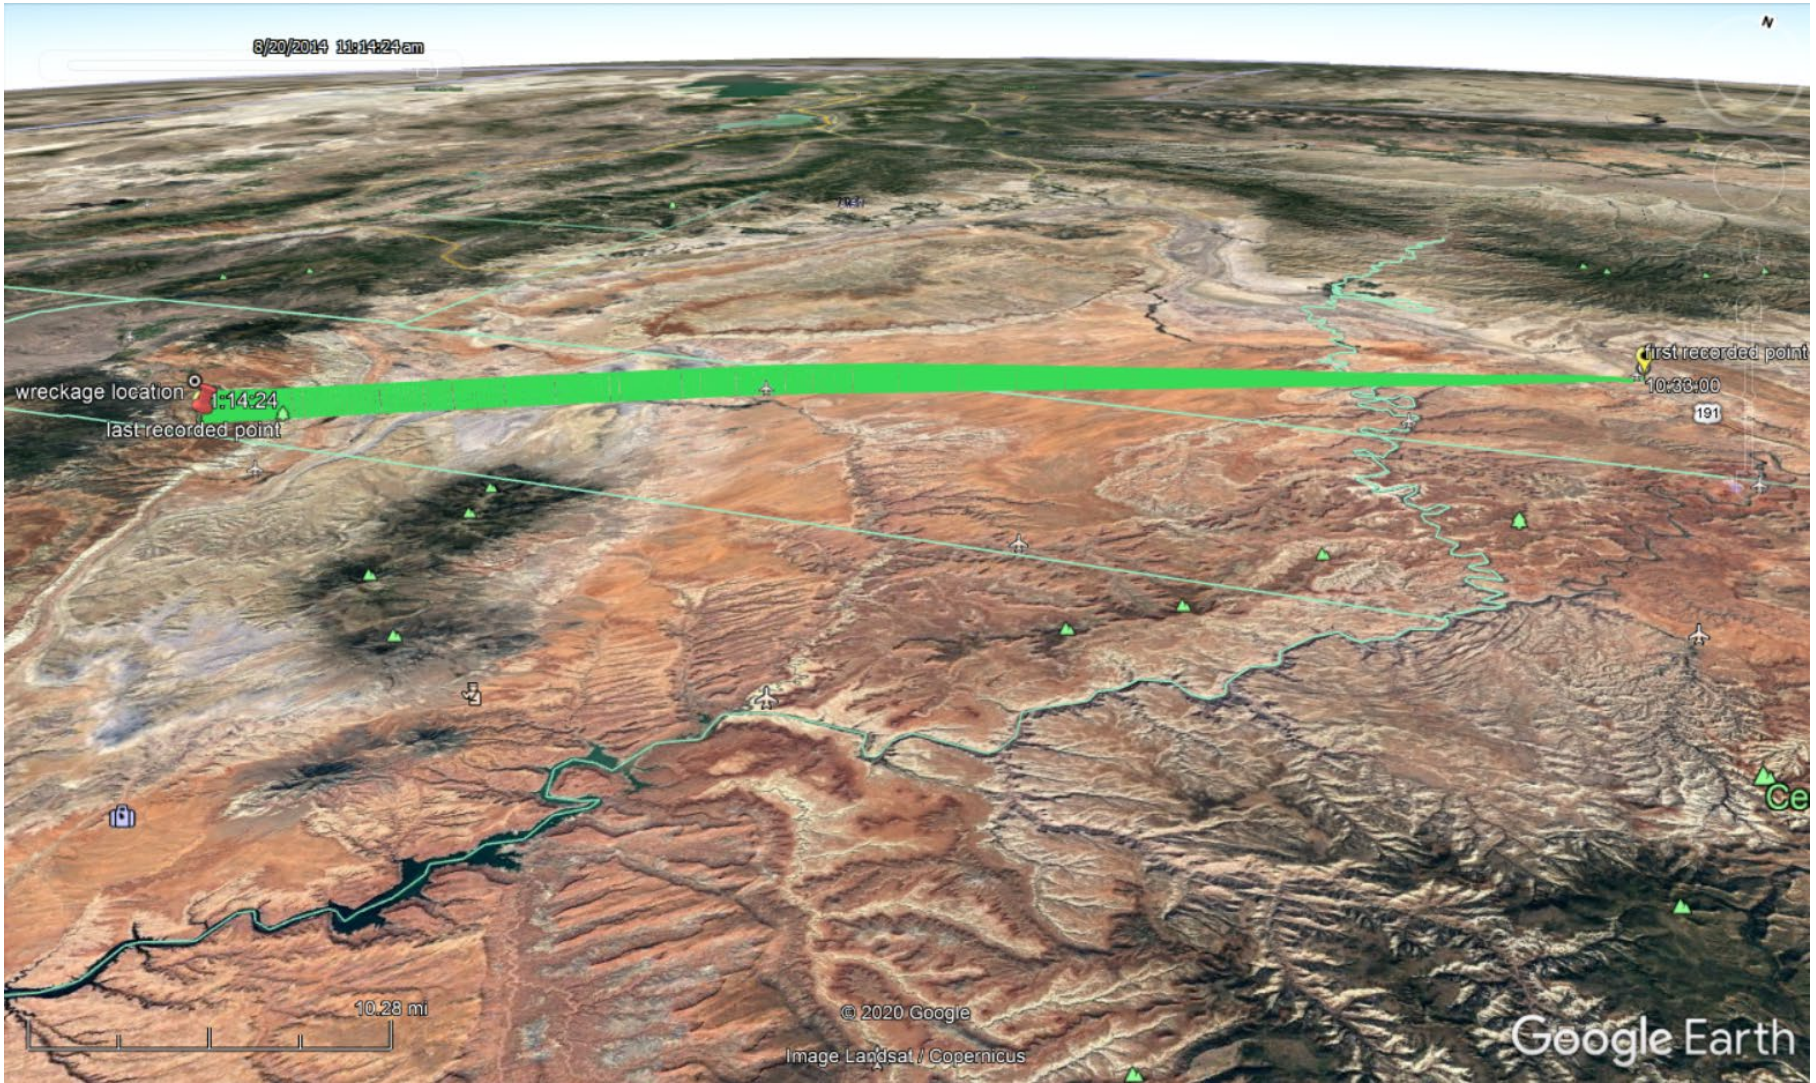
Figure 11: Google Earth overlay showing the sideview of the entire flight.

Figure 11 is a Google Earth overlay showing the sideview of the entire flight.

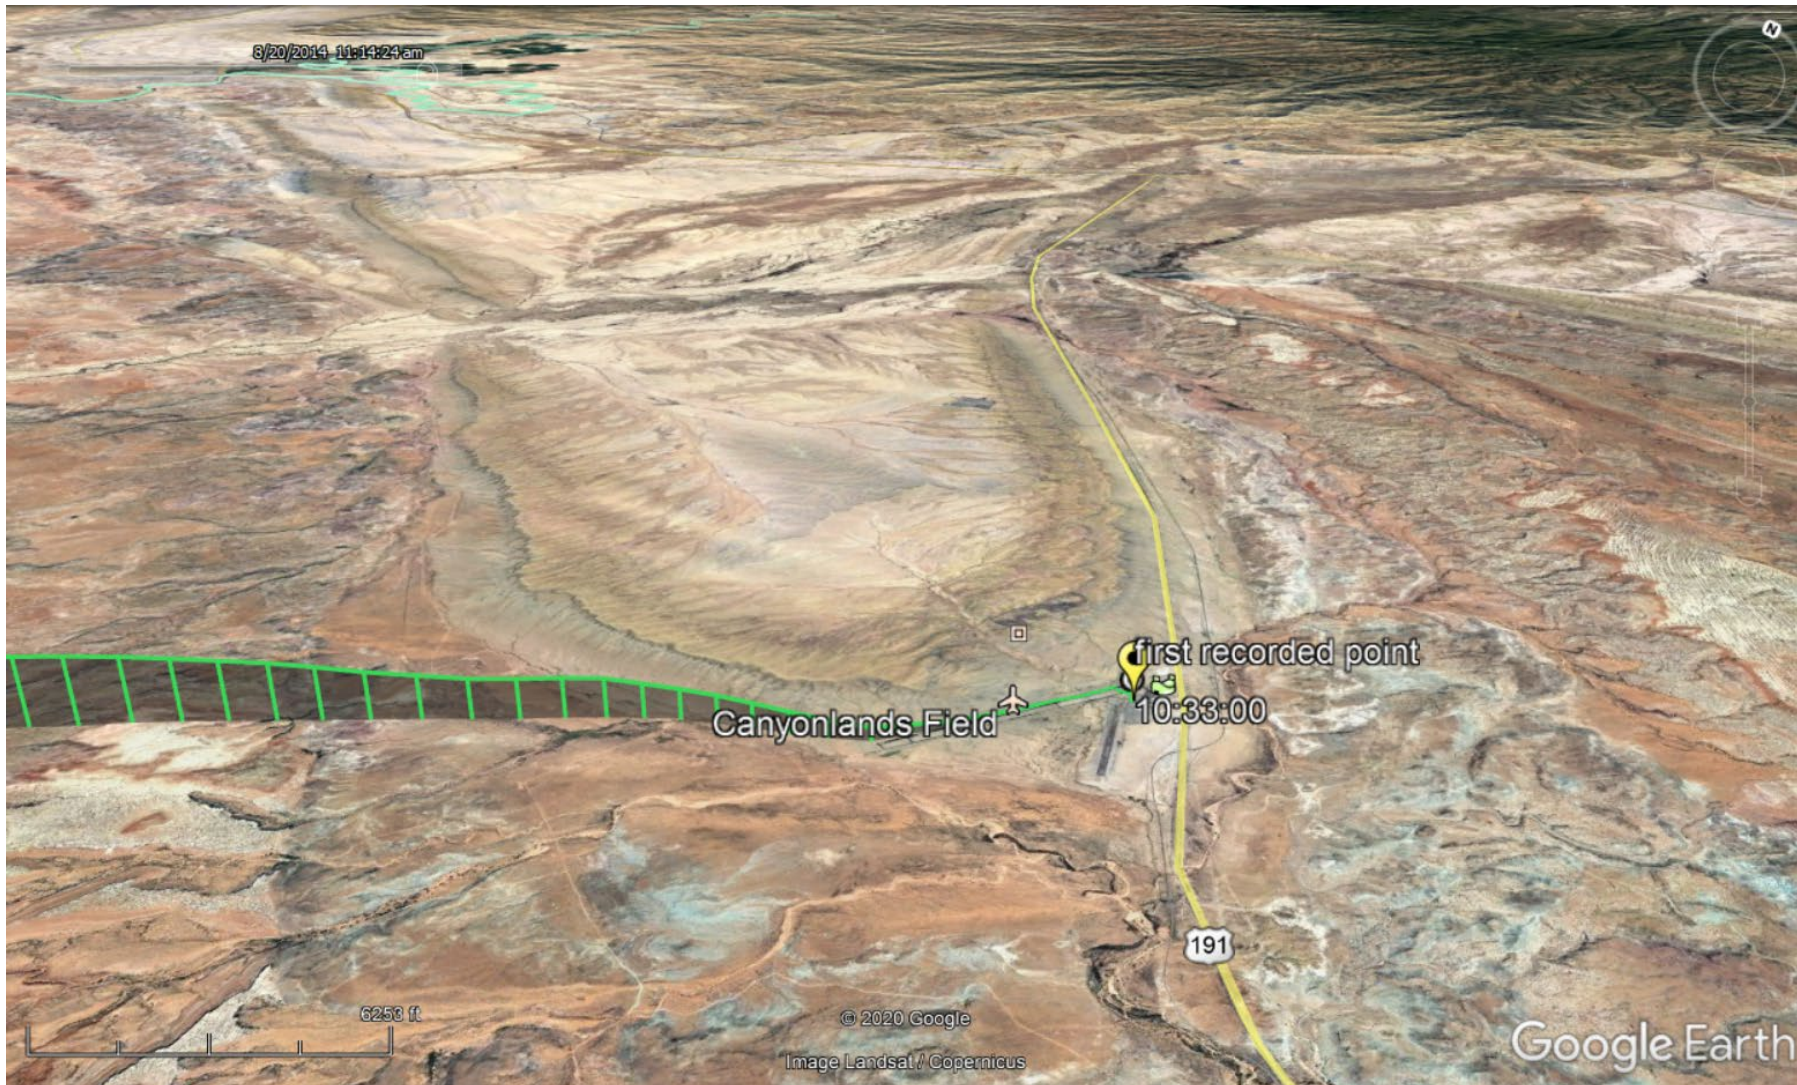
Figure 12: Google Earth overlay showing the flight originated at Canyonlands Filed Airport around 10:33:00 MDT.

Figure 12 is a Google Earth overlay showing the aircraft took off at Canyonlands Field Airport at about 10:33:00 MDT.
