**NATIONAL TRANSPORTATION SAFETY BOARD**  
Vehicle Recorder Division  
Washington, D.C. 20594

## **Electronic Devices**

### **Specialist's Factual Report by Gerald Kawamoto**

Location: La Grande, Oregon  
Date: September 8, 2019  
Aircraft: Piper PA32-300  
Registration: N6300Z  
Operator: Private  
NTSB Number: WPR19FA256

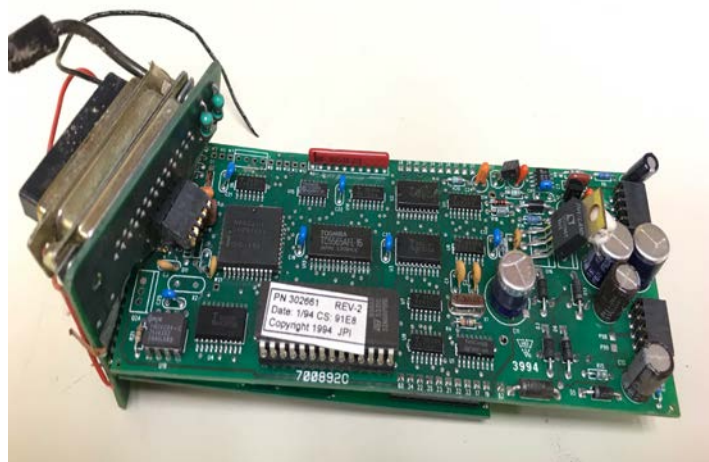
Figure 2. Internal components of JPI EDM-700. No presence of non-volatile memory.

Upon arrival at the Vehicle Recorder Laboratory, an external examination revealed the device had sustained impact damage, as shown in Figure 1. An internal examination of the device revealed that this model of JPI EDM-700 does not have the capability to record non-volatile memory<sup>1</sup>, as shown in Figure 2, therefore no data from this device were recovered.

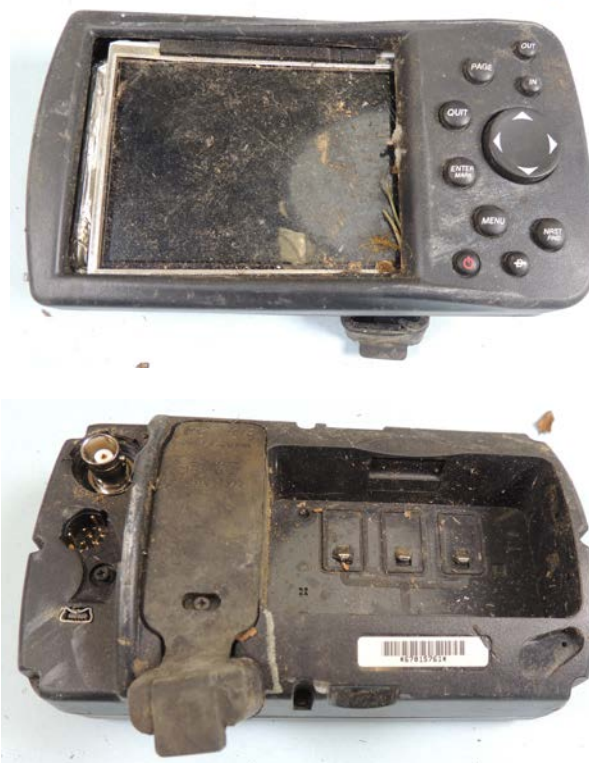
Upon arrival at the Vehicle Recorder Division, an exterior examination revealed the device had sustained impact damage, as shown in Figure 3, resulting in the device becoming inoperable. An internal examination revealed damage to the logic board. The non-volatile memory chip was removed, read out and converted to engineering units using laboratory tools.

Figure 3. Front and back of the Garmin GPSMAP 296 as received.

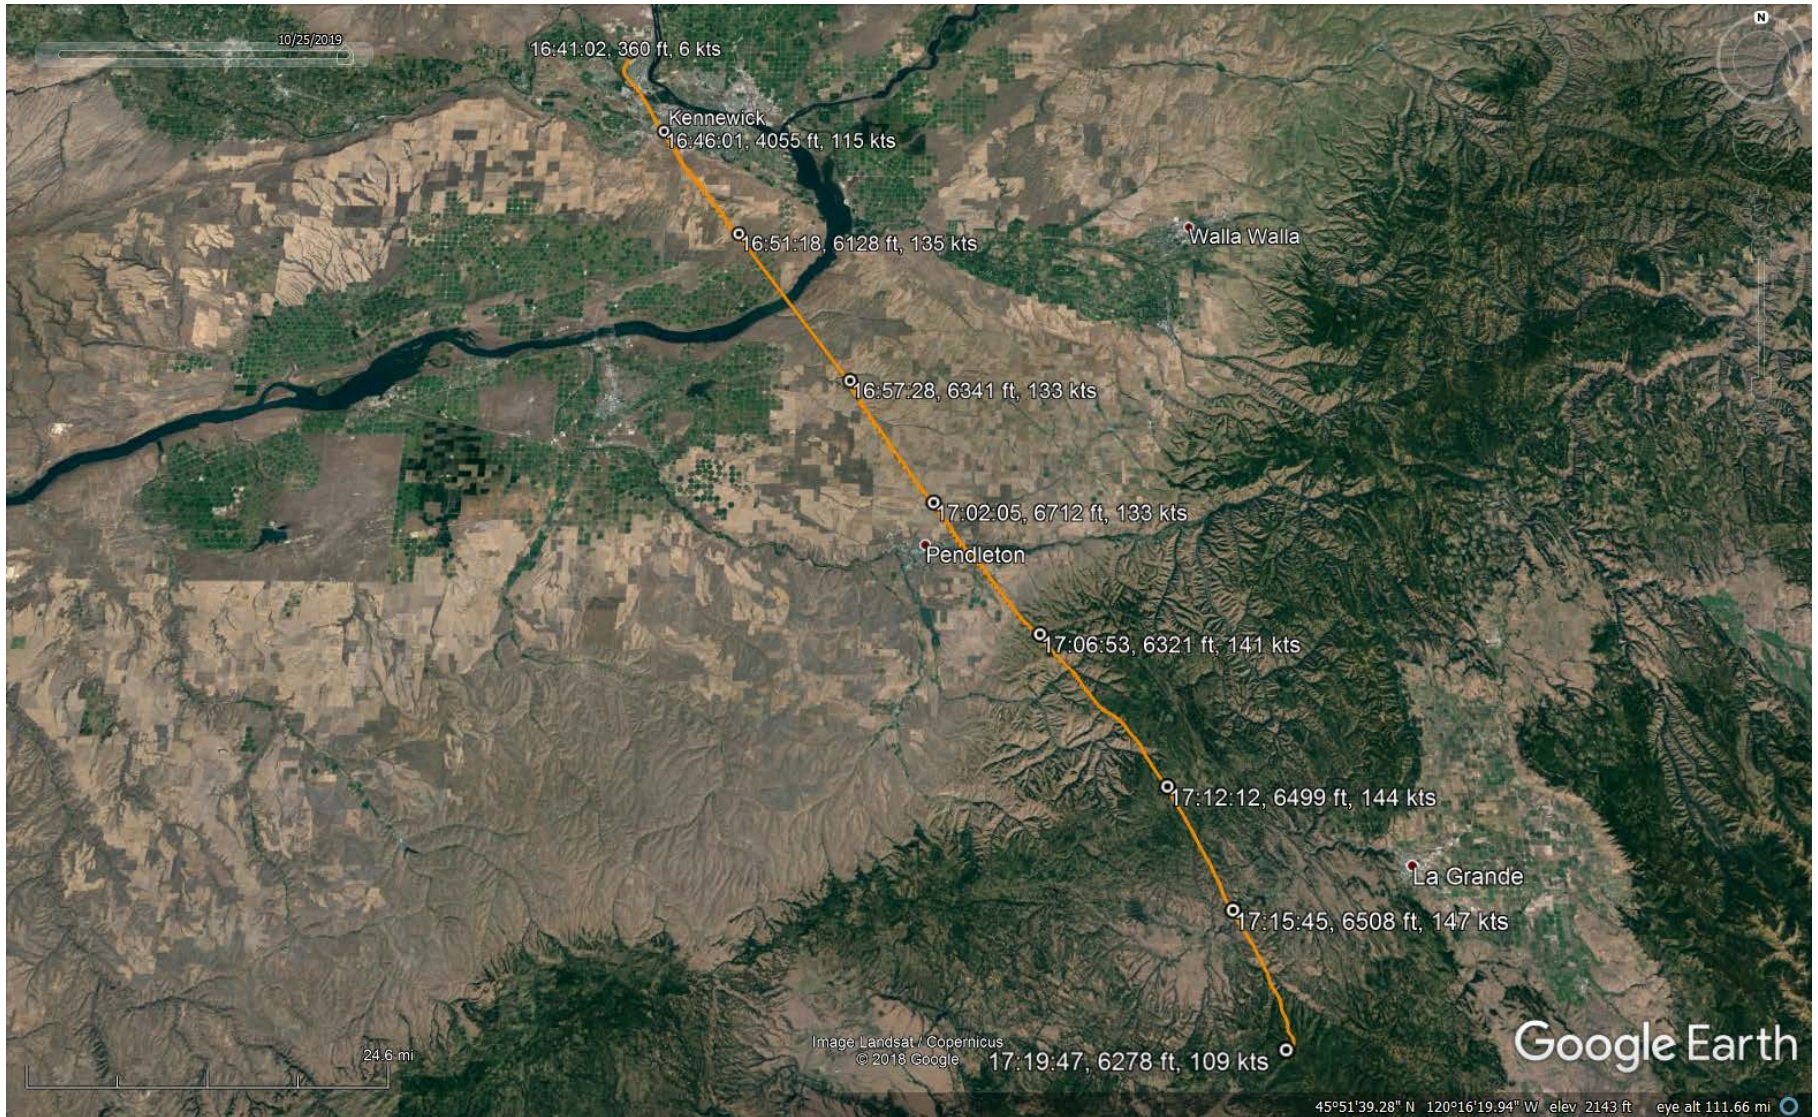
Figure 4 is a graphical overlay generated using Google Earth of the entire accident flight. The weather and lighting conditions in Google Earth are not necessarily the weather and lighting conditions present at the time of the recording. The recording started at 16:36:52 UTC and ended at 17:19:47 UTC.

Figure 4. Google Earth overlay of the entire accident flight.

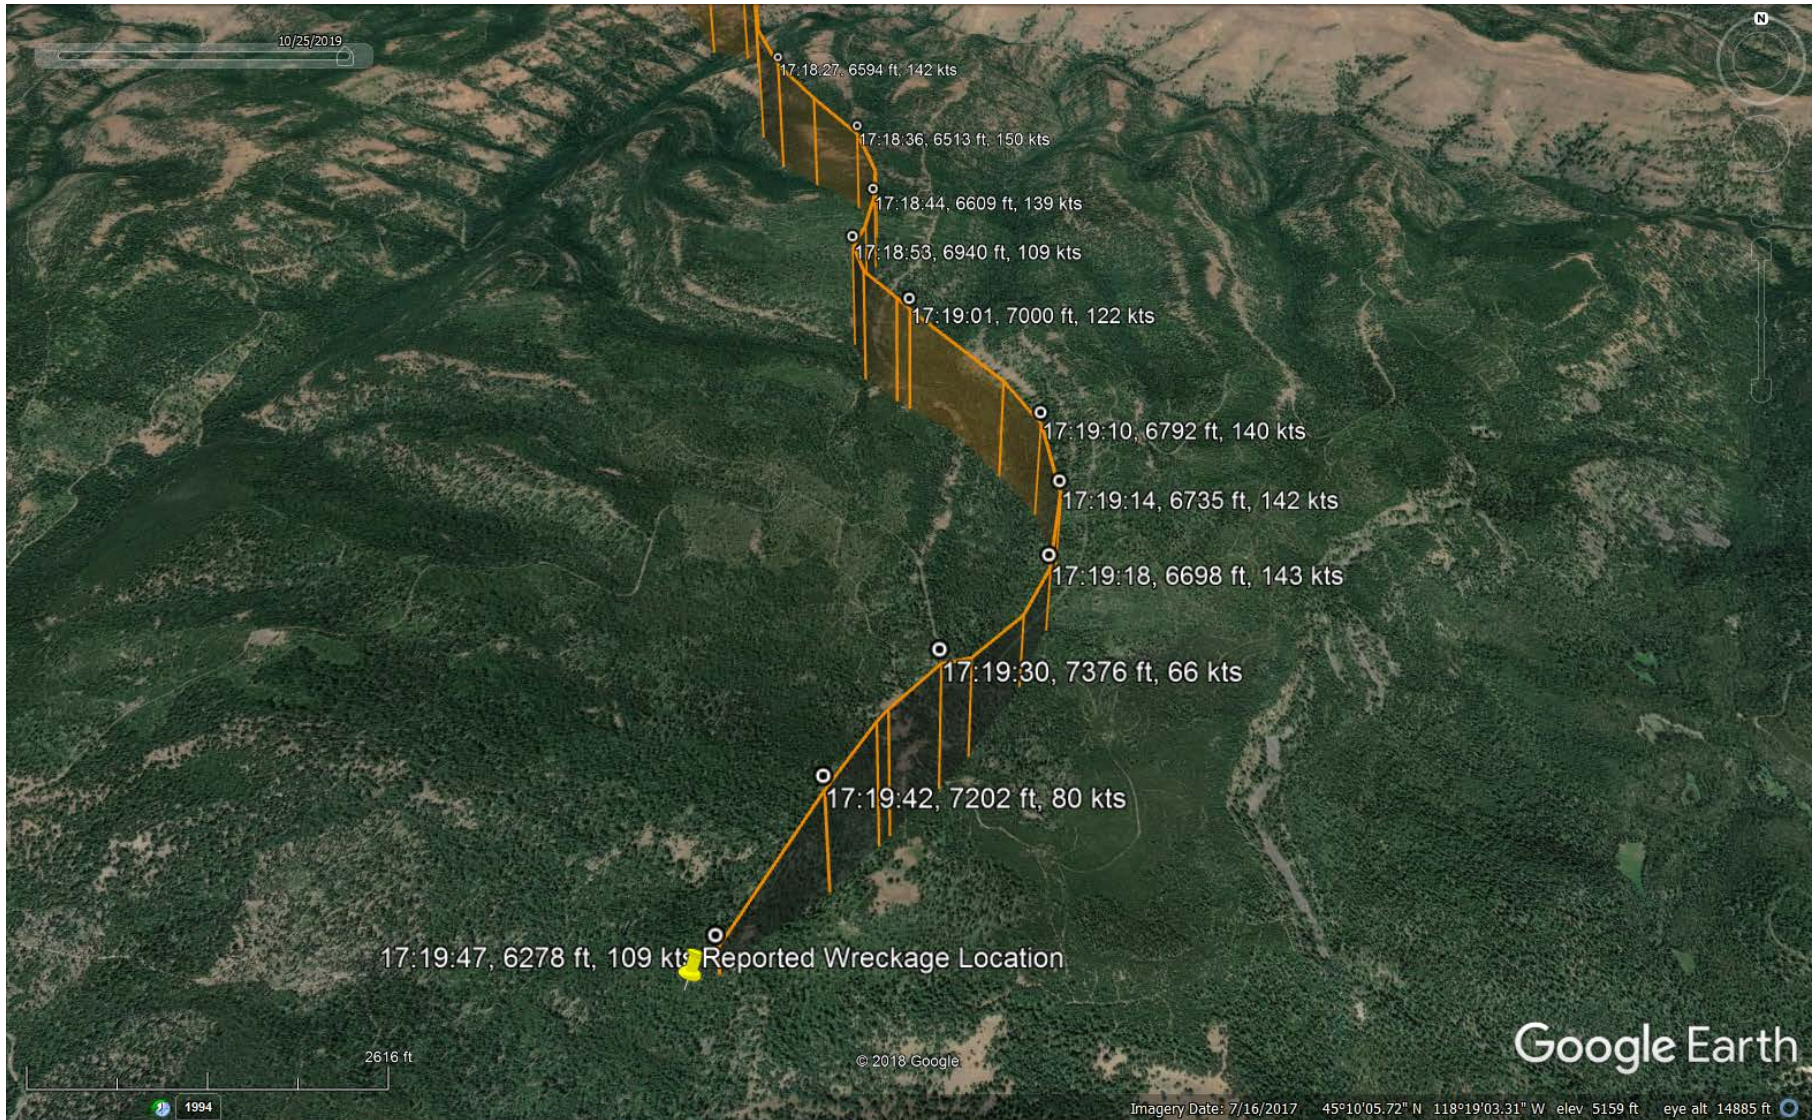
Figure 5 is graphical overlay generated using Google Earth of the end of the accident flight.

Figure 5. Google Earth overlay of the end of the accident flight.
