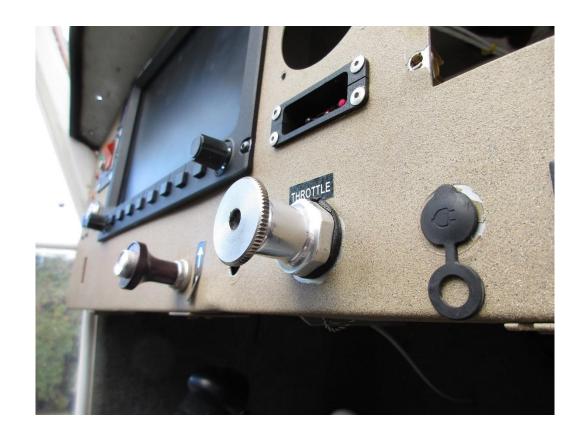
Photo 2 – View of the push-pull throttle control (Courtesy of FAA)

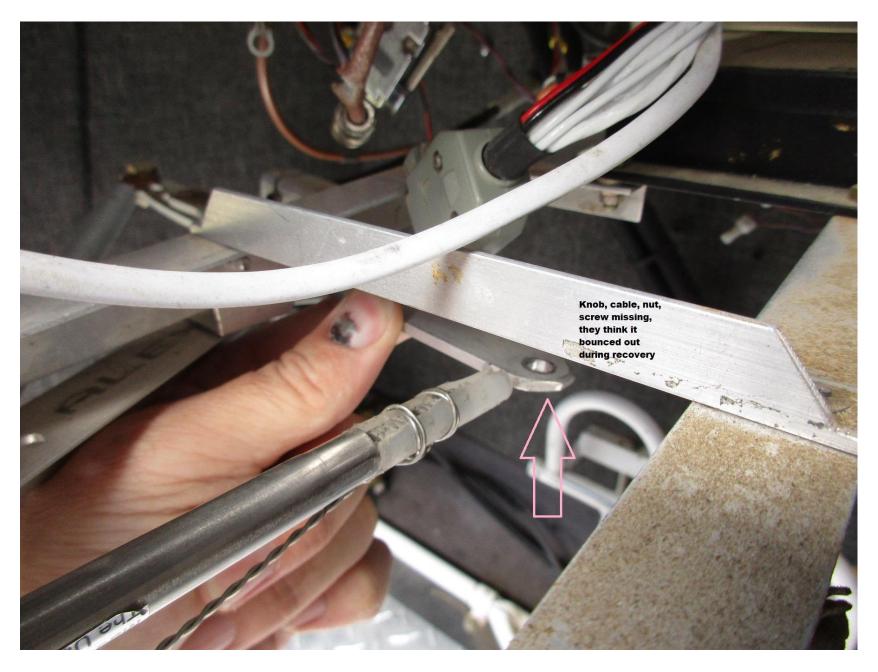
Photo 3 – View of the separated throttle control and pivot arm (Courtesy of FAA)
