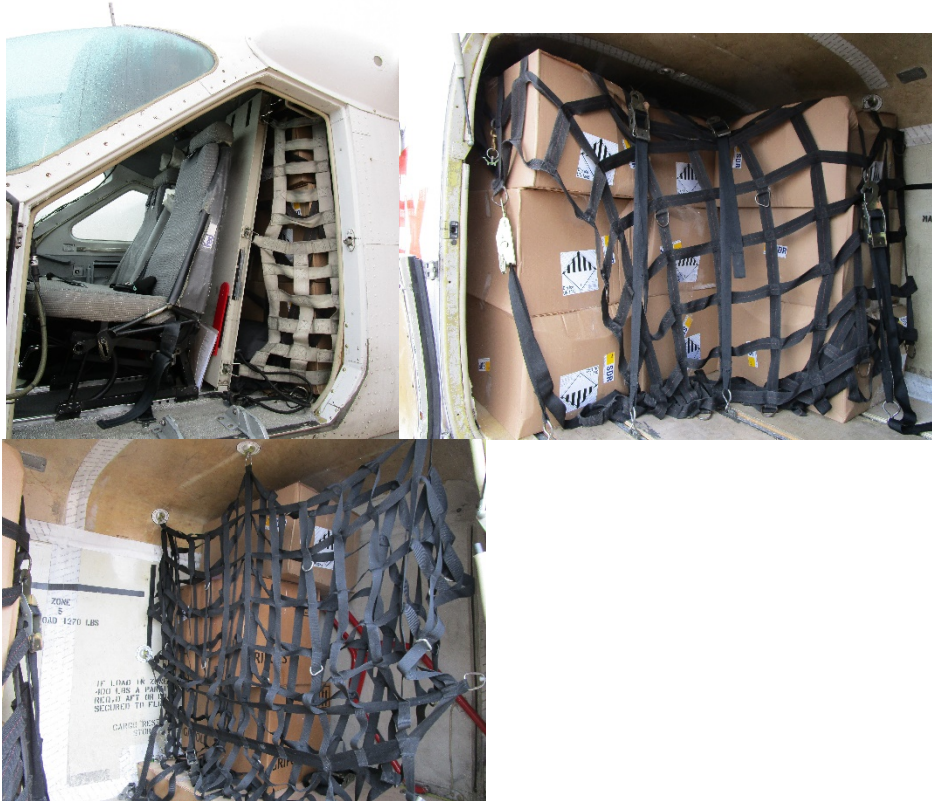
- What the cargo looked like - **Mostly boxes, some bags full of envelopes and small items. I believe all of the bags were located in the lower storage area (pod)**

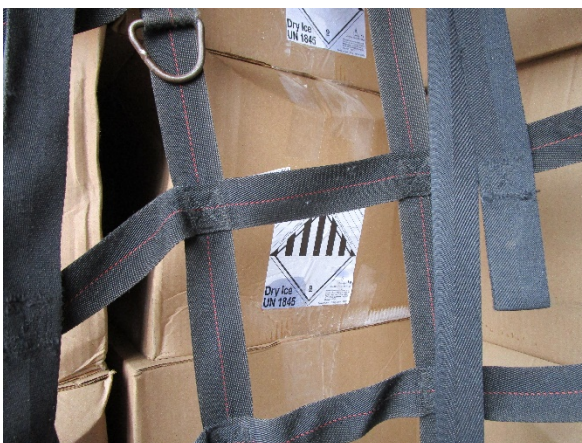
- How many boxes in upper cargo area - **I did not get a count of total boxes in the upper area. No Dry ice boxes were stored in the lower compartment. See Pics for reference of upper packing**
- Condition of the boxes - **Boxes marked with dry ice label appeared to be damp, in general good condition. Some boxes had visible frost on the outside of the box**

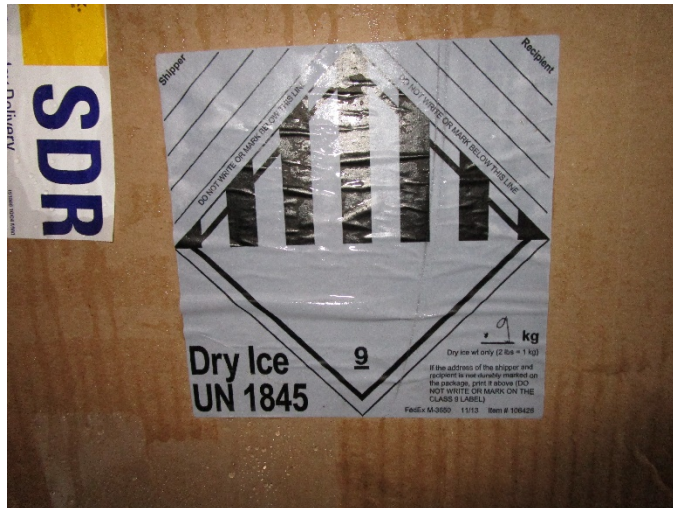
- Which boxes had dry ice - I did not open every box to inventory and weigh ice. Dry Ice boxes were labeled with Hazmat placard and listed .9 kg of Dry Ice.

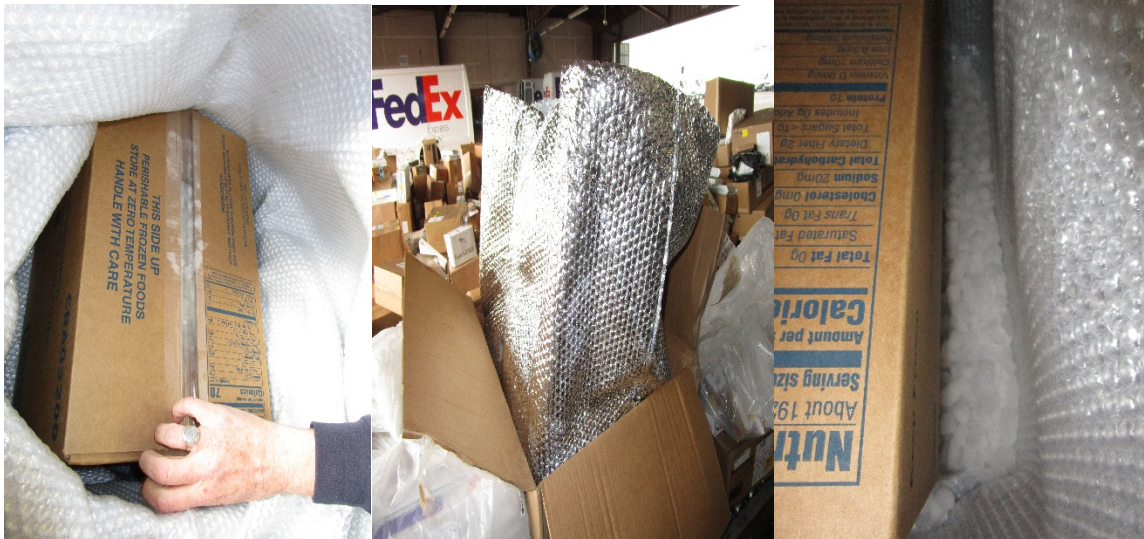
- How the dry ice appeared to have been packaged, - The packaging was minimal. Outer box had shipping and hazmat label, inside that box was thermal wrap/bag (see pics) which was basically bubble wrap with a Mylar coat, inside the thermal bag was the food product box and loosely placed dry ice pellets. The thermal bag was folded over and loosely taped closed.

The POI and I discussed possible changes to implement in the GOM regarding carriage of Dry Ice regardless of amount.

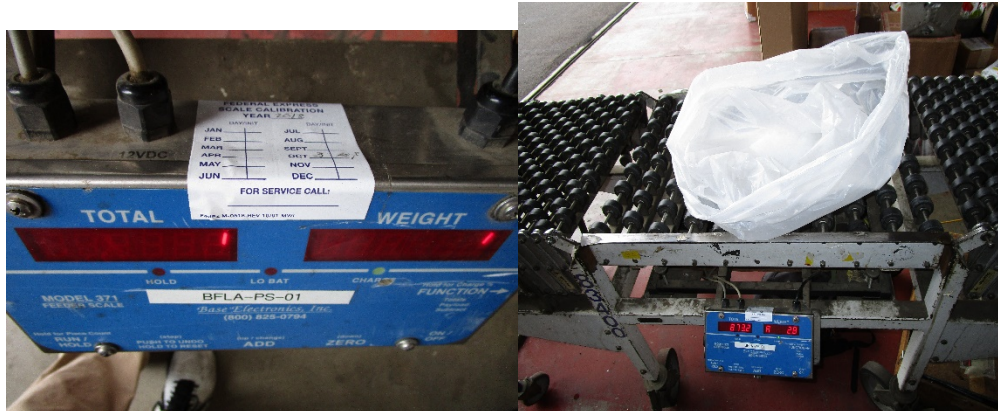
- How the cargo was weighed- The cargo was weighed using Fed Ex's conveyor scale which was certified on October 3, 2018

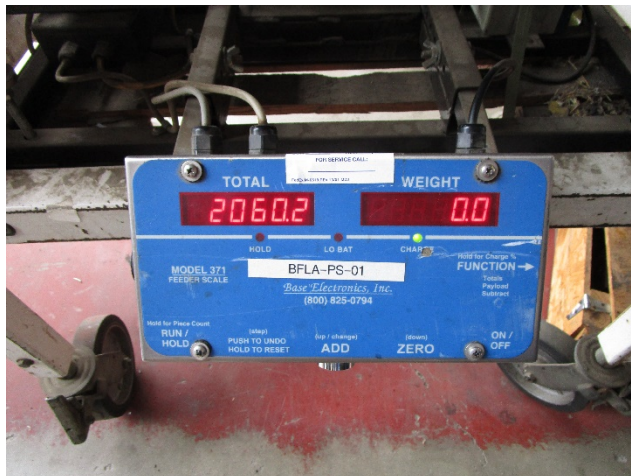
- What the results of the weighing was- 2060.2
