National Transportation Safety Board

ERA22LA120

FLIGHT DATA RECORDER

Specialist's Factual Report

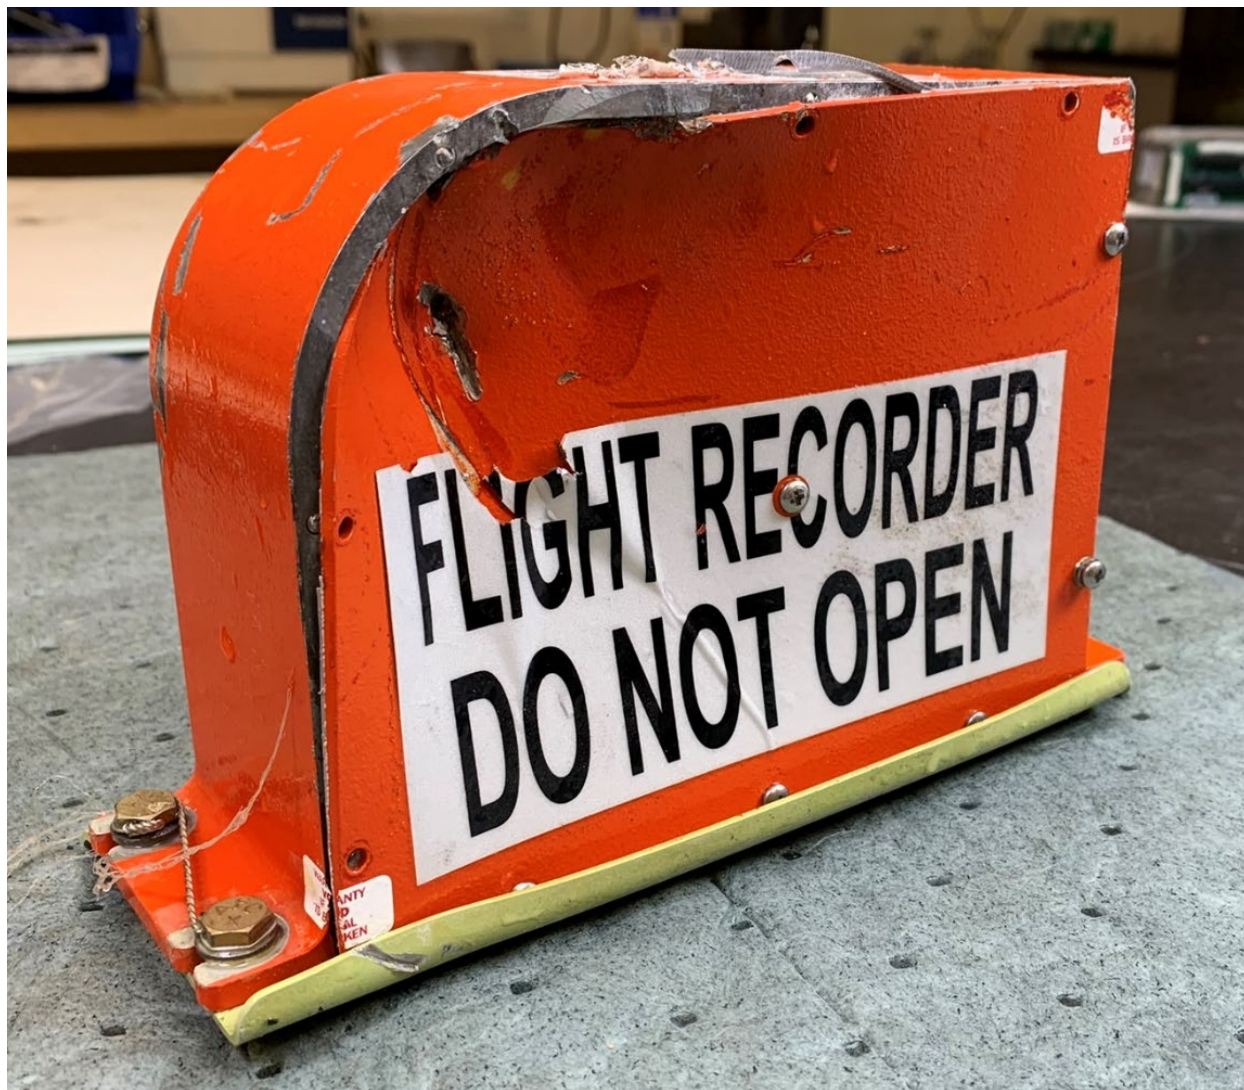
The wreckage was located 3 miles offshore in about 60 feet (ft) of water. The recorder was recovered from the wreckage by dive crews 5 days after the accident. The recorder was rinsed with fresh water and packed in a container of fresh water for shipment to the NTSB's vehicle recorder laboratory.

Figure 1. Condition of recorder after removal from water upon arrival at lab.

Upon arrival, the recorder was disassembled, and the solid-state memory module was cleaned and dried using the NTSB's standard process for handling of electronics submerged in sea water. During disassembly, it was found that due to mechanical impact damage, the backup power source had been electrically shorted to the crash survivable case of the memory module. Inspecting the memory module showed that many of the solder connections from the memory chips to the circuit

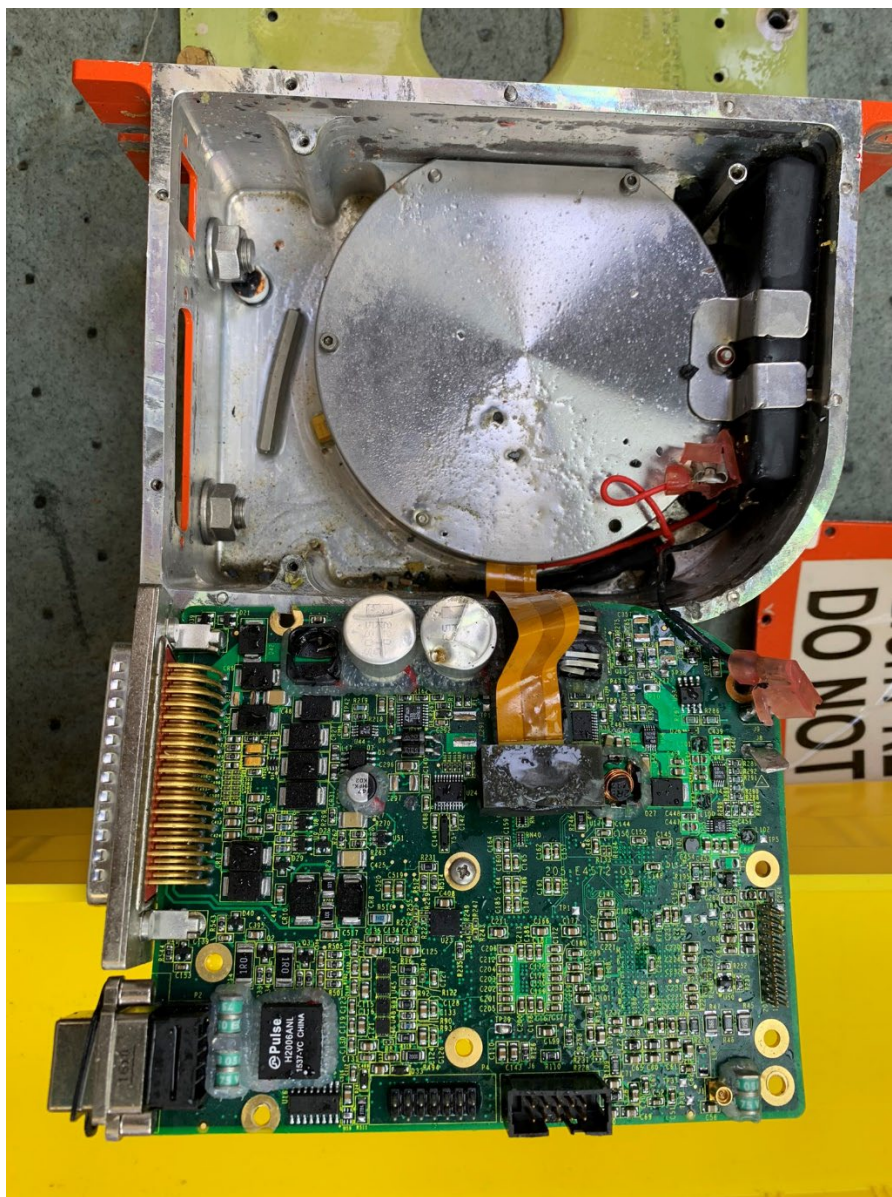
board had been corroded away. This was likely due to an oxidizing reaction between the solder and the sea water which was catalyzed by current flow from the backup power source.

Figure 2. LDR internals exposed showing backup power supply shorted to crash-survivable case.

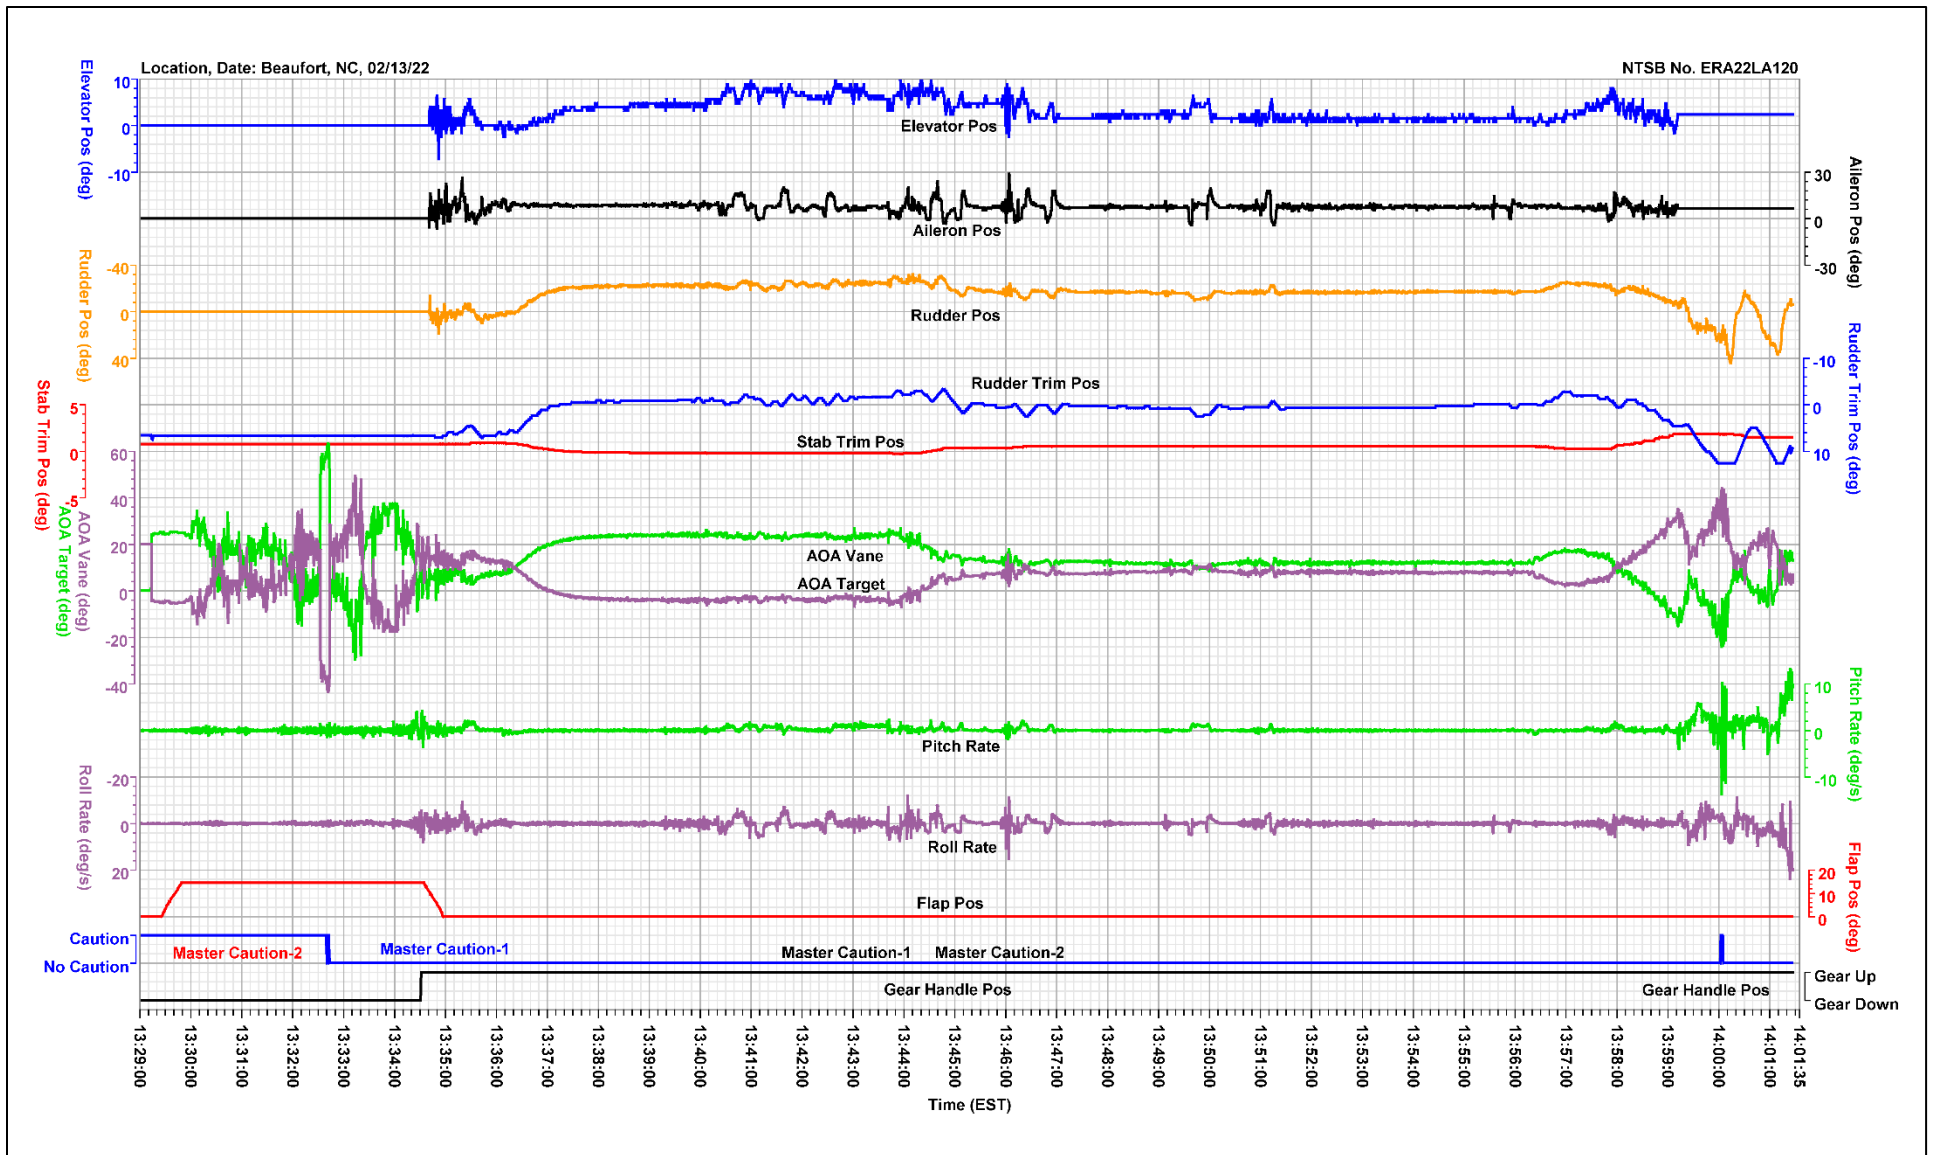
All figures cover the time from when the engine was started until the time of the accident, a span from 1329:00 EST to 1401:35 EST. Figure 4 is a plot of aircraft basic parameters providing an overview of the accident flight. Figure 5 is a plot of parameters related to aircraft automation. Figure 6 is a plot of flight control parameters. Note that control surface positions are sourced from the Actuator Input/Output Processor (AIOP) module and are only correctly reported when the autopilot is active. Figure 7 is a plot of engine parameters. Figure 8 is a map overlay in Google Earth of the flight path of the accident flight. Note that the atmospheric and lighting conditions in Google Earth are not representative of those at the time of the accident.

Figure 6. Plot of flight controls parameters.
