**NATIONAL TRANSPORTATION SAFETY BOARD**  
Vehicle Recorder Division

**Flight Management Computer & Maintenance Data Computer**

**Specialist's Factual Report**  
**By Kyle Garner**

Location: Truckee, California  
Date: July 26, 2021  
Aircraft: Bombardier Inc. CL-600-2B16  
Registration: N605TR  
NTSB Number: WPR21FA286

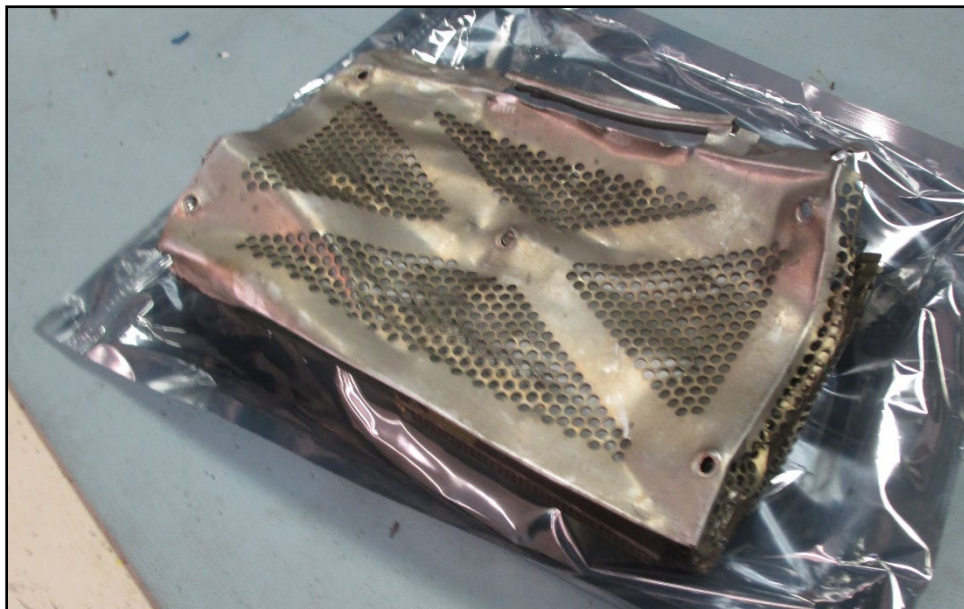
An external inspection revealed significant impact damage to all three FMC units, as shown in Figure 1, Figure 2, and Figure 3. Foreign object debris (FOD) was also audible when the units were examined.

**Figure 1. FMC 1, as received.**

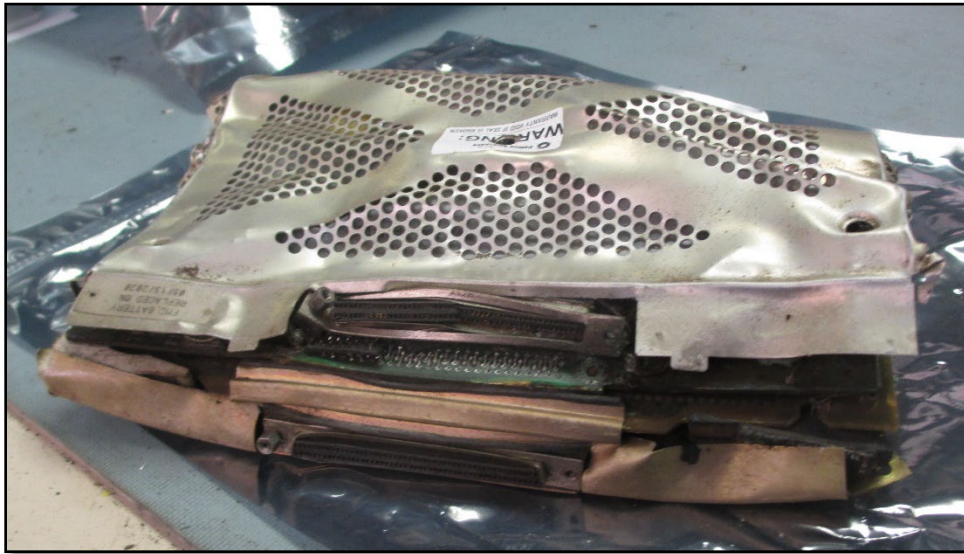
**Figure 2. FMC 2, removed from IAPS cage.**

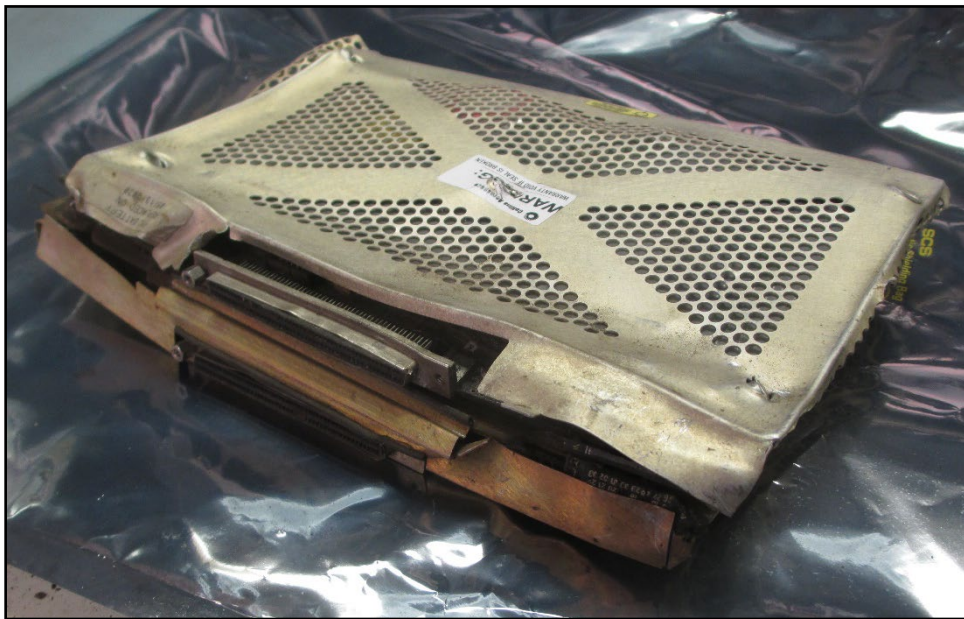
**Figure 3. FMC 3, removed from IAPS cage.**

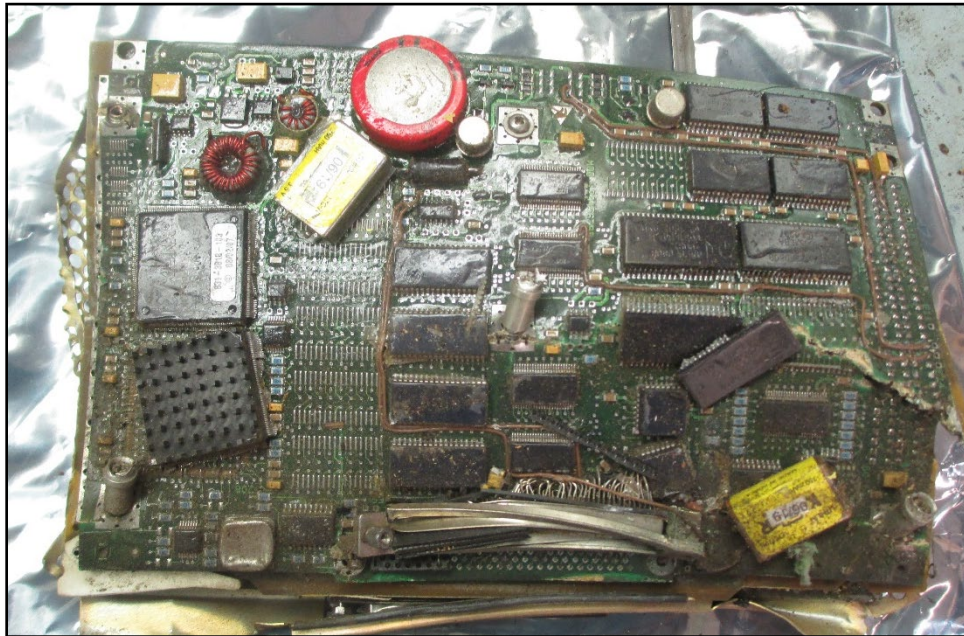
The covers on the FMCs were removed and the FOD was noted to be the SRAM batteries that had separated from the circuit cards. In addition, the backplane connector used to interface with the test equipment was damaged on all three units. Damage to FMC 2, with the cover removed, is shown in Figure 4.

**Figure 4. FMC 2 damage, with cover removed. Damage to FMC 1 and FMC 3 was similar.**

Due to the damage to the backplane connector and the separation of the SRAM batteries from the circuit cards, it was determined that data from the FMCs were not recoverable.

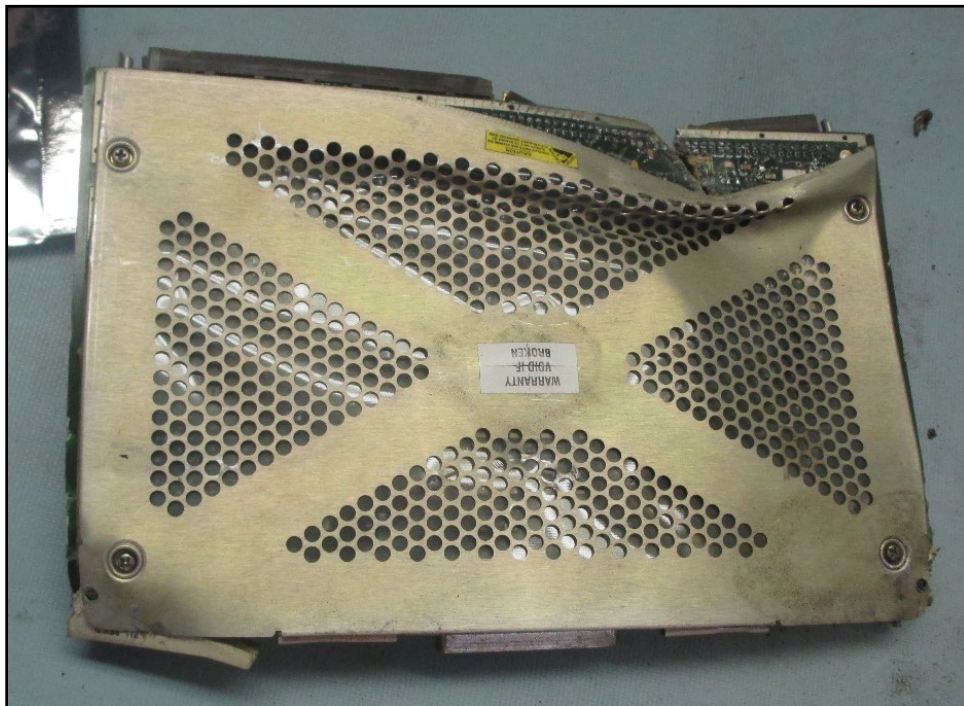
An external inspection revealed significant impact damage to the MDC cover and main connector, as shown in Figure 5.

**Figure 5. MDC, removed from IAPS cage.**

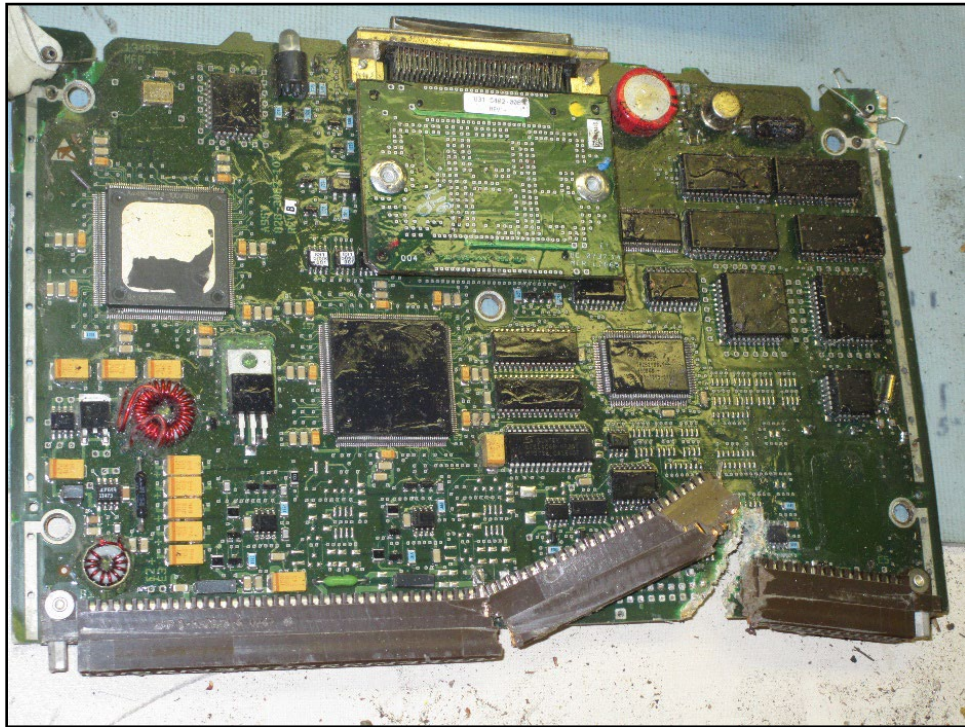
FOD was also audible when the unit was removed from the cage. The cover was removed and the FOD was noted to be the processor's heatsink and battery. An approximately 2-inch long gash was also visible on the circuit board in the area where the main connector was damaged. A photograph of the top and bottom of the MDC, with the cover removed, is shown in Figure 6 and Figure 7.

**Figure 6. Top of MDC, cover removed.**

It was determined that the MDC could not be downloaded as-is due to the damage to the main connector and circuit board.

An exemplar MDC-3110 with the same circuit card assembly was located and converted to the same top-level MDC assembly as the damaged unit. The exemplar unit was installed in an MDC test rig to ensure it was in working order. The NVM chip on the damaged MDC was located, removed, and installed on the exemplar MDC<sup>4</sup>.

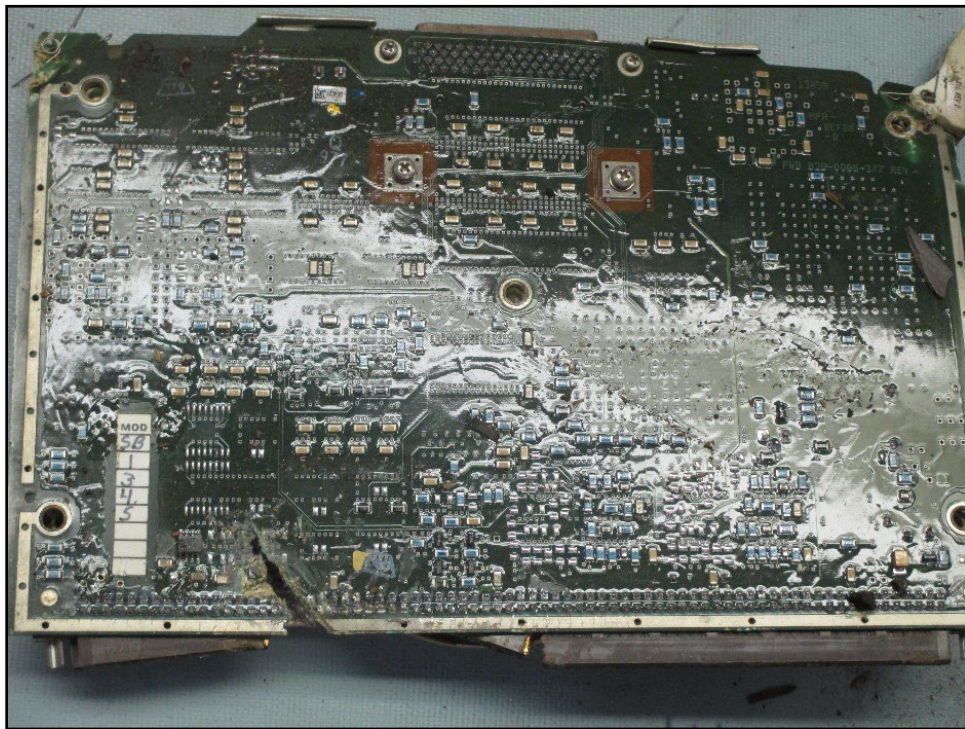
**Figure 7. Bottom of MDC, cover removed.**
