National Transportation Safety Board

WPR22LA231

GLOBAL POSITIONING SYSTEM DEVICES

Specialist's Factual Report

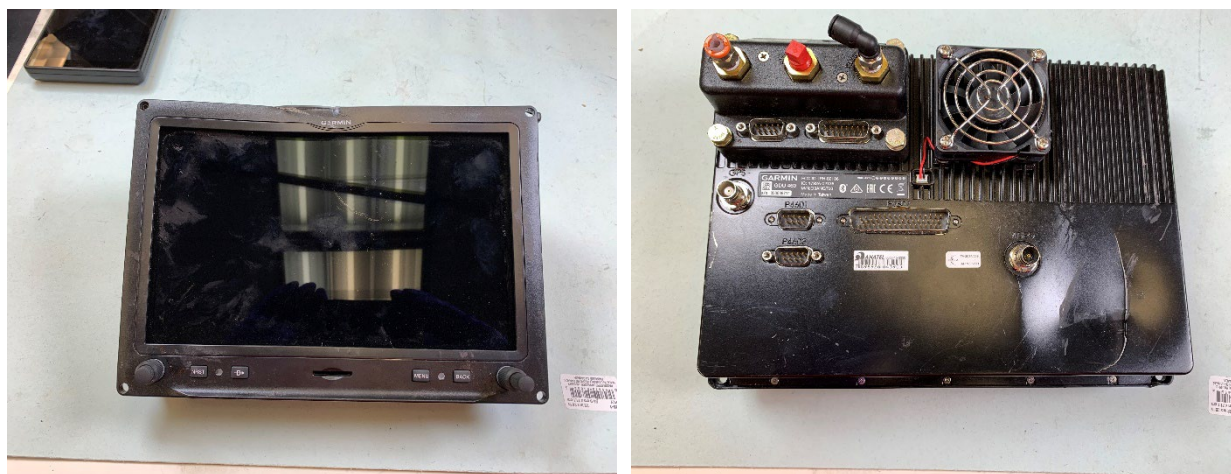
The unit suffered minor damage to the display and external casing in the accident, as shown in Figure 1. Power was applied to the unit and the display would not power on. A replacement display from a surrogate device was installed and the unit then powered on normally. Data were successfully recovered using instructions provided by the device manufacturer.

Figure 1. Garmin GDU 460 front (left) and rear (right), as received.

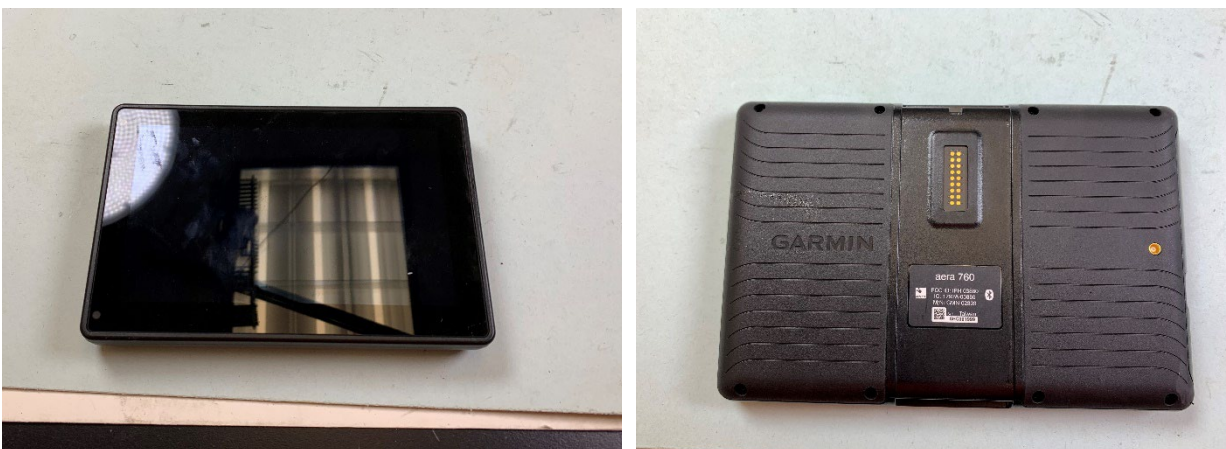
The unit arrived in good condition and had no visible damage, as shown in Figure 2. Data were successfully recovered using instructions provided by the device manufacturer.

Figure 2. Garmin aera 760 front (left) and rear (right), as received.

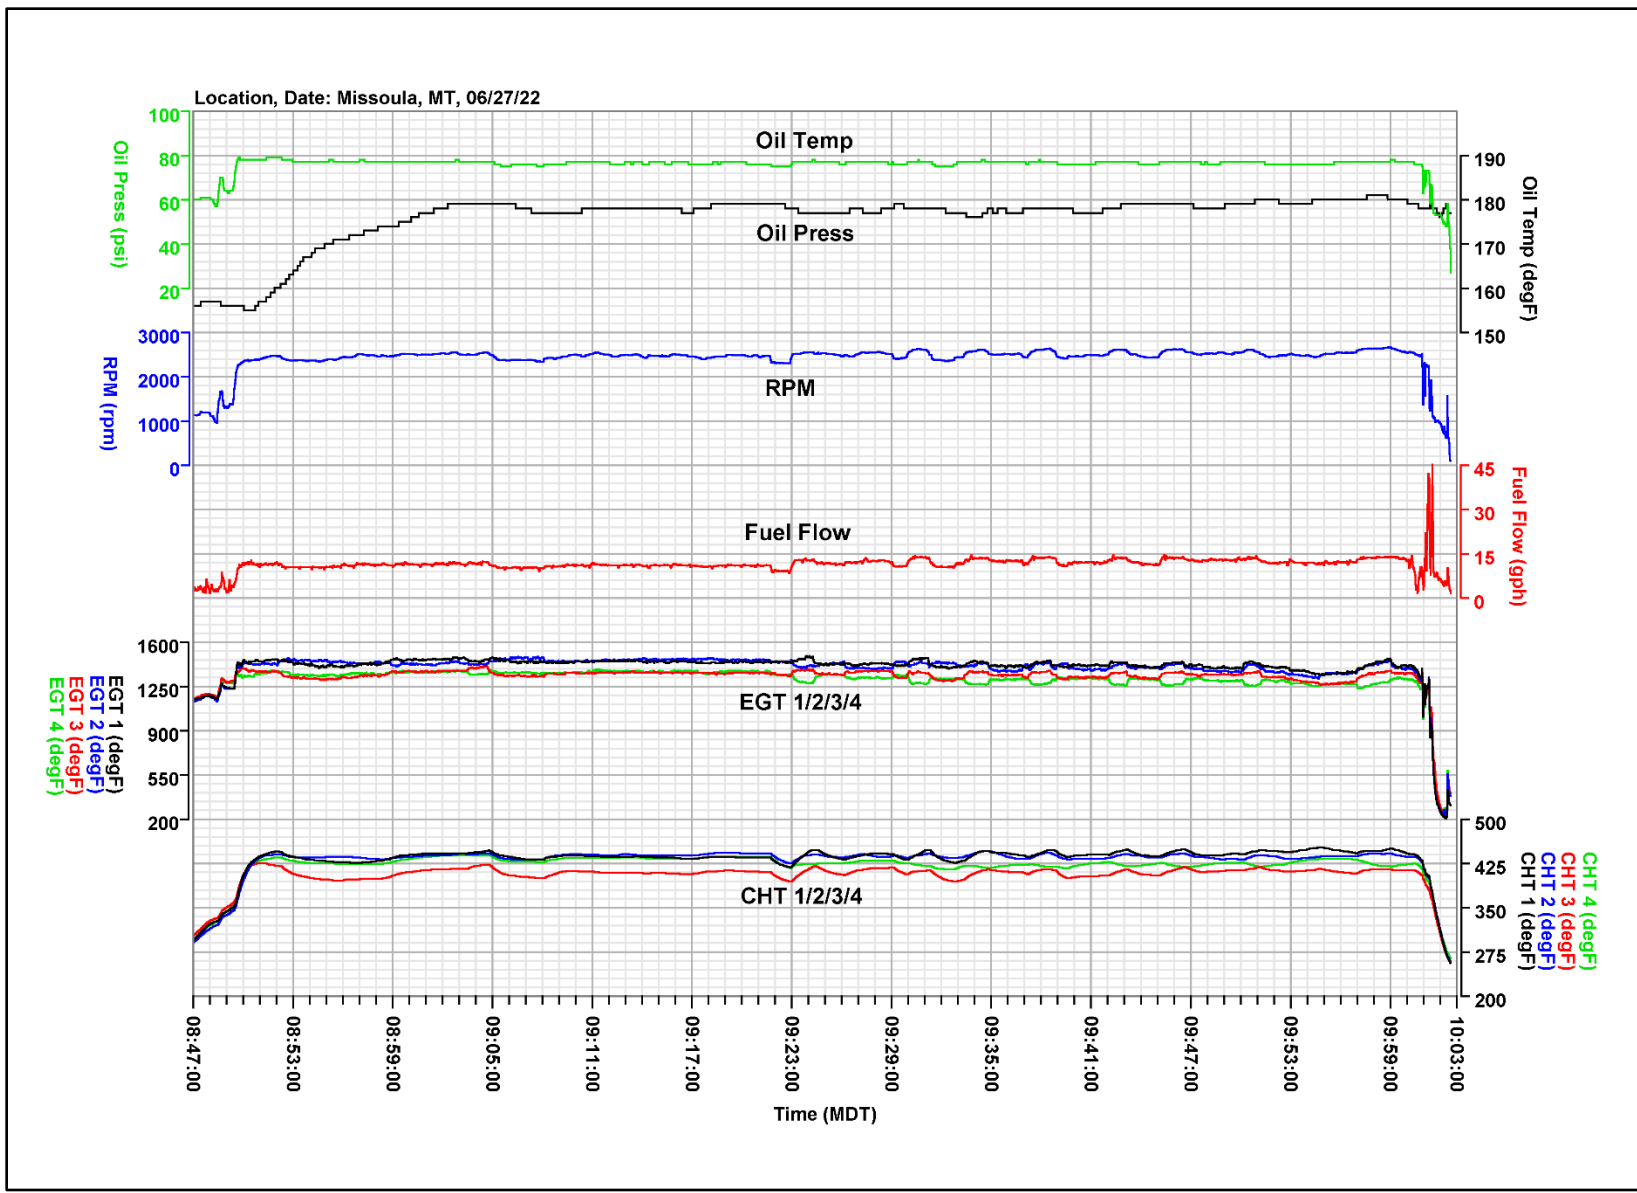
Figure 7 is a plot of engine parameters for the accident flight, from 08:47:00 MDT to the end of the recorded data at 10:02:53 MDT.

Figure 7. A plot of engine parameters for the accident flight.

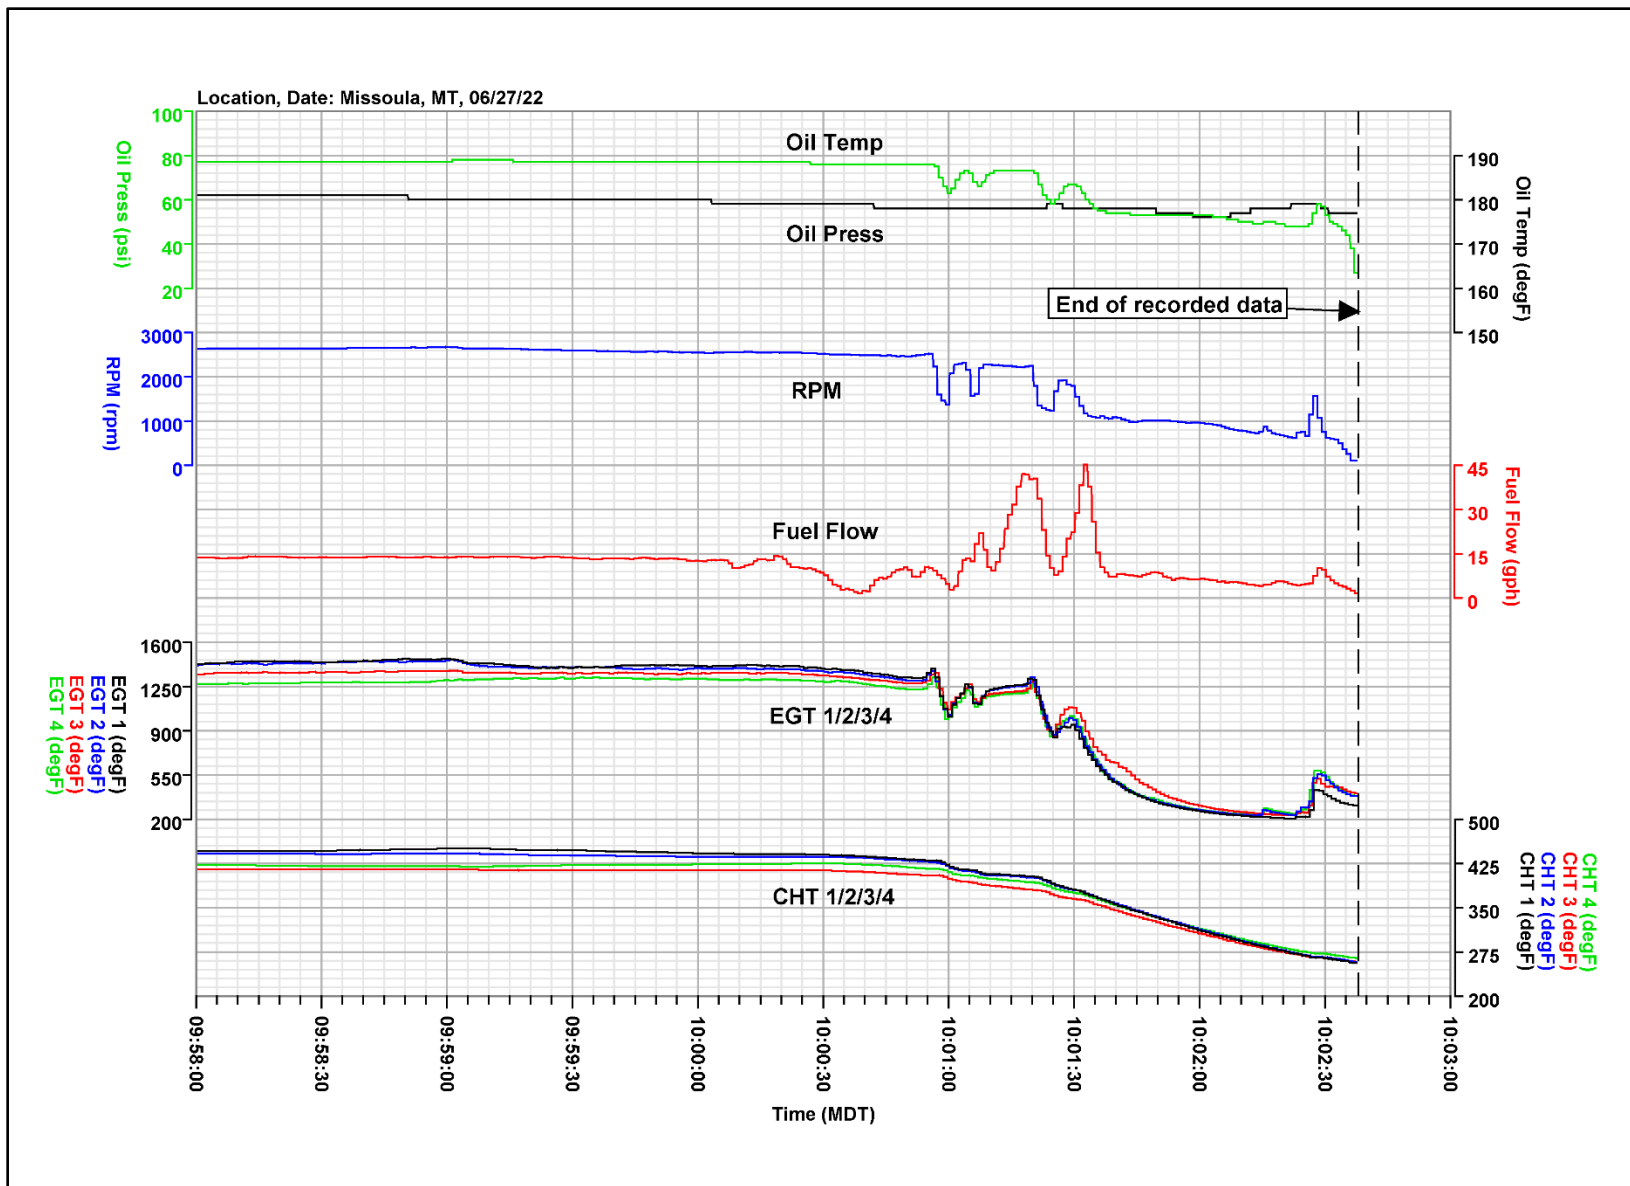
Figure 8 is a plot of engine parameters for the final portion of the accident flight, from 09:58:00 MDT to the end of the recorded data at 10:02:53 MDT.

Figure 8. A plot of engine parameters for the final portion of the accident flight.
