FLIGHT TRACK FIGURES

NTSB ACCIDENT NUMBER: ERA20FA088

AIRCRAFT REGISTRATION: N214K

ACCIDENT LOCATION: Grafton, West Virginia

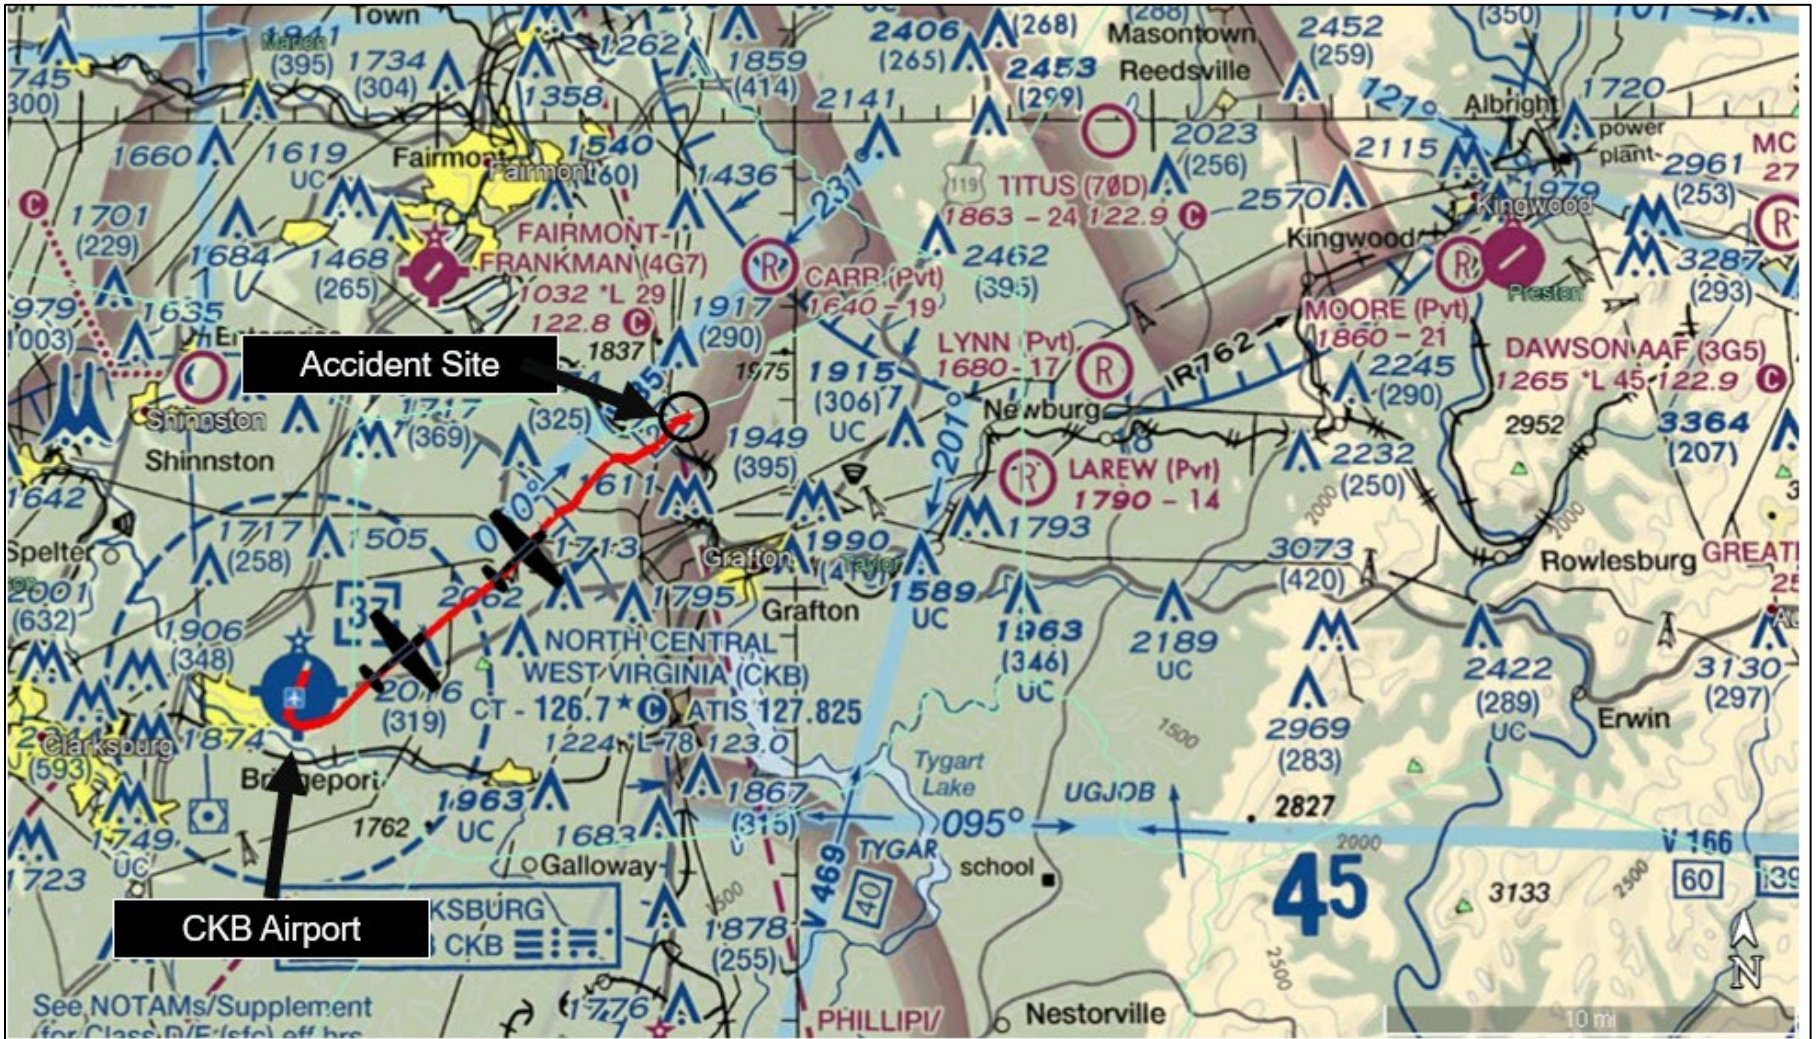
Figure 1: Flight track depicted on an FAA sectional chart

Figures 1 through 3 depict the Federal Aviation Administration (FAA) Automatic Dependent Surveillance-Broadcast (ADS-B) track data depicted on an FAA sectional chart and Google Earth. The red line represents the flight track. Figure 4 is a chart of the reported altitude and groundspeed.

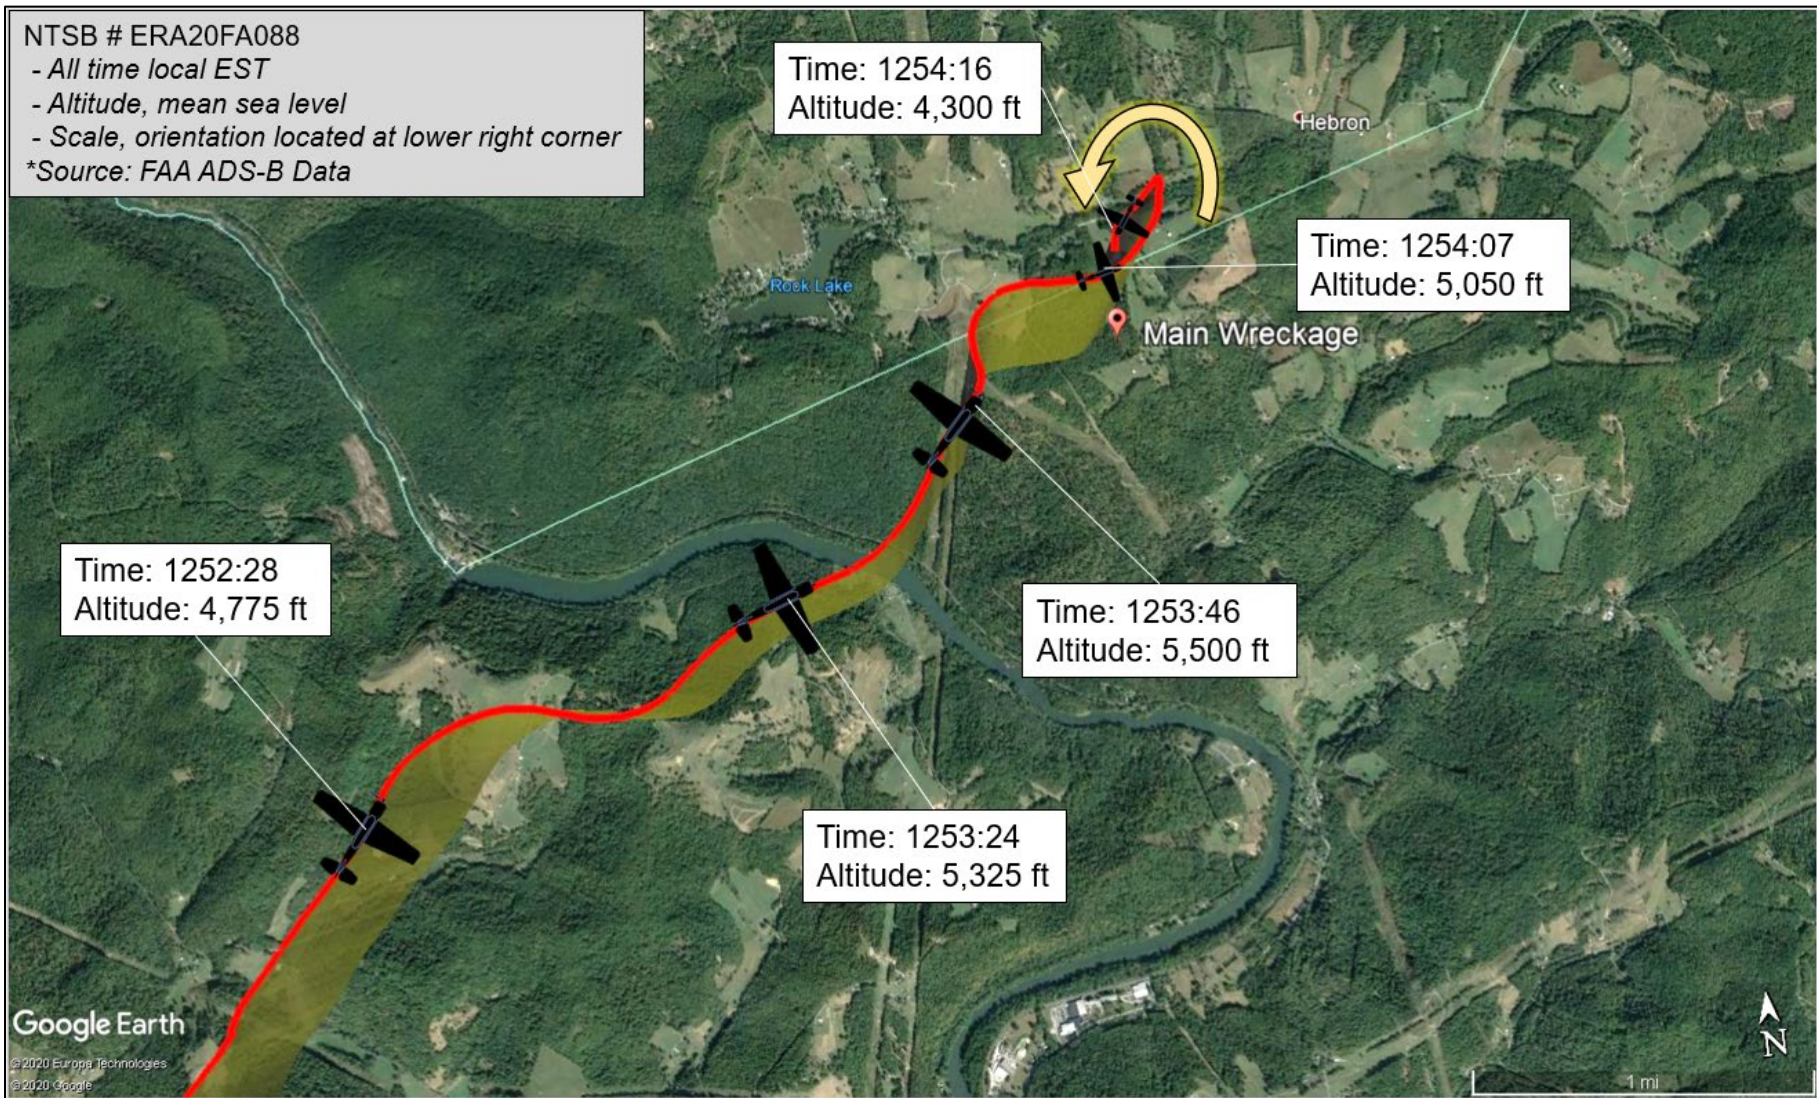
Figure 2: The final few minutes of the ADS-B flight track.

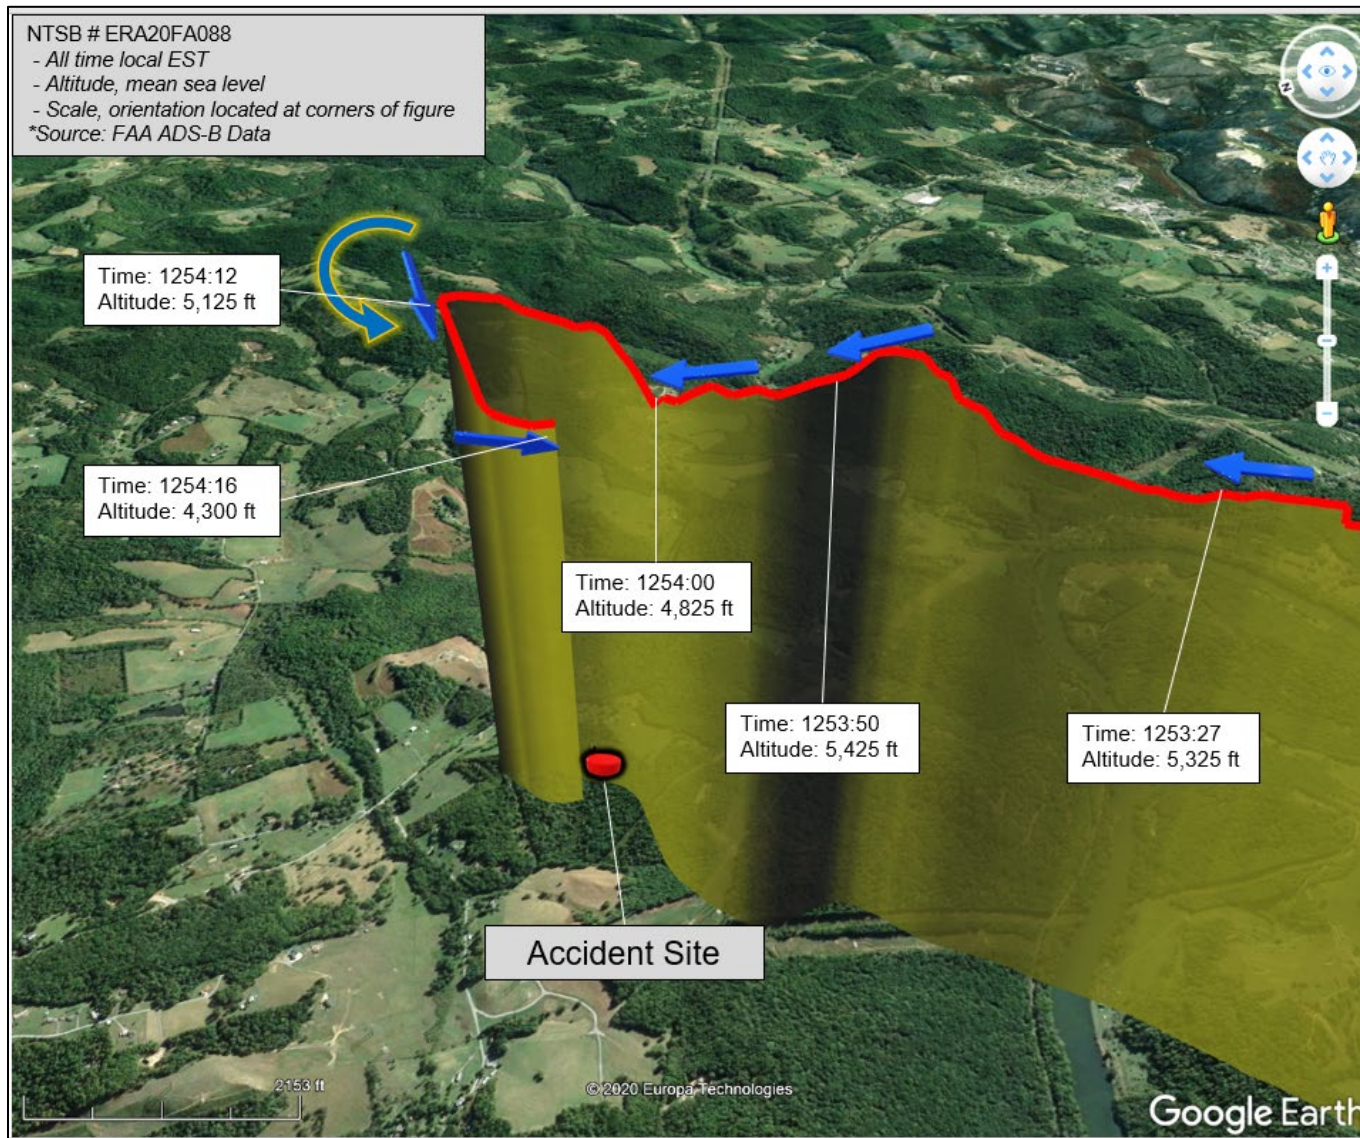
Figure 3: Three-dimensional view of the final minutes of the ADS-B flight track.

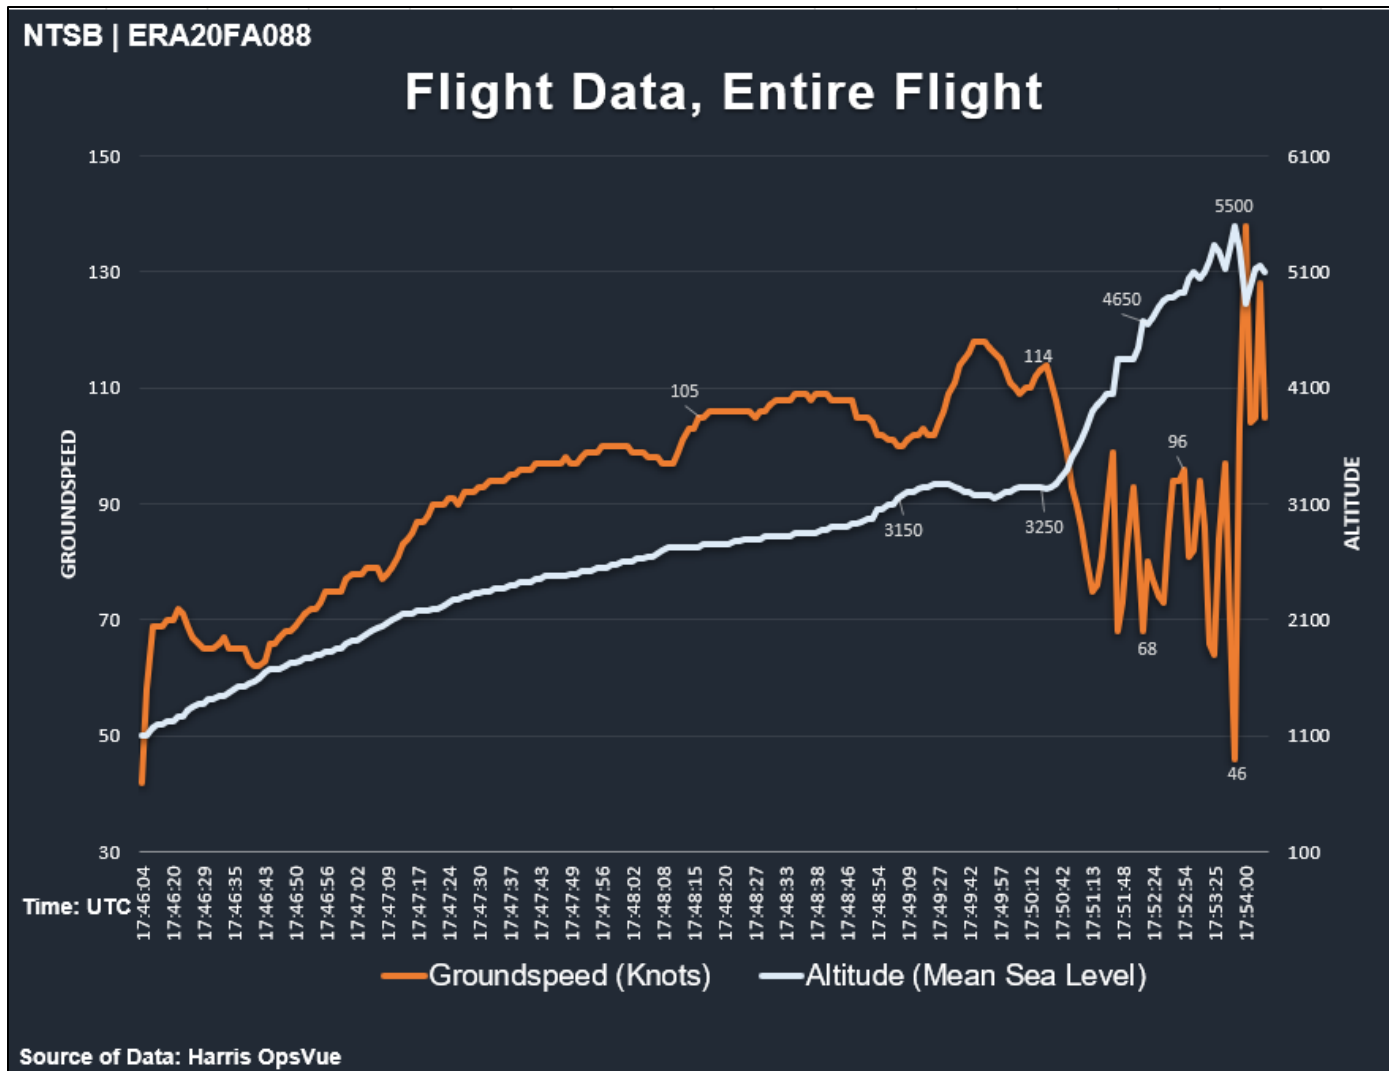
Figure 4: Chart of the reported altitude and groundspeed
