**NATIONAL TRANSPORTATION SAFETY BOARD  
Vehicle Recorder Division  
Washington, D.C. 20594**

**GPS Factual Report**

**SEA08LA158**

| Aircraft Type/ID: | Mauck RV-6A / N27WR |

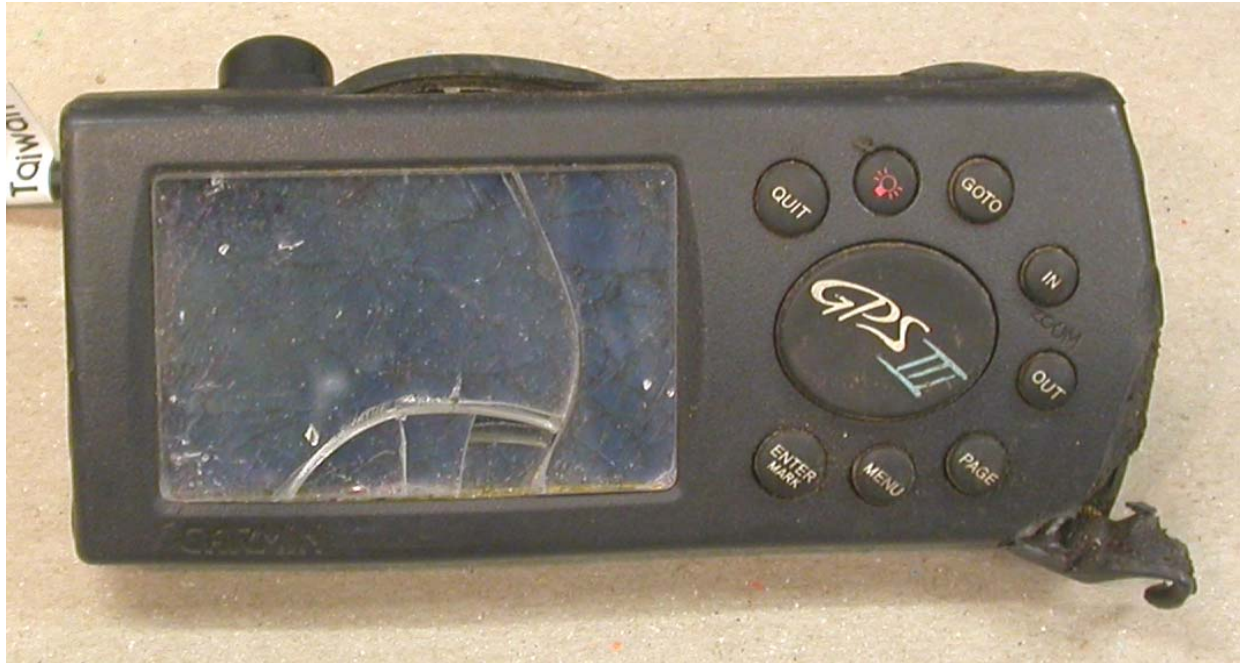
**Figure 1.** External front view of the Garmin GPS III Pilot (s/n 40903064) showing signs of impact damage to the outer case and display.

Upon arrival at the Vehicle Recorder Laboratory, an exterior examination that the unit had sustained moderate damage from impact forces (see figures 1 - 5). After applying +12VDC to the unit via the serial port connector, an internal inspection was performed. The battery case was found to be ruptured and 0.05v was measured across the battery terminals to the main PC board. The internal backup battery was tested and found to be producing 3.0 volts. However, one terminal of the internal backup battery was disconnected from the board by impact forces. 1 ferrite coil was found damaged and two others were disconnected from the main PC board. One SMD<sup>2</sup> 'chip' capacitor was found disconnected from the main PC board due to impact forces. All coils were repaired and continuity verified. The chip capacitor and backup battery were electrically re-attached. The main PC board was removed from the accident unit and placed into a surrogate case, LCD, and soft-key subassembly. Power was applied to the unit after making all practicable repairs and no response was observed.

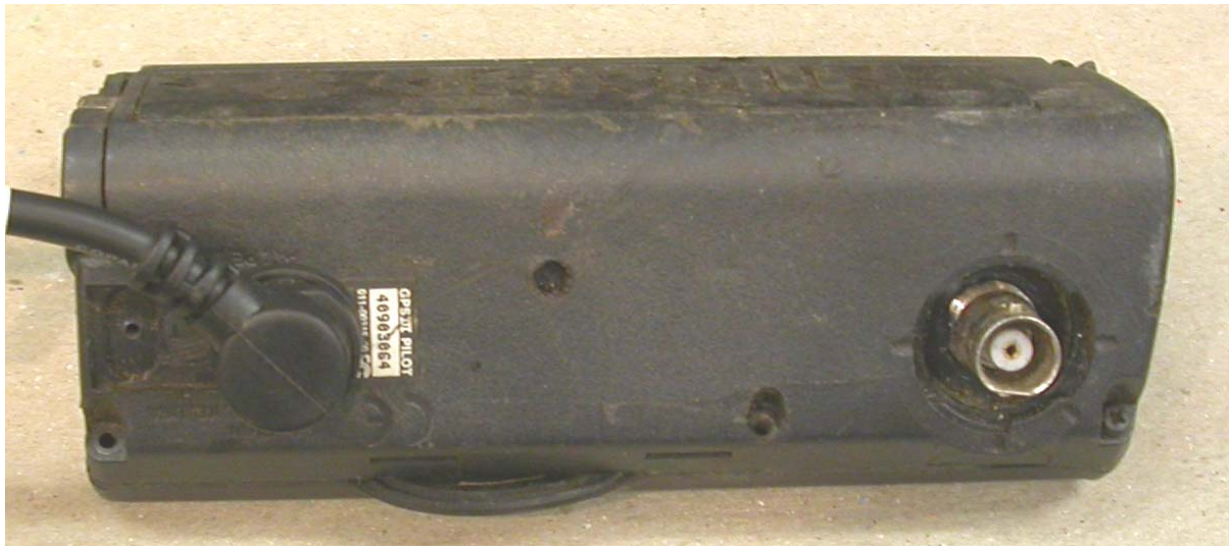
**Figure 2.** External rear view of the Garmin GPS III Pilot (s/n 40903064) showing signs of impact damage to the outer case and display.
