National Transportation Safety Board

ERA23LA071

GLOBAL POSITIONING SYSTEM DEVICES

Specialist's Factual Report

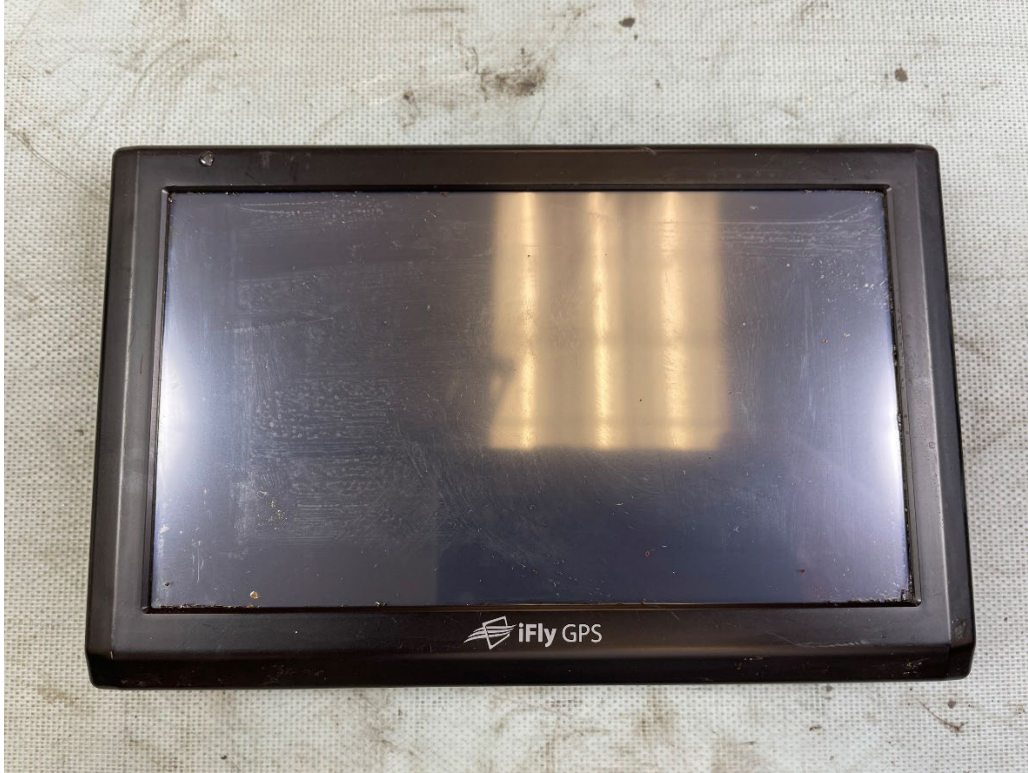
The GPS was in good condition and log files were present on the SD card.

Figure 1. Photo of iFly 740b GPS, as received.

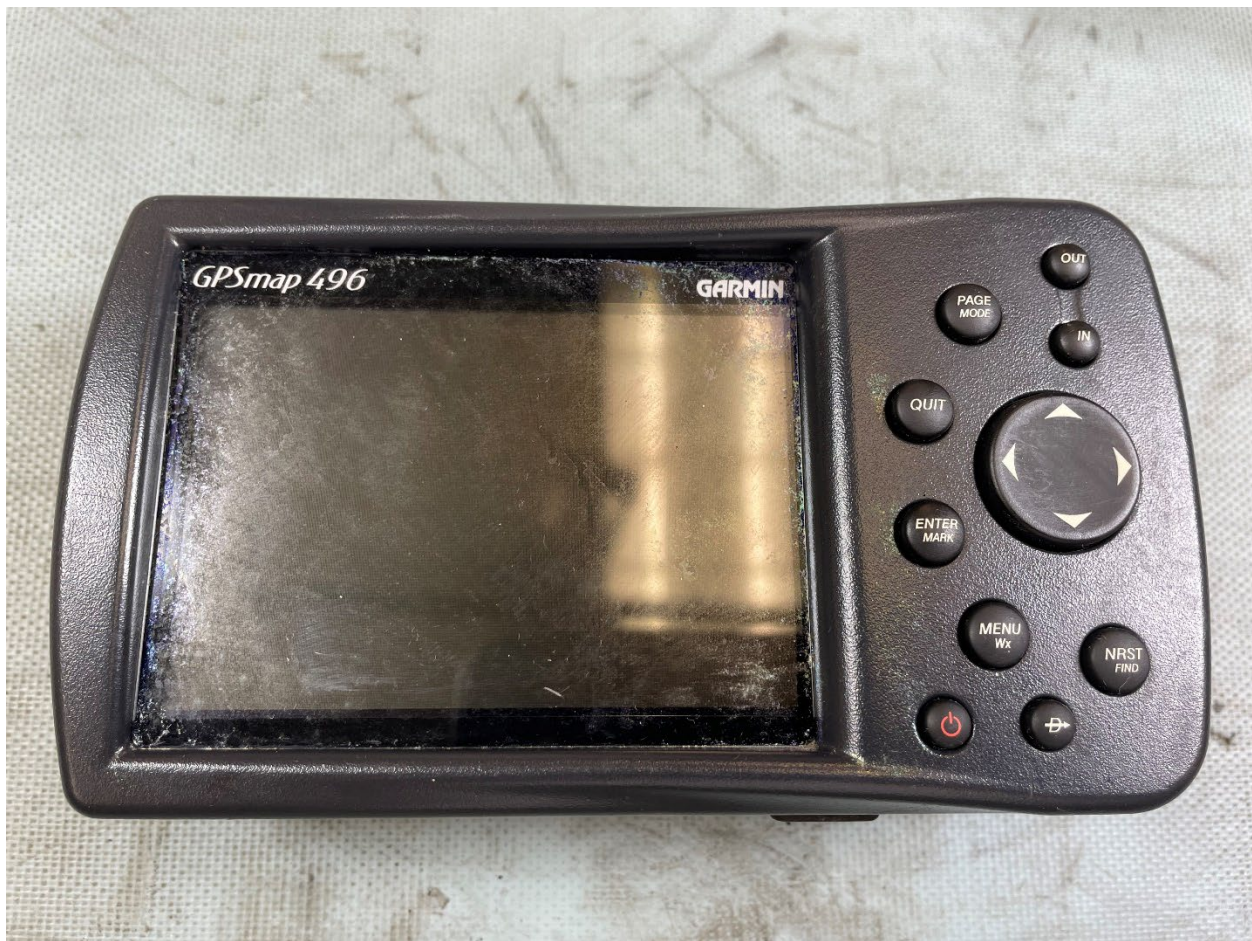
Figure 2. Photo of Garmin GPSmap 496 as received.

The data extracted included 36 sessions from September 23, 2022, to November 27, 2022. The accident flight was the last one recorded by the device in session 36. It was 3 hours, 4 minutes, and 14 seconds in duration and the track covered a total of 269.76 miles.

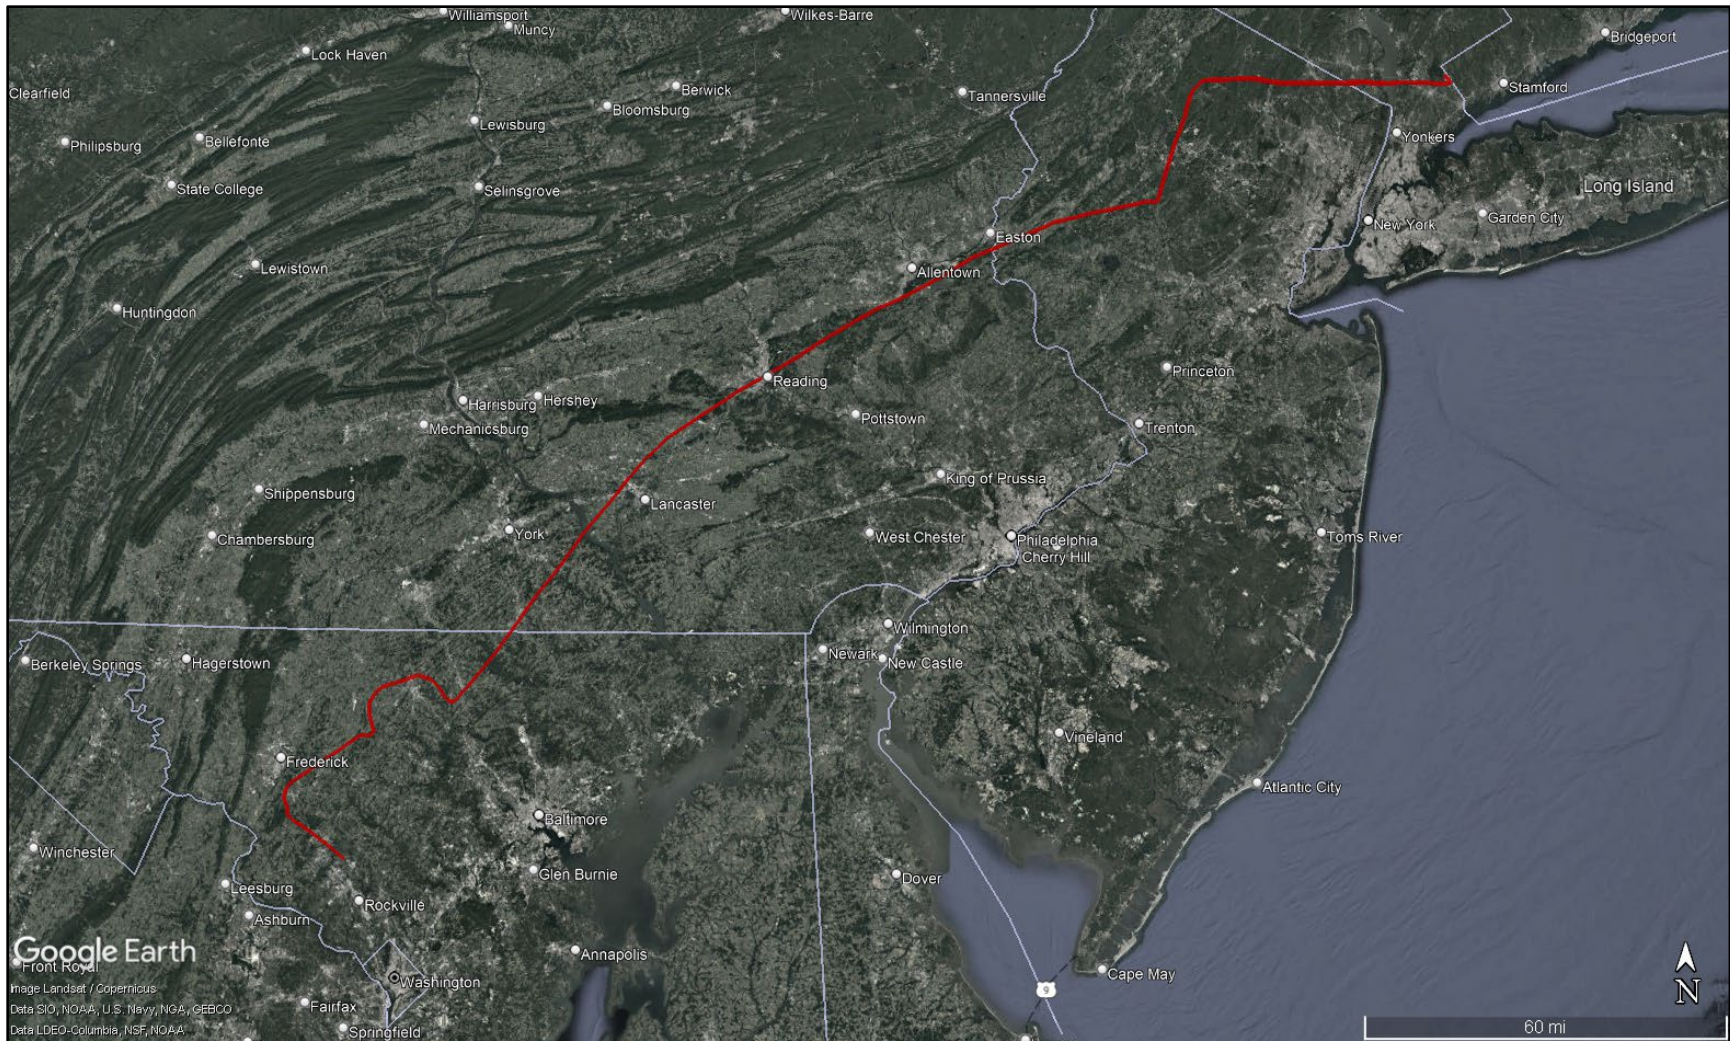
Figure 3 is a map overlay generated using Google Earth for the accident flight. Figure 4 is a map overlay showing the approach portion of the flight in a profile (overhead) view. Figure 5 is a map overlay showing the elevation profile of the flight with approach fixes at their published crossing heights. Figure 6 is a recreation of the approach plate elevation profile showing the aircraft's elevation profile throughout the approach. It should be noted that the weather and lighting conditions in Google Earth are not necessarily the weather and lighting conditions present at the time of the recording.

Figure 3. Map overlay of full accident flight.

The device was powered on and began recording at approximately 1926:35 UTC with the aircraft on the ramp at Westchester County Airport (KHPN). The aircraft began to taxi at about 1946:37 and began its takeoff roll on runway 16 at about 2000:50.

The aircraft climbed to about 8,000 ft and cruised there for about 1 hour and 5 minutes, beginning a descent towards Montgomery County Airpark (KGAI) at about 2120 UTC.

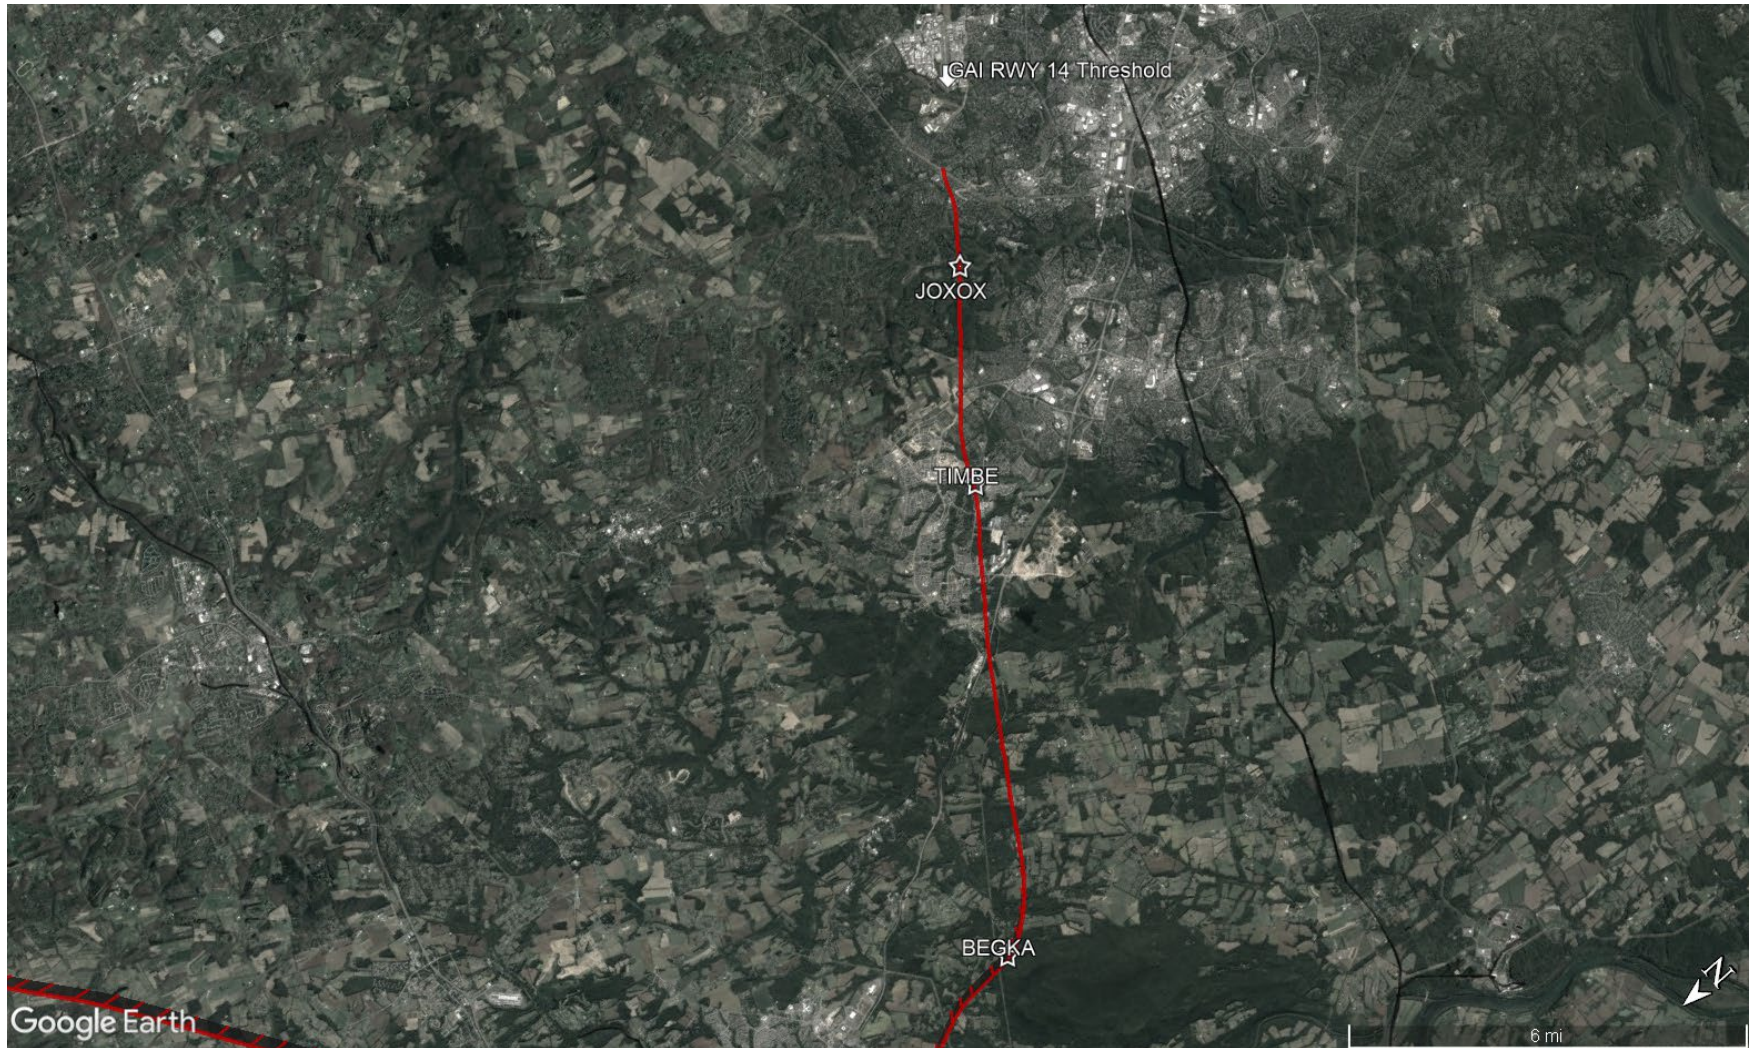
Figure 4. Google Earth overlay showing approach portion of the accident flight in an overhead view.

The aircraft crossed the RNAV RWY14 intermediate fix waypoint BEGKA at 2221:38 UTC at a GPS altitude of 2,877 ft. The published crossing altitude for BEGKA on the approach plate is listed as not lower than 3,000 ft.

The aircraft continued the approach and continued to descend below the published crossing altitudes. The aircraft crossed the final approach fix waypoint TIMBE at 2225:05 UTC. The aircraft was recorded at a GPS altitude of 1,618 ft, which is 582 ft below the published crossing altitude of not lower than 2,200 ft.

The aircraft then crossed the approach fix waypoint JOXOX at 2227:09 UTC at a GPS altitude of 863 ft. The crossing altitude for JOXOX is not lower than 1,280 ft.

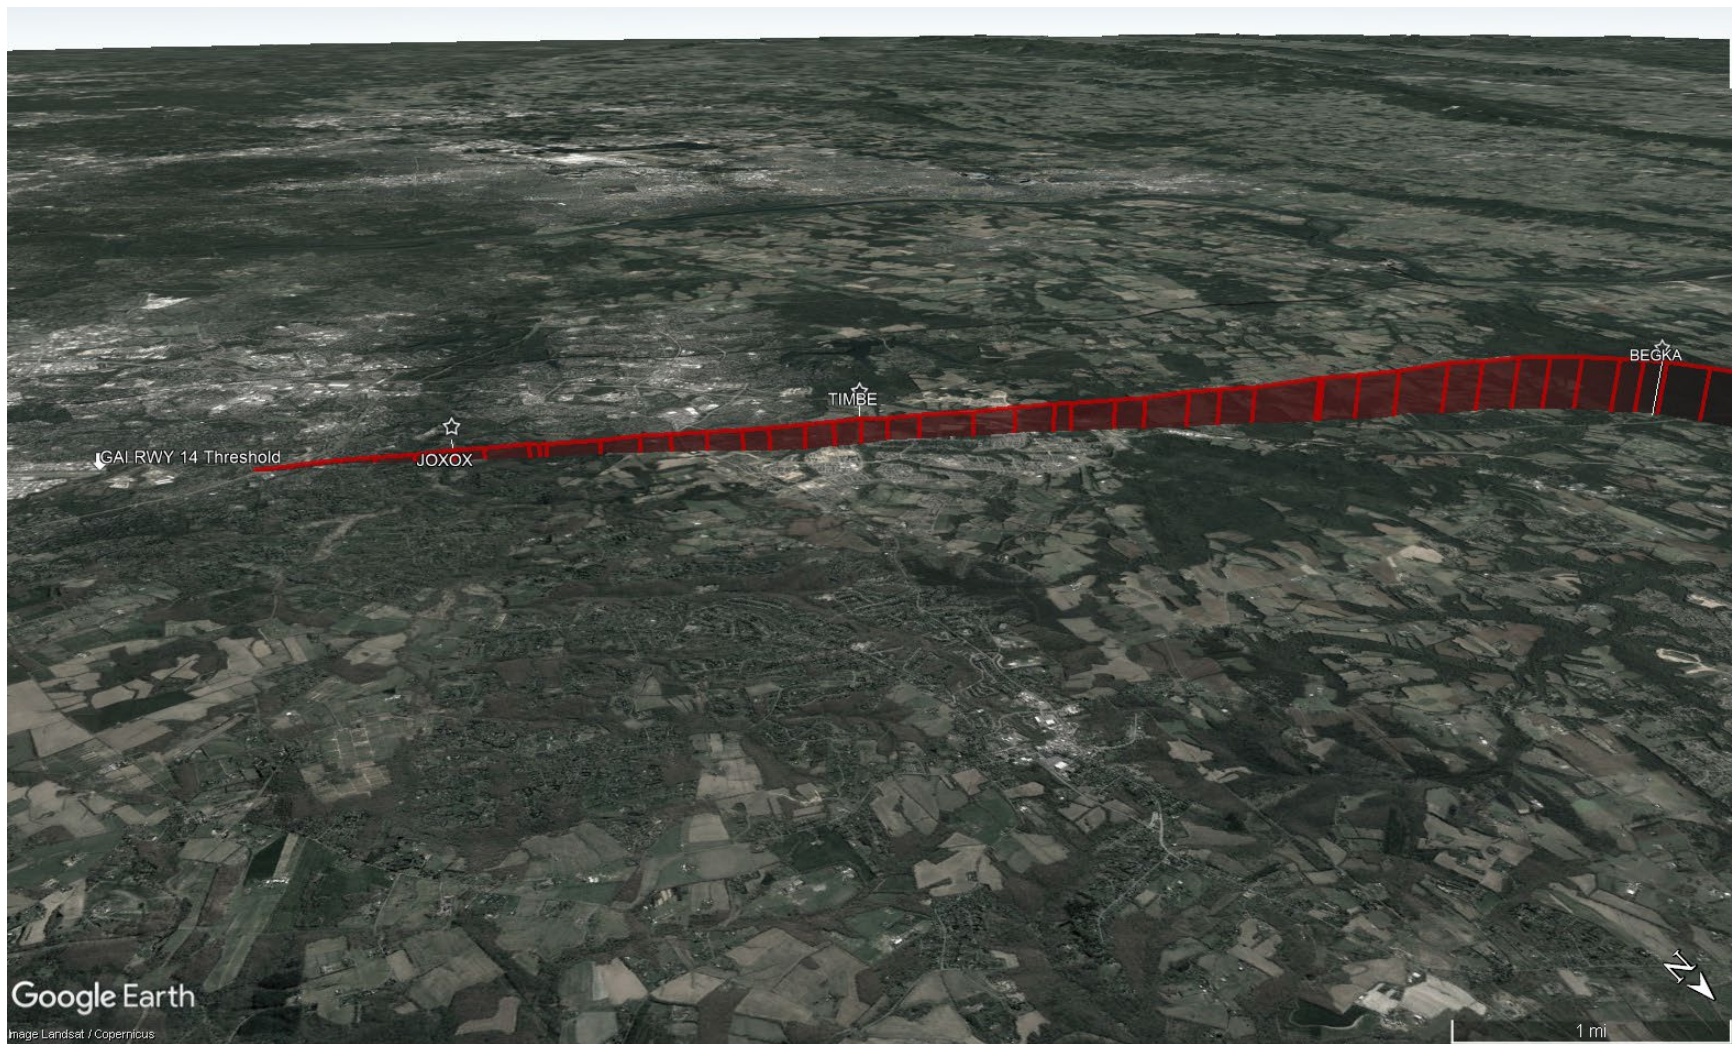
Figure 5. Google Earth overlay showing approach profile with approach fixes at their published heights.

The final point on the approach plate, the visual descent point (VDP), was 1.4 nautical miles from the runway 14 threshold. The aircraft crossed the VDP at 2227:57 UTC at a GPS altitude of 587 ft. The published decision altitude for the LPV approach was 789 ft.

The data ended shortly after at 2228:39 UTC. It showed the aircraft at a GPS altitude of 565 ft with no groundspeed. The field elevation is reported on the approach plate as 539 ft.

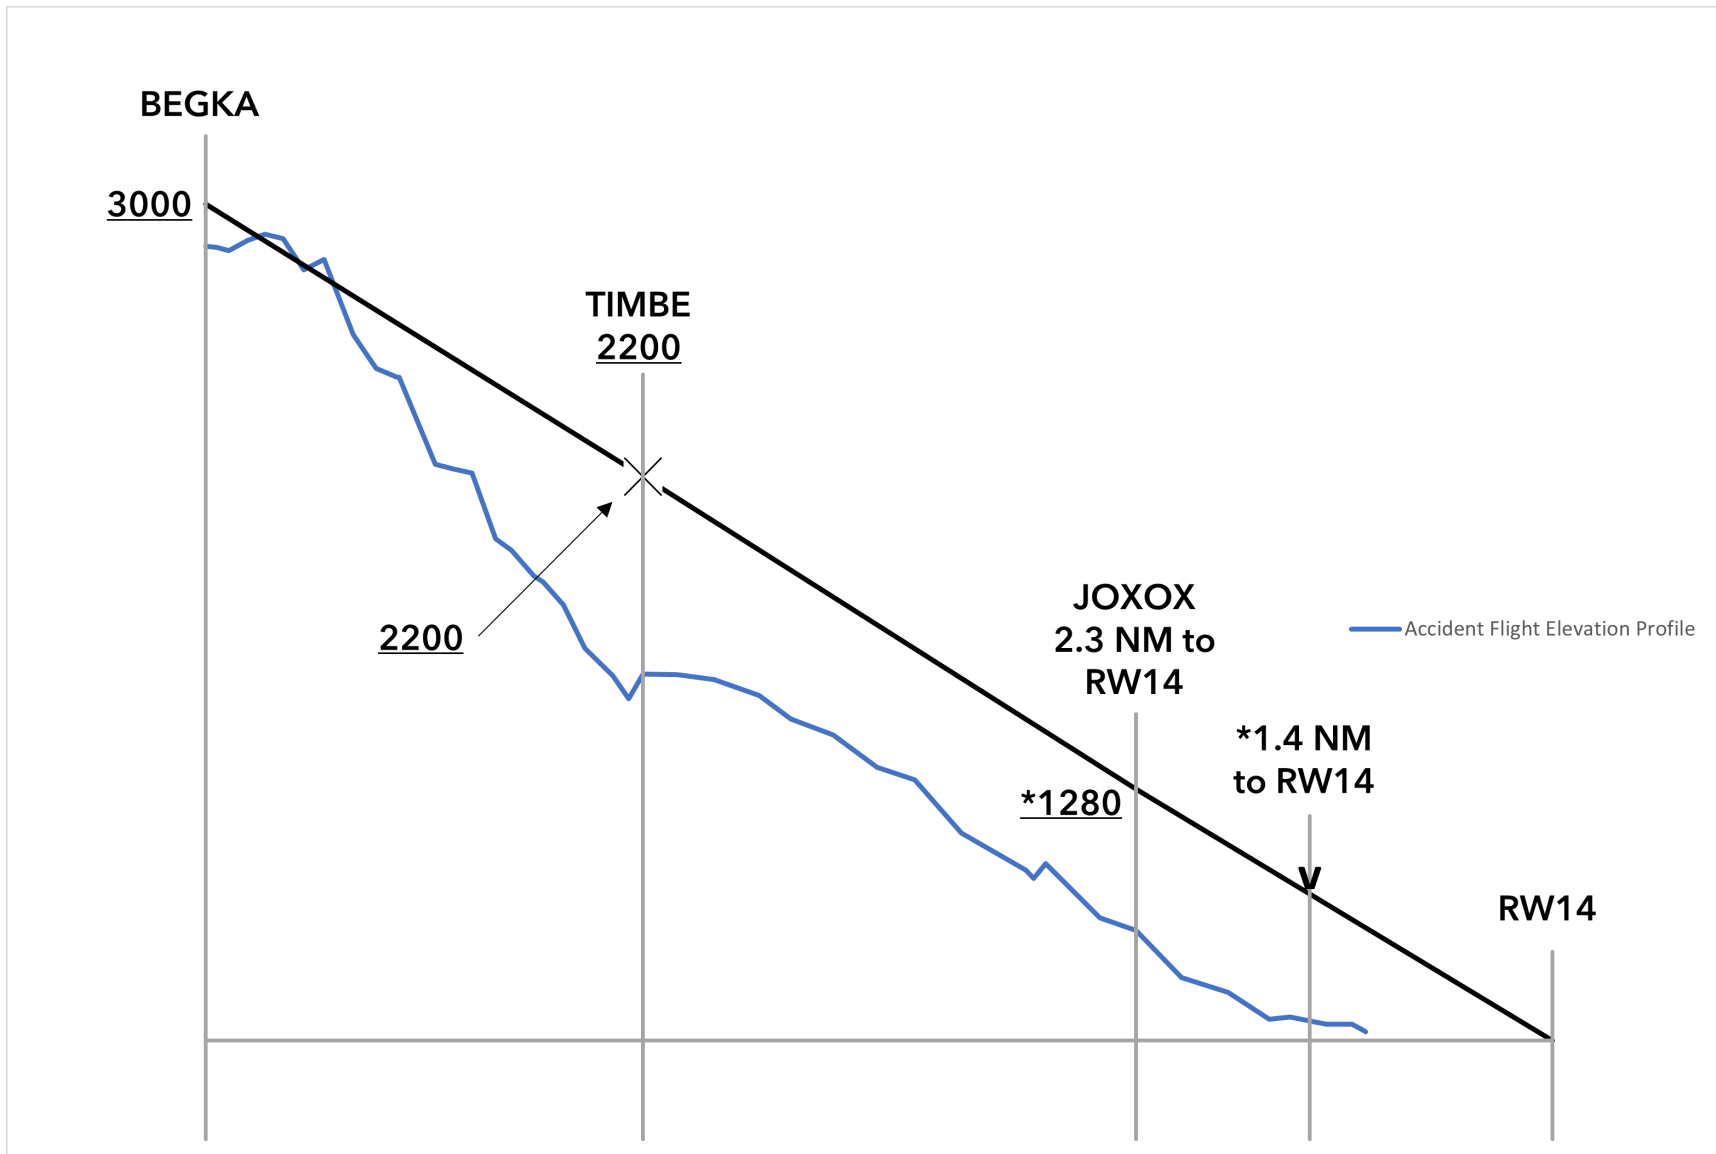
Figure 6. Recreation of KGAI RNAV RWY14 approach plate elevation profile.
