National Transportation Safety Board

WPR22FA196

GLOBAL POSITIONING SYSTEM DEVICE

Specialist's Factual Report

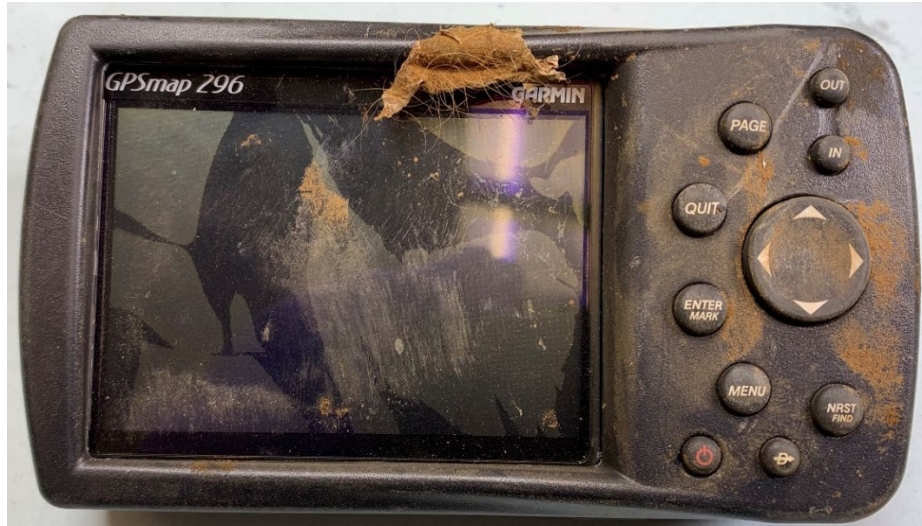
Upon arrival at the Vehicle Recorder Laboratory, an exterior examination revealed the unit had sustained impact damage, as shown in Figure 1. The unit powered on, however, the display was damaged, as shown in Figure 2. The unit successfully interfaced with laboratory tools and data were downloaded normally.

Figure 1. Photo of GPS received by the Vehicle Recorder Division.

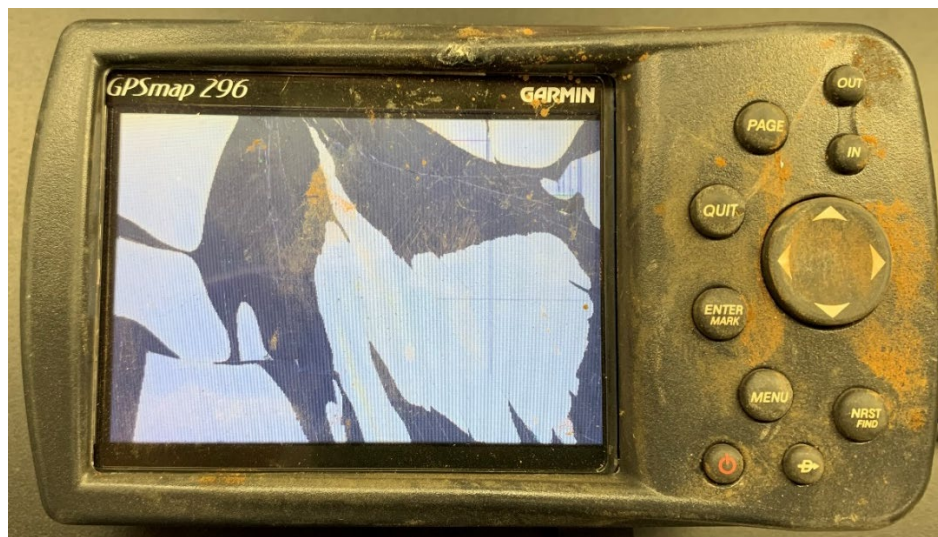
Figure 2. Photo of GPS powered on.

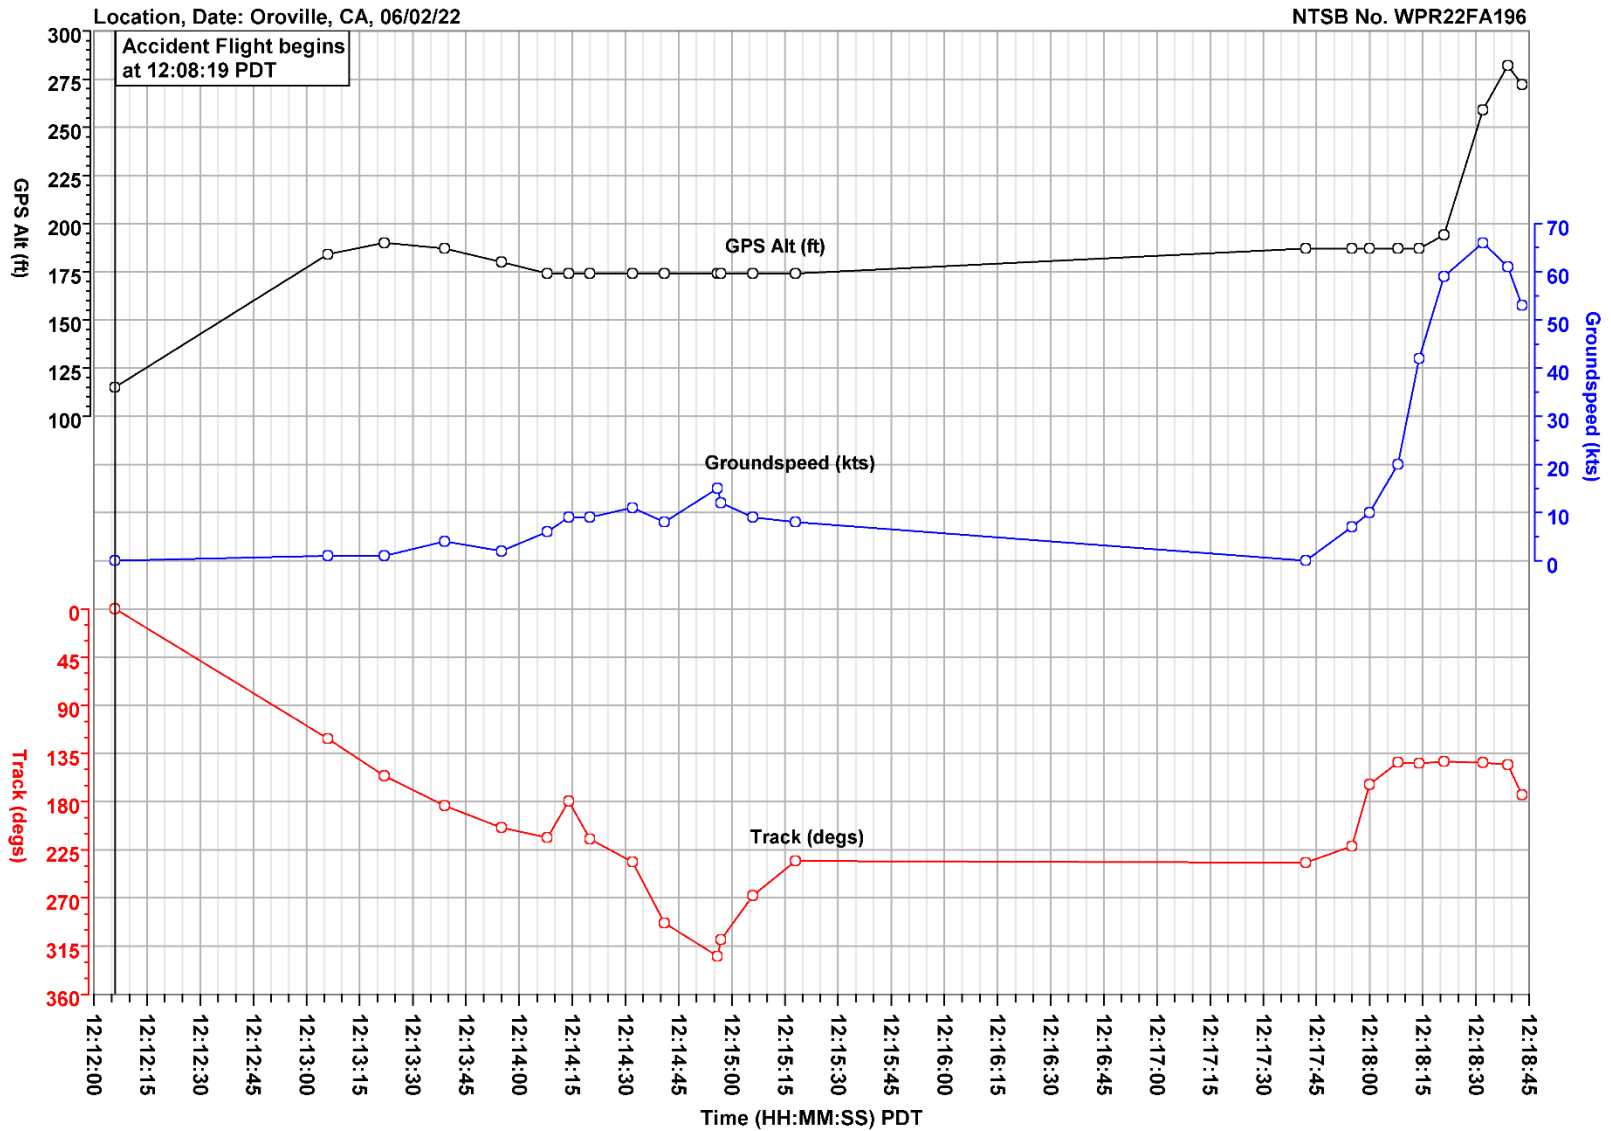
Figure 3 and Figure 4 are plots of the entire track log and the final minute of the recording, respectively. Figure 5 through Figure 7 are Google Earth overlays of the entire accident track log, takeoff roll, and the end of the recording, respectively. Note that the weather and lighting conditions in Google Earth are not necessarily the weather and lighting conditions present at the time of the recording.

Figure 3. Plot of GPS parameters of the entire accident flight.

In summary, the aircraft began taxiing at approximately 12:08:19 PDT, and began the takeoff roll at approximately 12:18:00 PDT from Oroville Municipal Airport (KOVE). The last recorded data point collected by the Garmin GPSMAP 296 was at approximately 12:18:43 PDT.

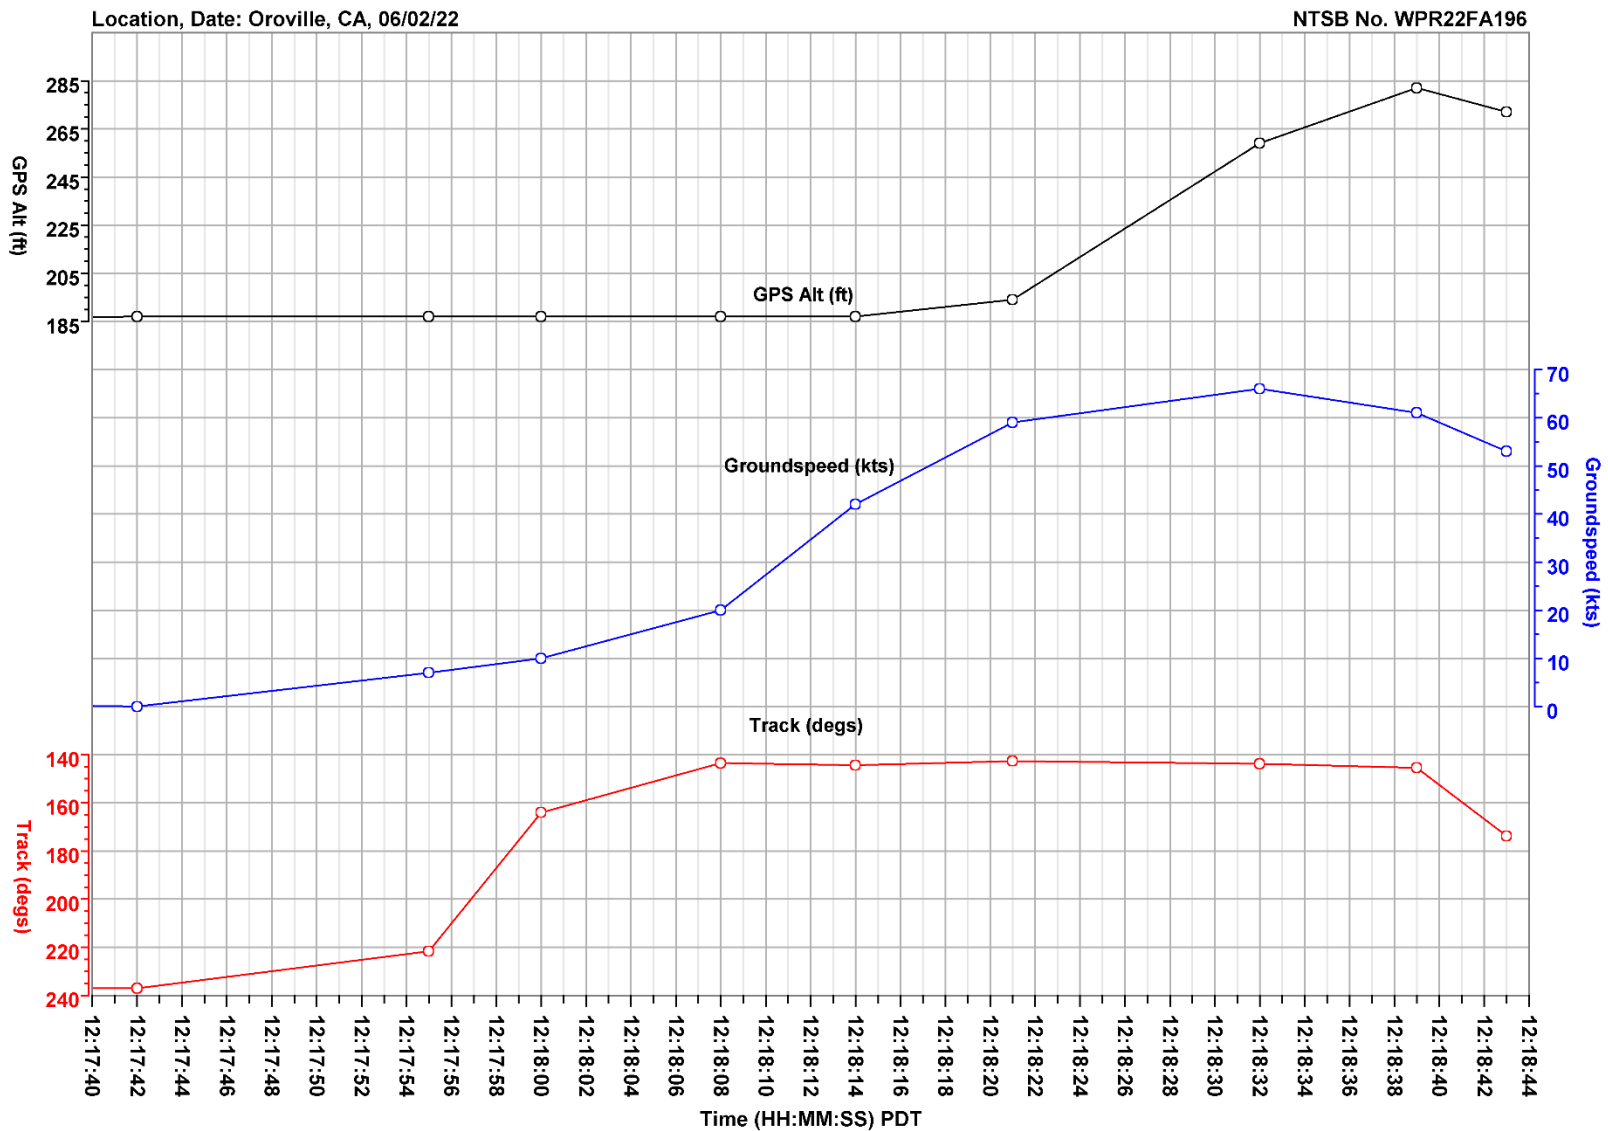
Figure 4. Plot of GPS parameters from takeoff roll to the accident time.

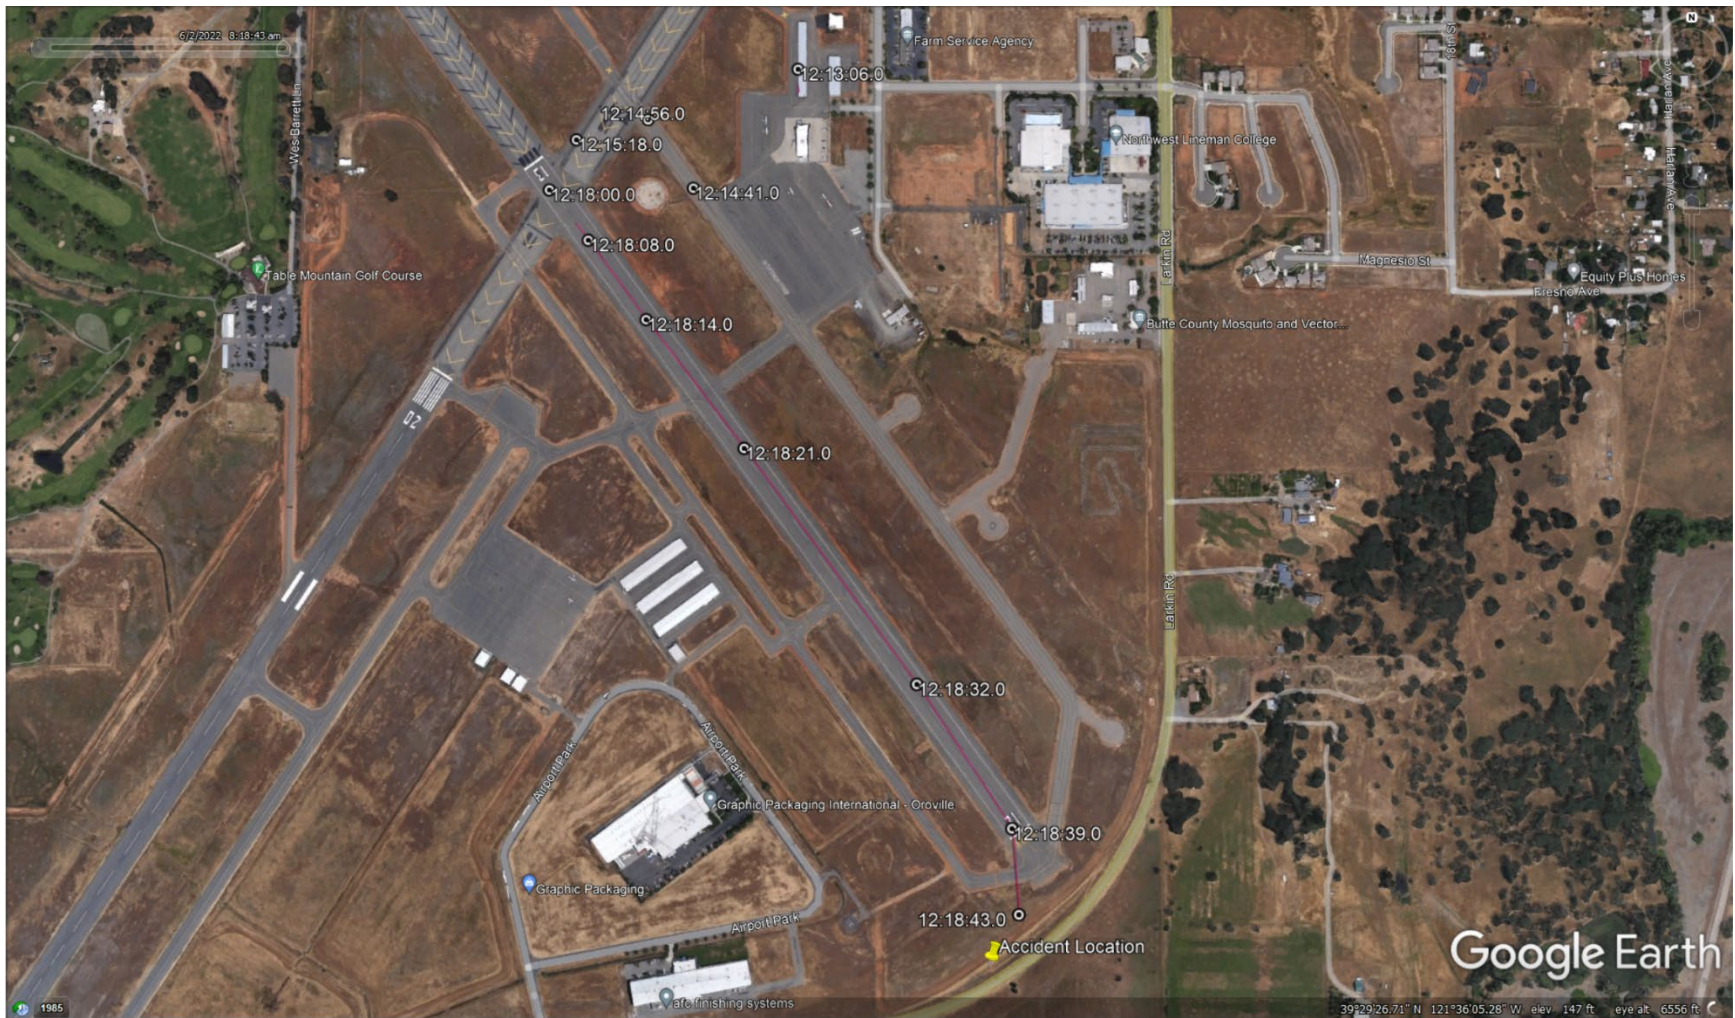
Figure 5. Google Earth overlay showing the entire flight overview.

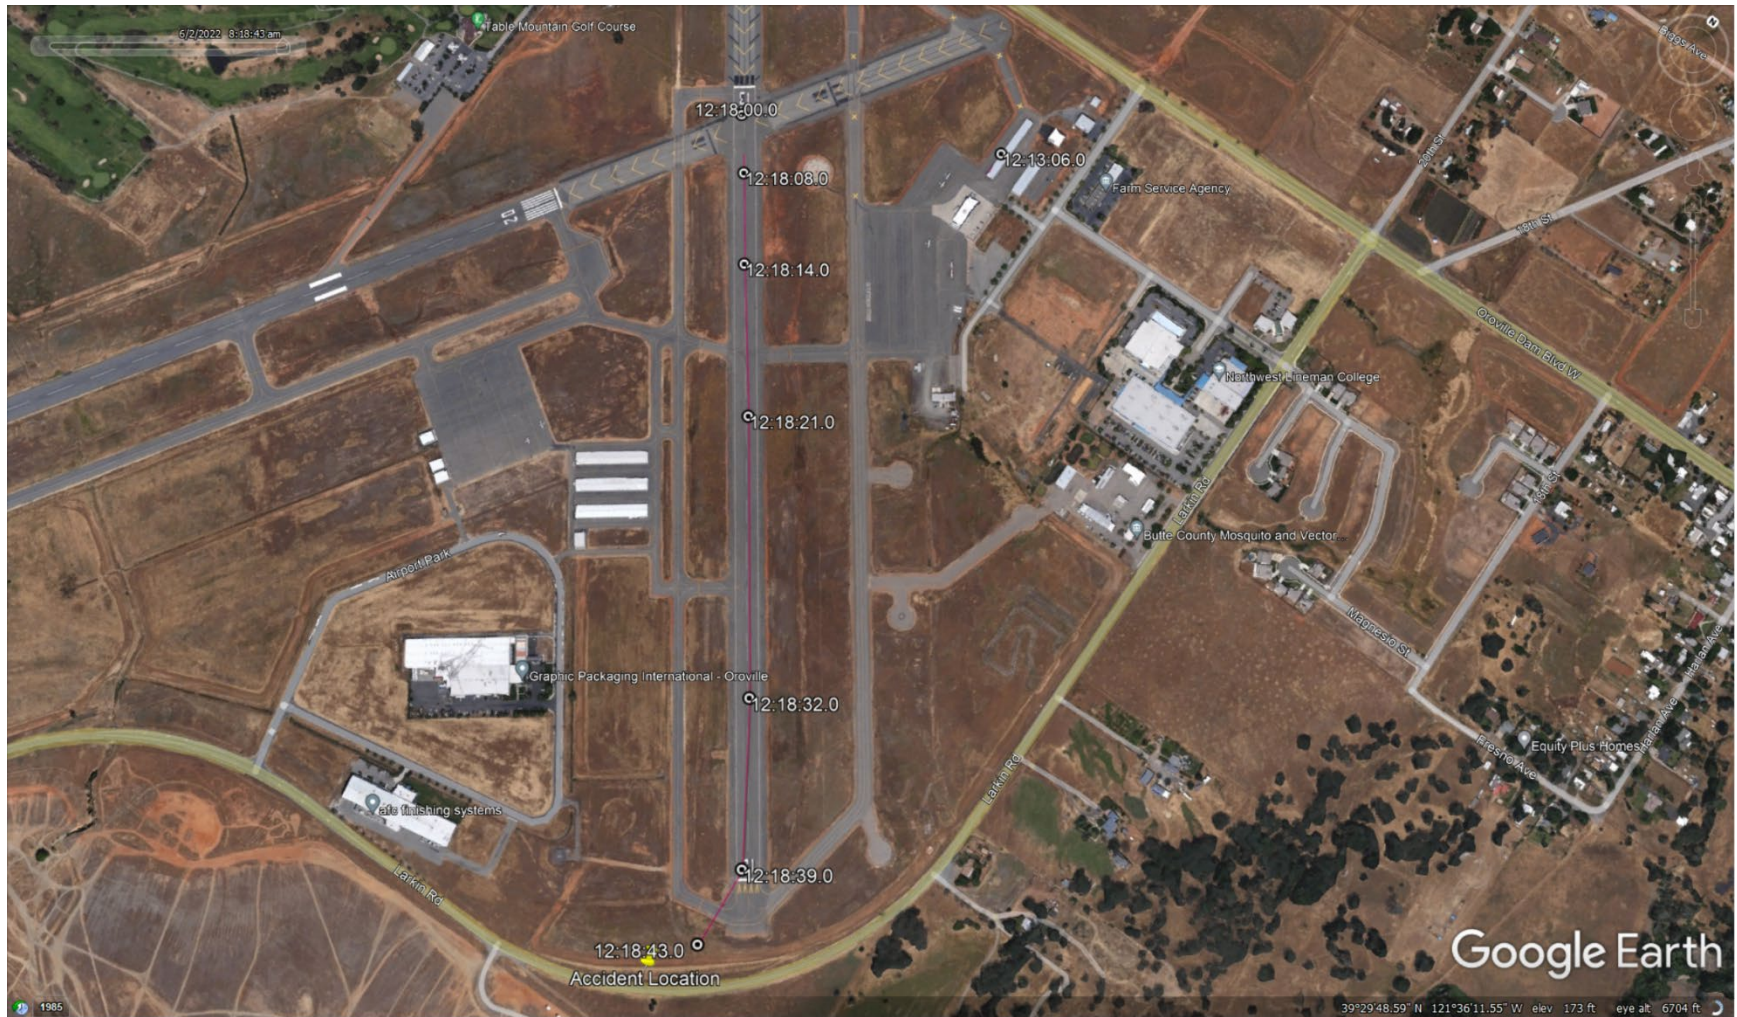
Figure 6. Google Earth overlay showing takeoff and the accident location.

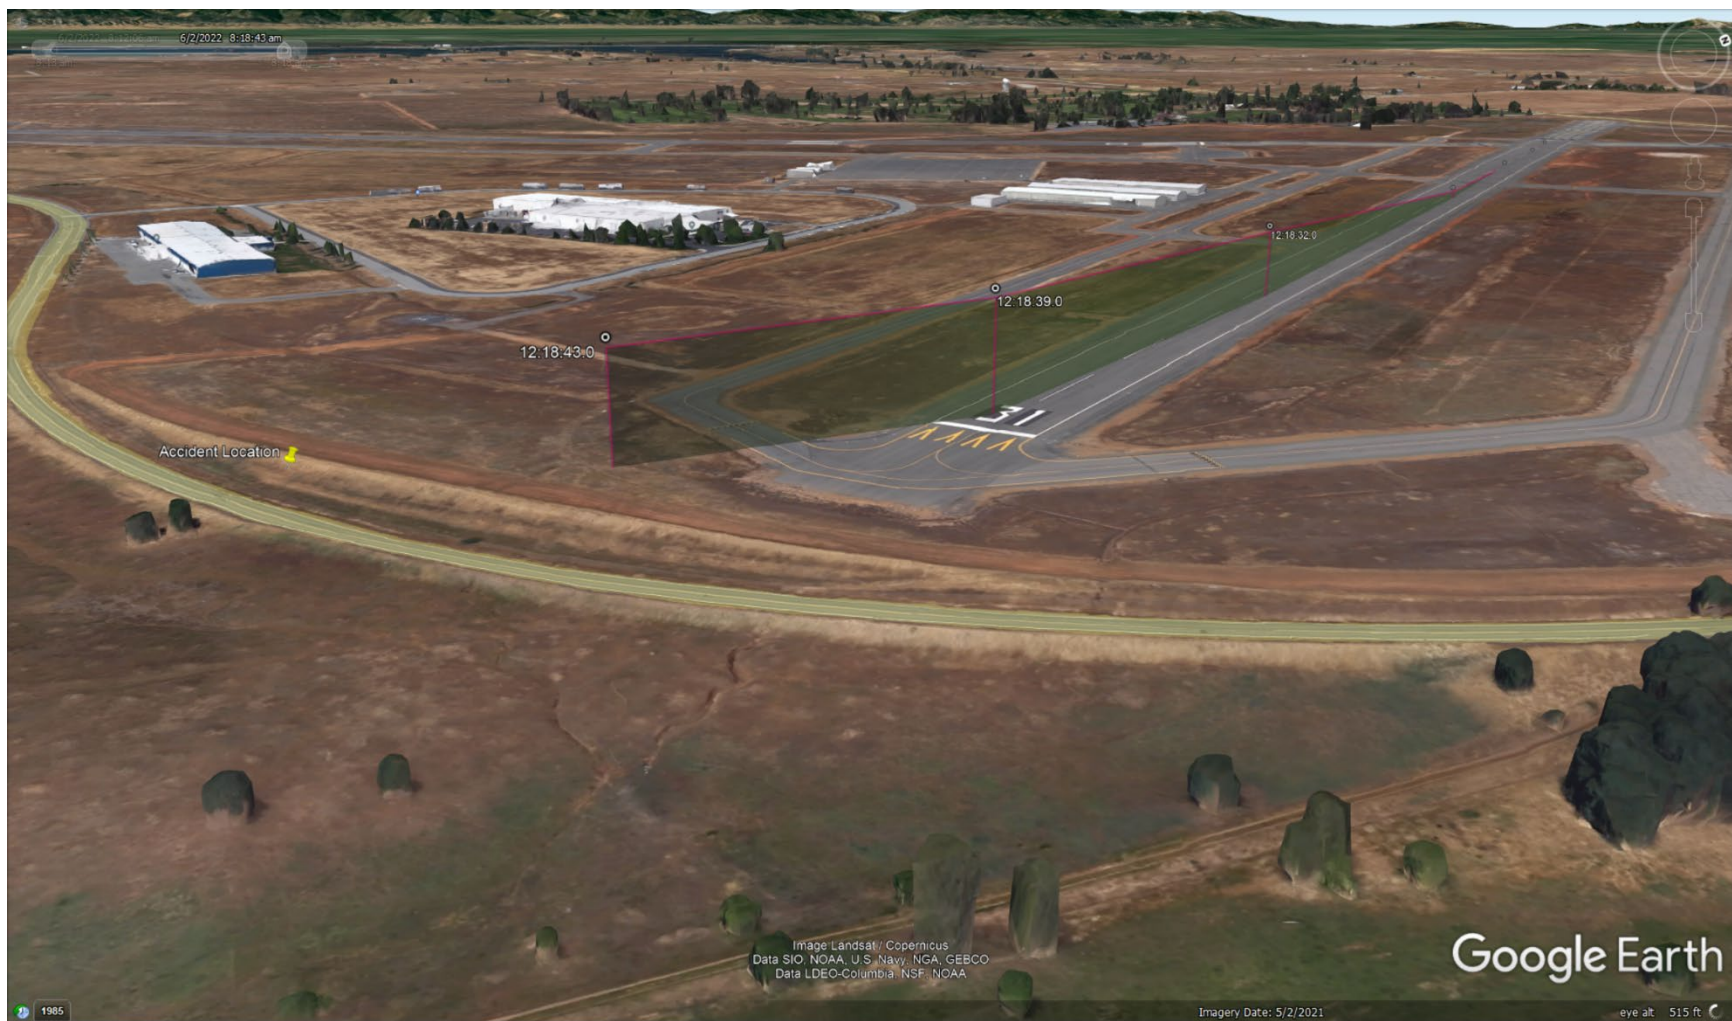
Figure 7. Google Earth overlay showing the accident flight path.
