NATIONAL TRANSPORTATION SAFETY BOARD

Voyage Data Recorder

Specialist's Factual Report

Location: Jekyll Island, GA
Date: September 8, 2019
Ship: Vehicle Carrier
Registration: 9775816
Vessel Name: Golden Ray
NTSB Number: DCA19FM048

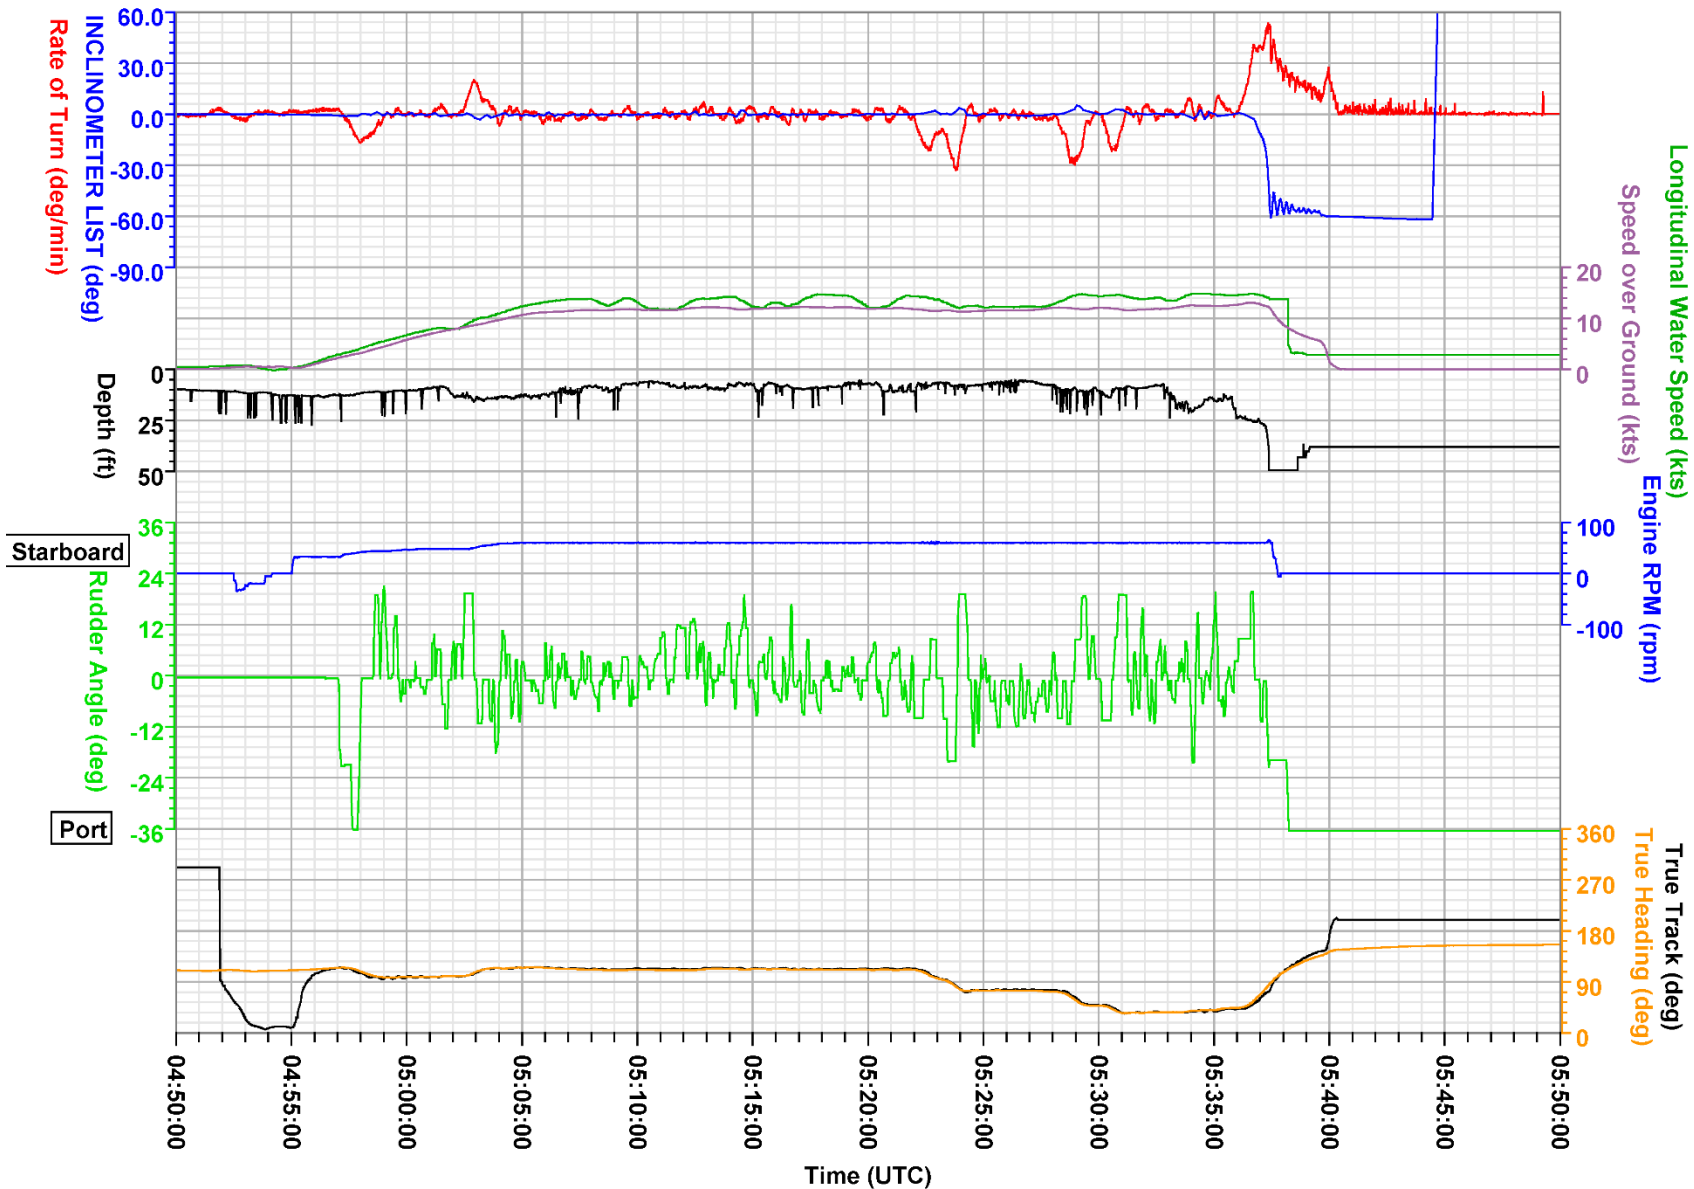
Figure 1. An overview of the data from an accident voyage leaving Brunswick.

Figure 1 shows the data from the VDR and IMAC system for the entire accident voyage.

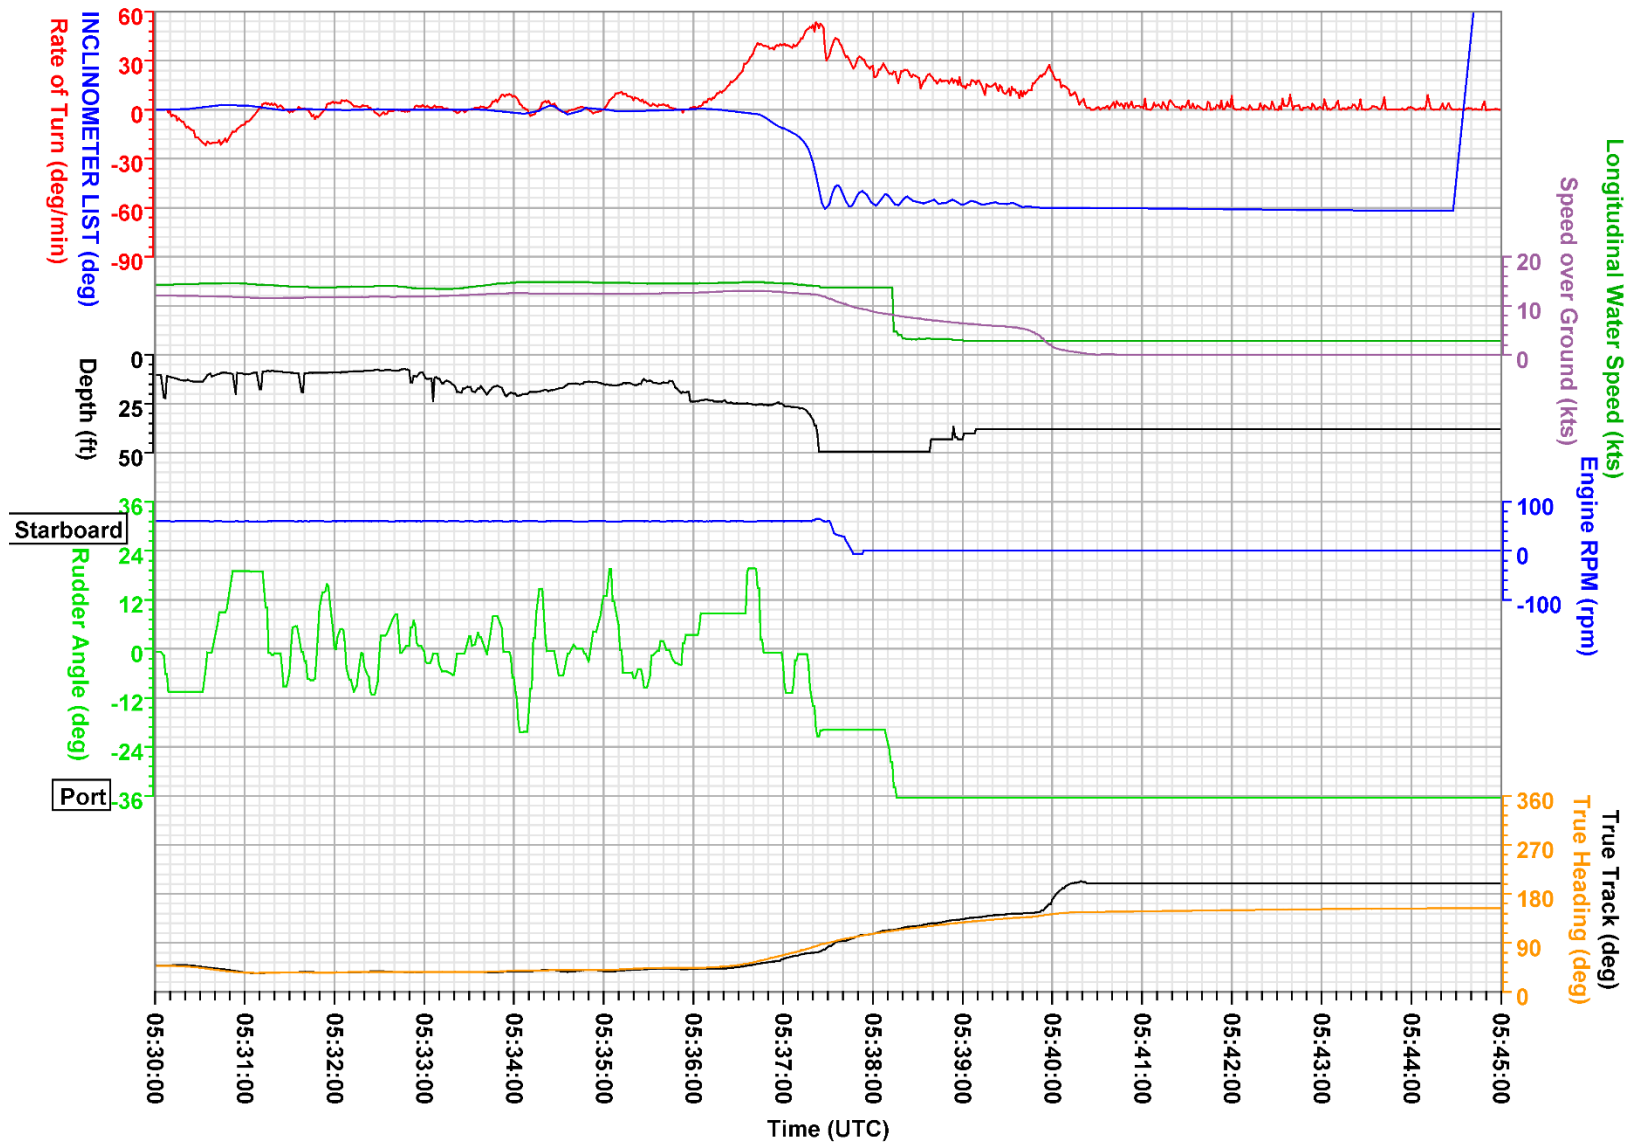
Figure 2. A detailed view of data surrounding the accident.

The rudder angle sign notation is such that a negative rudder angle signifies a turn to port. A positive rudder angle signifies a turn to starboard. A negative angle on the inclinometer signifies a lean to port while a positive angle signifies a lean to starboard. A negative value for the rate of turn parameter indicates a turning motion to port while a positive value for the rate of turn indicates a turning motion to starboard. A negative value of Engine RPM signifies engine power to move the ship astern while a positive value signified engine power to move the ship forward.

Figure 2 shows the data from the VDR and IMAC system for a closer time period surrounding the accident.

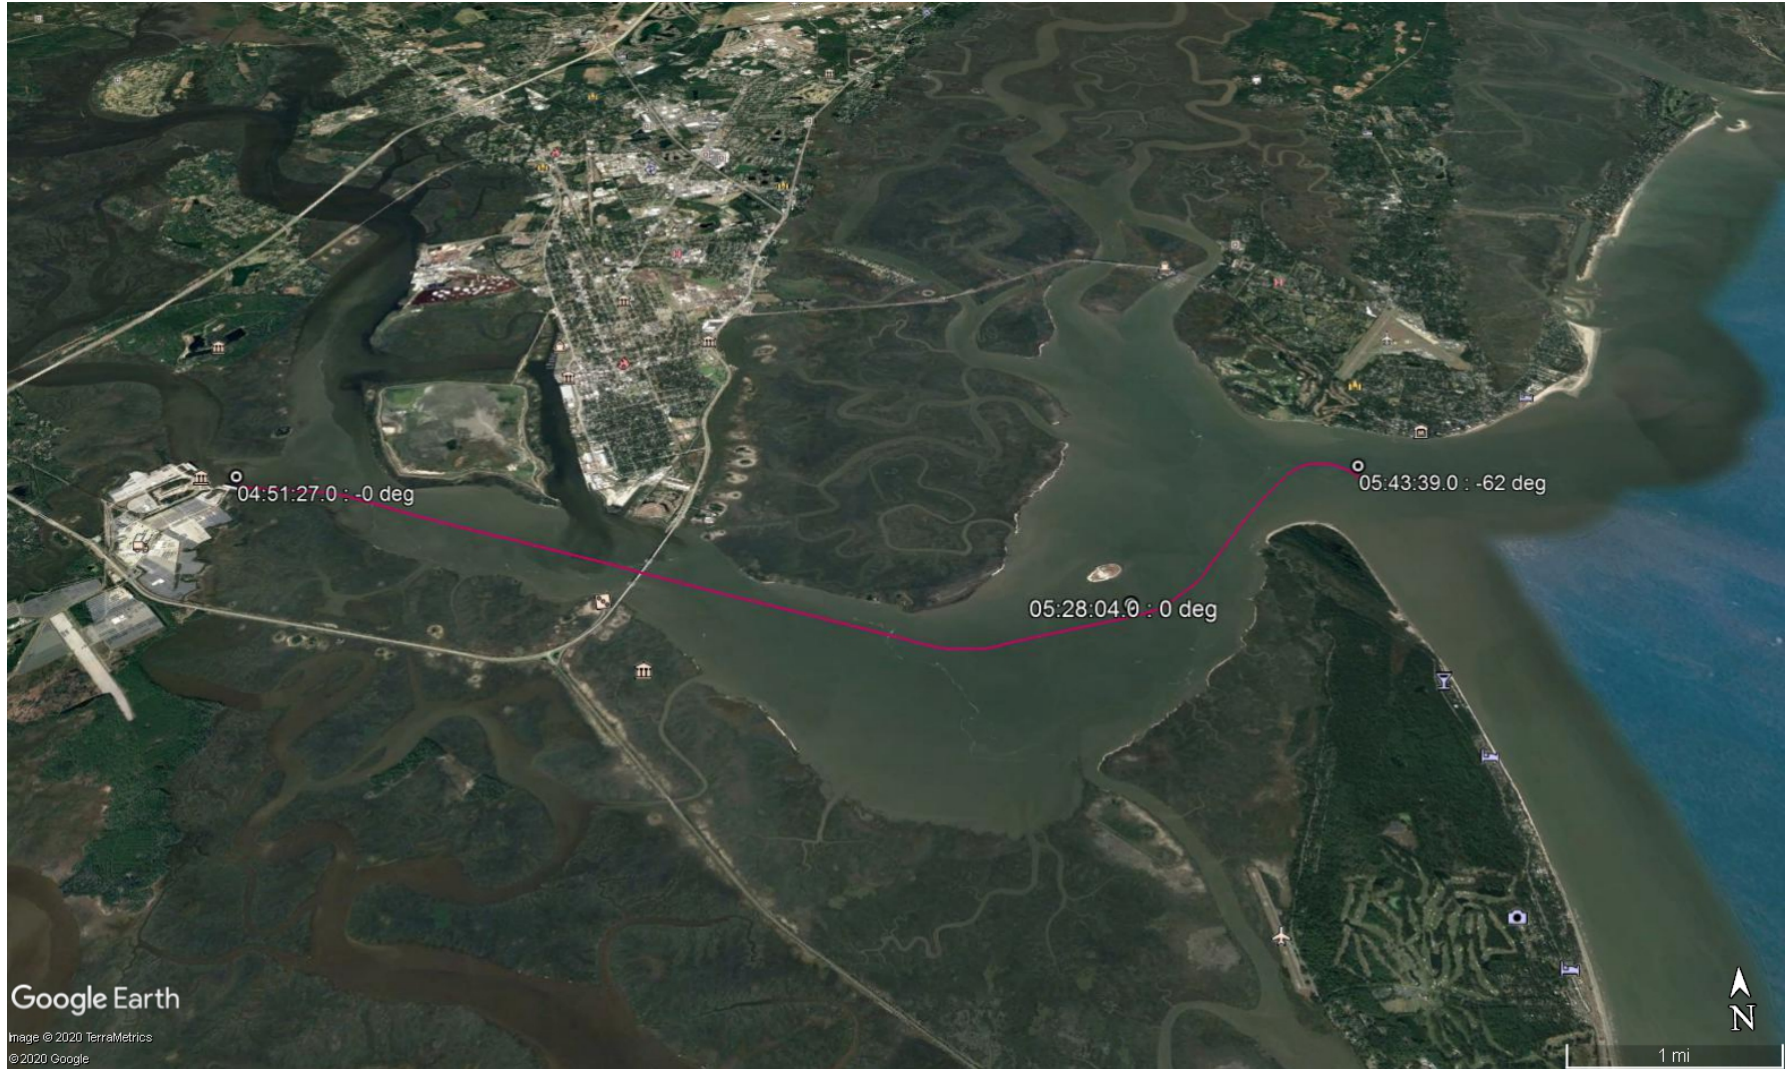
Figure 3. A Google Earth overlay of the accident voyage leaving Brunswick.

Figures 3 and 4 are Google Earth overlays from the accident voyage. The data points show both the time the vessel was at that position and the ship's list in degrees. Weather and lighting conditions shown in the Google Earth overlay is not indicative of weather and lighting conditions during the accident.

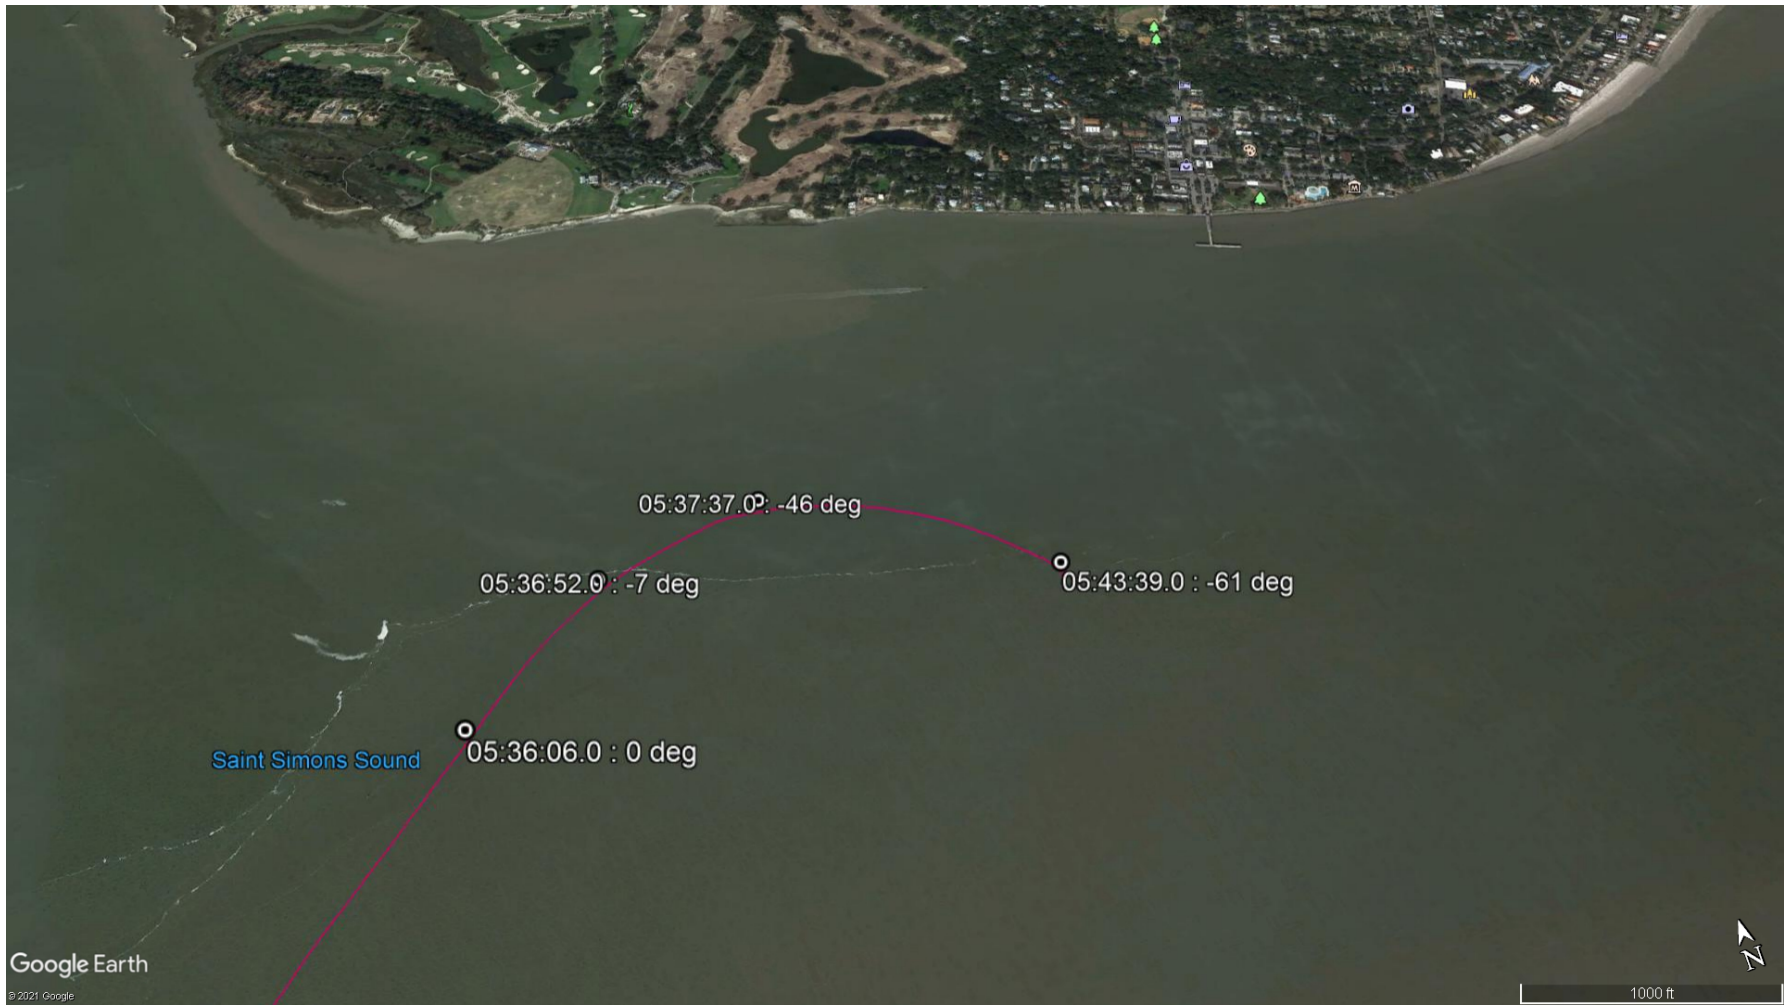
Figure 4. A Google Earth overlay surrounding the accident.

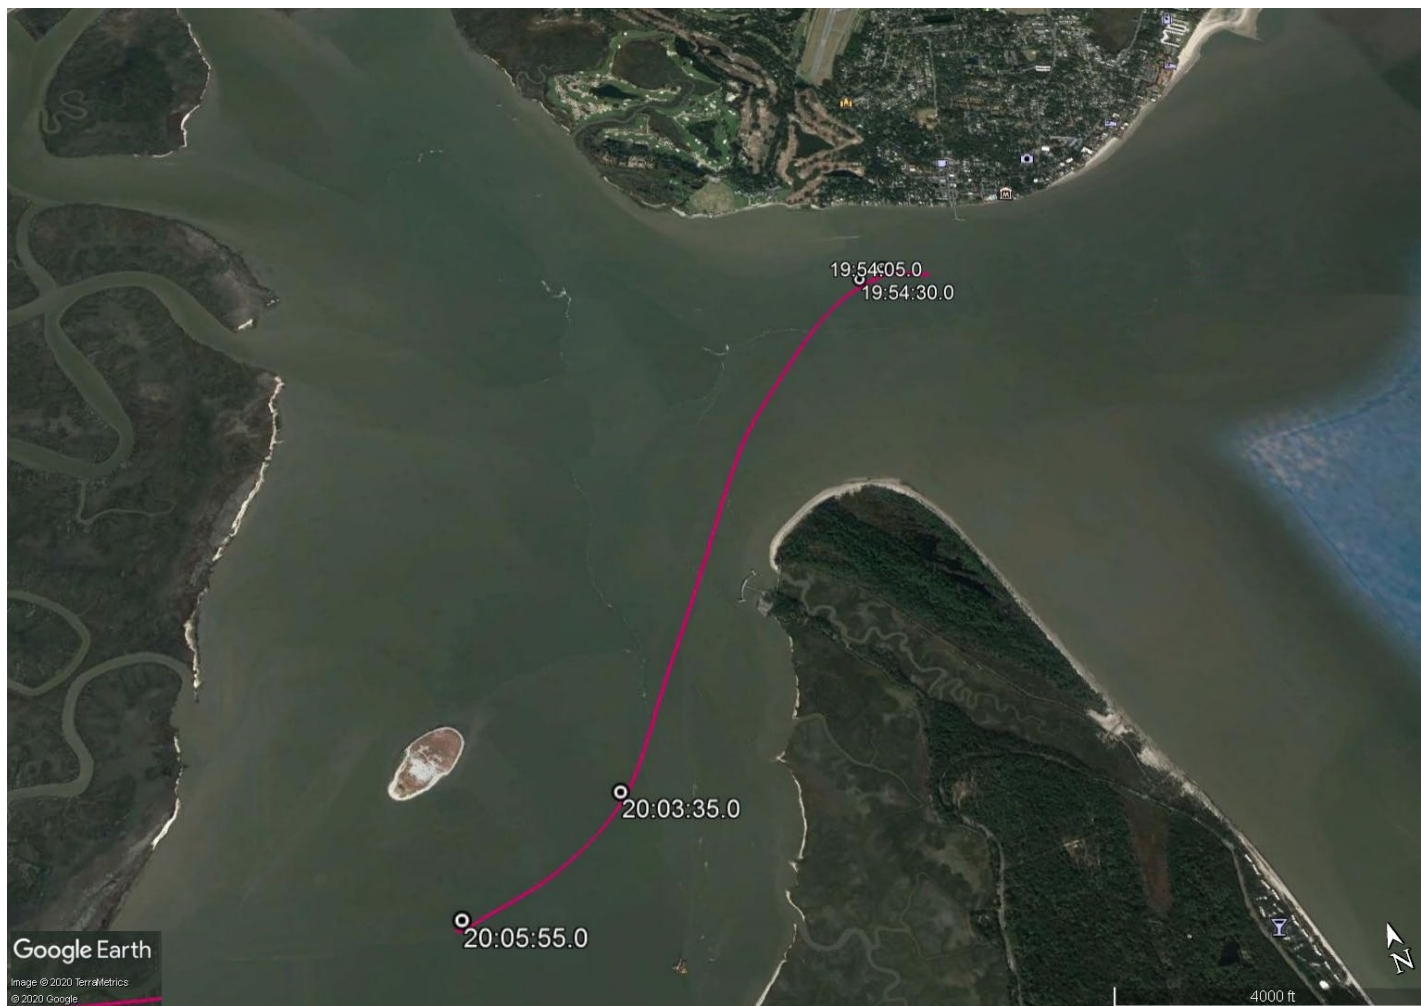
Figure 5. Google Earth overlay of the previous voyage into Brunswick.

Data from the previous voyage into Brunswick is shown in figures 5 and 6. The VDR had several recording gaps in the data from the previous voyage. One period without a gap was taken in the same location as the accident. An attempt was made to get the inclinometer data from this part of the previous voyage, but during this period the IMAC system only recorded 10 data points and therefore is a limited representation of the ship's behavior.

Figure 5 is a Google Earth overlay of the previous voyage into Brunswick at the location of the accident. The data points show both the time the vessel was at that position and the ship's speed over ground in knots.

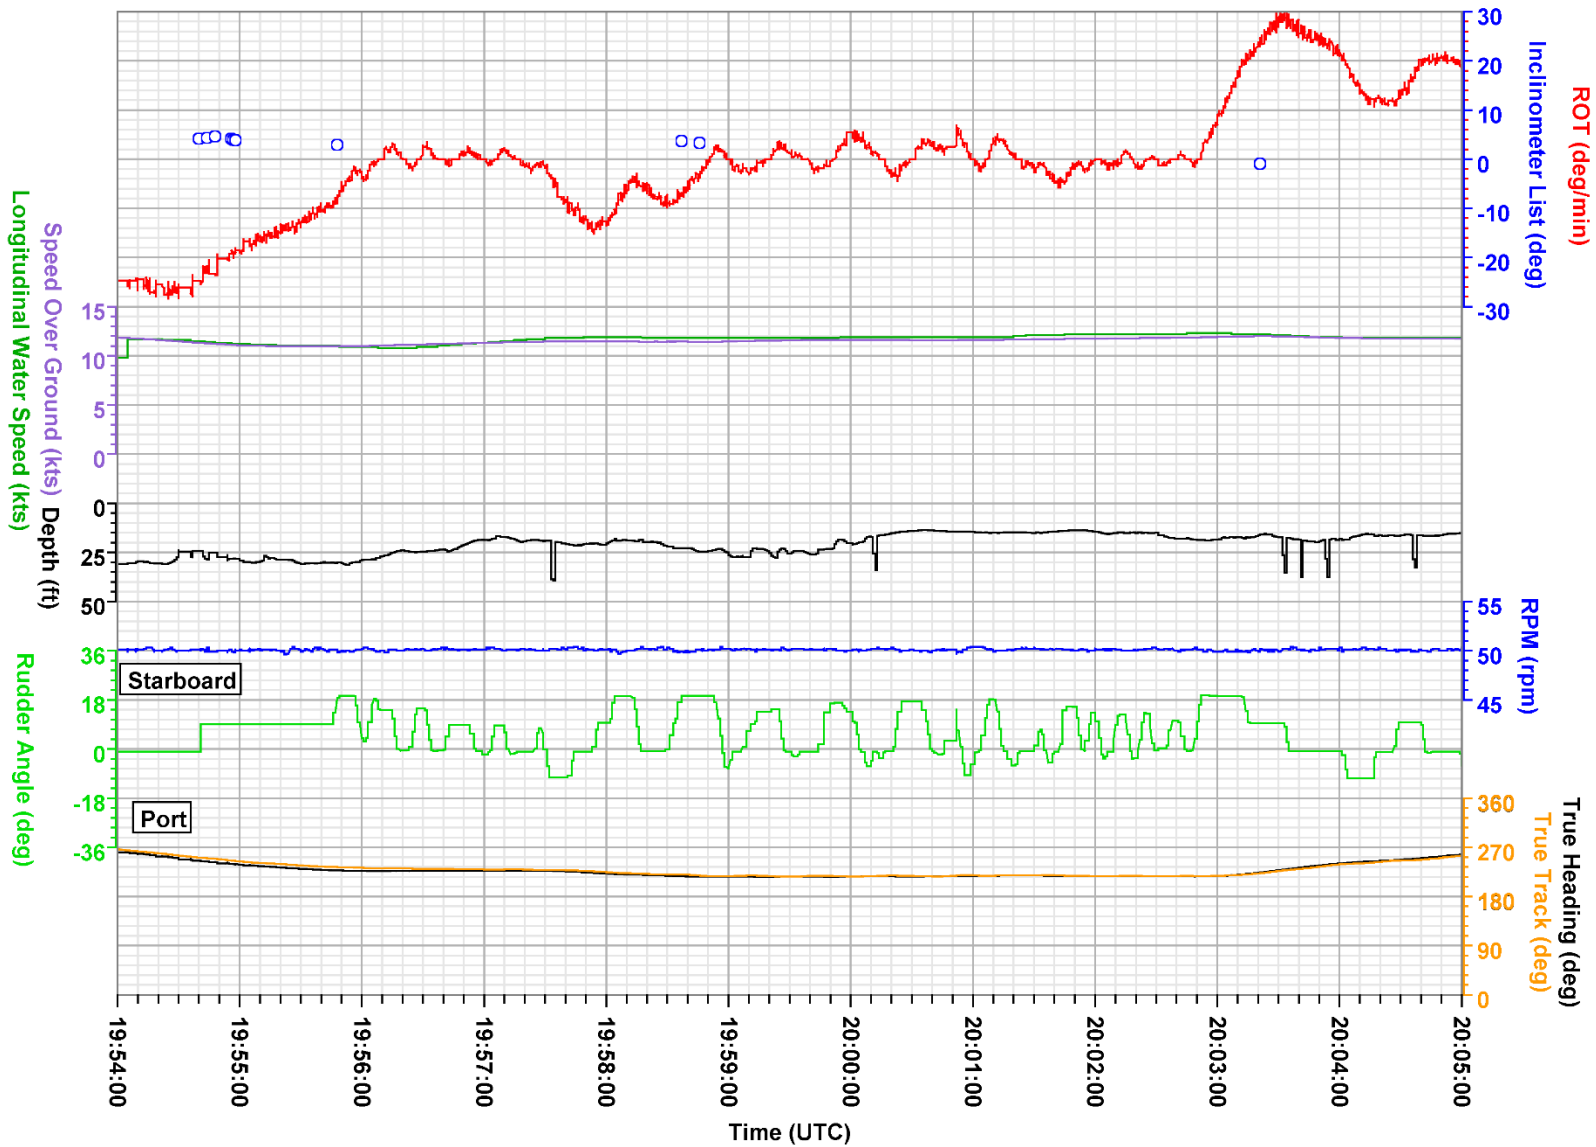
Figure 6. A detailed view of parametric data from the previous voyage into Brunswick.

Figure 6 shows the data from the VDR for the previous voyage into Brunswick at the location of the accident.
