NATIONAL TRANSPORTATION SAFETY BOARD
Investigative Hearing

Norfolk Southern Railway general merchandise freight train 32N
derailment with subsequent hazardous material release and fires,
in East Palestine, Ohio, on February 3, 2023

GROUP	D
EXHIBIT	
49

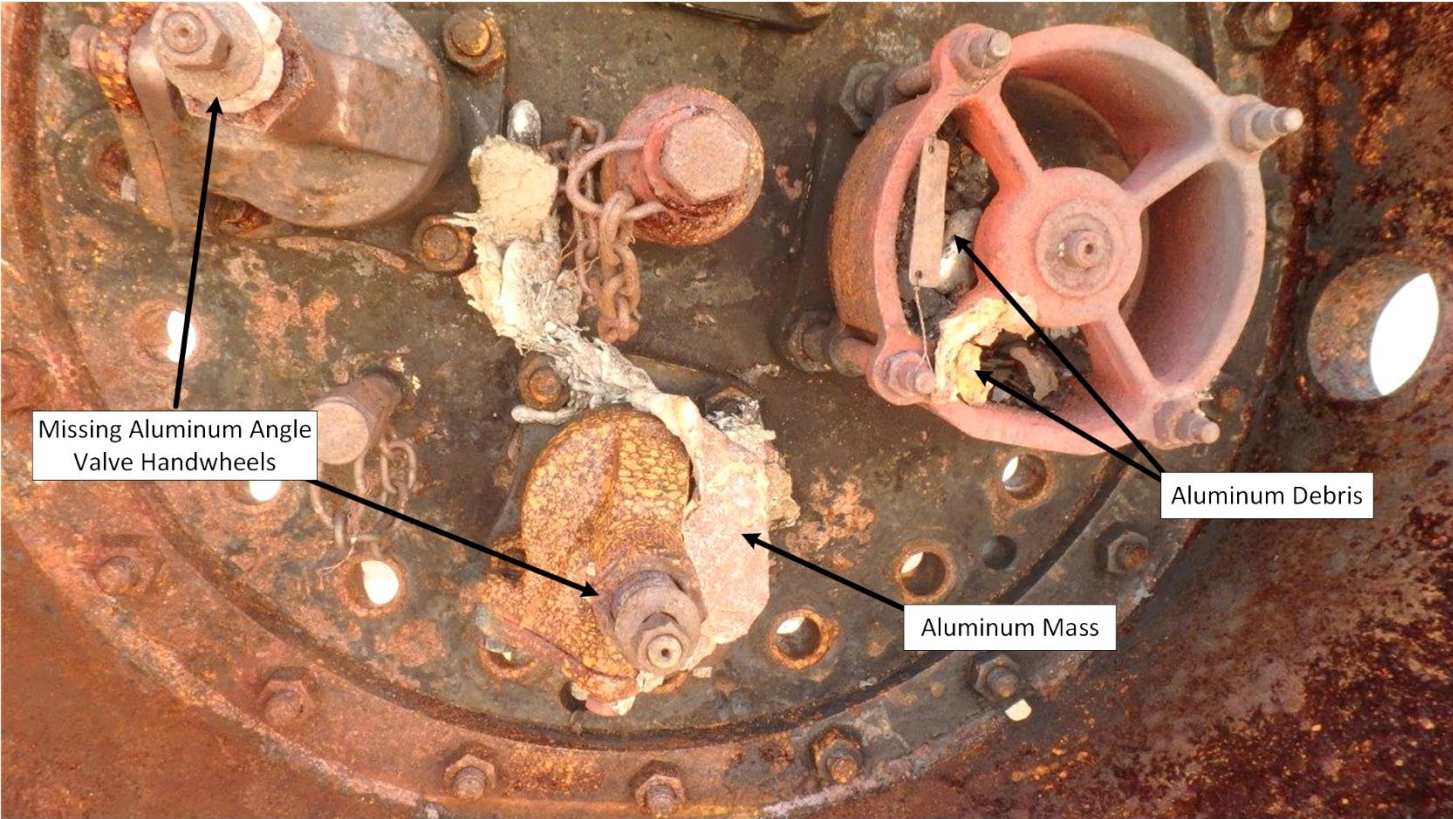
**Figure 47, Hazardous Materials Group Chair's Factual Report. OCPX80235 pressure plate showing PRD and angle valves. The aluminum liquid and vapor valve handwheels were missing, a solidified mass of melted aluminum surrounds the base of a liquid valve. The PRD top guide contained loose aluminum debris.
March 15, 2023.**

Missing Aluminum Angle
Valve Handwheels

Aluminum Debris

Aluminum Mass
