NATIONAL TRANSPORTATION SAFETY BOARD
Investigative Hearing

Norfolk Southern Railway general merchandise freight train 32N
derailment with subsequent hazardous material release and fires,
in East Palestine, Ohio, on February 3, 2023

GROUP	D
EXHIBIT	
52

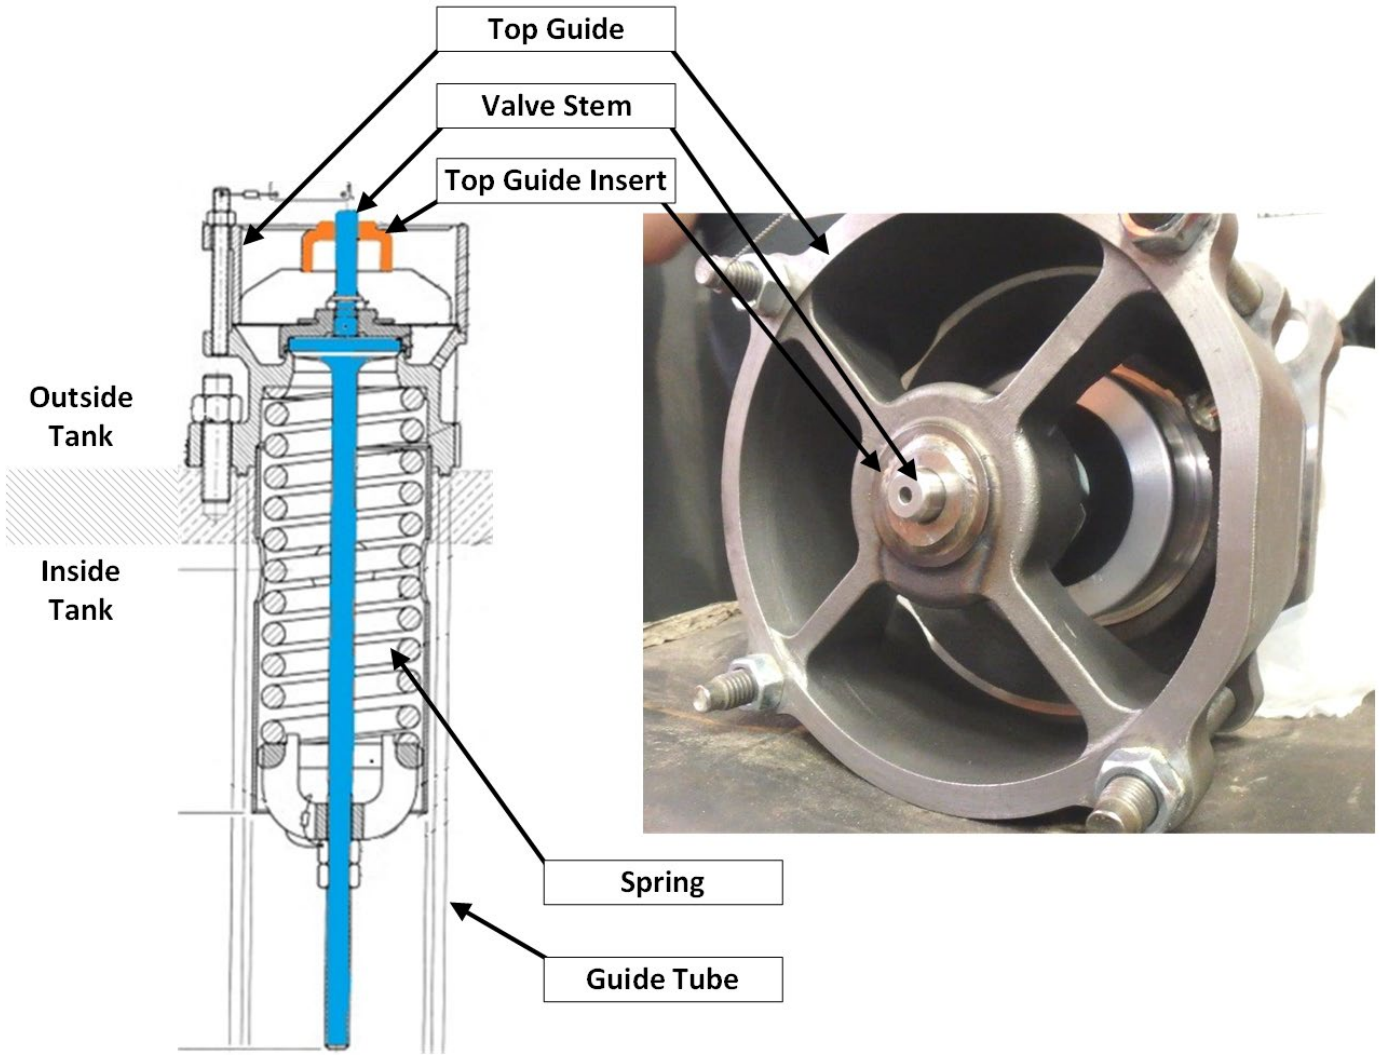
Figure 59, Hazardous Materials Group Chair's Factual Report. Exemplar Midland Manufacturing Model A-37000-series pressure relief valve, with diagram excerpted from Midland drawing 34-1-XS, highlighting the valve stem (blue) and top guide insert (orange). Photograph and annotations, NTSB.
