# Pedestrian Bridge Collapse Over SW 8th Street

Miami, Florida

March 15, 2018

NTSB/HAR-19/02

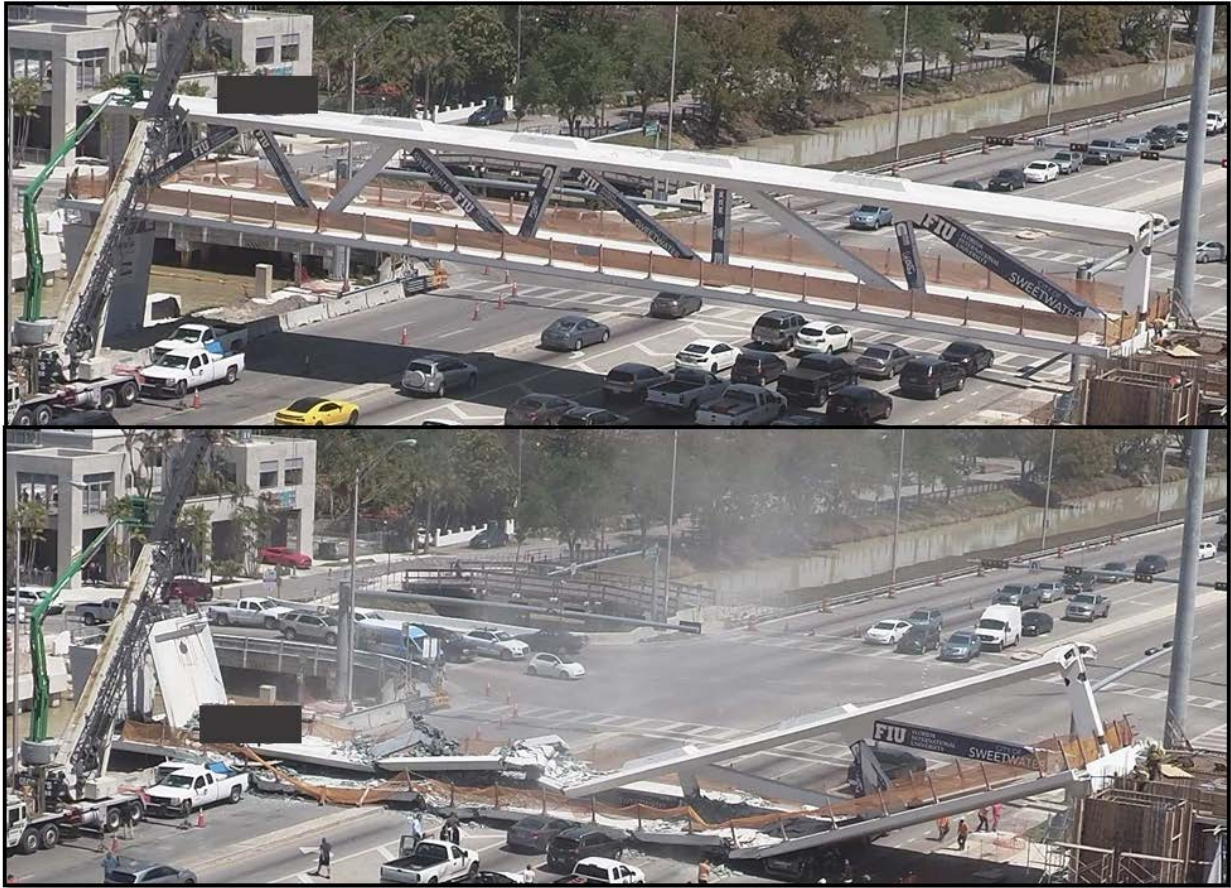
**Figure 4.** Still images from FIU parking garage camera, showing east views of pedestrian bridge, March 15, 2018, precollapse (top) and postcollapse (bottom). (Source: FIU video camera)

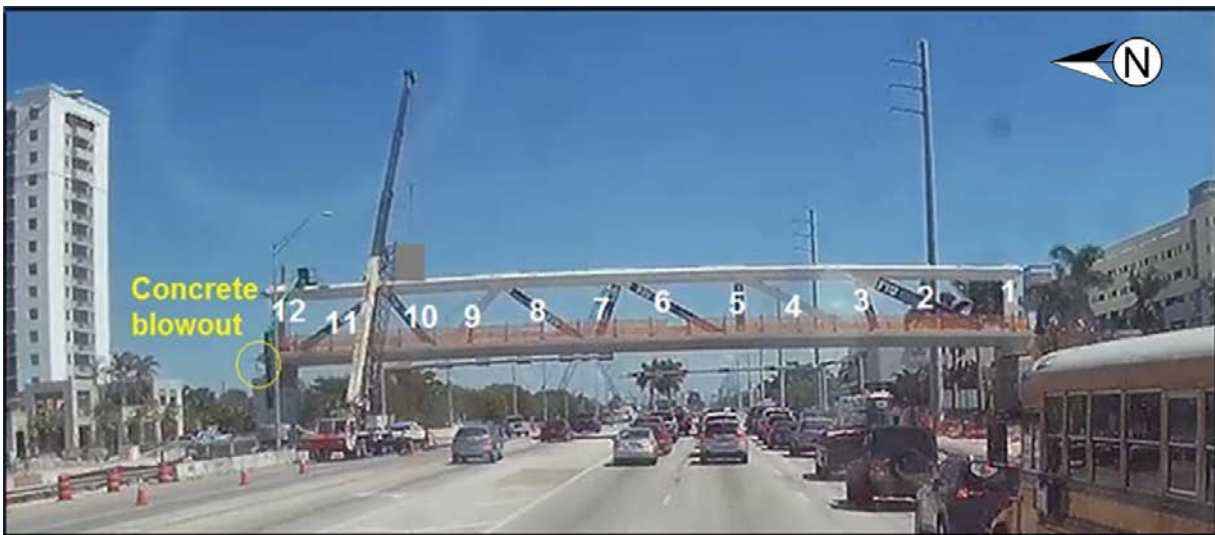
The video includes the entire bridge span structure. Workers are visible on the canopy of the main span in the vicinity of truss member 10, and eastbound traffic is stopped underneath the bridge. Figure 9 shows the video frame with time stamp 13:46:43:881. Debris consistent with concrete dust blowout is observed on the north side of the main span diaphragm—at the location of the deck, diaphragm, and pylon pier.<sup>11</sup> Figure 10, the video still image with time stamp 13:46:44:046, shows the beginning collapse sequence, with the north end at truss member 10 hinging downward as compared with its position in the precollapse recorded images. The video captures the continued hinge movement of the main span structure, which rotates downward as a rigid structure. Full-width fracturing of the canopy is visible north of the member 10/11 nodal region and in the deck structure north of the member 9/10 nodal region. Figure 11, the video image with time stamp 13:46:44:310, shows the main span completely collapsed, with members 4, 3, 2, and 1 intact at the south end.

**Figure 9.** Still image (time stamp 13:46:43:881) from in-vehicle mounted video camera on pickup truck traveling east on SW 8th Street, showing concrete dust and debris blowout at north end (pylon pier), March 15, about 1:46 p.m.

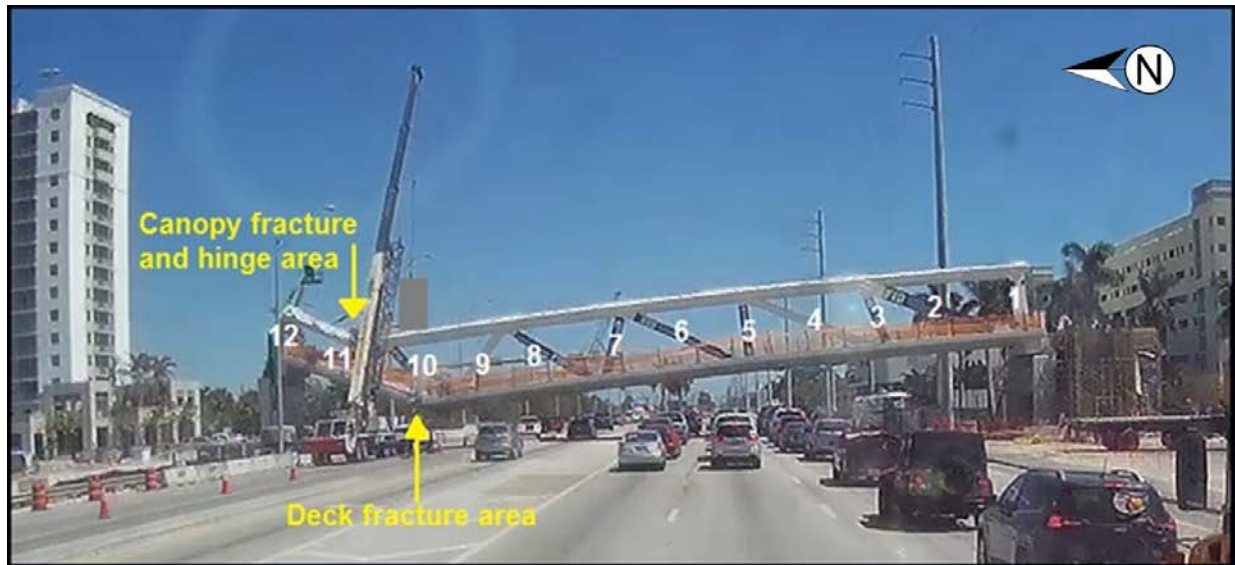
**Figure 10.** Still image (time stamp 13:46:44:046) from in-vehicle mounted video camera on pickup truck traveling east on SW 8th Street, showing full-width canopy fracture and deck fracture areas at north end (pylon pier), March 15, about 1:46 p.m.

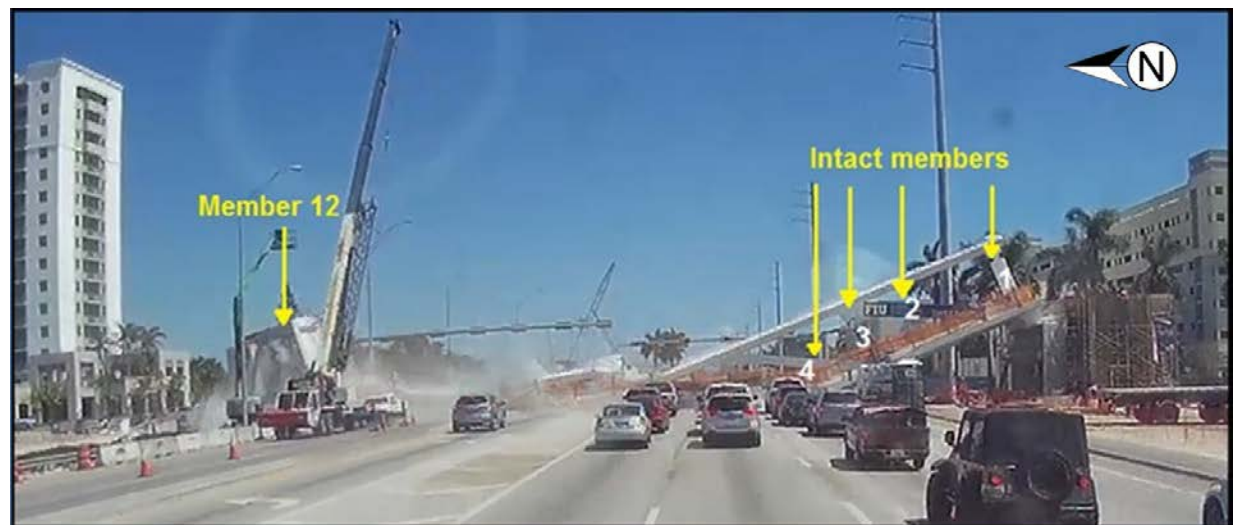
**Figure 11.** Still image (time stamp 13:46:44:310) from in-vehicle mounted video camera on pickup truck traveling east on SW 8th Street, showing main span completely collapsed, March 15, about 1:46 p.m.

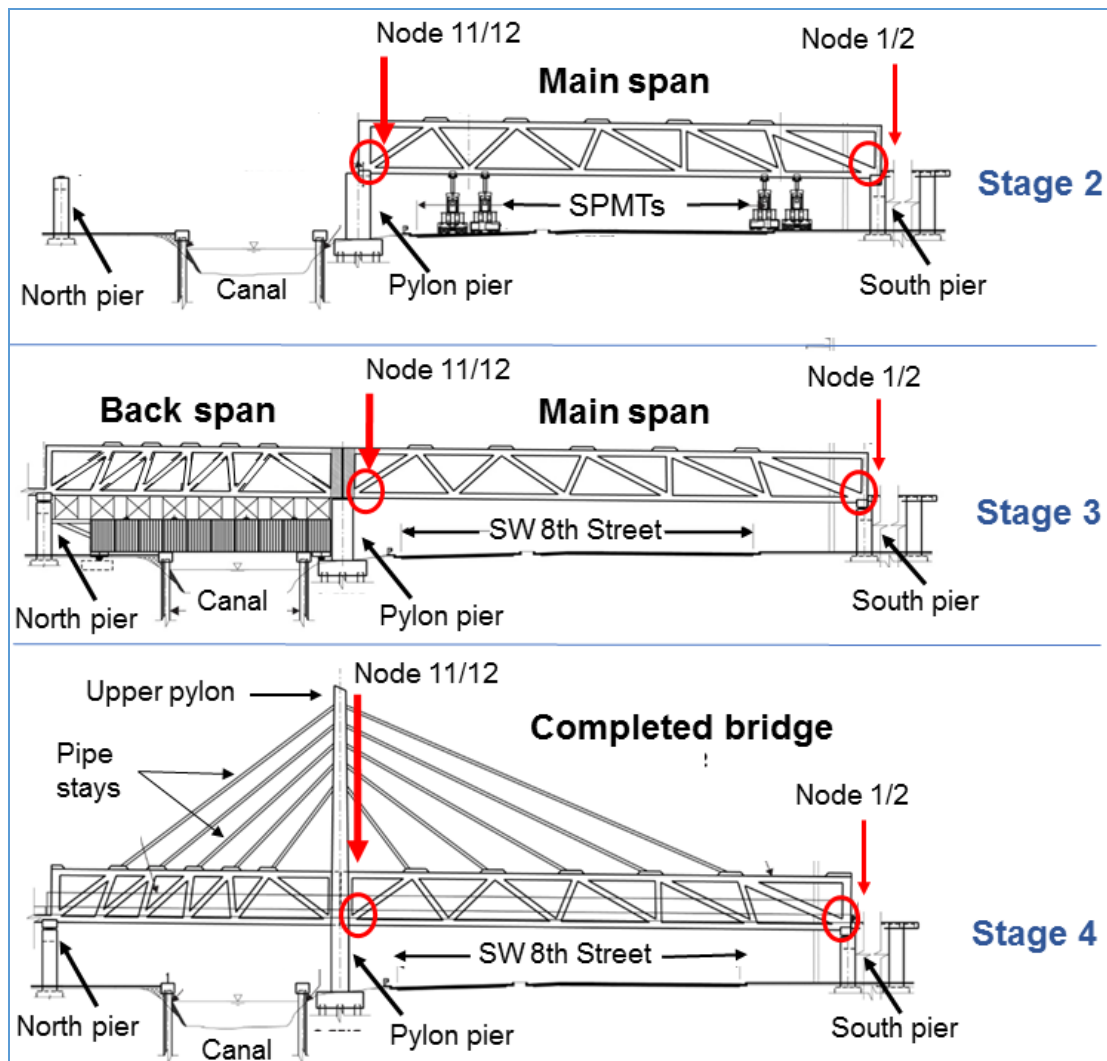
- Stage 1: Construction of the bridge substructure elements and the fabrication of the main span truss members in the casting yard.
- Stage 2: Transport of the main span from the casting yard using a self-propelled modular transporter (SPMT) and its placement in a “simply supported” condition on the south pier and pylon pier, then detensioning truss members 2 and 11.<sup>25</sup>
- Stage 3: Construction of the back span, supported on the pylon pier and north pier.
- Stage 4: Connection of the main span, back span, and pylon pier; construction of the upper pylon; and installation of steel pipe stays (see figure 13 for representation of stages 2–4).

**Figure 13.** Construction stages 2–4, east view. (Source: FIGG, annotated by NTSB)

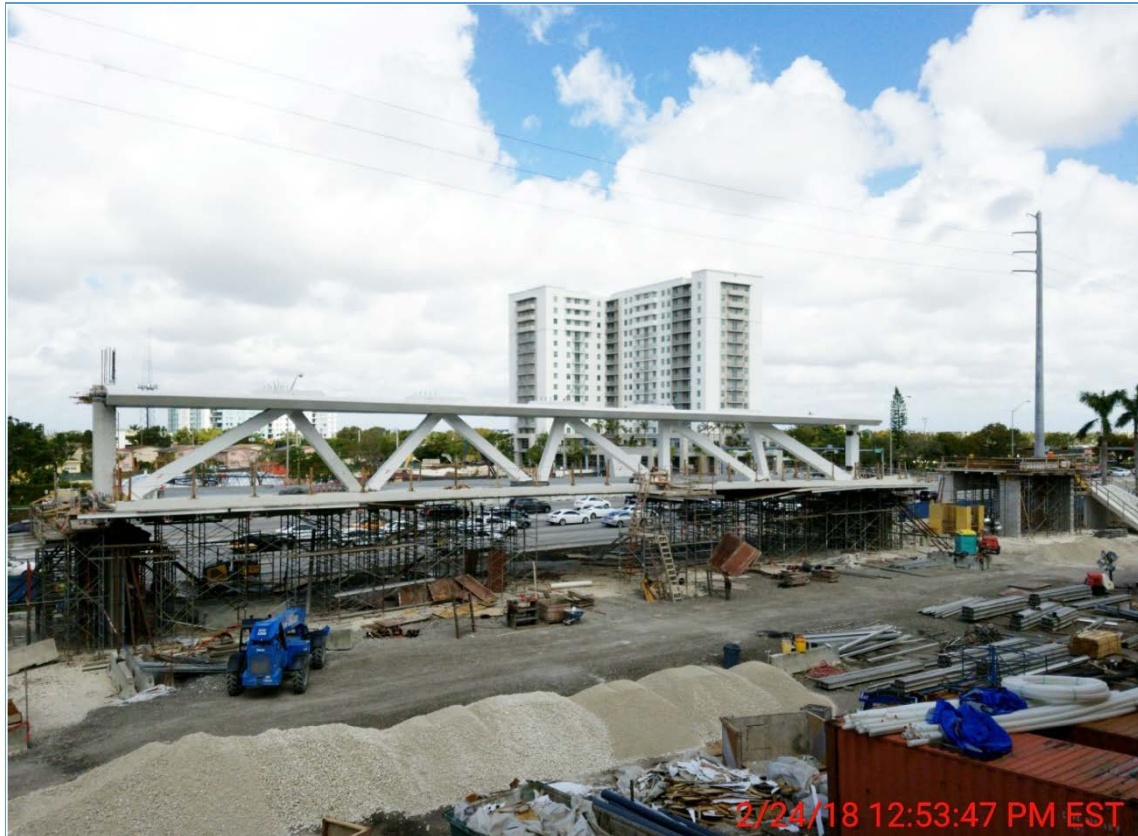
**Figure 15.** Temporary falsework supporting the bridge span in the casting yard on February 24, 2018, being sequentially removed from the middle of the span toward the ends of the span. (Source: MCM)

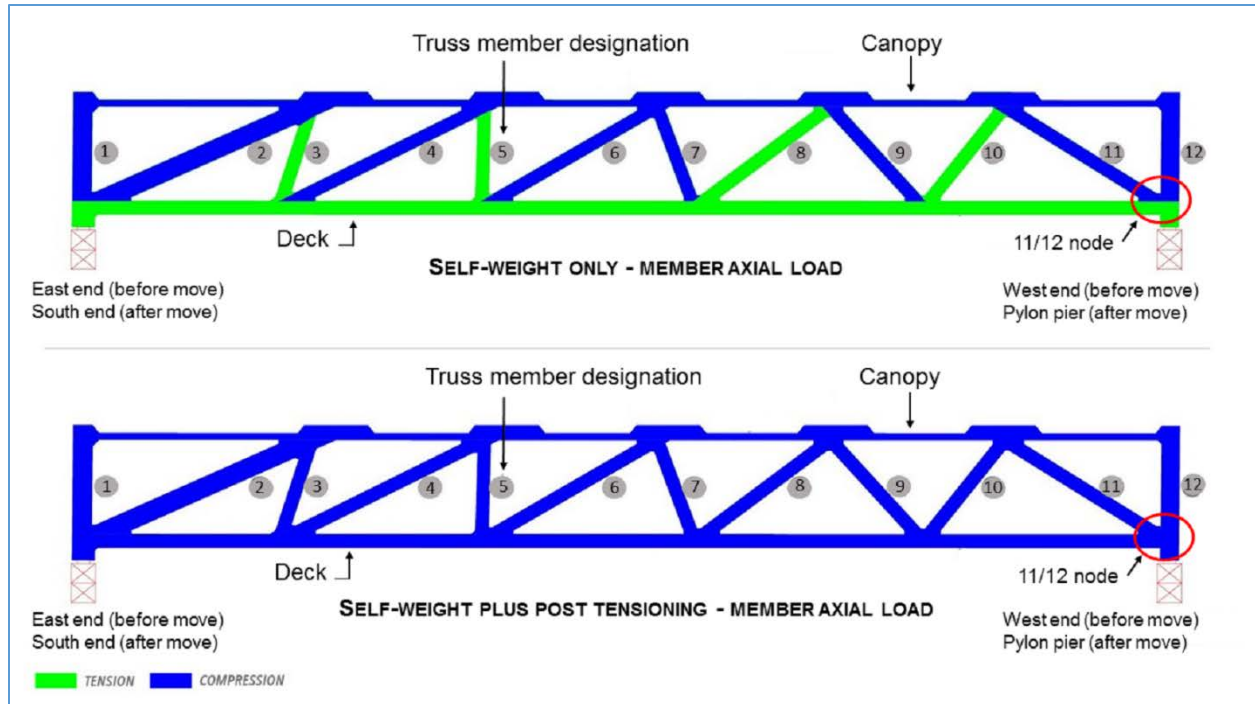
**Figure 21.** Self-weight axial forces only (top) for diagonal truss members 2 and 11, which are combined with post-tensioning forces concurrently acting on main span to produce net axial forces (bottom) at each end before transport and on permanent pier following transport. Top illustration is shown without post-tensioning; bottom illustration is shown with actual loads. (Source: FIGG, annotated by NTSB)

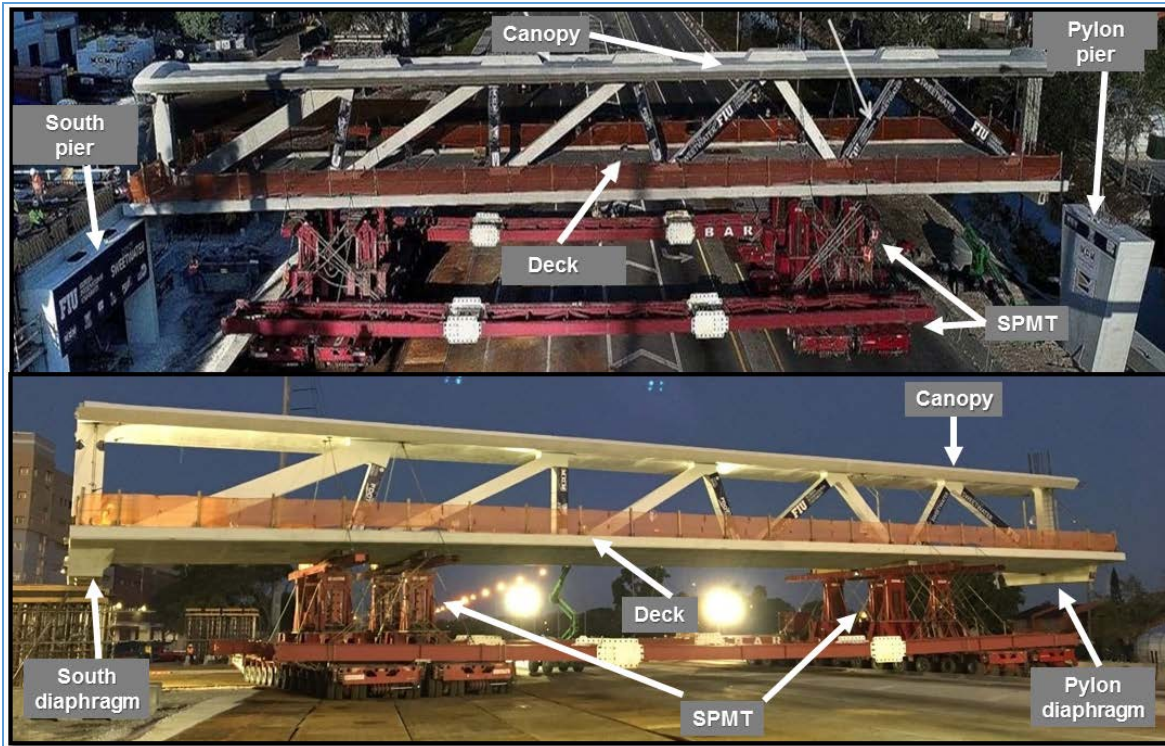
**Figure 22.** SPMT being moved overnight on March 10 (bottom) and main span being placed on south and pylon piers, facing west (top). Transport occurred over 8 hours, starting at 4:30 a.m., with placement of final permanent pier support concluding at 12:30 p.m. (Source: FIGG, annotated by NTSB)

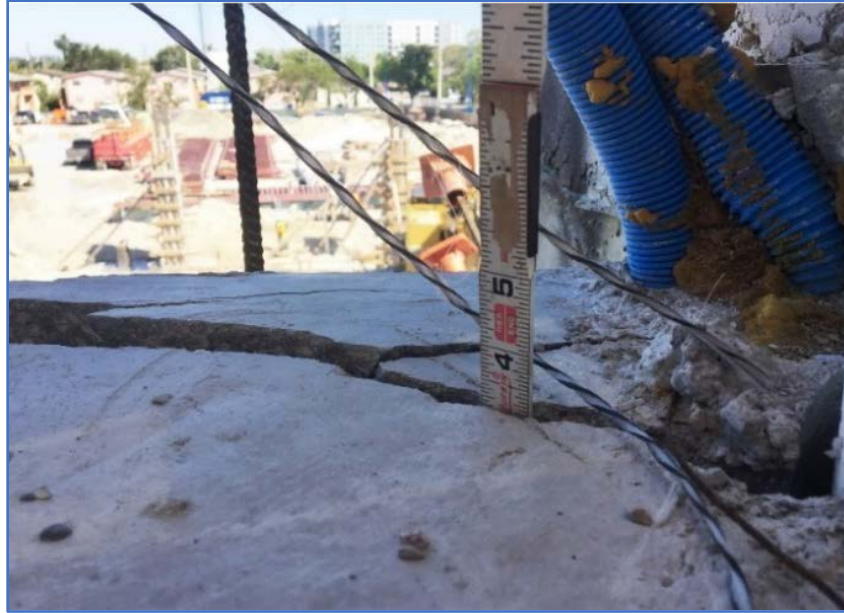
**Figure 24.** Cracks of 3–4 inch depth at northern end of precast main span, along west side of diaphragm 2 (north view), March 13, 11:17 a.m. (Source: MCM)

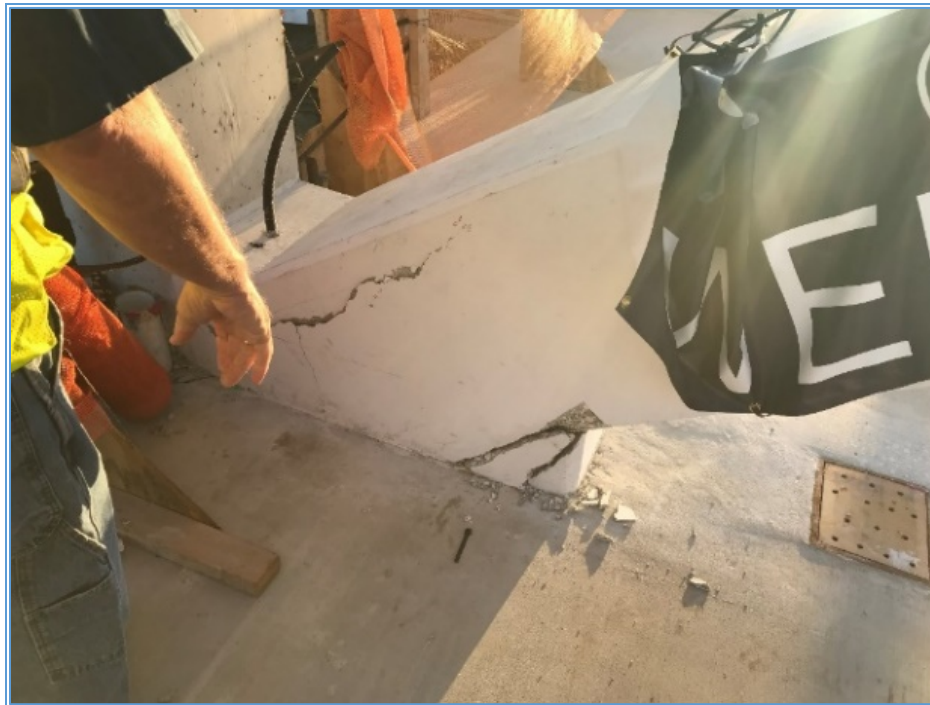
On March 15, about 8:00 a.m., the FIGG EOR and another employee went onto the main span and viewed the cracks at the member 11/12 nodal region—in advance of a 9:00 a.m. presentation by FIGG to FDOT, FIU, MCM, and Bolton, Perez to discuss the cracking. The FIGG employee (not the EOR) took seven photographs of the cracks. The FIGG EOR did not view these photographs before, during, or after the 9:00 a.m. meeting. Prior to the presentation, MCM provided site inspection photographs to the FIGG EOR, and he stated during the meeting that “the cracks look more significant in person than on the photographs.”<sup>50</sup> The bridge collapsed about 1:46 p.m. Postcollapse, FIGG provided the photographs to NTSB investigators, accompanied by a description of the location of the cracks, with date, time, and source (see figures 25 and 26).

**Figure 25.** Cracks at bottom of diagonal member 11 (west view), March 15. (Source: FIGG)

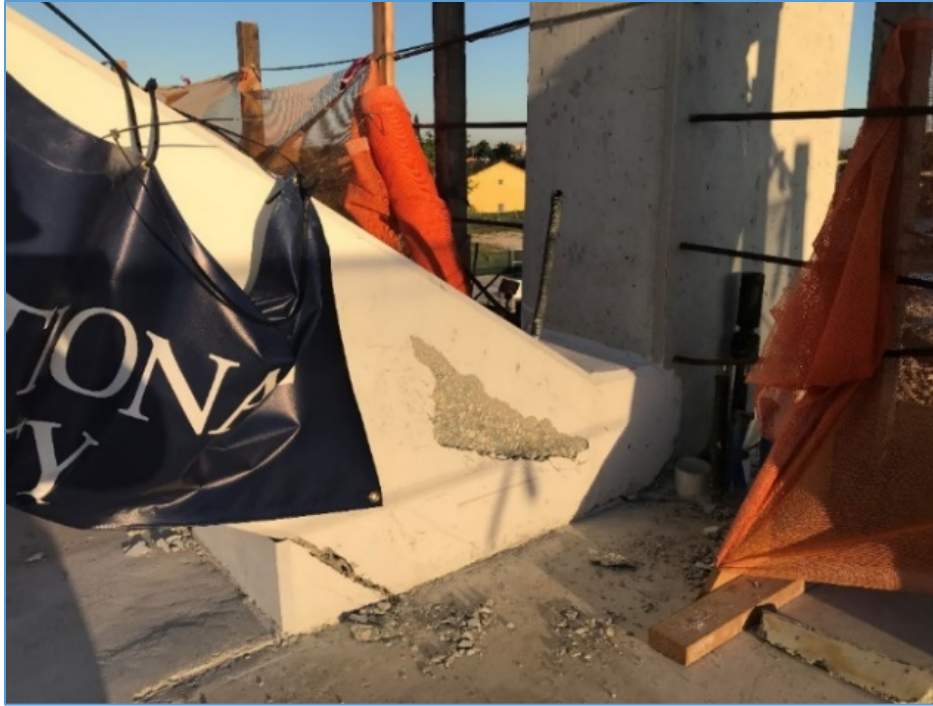
**Figure 26.** Cracks at bottom of diagonal member 11 (east view), March 15. (Source: FIGG)

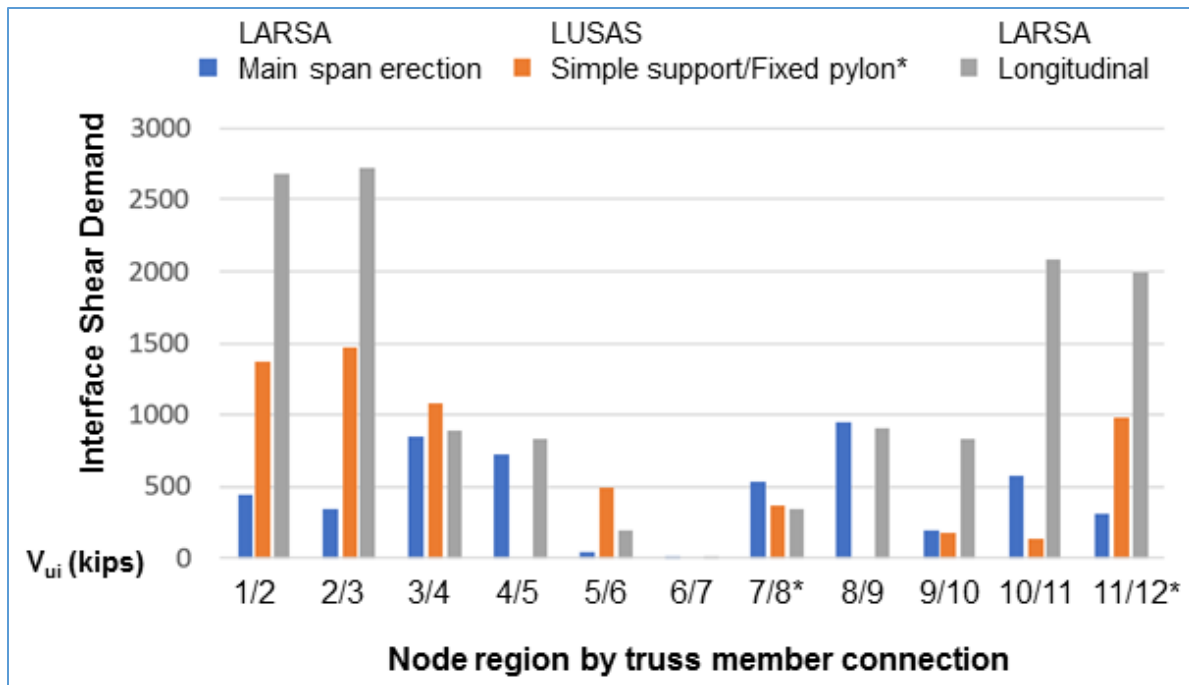
**Figure 27.** Nodal region interface shear demand results generated for FIGG bridge design, with horizontal axis showing two truss member identification numbers that connect into each nodal region. (Source: FHWA 2019)

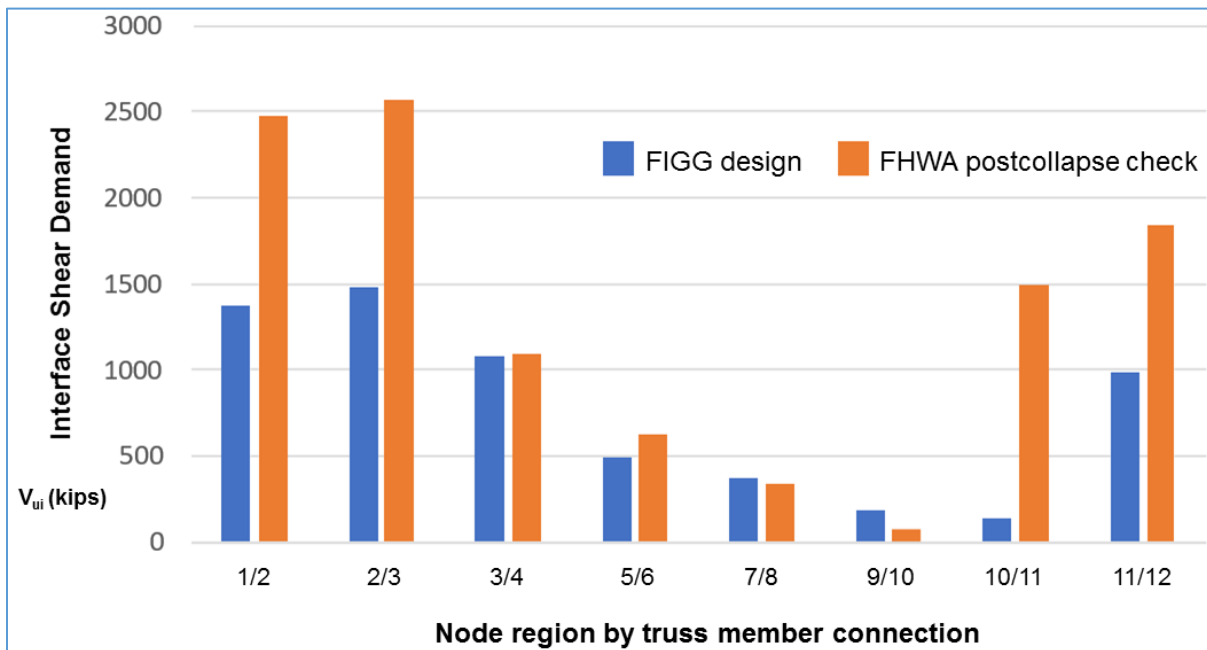
**Figure 30.** Comparison of nodal region horizontal shear modeling results from FIGG design and FHWA analysis. (Source: FHWA 2019)

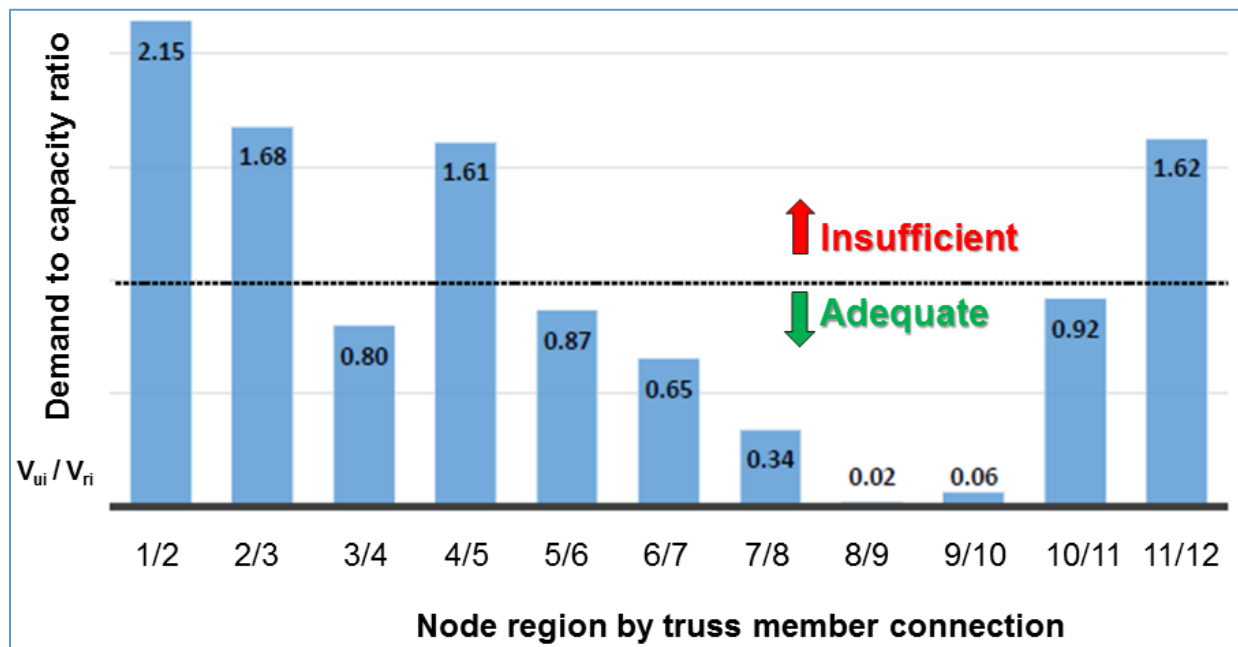
**Figure 31.** D/C ratios for main span nodal regions. (Source: FHWA 2019)
