BNSF Railway Company Embankment Stabilization Hi Line Subdivision, Montana	
MP 1014 SITE AND EXPLORATION PLAN	
September 2022	108788-001
  SHANNON & WILSON, INC. <small>GEOTECHNICAL AND ENVIRONMENTAL CONSULTANTS</small>	FIG. A-1 Sheet 1 of 2

BNSF Railway Company Embankment Stabilization Hi Line Subdivision, Montana	
MP 1014 TYPICAL SECTION AND SUBSURFACE PROFILE STA 5356+850	
September 2022	108788-001
SHANNON & WILSON, INC. <small>GEOTECHNICAL AND ENVIRONMENTAL CONSULTANTS</small>	FIG. A-2

BNSF Railway Company Embankment Stabilization Hi Line Subdivision, Montana	
MP 1014 TYPICAL SECTION AND SUBSURFACE PROFILE STA 5357+413	
September 2022	108788-001
SHANNON & WILSON, INC. <small>GEOTECHNICAL AND ENVIRONMENTAL CONSULTANTS</small>	FIG. A-3

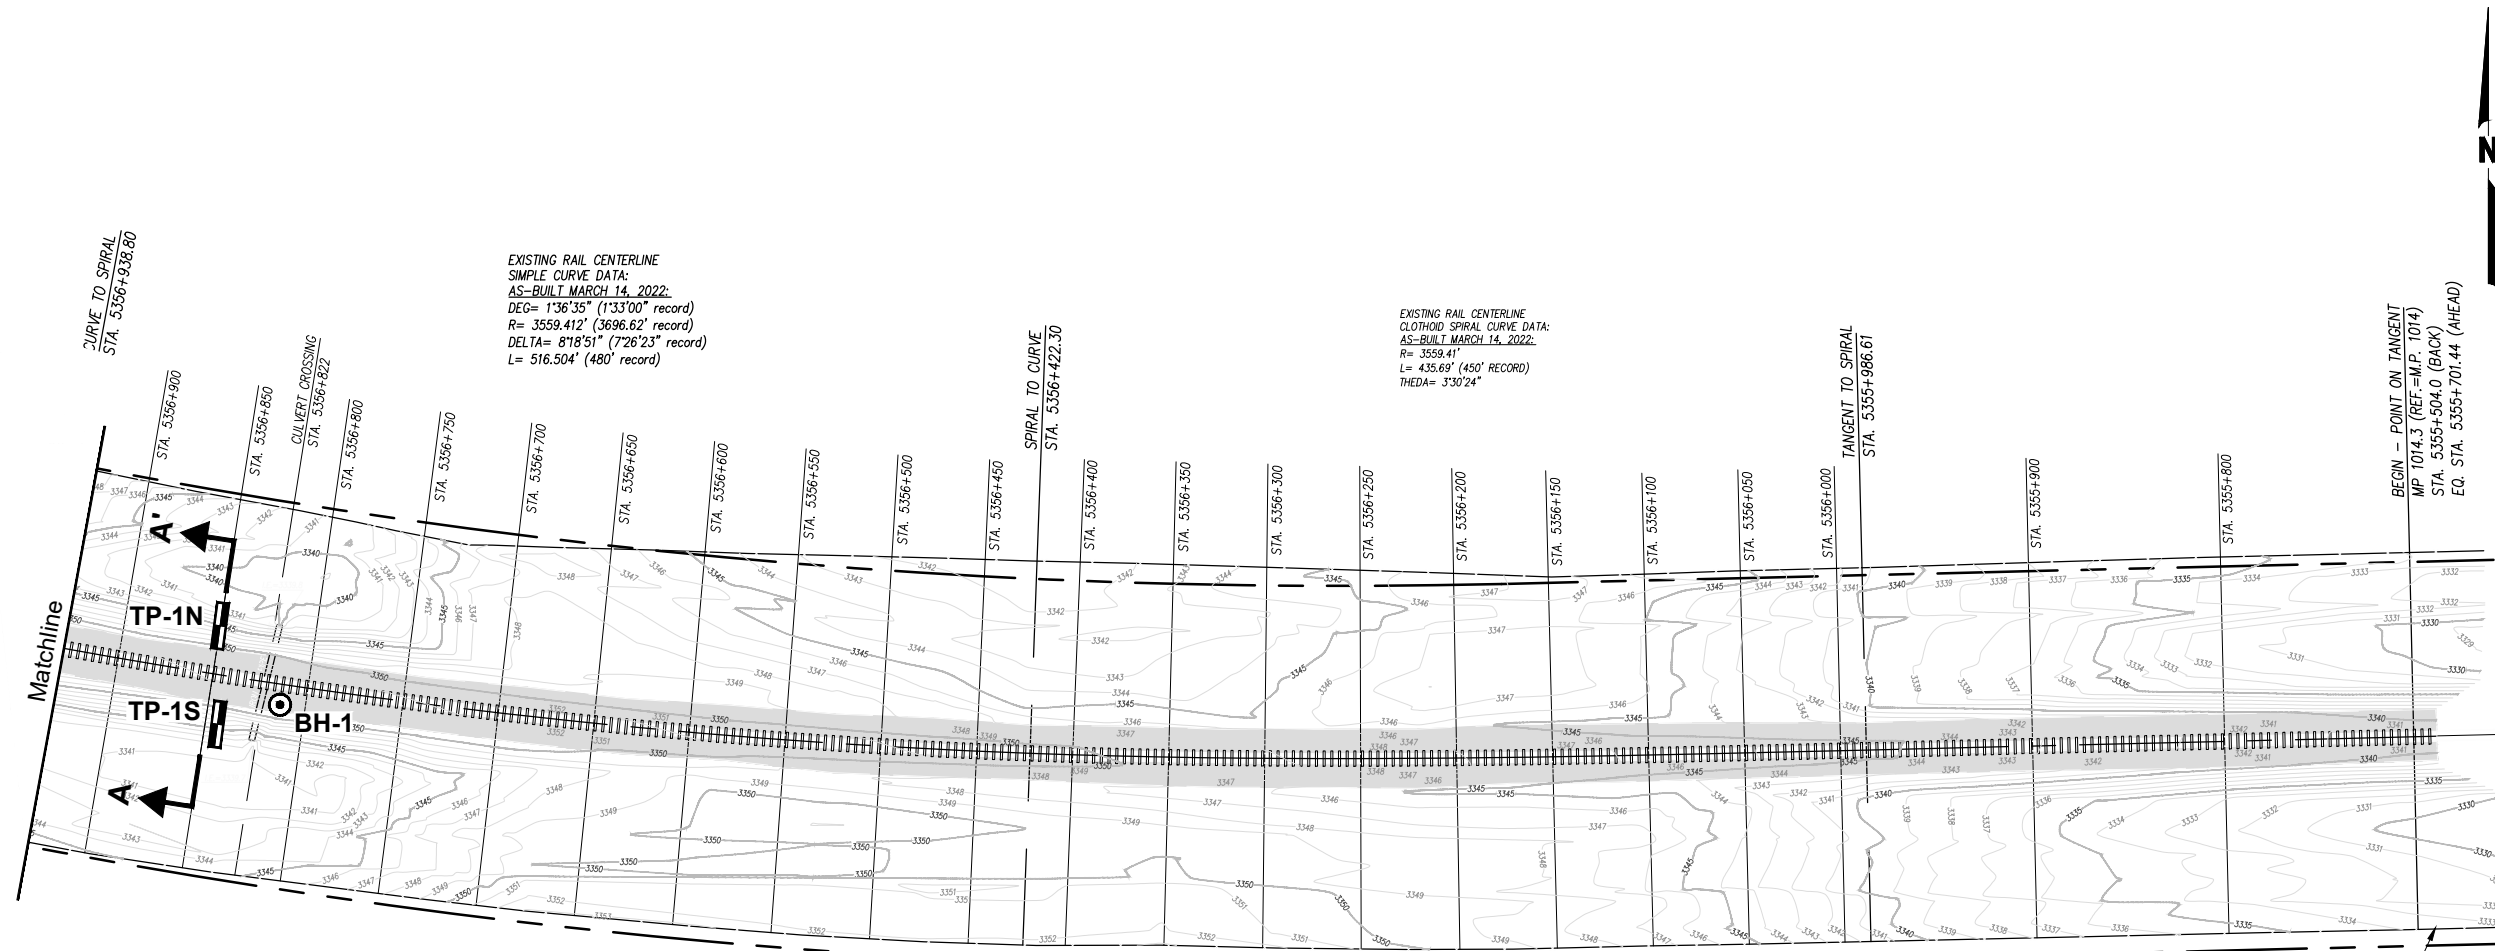
EXISTING RAIL CENTERLINE
SIMPLE CURVE DATA:
AS-BUILT MARCH 14, 2022:
DEG= 1°36'35" (1°33'00" record)
R= 3559.412' (3696.62' record)
DELTA= 8°18'51" (7°26'23" record)
L= 516.504' (480' record)

EXISTING RAIL CENTERLINE
CLOTHOID SPIRAL CURVE DATA:
AS-BUILT MARCH 14, 2022:
R= 3559.41'
L= 435.69' (450' RECORD)
THEDA= 3°30'24"

CONTROL POINT #1001:
DESCRIPTION: 5/8" DIA. REBAR, 24" LONG, WITH 2-1/2" DIA. ALUMINUM CAP
STAMPED "STEPHEN D. BABB, PLS 11699, OFeds #1355" SET FLUSH WITH THE
SURFACE, 2.5 FT. N. OF S. R/W FENCE NEAR A POST WITH METAL MARLS
MONUMENT SIGN ATTACHED, 97.6 FEET S. OF TRACK CL
N=9957.740 E=48145.458 ELEV.=3333.32 (NAVD88)
MGS_84_NAD_83(2011)(EPOCH: 2010.0000):
LAT.=N48°33'26.80512" LONG.=W110°48'22.10862"
Ellipsoid HT.=3283.14' (±0.04')
OPUS processed 38,344 observations, Overall RMS: 0.015 m, Rapid Ephemeris

Figure based on Babb topographic survey performed 3-14-22.

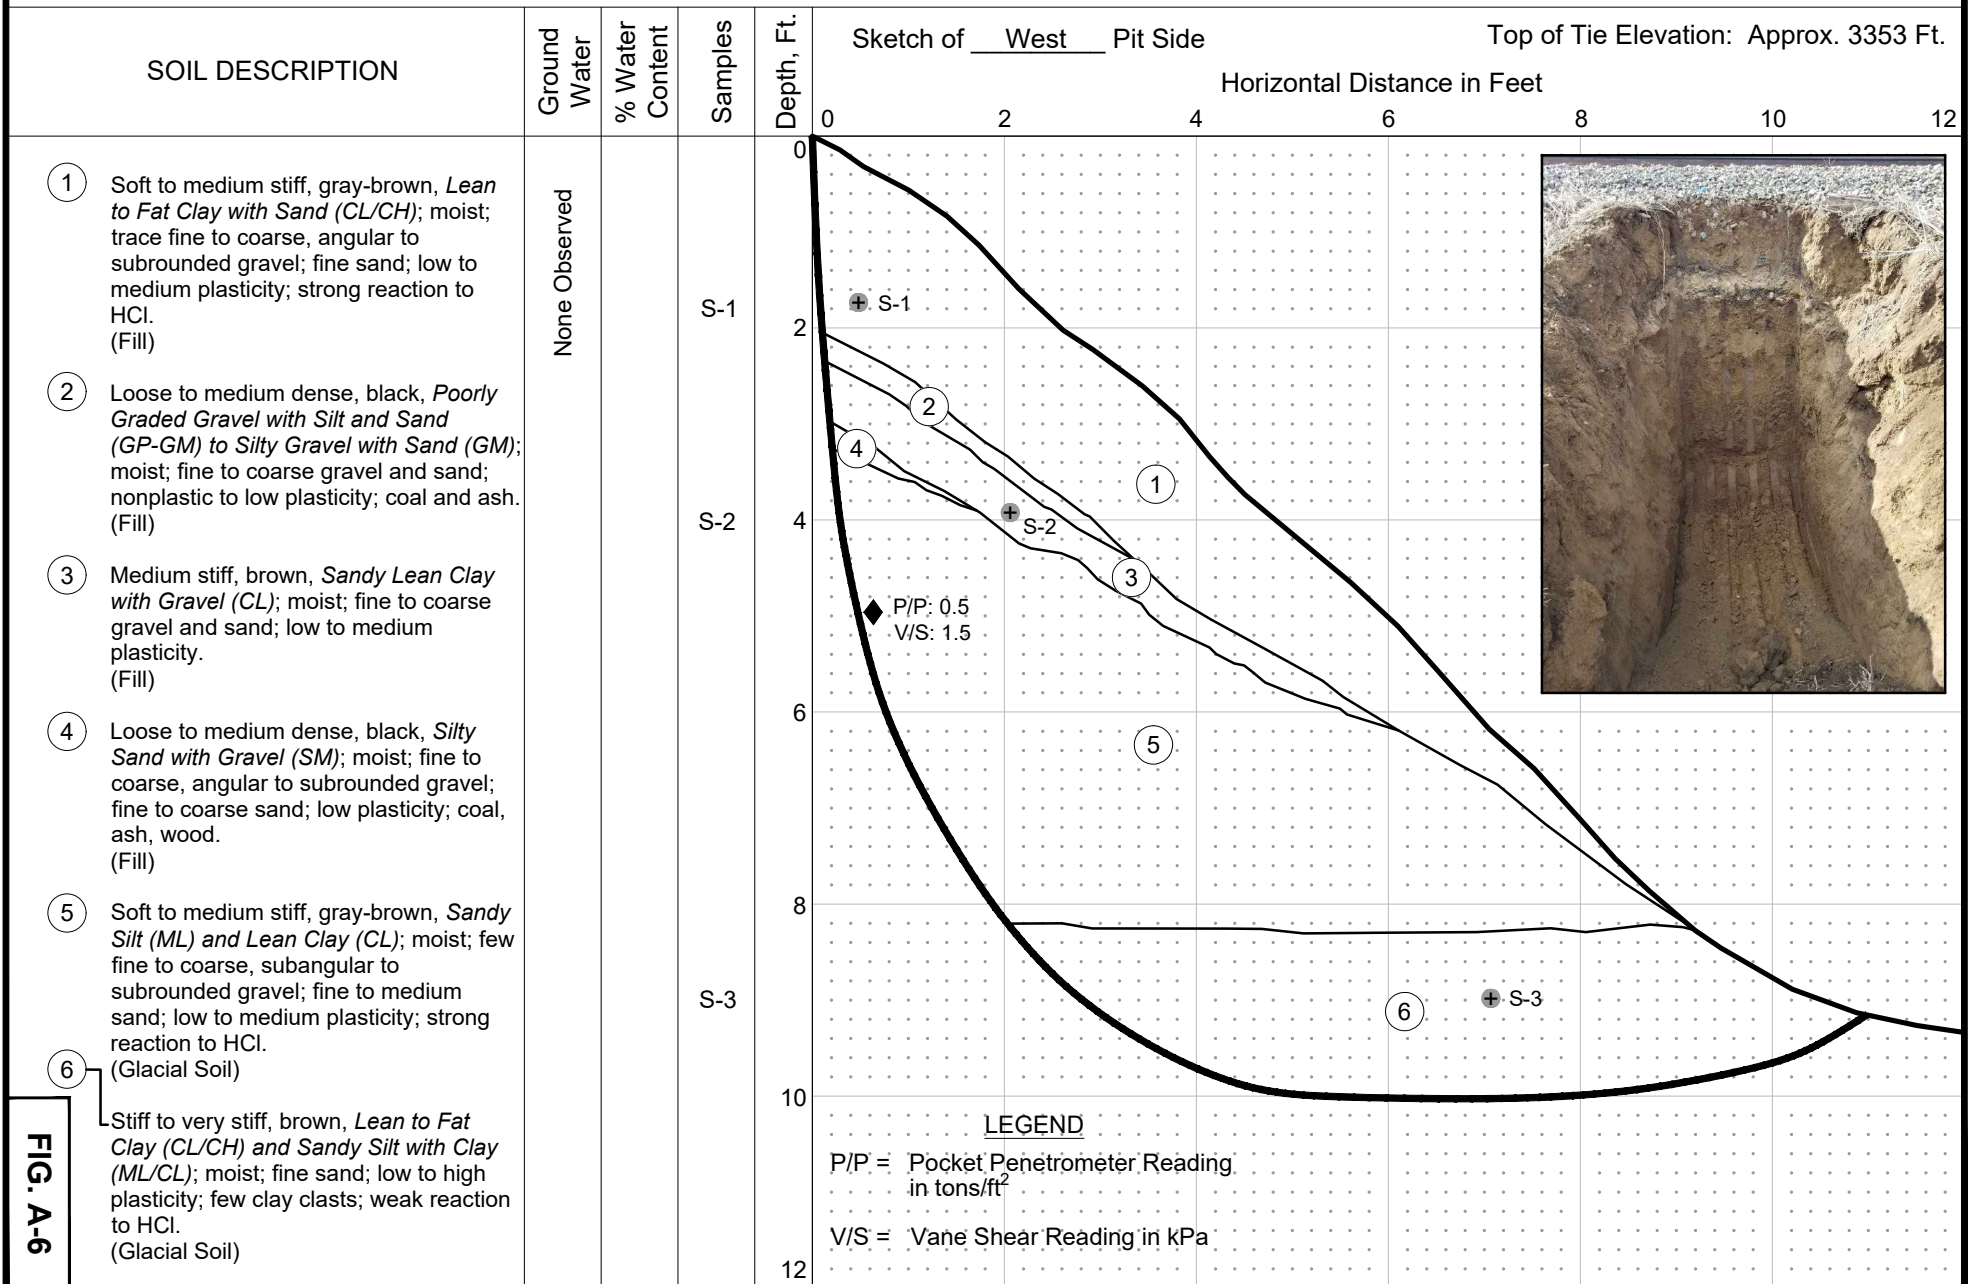
FIG. A-6

SHANNON & WILSON, INC.
GEOTECHNICAL AND ENVIRONMENTAL CONSULTANTS
LOG OF TEST PIT TP-1N

JOB NO: 108788-001 DATE: 3-29-22 LOCATION: MP 1014
 PROJECT: BNSF Hi Line Sub

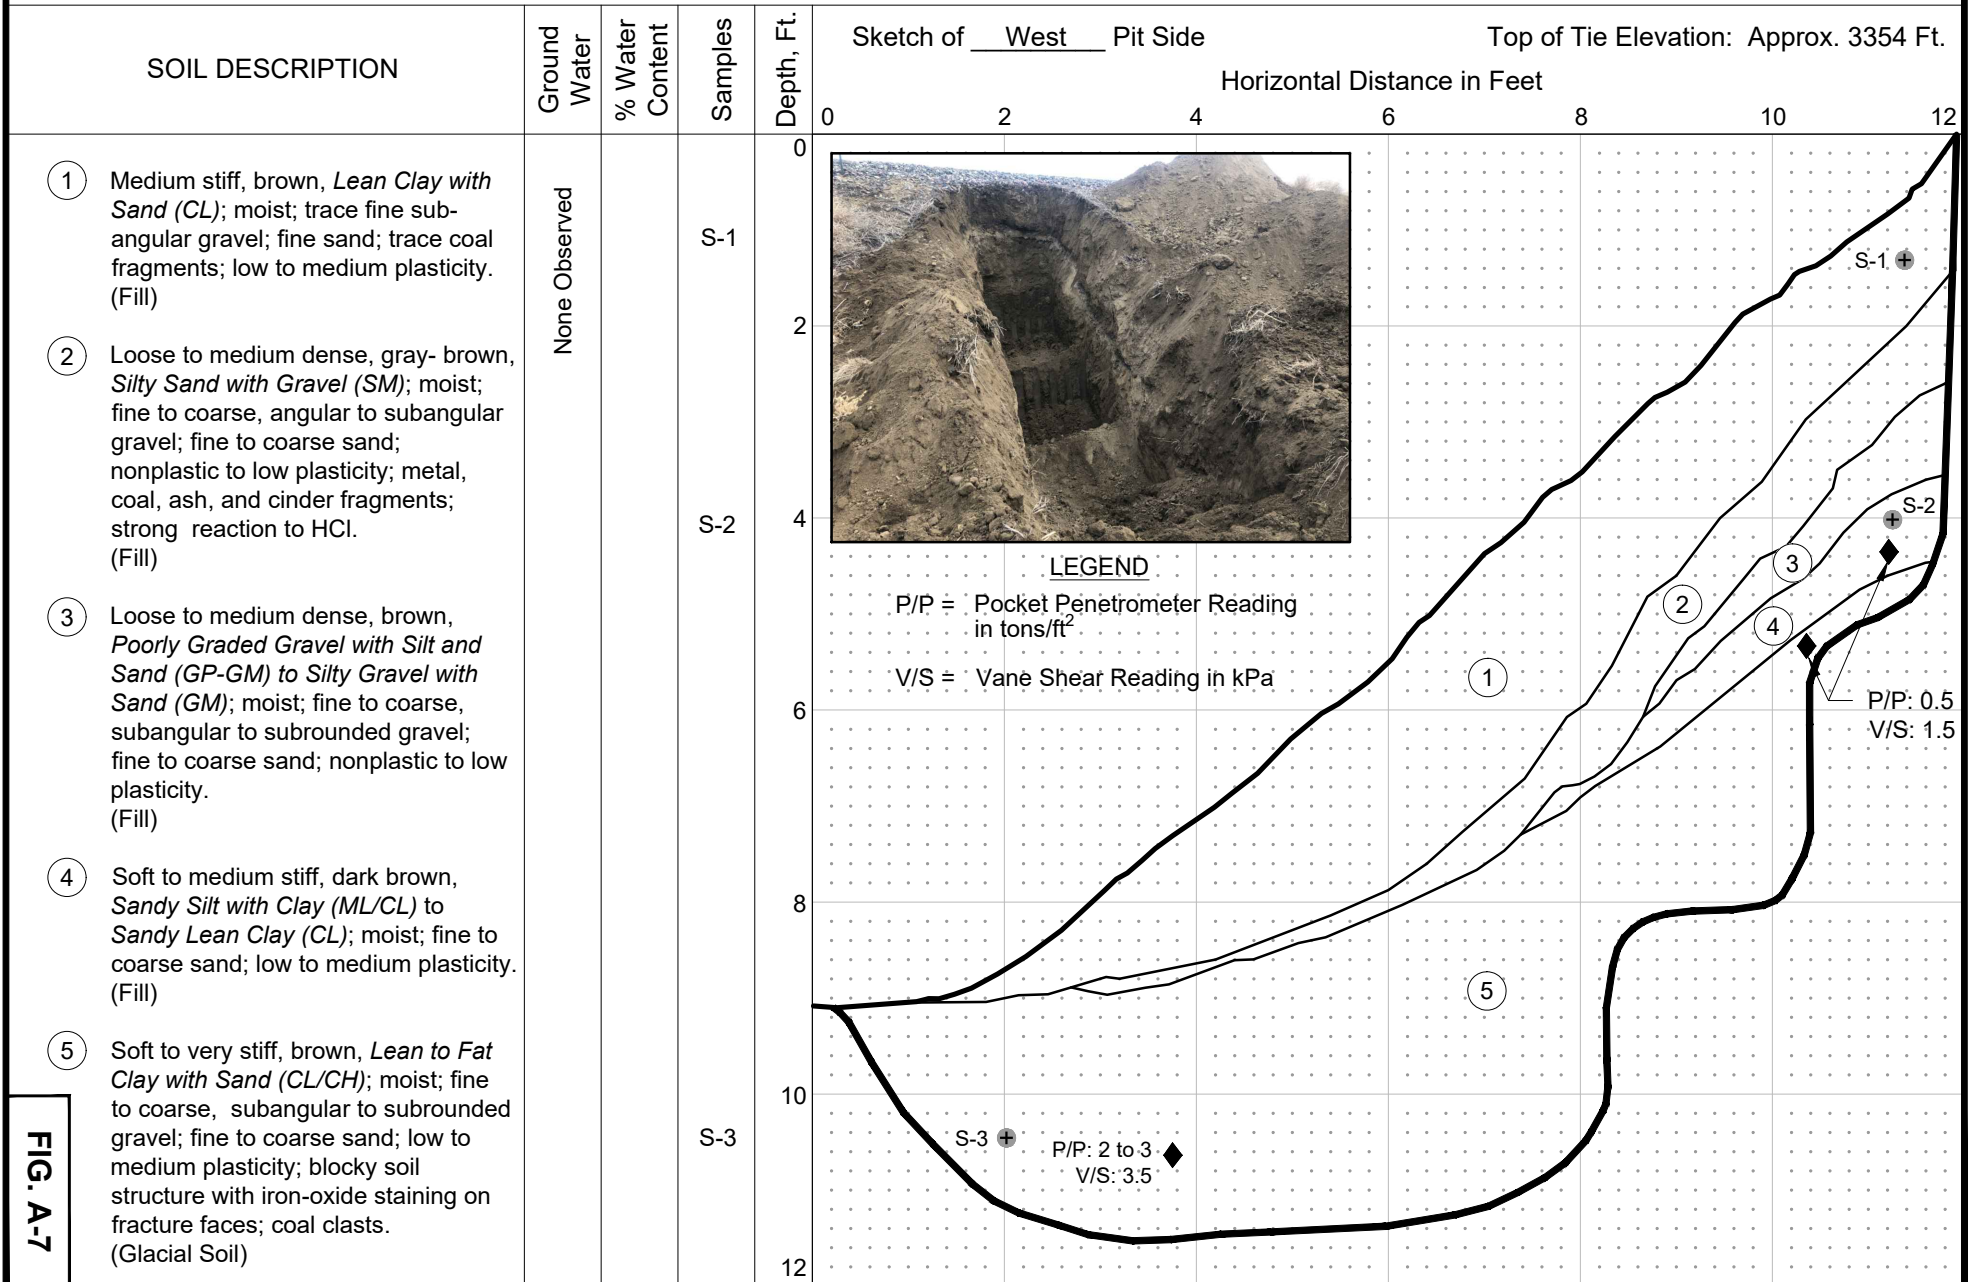
FIG. A-7

P/P = Pocket Penetrometer Reading in tons/ft²

V/S = Vane Shear Reading in kPa

SHANNON & WILSON, INC.
GEOTECHNICAL AND ENVIRONMENTAL CONSULTANTS
LOG OF TEST PIT TP-1S

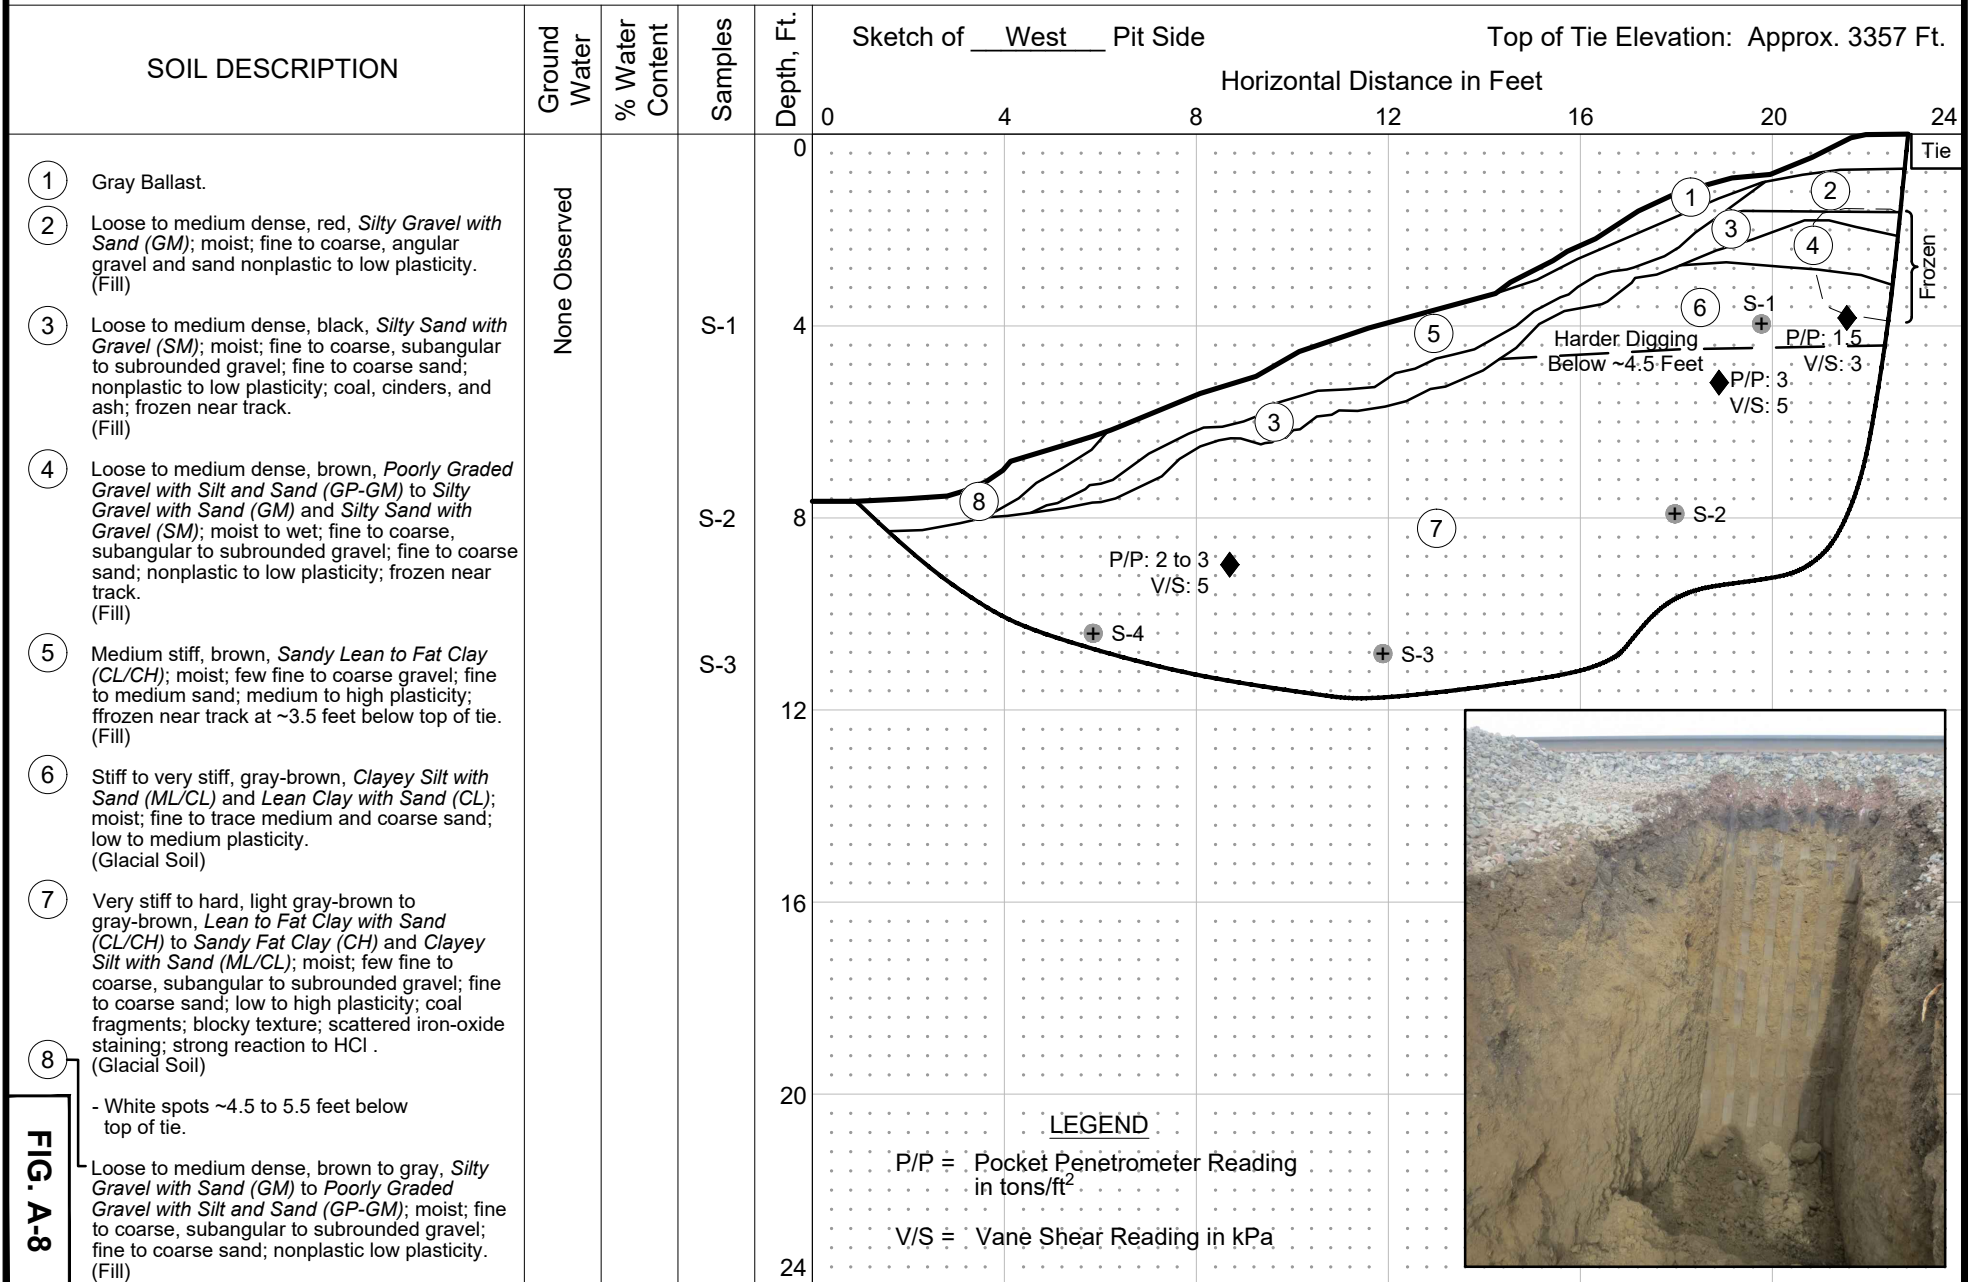
FIG. A-8

SHANNON & WILSON, INC.
GEOTECHNICAL AND ENVIRONMENTAL CONSULTANTS
LOG OF TEST PIT TP-2S

JOB NO: 108788-001 DATE: 3-28-22 LOCATION: MP 1014
 PROJECT: BNSF Hi Line Sub

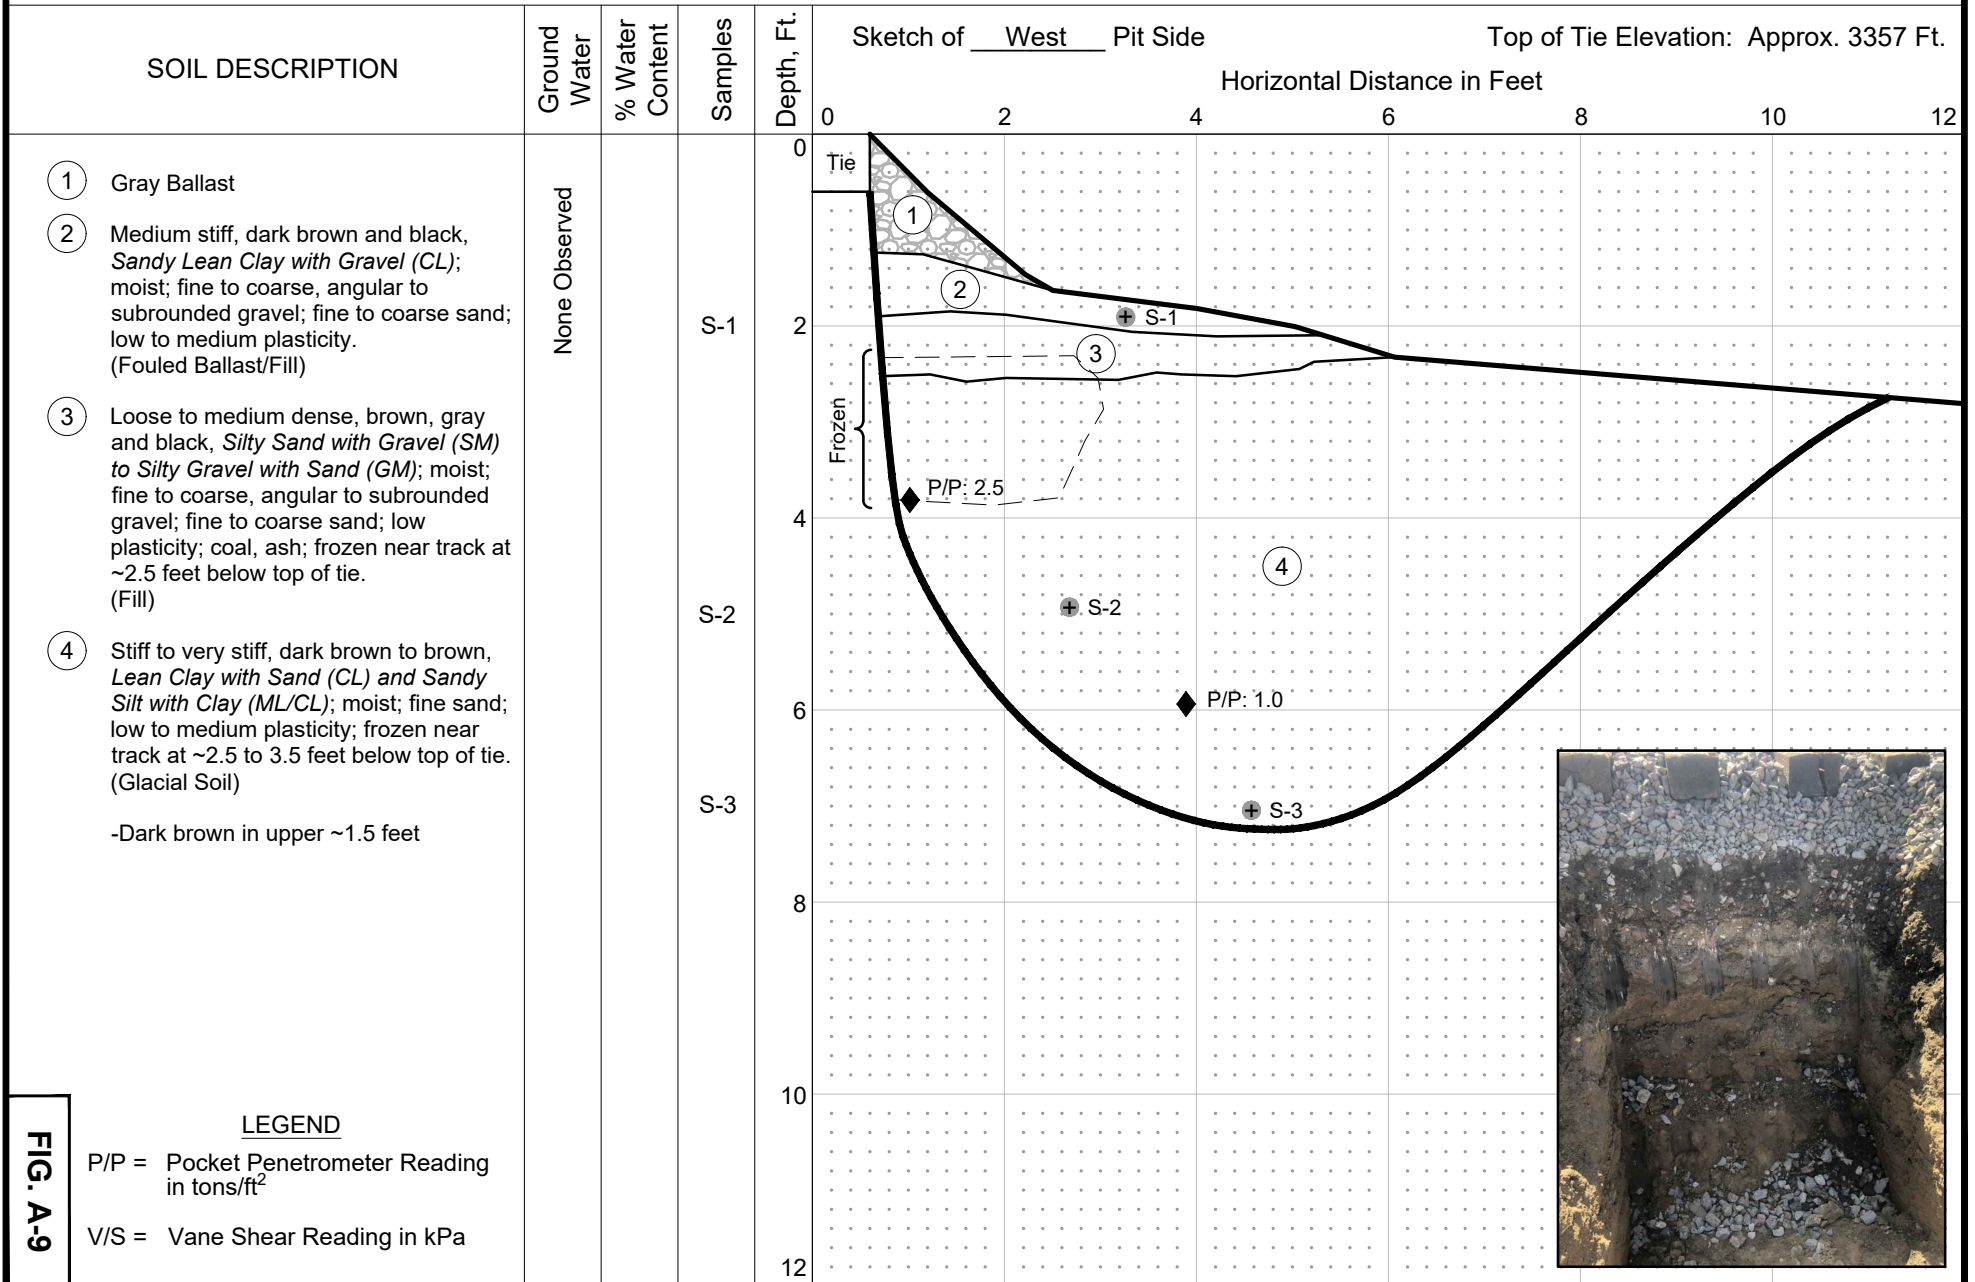
FIG. A-9

SHANNON & WILSON, INC.
GEOTECHNICAL AND ENVIRONMENTAL CONSULTANTS
LOG OF TEST PIT TP-3N

JOB NO: 108788-001 DATE: 3-29-22 LOCATION: MP 1014
 PROJECT: BNSF Hi Line Sub

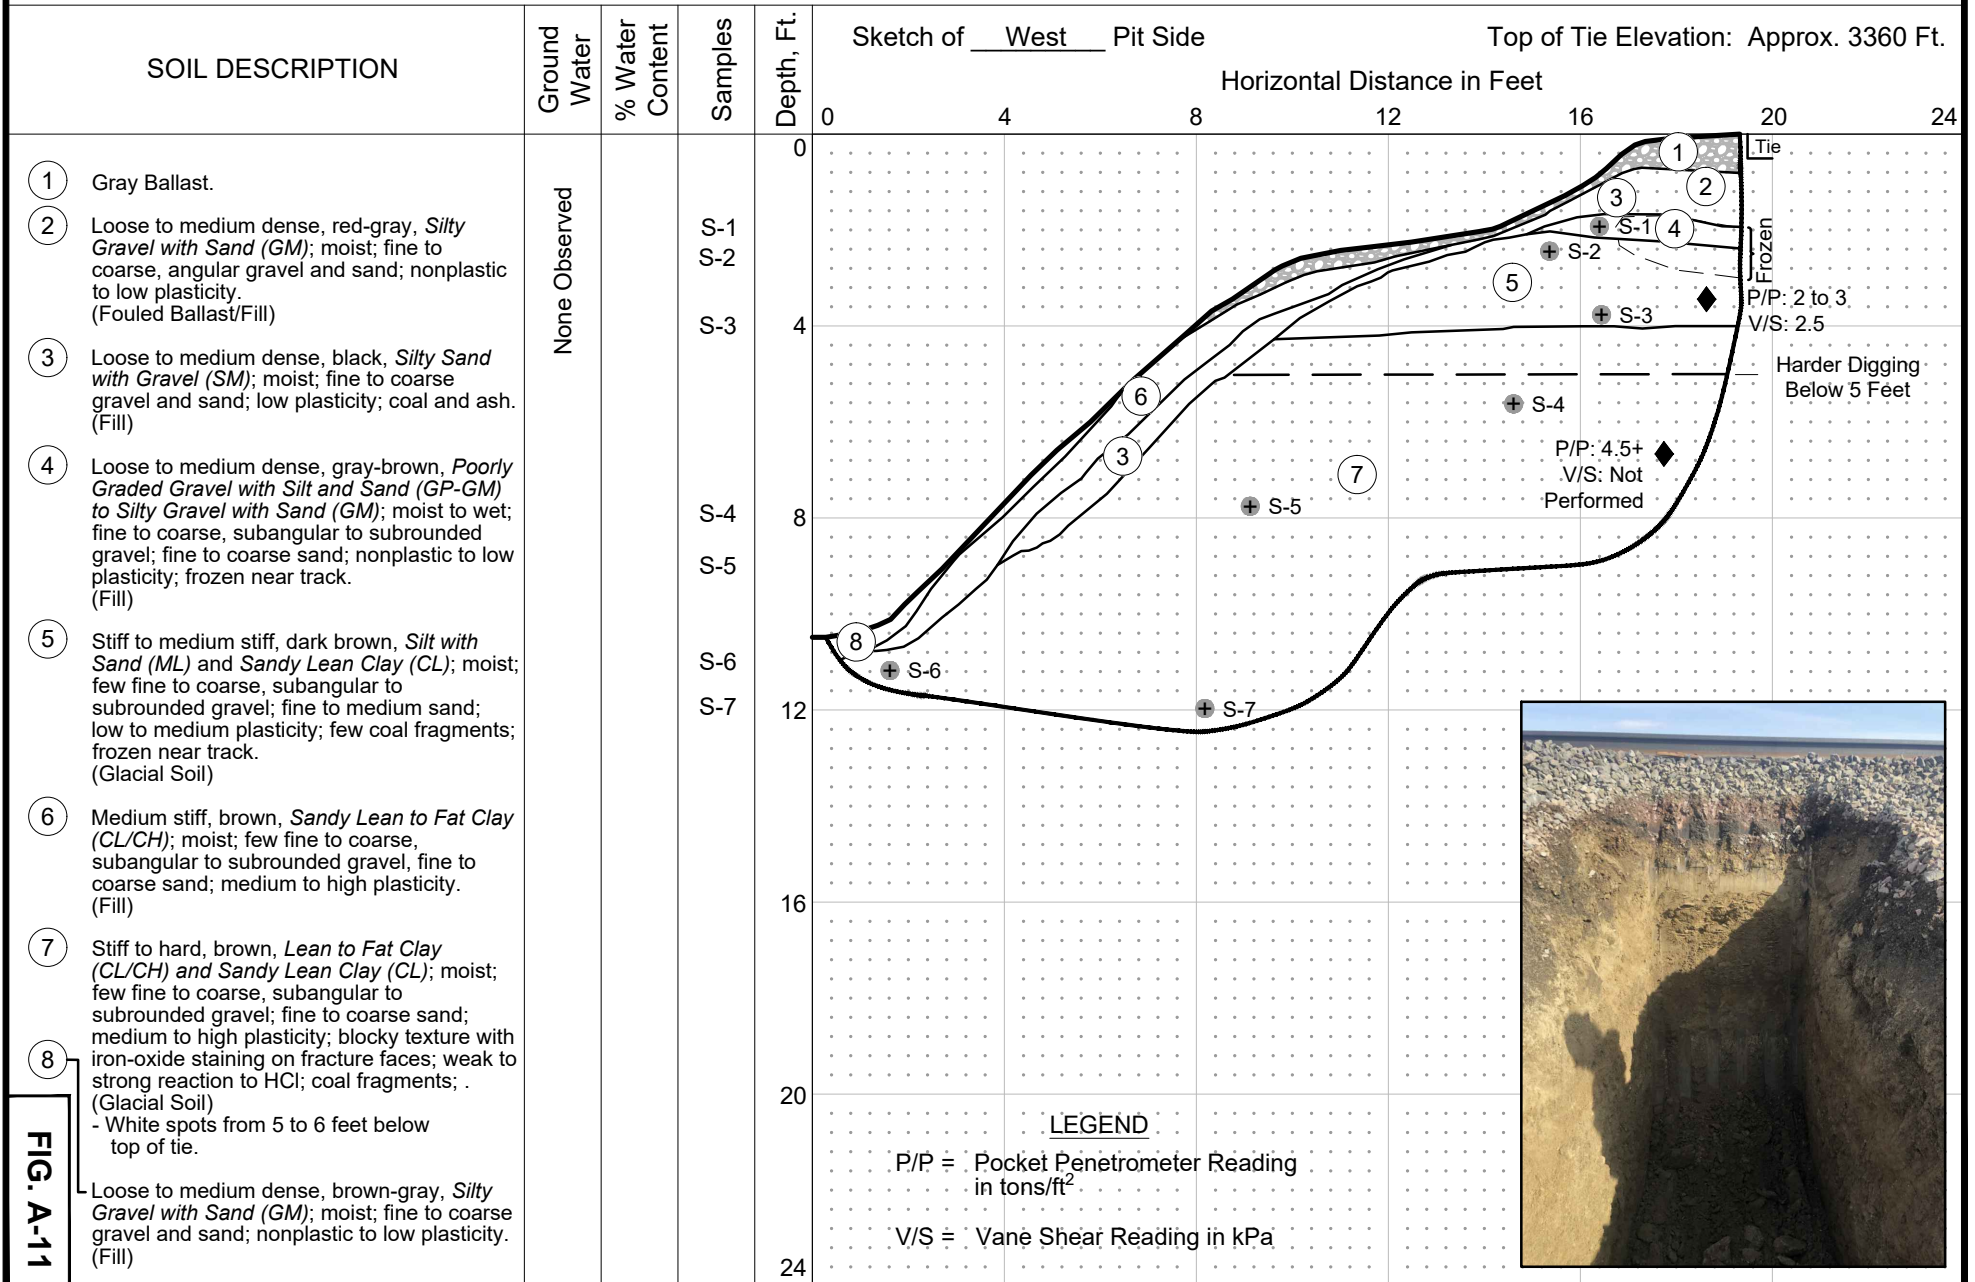
SHANNON & WILSON, INC.
GEOTECHNICAL AND ENVIRONMENTAL CONSULTANTS
LOG OF TEST PIT TP-4S

JOB NO: 108788-001 DATE: 3-28-22 LOCATION: MP 1014
 PROJECT: BNSF Hi Line Sub
