PRELIMINARY REPORT

HIGHWAY

HWY21FH007

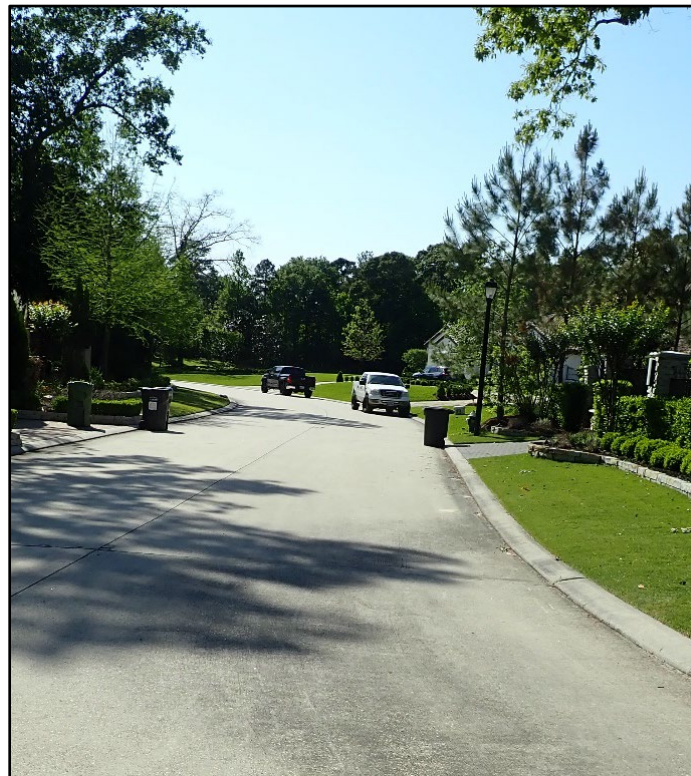
Figure 1. Hammock Dunes Place looking toward crash site.

departing the road on a curve, driving over the curb, and hitting a drainage culvert, a raised manhole, and a tree.

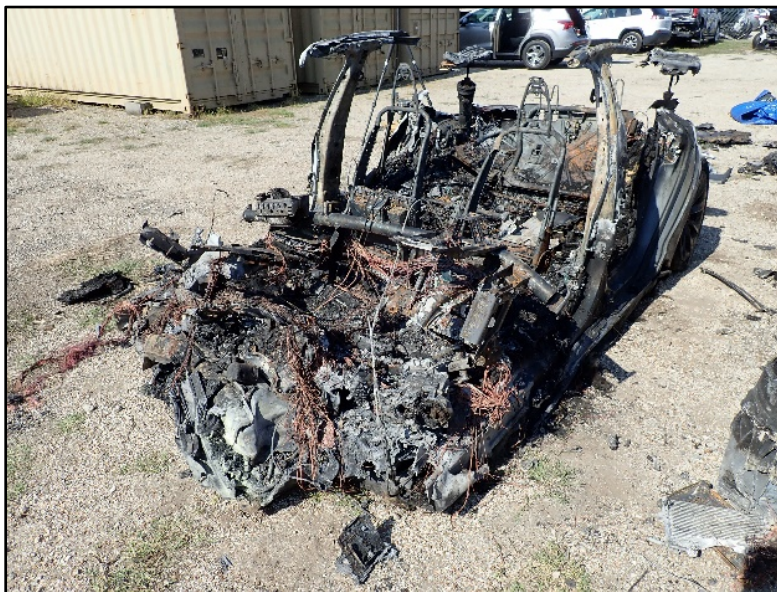
The crash damaged the front of the car's high-voltage lithium-ion battery case, where a fire started. The fire destroyed the car, including the onboard storage device inside the infotainment console (figure 2). The car's restraint control module, which can record data associated with vehicle speed, belt status, acceleration, and airbag deployment, was recovered but sustained fire damage. The restraint control module was taken to the National Transportation Safety Board (NTSB) recorder laboratory for evaluation.

Figure 2. Fire and impact damage to car.
