National Transportation Safety Board

DCA24MM031

HAZMAT - CARGO AND RESPONSE

Specialist's Factual Report

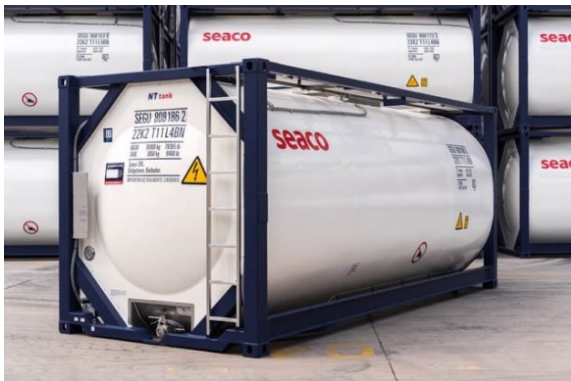
UN portable tank T22 are designed for the carriage of high-hazard pressurized liquids or liquefied gases (see Figure 2). These tanks are 20- feet in length, 8'0" in width, and 8'6" in height. Typical capacity is about 5,900 gallons. Working pressure

is 96.7 psig, test pressure is 145.0 psig. Under 49 CFR 173.241, UN portable tanks conforming to 46 CFR Part 64 are authorized.

Figure 2. Typical UN portable tank T22, image source Seaco America LLC.⁴

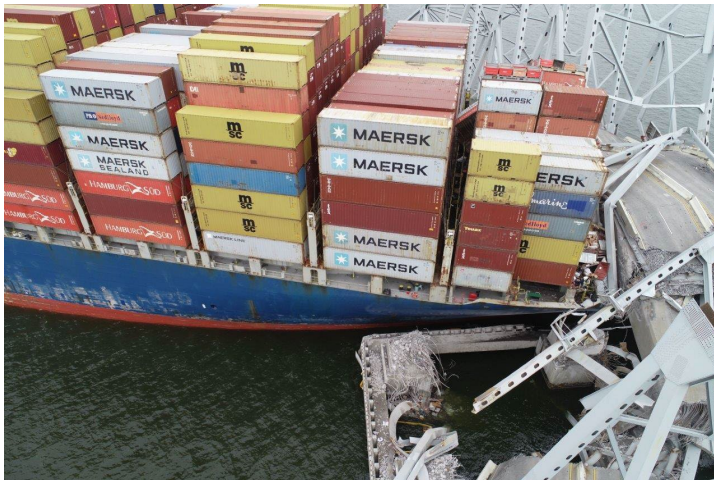
Figure 3. ISO 20 and 40-foot shipping containers stowed in *Dali* forward above deck cargo bays and fallen bridge debris on the bow, March 28, 2024.

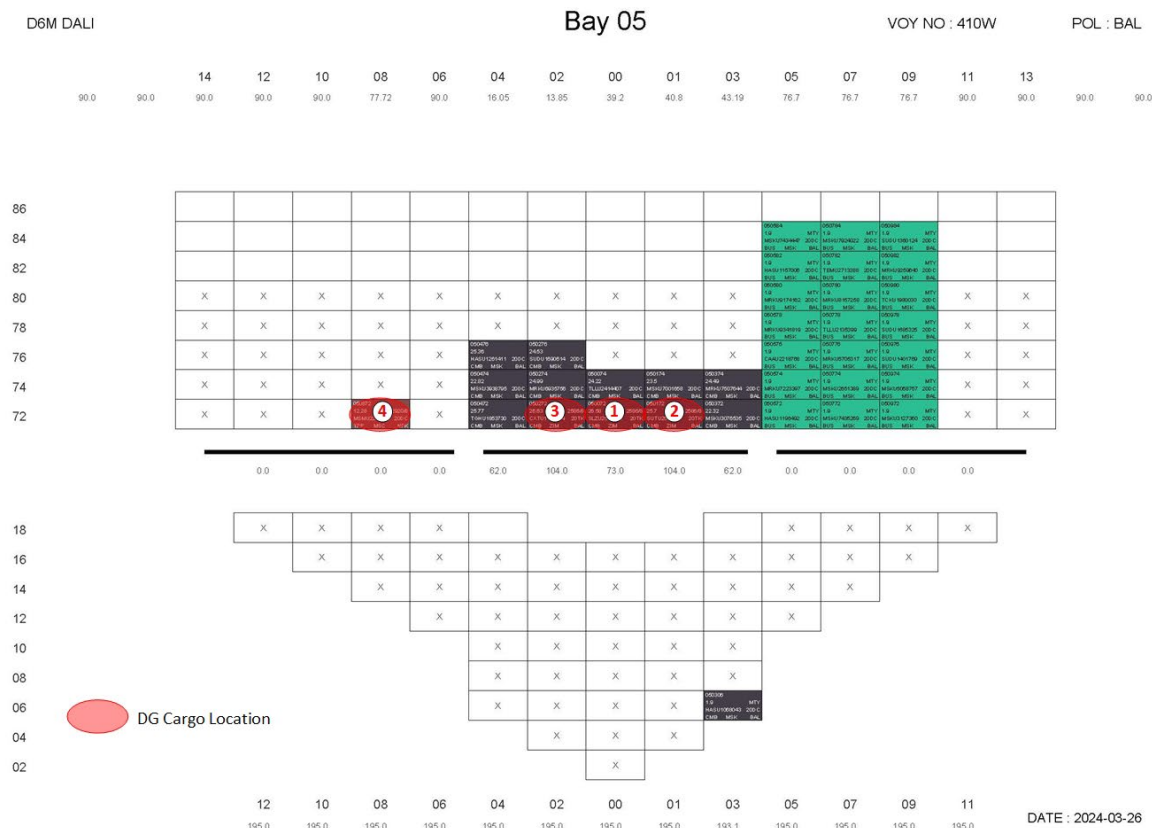
Figure 10. Bay 5 Freight Container Stowage Plan, March 26, 2024, Synergy Marine, PTD, LTD.

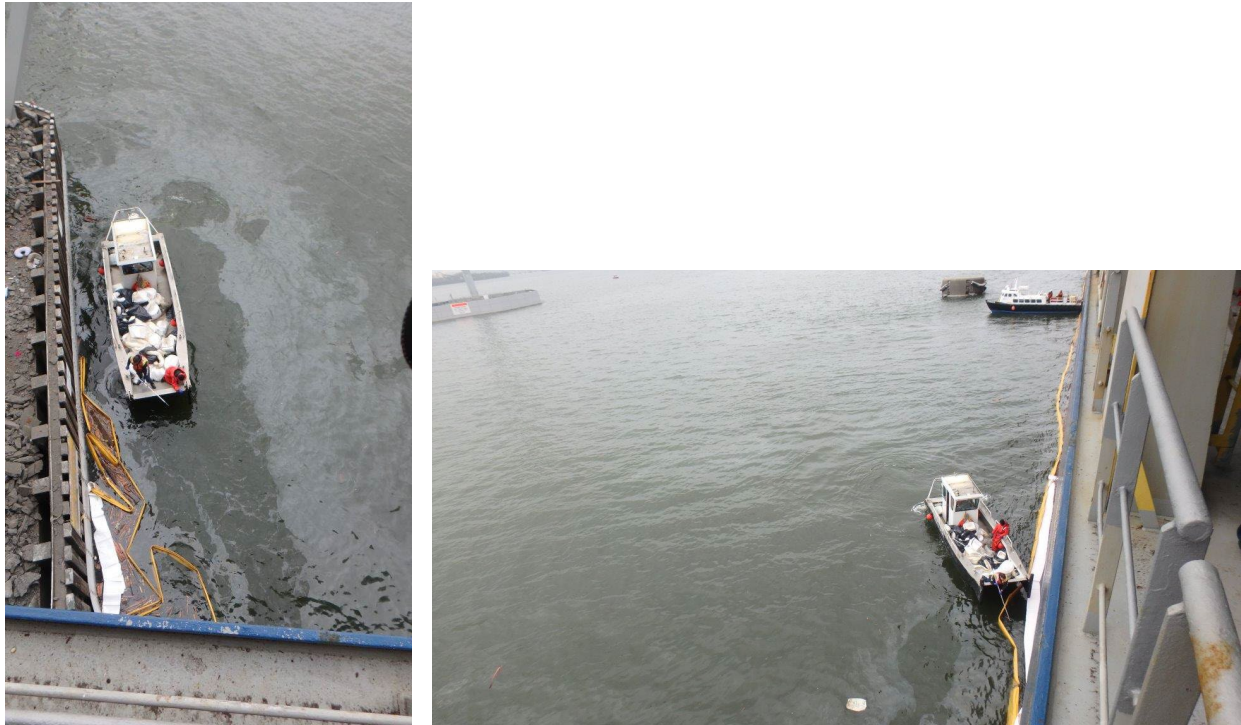
During the operational period March 28 to March 29, the Recovery and Protection Branch was assigned to assess the condition of the sorbents placed within the containment boom around the vessel and to maintain the 2,400-foot boom during salvage assessment operations (Figure 15). MSRC continued to deploy and

Figure 15. Spill response operations for oil sheen on starboard side of the *Dali*, March 28, 2024.

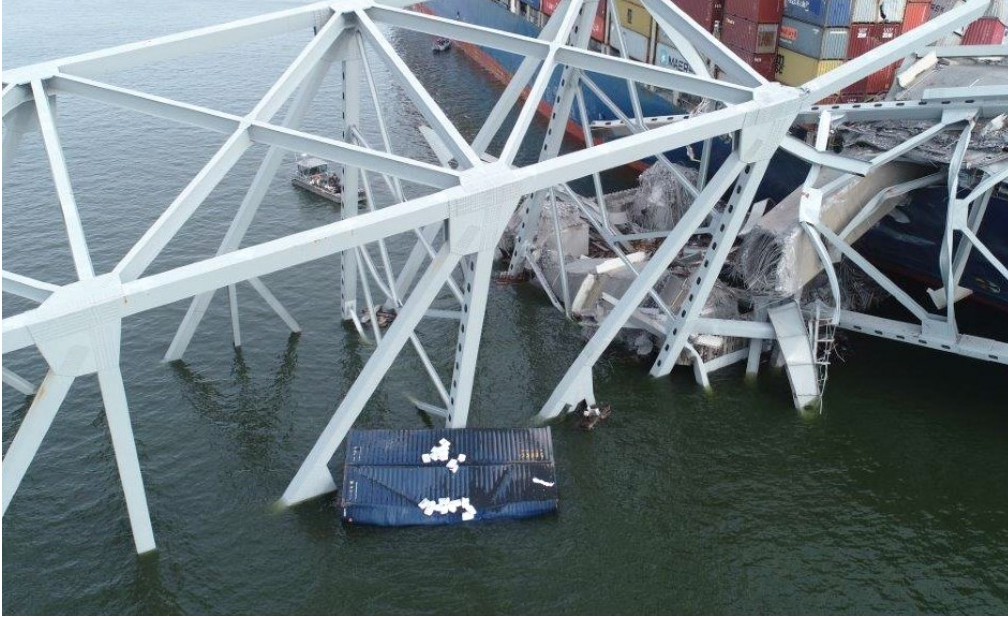
The State on-scene coordinator (SOSC) told NTSB investigators that all released hazardous materials aboard the *Dali* were contained within the forward ship holds. He confirmed that following contact with the bridge, two cargo containers fell from the ship into the Patapsco River, but neither container displayed hazardous materials placards. On the morning of March 26, NTSB investigators observed the two floating containers secured to bridge wreckage (Figure 16).

Figure 16. Two unidentified non-placarded cargo containers floating in the Patapsco River next to fallen bridge debris, March 26, 2024, 09:54.

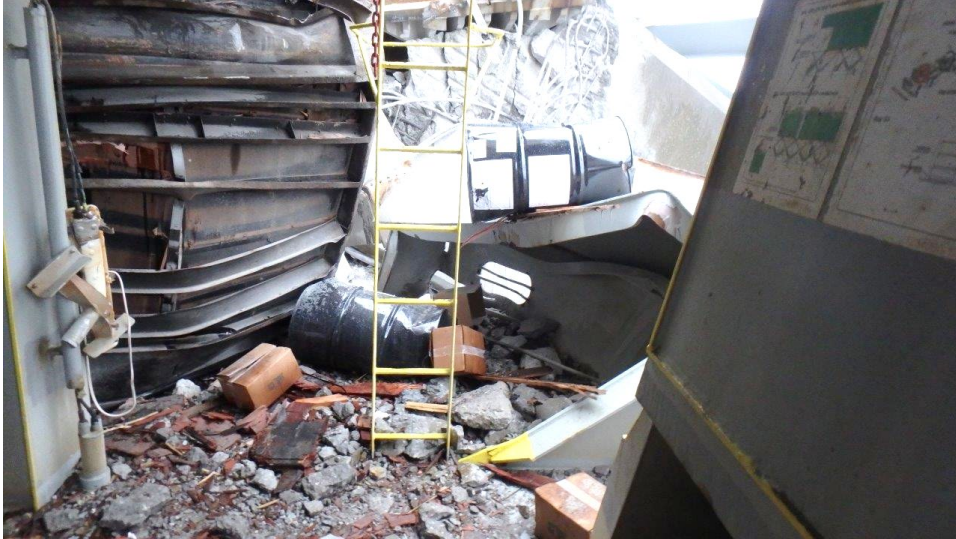
However, while at location 1, starboard side of Bay 7, the inspection team observed 4 x 55-gallon steel drums marked “Weston 705T” antioxidant that had fallen from an open and severely damaged container that had been impacted by bridge structure and had fallen from its stack (Figures 19 and 20). The cargo container

number was not visible, but it appeared to be one of six containers that had been stationed in Bay 3, Row 13. The drums did not bear any hazardous materials labeling. The SI Group SDS for the material indicates the material is a colorless and odorless liquid with a flash point of 228 °C. According to the labeling, the product did not contain any regulated hazardous substances and is not regulated in transportation as a hazardous material. The 20-foot transport container was torn in several locations, from which it was evident there were many additional drums within. An organic liquid was weeping from a couple of tears in the bottom of the container.

Figure 19. Location of damaged container impacted by bridge debris, loaded with 55-gallon drums of non-hazardous Weston 705T, from Bay 3, Row 13. March 28, 2024.

Figure 20. 55-gallon drums of Weston 705T that had come to rest on the main deck. The bottom surface of the damaged cargo container is visible on the left side of the photograph. March 28, 2024.

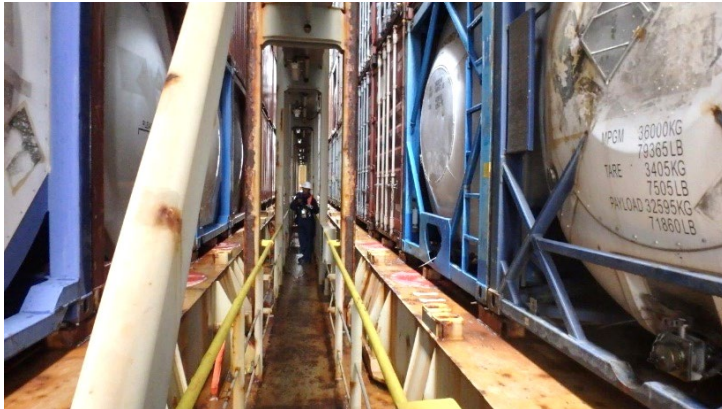
NTSB investigators further examined the aisle-ways between Bays 11 - 13, and Bays 15 -17, finding no visual evidence of hazardous materials releases. At location 3 in Figure 18, investigators checked several ISO-tanks containing hazardous materials between Bays 15-17, finding no evidence of releases (Figure 22). Tank numbers and locations matched the Dali loading plan documents.

Figure 22. Iso-tanks stationed in Bay 15 (right) and Bay 17(left). No evidence of material releases were observed. March 28, 2024.

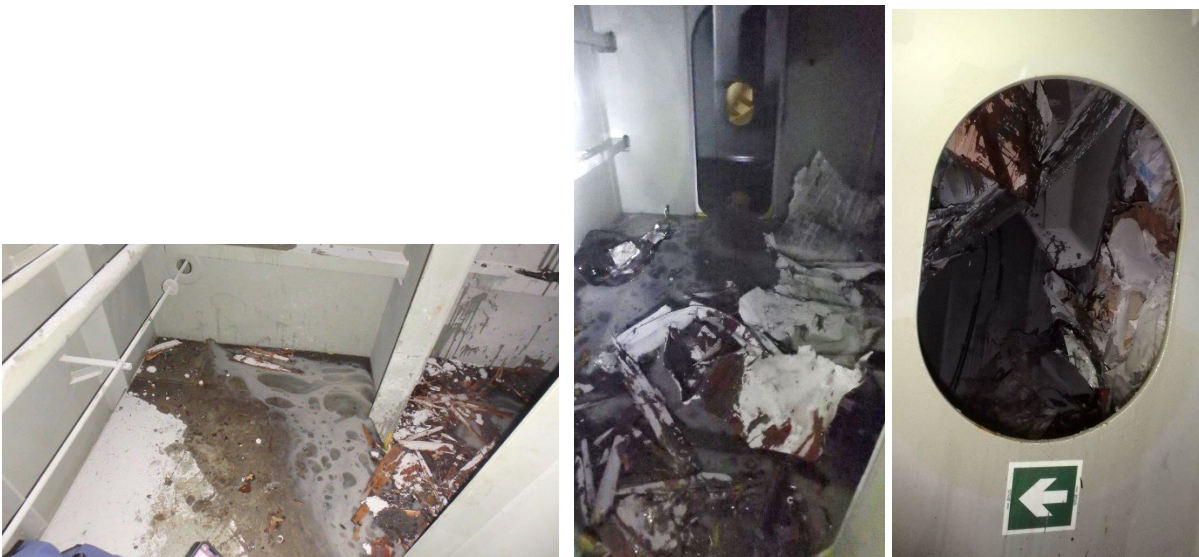
From the area just forward of Piller 17 in Bay 10, the deck of at least four compartments had an accumulation of a viscous liquid with surfactant-like foam on the surface. USCG Strike Team personnel did not detect any evidence of elevated volatile organic compounds during air monitoring of this area or near the spillage. Liquid was continuing to drip down from debris suspended from the collapsed main deck of Bay 6, which could only be observed from a circular cutout in the bulkhead separating Bay 10 from Bay 6 (Figure 24).

Figure 24. 2nd Deck below Bays 6-10. Surfactant-like material on deck at bulkhead between Bays 6 and 10 (left); view into area below Bay 6 with fallen debris and accumulating liquid (center); view through bulkhead into area below Bay 6 with liquid dripping from above (right). March 28, 2024.

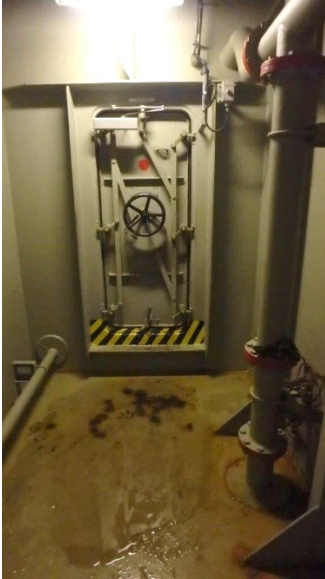
Finally, NTSB investigators came to the Bay 2 water-tight door to the starboard bow thruster room. The Synergy Marine mate warned that he was unable to open this door because liquid had accumulated behind it. A viscous sticky liquid was weeping from the bottom of the door onto the deck (Figure 25). The material did not exhibit any evidence of flammability as indicated by the USCG's flammable gas detector (LEL/PID meter).

Figure 25. Viscous non-volatile sticky liquid leaking from the Bay 2 bow thruster room water-tight door. March 28, 2024.
