**Highway Factors Attachment – 2019 Pavement Inspection Report, North Tarrant
Expressway, Segment 3, May 2020, prepared by Data Transfer Solutions, LLC**

2019 Pavement Inspection Report

North Tarrant Expressway, Segment 3
May 2020

Prepared by:
Data Transfer Solutions, LLC
3680 Avalon Park East Blvd., Suite 200
Orlando, FL 32828
www.dtsgis.com

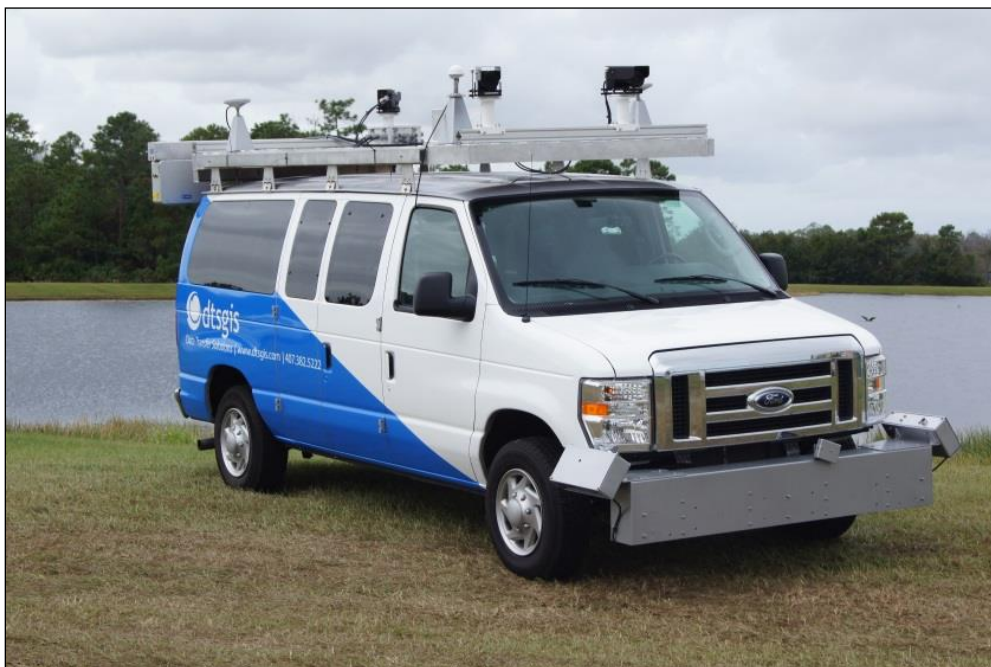
Figure 7 - DTS MAC Vehicle

In order to determine the general distress characteristics of each roadway segment, DTS utilized one of our Mobile Asset Collection (MAC) vehicles to collect street-level right-of-way (ROW) imagery and downward pavement imagery. DTS MAC vehicles combine multiple engineered technologies to collect real-time pavement data, ROW data and images at posted speed limits. This effectively eliminates the need to place pavement inspection technicians in the field in close proximity to vehicle traffic. Some MAC vehicle components include:

- Two line-scan cameras and lasers configured to image 4m transverse road sections with 1 mm resolution (4000 pixel) at speeds that can reach 100 km/h
- Allows fully illuminated pavement image collection even in heavy shadow/canopy areas

- International Cybernetics Corporation MDR 4087 (with Geolocator line lasers)
- Texas A&M Transportation Institute - HMA/PCC1 Certification Level
- Consistent with Tex-1001-S specification
- Utilizes 5 lasers to accurately determine IRI and Rutting of travel lanes
- Calibration checks done on a daily basis
- GIS-centric reporting

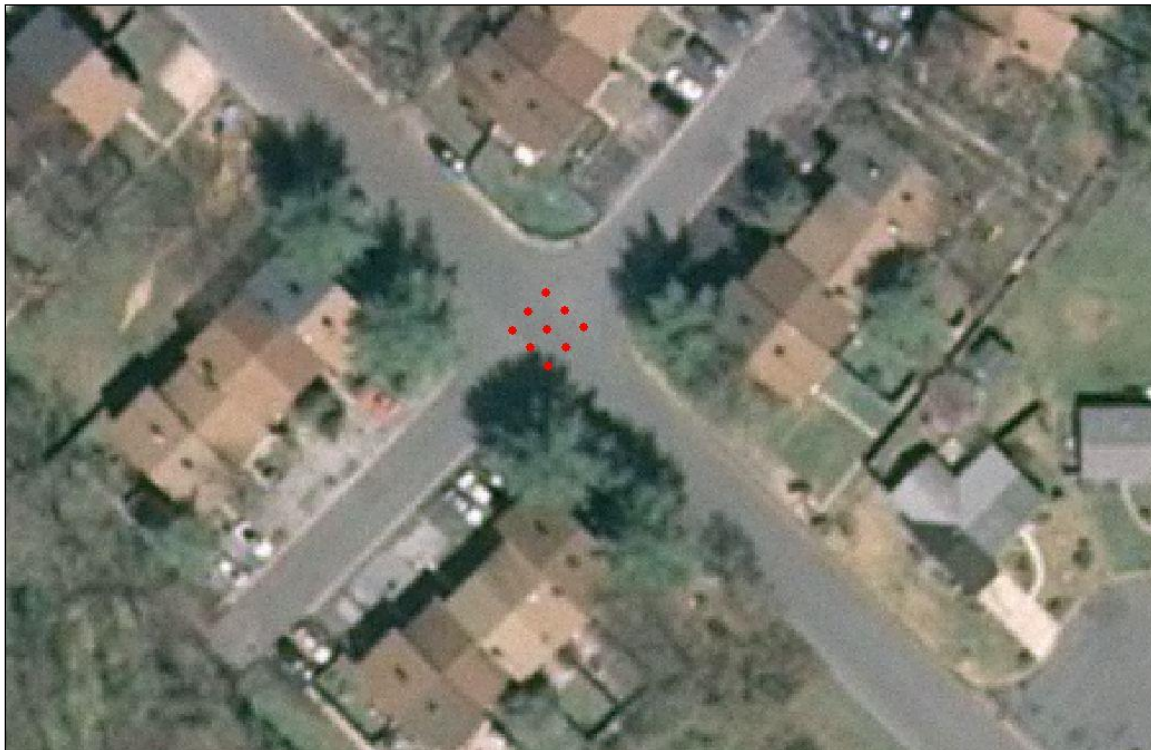
Figure 8 - An Example of a 9-Point Calibration Site

DTS MAC image collection included a daily check of the on-board systems. This vehicle component check consisted of a calibration site survey of a nine-point grid in state plane coordinates. Each morning and afternoon, before and after a day's image collection, the MAC vehicle drove over the surveyed location. The MAC technician then extracted each point's location to verify the location of the point extracted was within approximately three feet of the surveyed points. DTS' QA/QC manual includes further details regarding MAC quality control procedures.

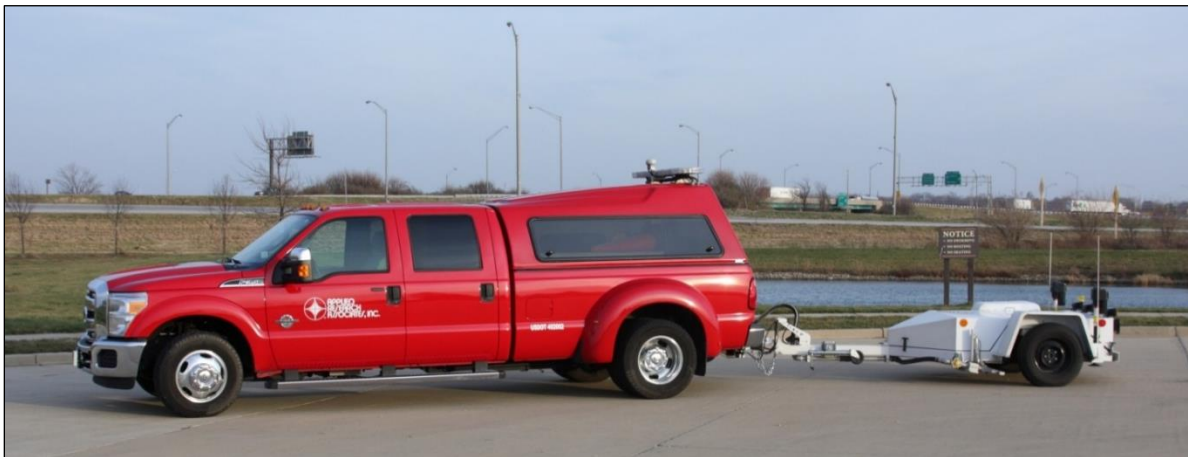
Figure 10 - Pavement Skid Friction Testing Equipment

The first round of data collection was conducted September 13-16, 2018. A locked-wheel skid friction tester was used. It was manufactured by International Cybernetics Corporation that meets all specifications set forth in ASTM E-274, Standard Test Method for Skid Resistance of Paved Surfaces Using a Full-Scale Tire. All tests were performed using an ASTM E-524 smooth testing tire in the right wheel path of each lane. The testing interval for the managed lanes and general purpose lanes was set at 0.05 miles at 50 mph, a speed required by TxDOT but varying from the ASTM E-274 standard. Testing on ramps was done as frequently as possible and at 50 mph. The results collected represent the SN50S (Skid Number at 50 mph as measured with a Smooth tire). Testing on all frontage roads was conducted at 40 mph or the posted speed limit, which was lower. In cases where testing was conducted below 50 mph, data was corrected to an SN50S.

The pavement skid friction tester was manufactured in 2012 and has been maintained in accordance with all manufacturer recommendations since that time. The most recent calibration was conducted by the manufacturer in July 2019. A copy of the calibration report is available upon request.
