**NATIONAL TRANSPORTATION SAFETY BOARD
OFFICE OF HIGHWAY SAFETY
WASHINGTON, D.C.**

**HIGHWAY FACTORS GROUP CHAIRMAN'S
FACTUAL REPORT**

Location: State Highway 2 (SH-2), Randolph, in Coos County, New Hampshire

Operator #10: 52-year-old female (injured)
Vehicle #11: 2007 Harley Davidson FLHRSE3
Operator #11: 51-year-old male (injured)
Vehicle #12: 2019 Harley Davidson FLXH
Operator #12: 53-year-old male (not injured)
Vehicle #13: 2006 Harley Davidson FLTRI
Operator #13: 70-year-old male (injured)
Passenger #13: 69-year-old female (injured)
Vehicle #14: 2015 Harley Davidson FLHTKS
Operator #14: 46-year-old male (not injured)
Passenger #14: 48-year-old female (injured)
Date: Friday, June 21, 2019
Time: 6:26 p.m. local time
NTSB #: **HWY19MH010**

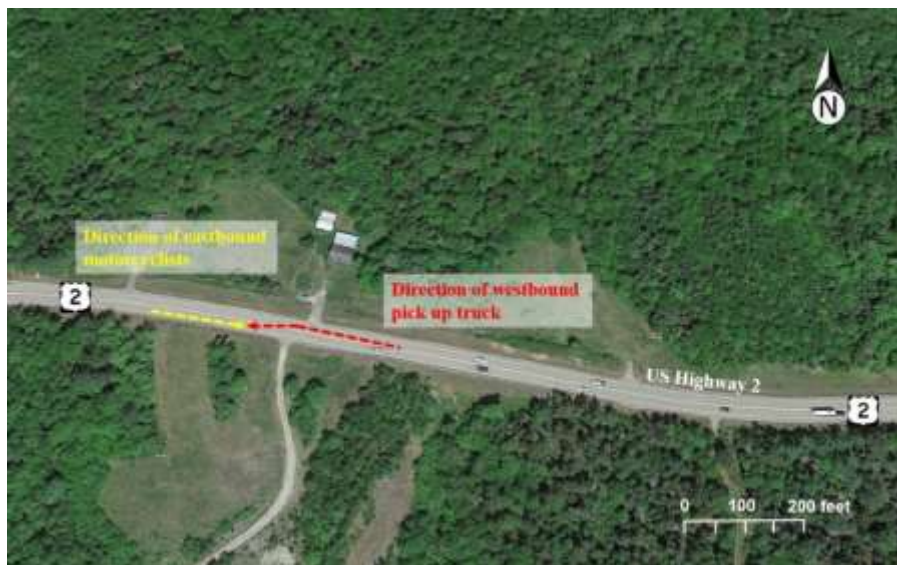
Figure 2 – Directional map (Source: Google Maps revised)

Figure 2 is a directional map that illustrates the pickup truck was travelling in the westbound direction of US Highway 2 as shown in the red dashed line and the group of motorcyclists was travelling in the eastbound direction as shown in the yellow dashed line. The pickup truck crossed the center of the road, entered the eastbound lane, and collided with the approaching motorcycles.

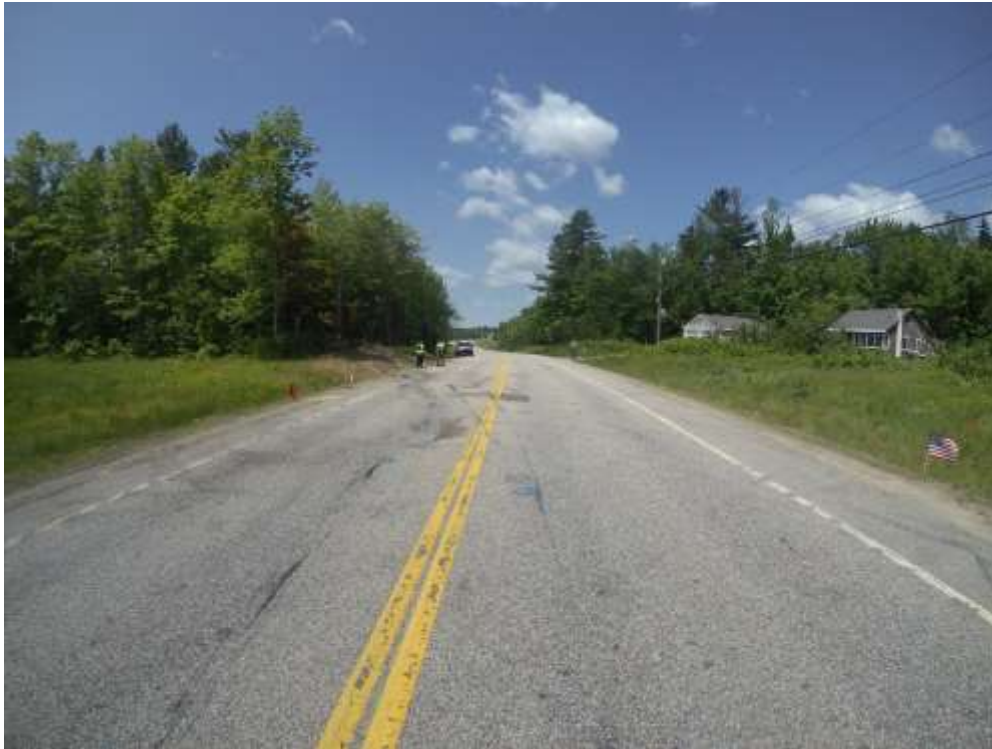
Figure 3 – View of westbound approach to crash location on US Highway 2

Figure 3 illustrates tire markings left by the pickup truck as it crossed the center of the road and entered the eastbound lane. After colliding with the approaching motorcycles, the pickup truck continued across the eastbound lane of US Highway 2 and came to rest on an earthen embankment next to the eastbound shoulder. A fire ensued after the crash.

The crash location was on a straight (tangent) section of roadway as shown in **Figure 3**. The horizontal alignment west of the crash location consisted of a 2,625-foot radius curve to the left for motorists travelling in the westbound direction of US Highway 2. The horizontal curve was approximately 511 feet in length.

Highway Factors Photo 1 – View of westbound approach to crash location on US Highway 2

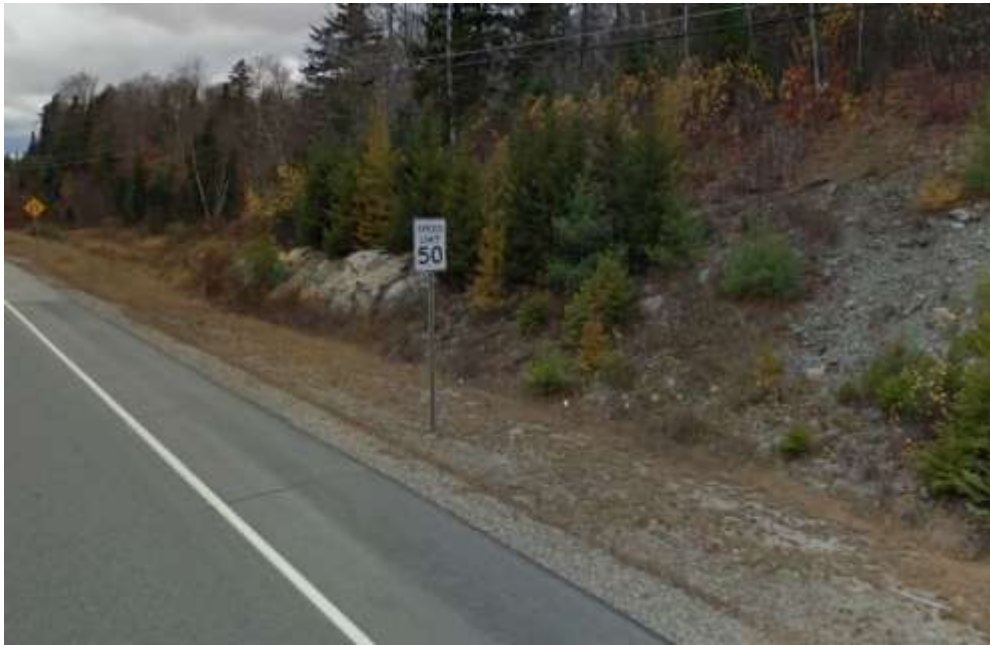
Figure 4 – View of 50 miles per hour (mph) speed limit sign for motorists travelling in the westbound direction of US Highway 2 located approximately 3,623 feet east of the crash location (Source: Google Maps)

Figure 4 illustrates a photograph of the 50 miles per hour (mph) speed limit sign for motorists travelling in the westbound direction of US Highway 2 located approximately 3,623 feet east of the crash location.

Highway Factors Photo 2 – View of 50 miles per hour (mph) speed limit sign for motorists travelling in the westbound direction of US Highway 2 located approximately 3,623 feet east of the crash location (Source: Google Maps)
