**NATIONAL TRANSPORTATION SAFETY BOARD
OFFICE OF HIGHWAY SAFETY
WASHINGTON, D.C.**

**HIGHWAY FACTORS GROUP CHAIRMAN'S
FACTUAL REPORT**

Location: Interstate 70/76 (I-70/76), Pennsylvania Turnpike at mile-marker 86.1 westbound, Mount Pleasant Township, in Westmoreland County, Pennsylvania

Passenger: 41-year-old male (not injured)
Carrier: United Parcel Service, Willow Grove, PA
Date: January 5, 2020
Time: Approximately 3:30 a.m. local time
NTSB #: **HWY20MH002**

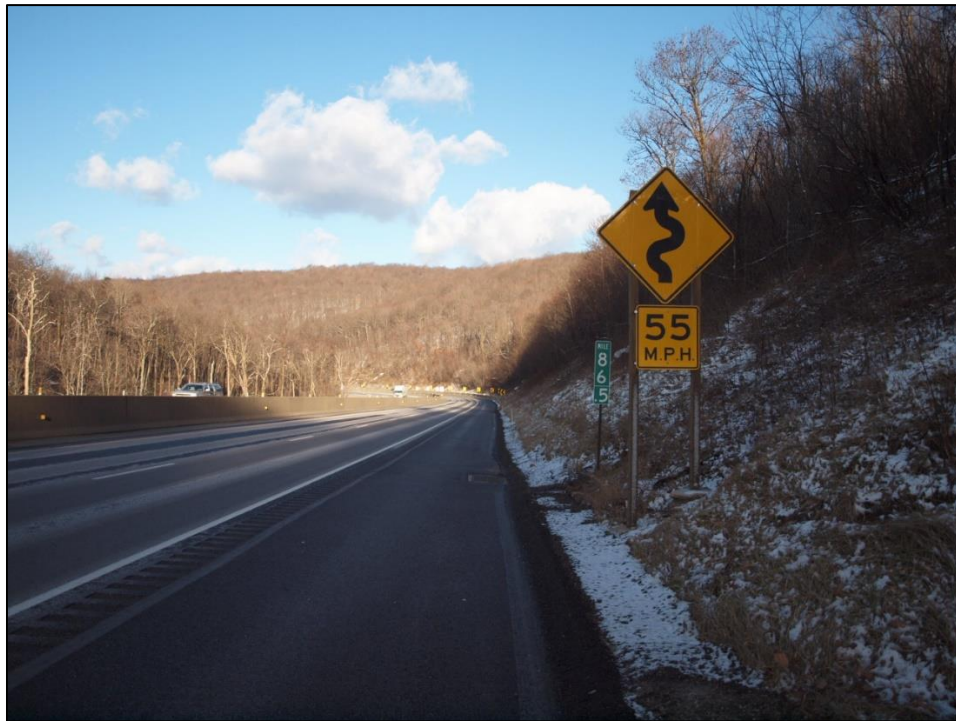
Figure 3 – Advisory speed sign of 55-mph was posted approximately 2,112 feet prior to the crash site.

The posted regulatory speed limit for the Pennsylvania Turnpike was 70 miles per hour (mph). An advisory speed sign of 55-mph¹ was posted approximately 2,112 feet prior to the crash site as illustrated in **Figure 3**.² Numerous advisory speed signs of 55-mph were posted along the Pennsylvania Turnpike warning motorists to reduce their speed before entering horizontal curves.

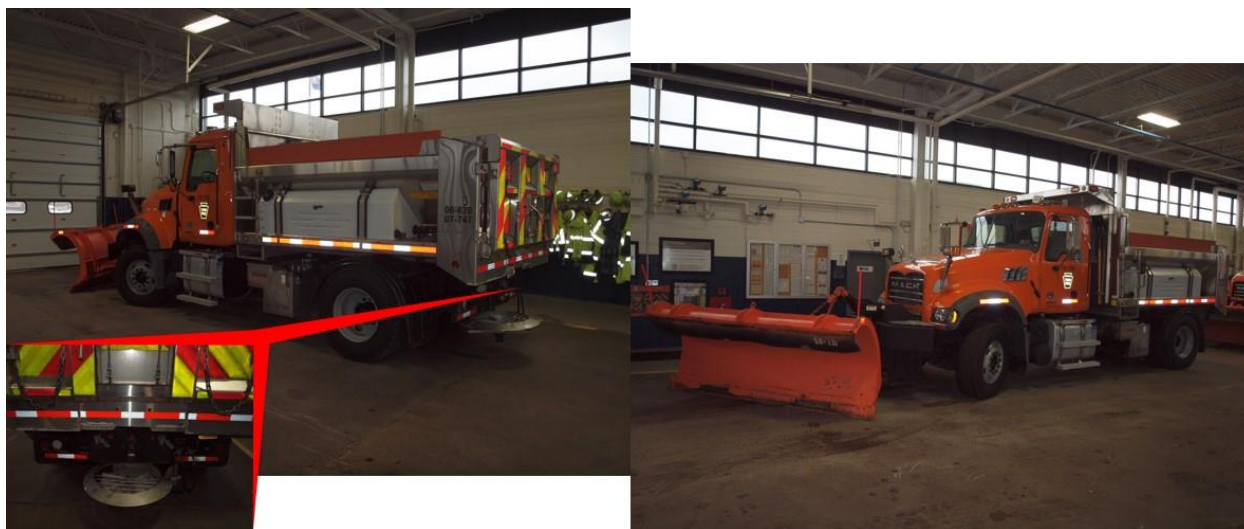
Figure 5 – PTC single axle truck number 75-728, the truck used in applying salt in the westbound direction of I-70/76 in the vicinity of the crash.

Figure 5 illustrates Pennsylvania Turnpike Commission single axle truck number 75-728, the truck used in applying salt in the westbound direction of I-70/76 in the vicinity of the crash. The truck has a straight blade plow in the front and the salt is dispensed in the back of the truck through a gate, controlled by the driver using a valve. The salt falls on to a spinner in which the setting is also controlled by the driver. The spinner setting in the vicinity of the crash was set at 40 which means the salt hits the entire lane in which the truck is traveling and portions of the shoulder and adjacent lane.¹⁴ The application rate of salt was set at 450 pounds per lane mile at approximately 11:00 p.m. on January 4, 2020 and was changed to 300 pounds per lane mile at approximately 1:00 a.m. on January 5, 2020.¹⁵

A typical Pennsylvania Turnpike Commission single axle truck holds approximately 10 cubic yards of salt. The gross vehicle weight of the single axle truck was approximately 43,000 pounds. The usable capacity of the fuel tank was approximately 70 gallons. A 7-inch-wide color touch screen controller display was available to the driver capable of operating the spinner setting and application rate.

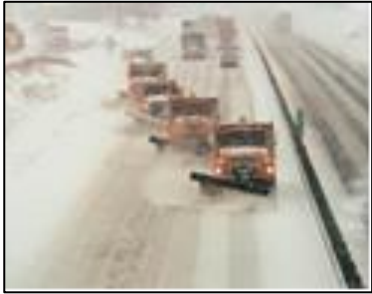
<p>Condition 3: <i>Snow and/or Slush Covered - Accumulations of loose snow or slush are regularly found on the pavement surface. Light to moderate snow cover may be present in some areas (up to 2 inches on secondary routes).</i></p>	<p><i>Some snow packed and/or icy conditions may be present but do not represent predominate road conditions on the interstates. Reduced travel speeds may be required due to slick road conditions.</i></p>

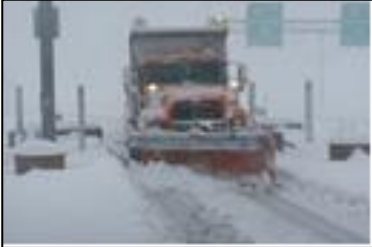
<p>Condition 4: <i>Snow Packed / Significant Snow Cover - The pavement surface has continuous stretches of packed snow with or without loose snow on top of packed snow and ice. Significant snow accumulations are present in some areas (2 – 5 in).</i></p>	<p><i>This condition may become prevalent during periods of heavy snowfall. Speed limit reductions and vehicle restrictions should be considered when this becomes the predominate condition on the roadway.</i></p>

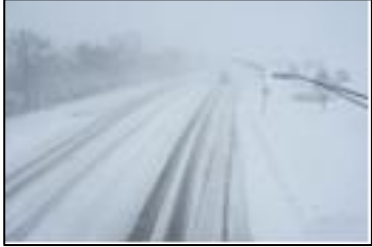
<p>Condition 5: <i>Icy - The pavement surface is predominantly covered with ice and packed snow. There may be loose snow or sleet on top of the icy or packed snow surface.</i></p>	<p><i>This condition may be the result of sleet, freezing rain, snow melt or refreeze. Reduced travel speeds may be necessary and motorist should be advised to limit travel or travel at significantly reduced speeds until conditions improve.</i></p>

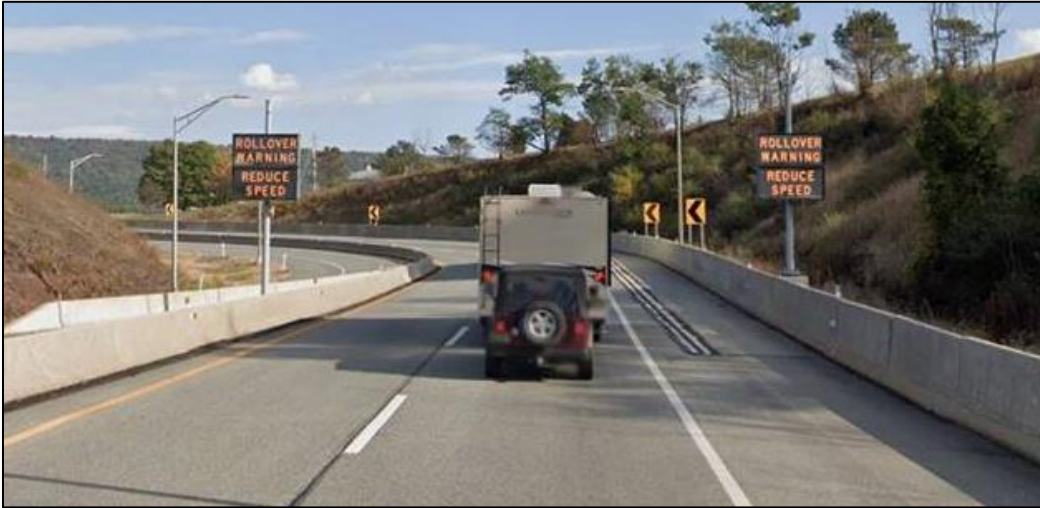
Figure 7 – Automated Truck Rollover Warning System (ATRWS) at the Breezewood eastbound exit ramp.

The selected partial system is composed of a series of radar detection, static signs, flashing lights and blankout signs. The basic configuration consists of two detection zones. Zone 1, located within the end of the tangent, identifies the vehicle class. If a truck is detected, overhead flashing lights are displayed in conjunction with static rollover signs. Zone 2, located prior to the curve, assesses the vehicle class and speed. If a truck is detected in Zone 2 and is exceeding the advisory speed of 35 mph, the blankout sign is activated, reading “ROLLOVER WARNING, REDUCE SPEED”.

The system was installed in 2003 followed by an independent evaluation of the project in 2006. Prior to the system there were an average of 3 to 6 rollover crashes annually. After installation there was only one rollover crash between 2003 and 2005. **Figure 7** illustrates the Automated Truck Rollover Warning System (ATRWS) at the Breezewood eastbound exit ramp.
