**NATIONAL TRANSPORTATION SAFETY BOARD
OFFICE OF HIGHWAY SAFETY
WASHINGTON, D.C.**

**HIGHWAY FACTORS GROUP CHAIRMAN'S
FACTUAL REPORT**

Location: Intersection of State Routes 30A and State Route 30, Schoharie,
Schoharie County, New York

NTSB #: **HWY19MH001**

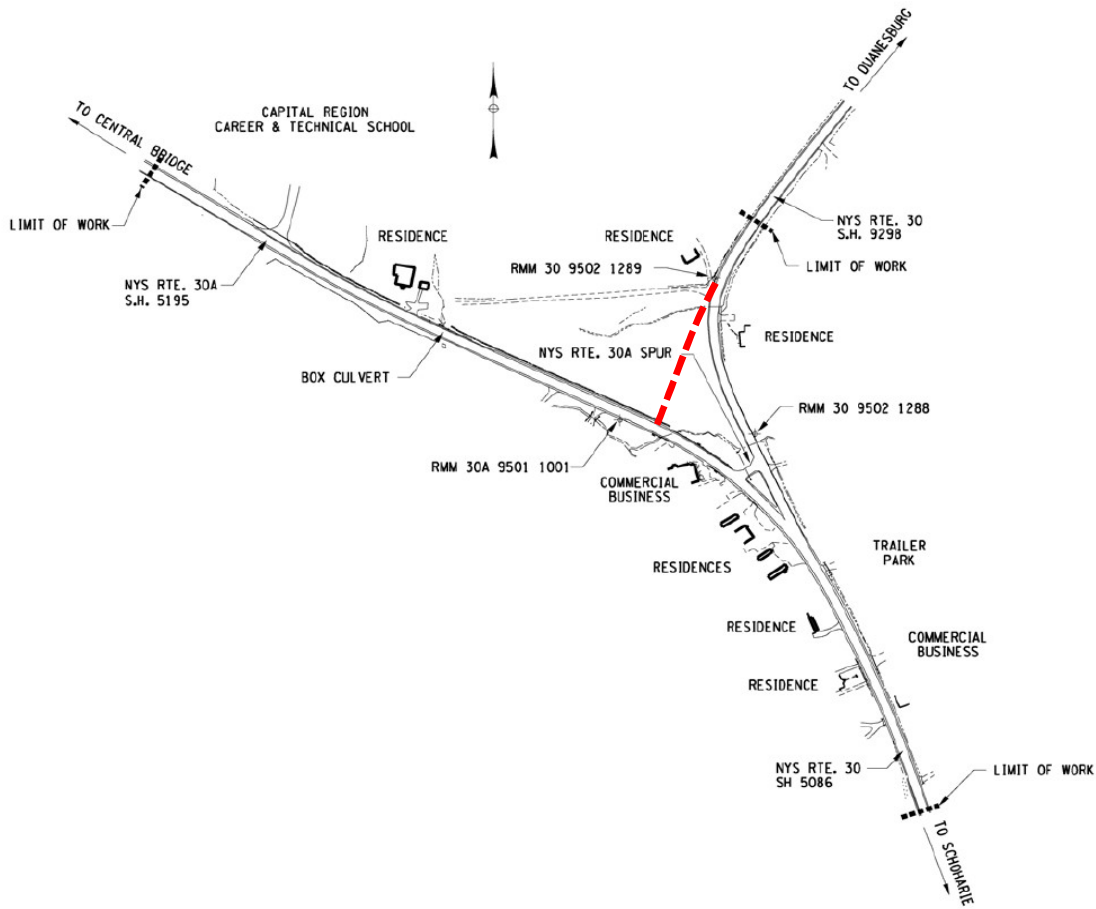
Figure 3: Image of Project Map for NY State Routes 30/30A intersection before redesign as illustrated in the project Final Design Report, PIN 9125.05 (2008). The red dashed line represents the redesigned leg of NY-30 to form the “T” intersection.

The reconstruction plan did note the non-standard grade along the northern leg of NY-30 at the intersection. The design called for a six-percent grade, as opposed to the recommended four-percent but was considered justified because it is a short extension of the existing grade to which the project was matching. The plan stated that while this feature is technically a nonstandard grade, it is at a location where speeds would be lower, is considered an acceptable design in rolling terrain and the inability to achieve standard criteria grade due to the proximity of the intersection. The roadway along NY-30A and NY-30 south of the intersection was raised as much as possible without requiring extensive additional right-of-way takes, relocation of a well, impact to a historic property, and significant driveway modifications. **Figure 3** depicts an image of the Project Map for the intersection before redesign as illustrated in the project Final Design Report, dated 2008. The red dashed line represents the redesigned leg of NY-30 to form the “T” intersection.

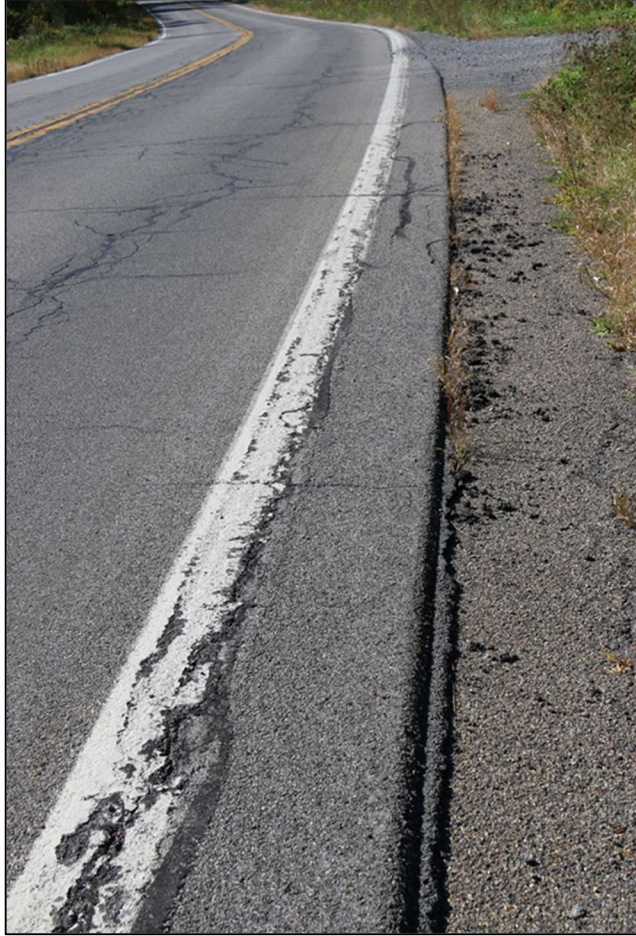
Figure 4: Photograph depicting an example of pavement edge and edge line condition. View is looking southward.

In certain areas previous resurfacing overlays measuring one to two inches in height could be seen along the pavement edge. While creating minor pavement edge drops, as depicted in **Figure 4**, no evidence of additional issues was observed. Areas of pavement through this segment exhibited evidence of minor wheel path rutting and surface cracking but no substantial deficiency to the travel surface.

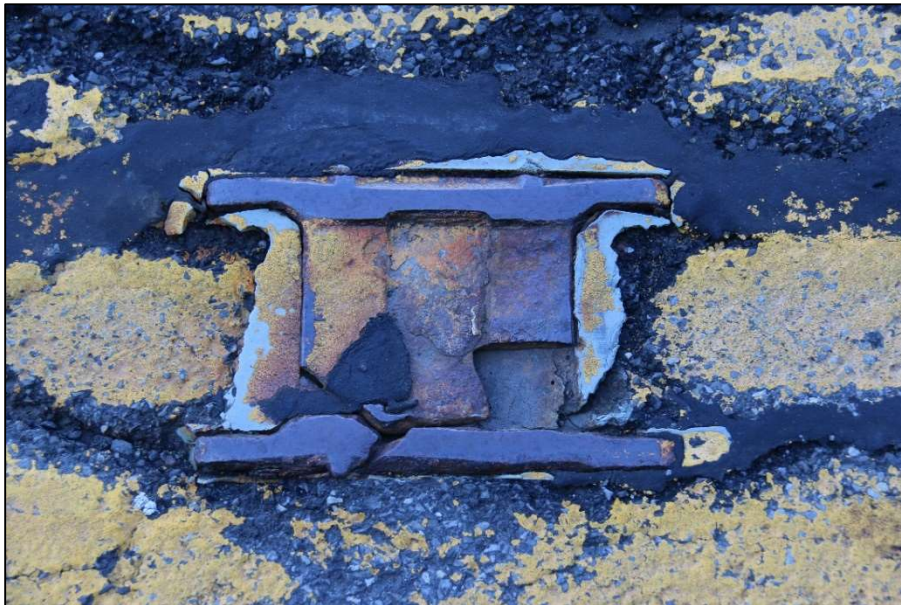
Figure 5: Example of degraded centerline retroreflective raised pavement marker.

The travel lanes are delineated by solid double yellow (painted) pavement striping except for about 675 feet at the southern end where striping permitted passing in the northbound direction of travel. The remnants of centerline retroreflective raised pavement markers (RPM) were observed covering about 1,200 feet beginning at the end of northbound passing zone, continuing through the horizontal curve and terminating north of the curve. Most of the RPMs were in disrepair and had been painted over by the double-yellow pavement striping. See **Figure 5**.

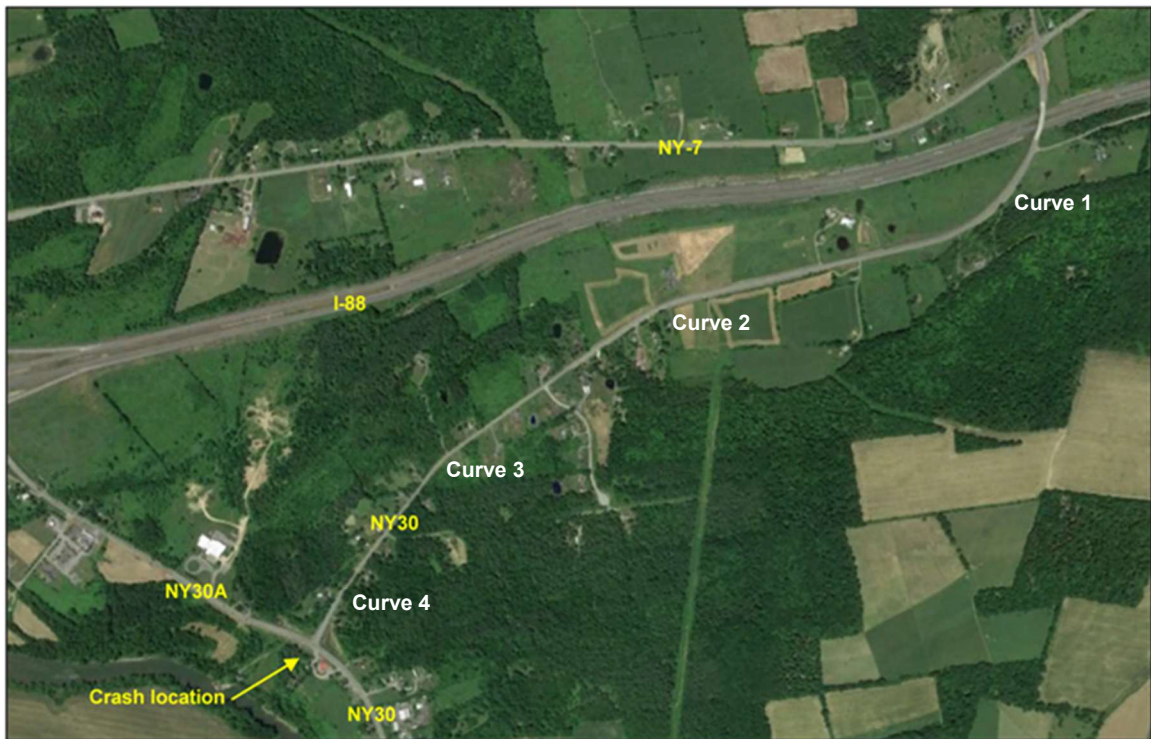
Figure 6: Google Earth image depicting location of highway curves as referenced in descriptive text and Table 1.

Horizontal alignment north to south	Curve radius (feet)	Segment Length (feet)	Cumulative distance to onset of horizontal segment relative to intersection	
			South from NY-7 Intersection (feet)	North from NY-30/30A Intersection (feet)
Tangent		117	0	9451
Curve C ₁ (right)	1432	2358	117	7093
Tangent		2077	2475	5016
Curve C ₂ (left)	2004	784	4552	4232
Tangent		1861	5336	2371
Curve C ₃ (left)	1641	458	7197	1913
Tangent		1119	7655	794
Curve C ₄ (left)	3000	626	8774	168
Tangent		168	9400	0

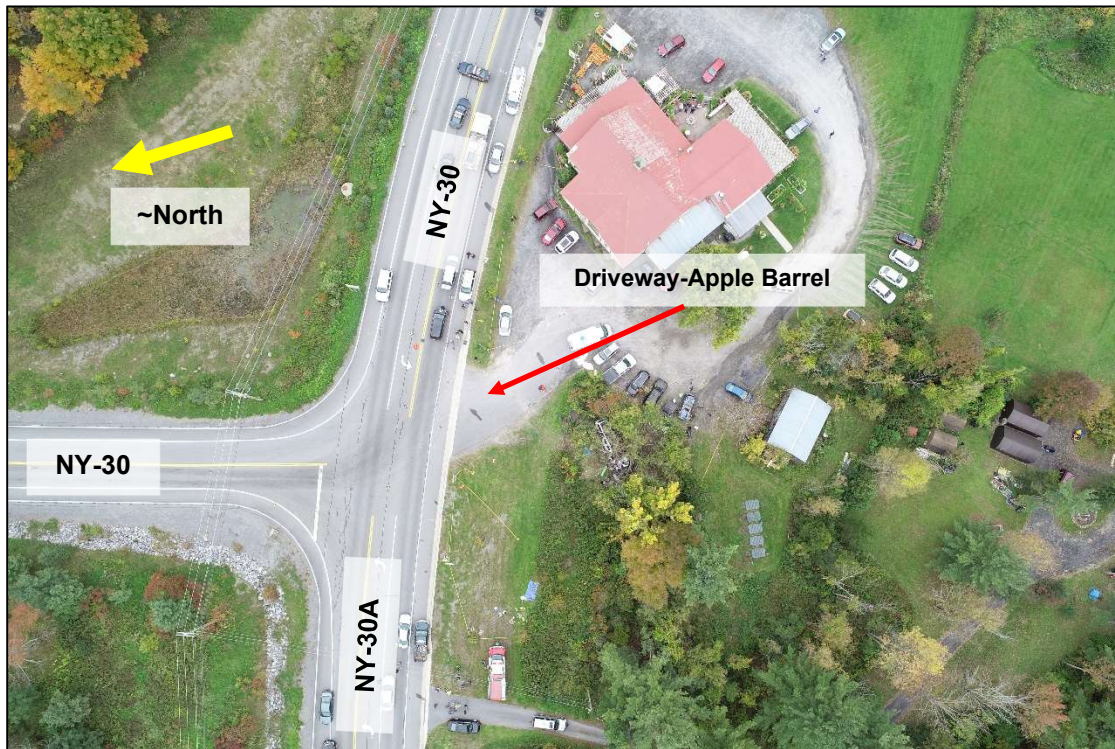
Figure 7: sUAS image depicting an overhead view of NY-30/30A intersection and intersection of Apple Barrel Country Store driveway. Source: New York State Police.

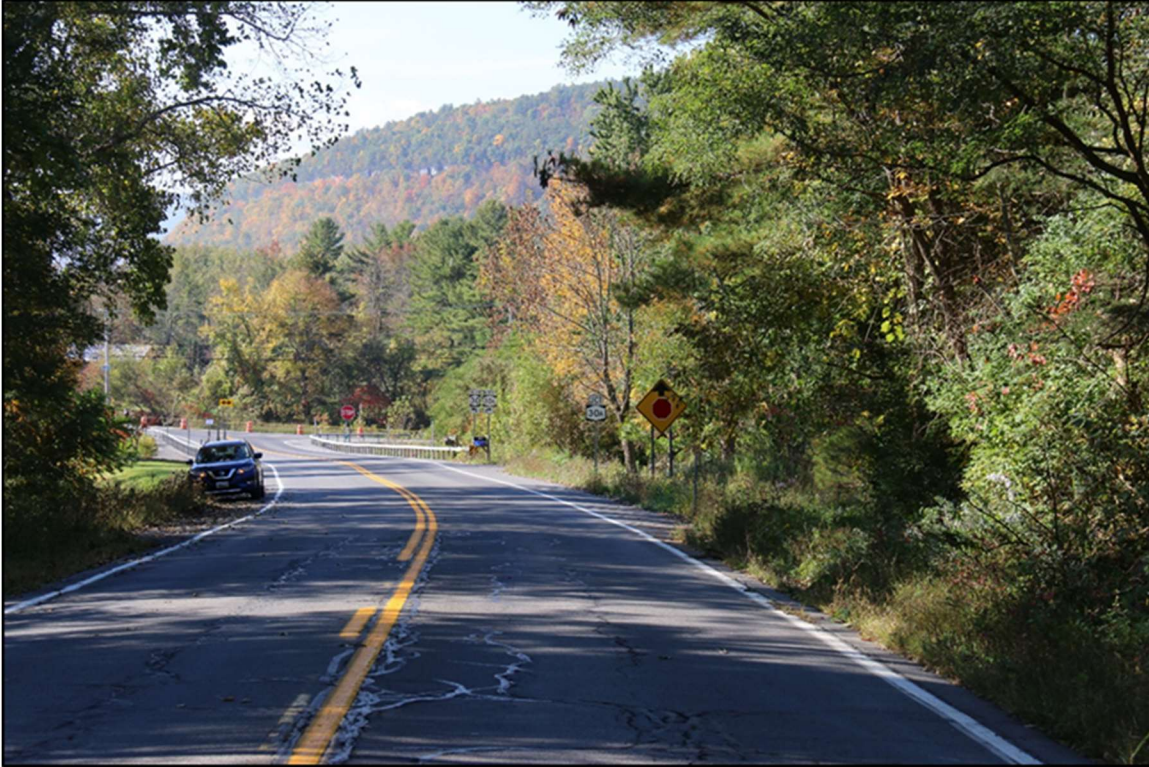
Figure 8: Photograph depicting the approach view of NY-30/30A intersection from the southbound travel lane about 660 feet before the intersection.

Chapter 9.5 of the AASHTO A Policy on Geometric Design of Highways and Streets conveys that stopping sight distance should be preserved on intersection approaches. The policy recommends that all drivers should have an unobstructed view of the intersection and all traffic control devices. Observations made along the southbound approach to the intersection confirmed that the SSD specified in the plan was preserved.¹⁰ Beginning at least 730 feet north of the intersection, the entire intersection could be viewed, except for a portion of the southeast corner due to some low hanging roadside vegetation. At 660 feet, which was still more than the recommended SSD, the entire intersection and all traffic control devices were visible from the southbound travel lane, as depicted in **Figure 8**.

Overall, observations along the southbound travel lane revealed that all the intersection traffic control devices – stop ahead sign and stop sign – began to come into simultaneous view about 1,125 feet before the stop sign. Within 1,015 feet of the stop sign, view of these signs was unaffected by roadside vegetation. While the intersection approach sight line and view of signage met AASHTO recommendations, roadside foliage, primarily low tree branches, did present partial signage obstruction from greater distances.

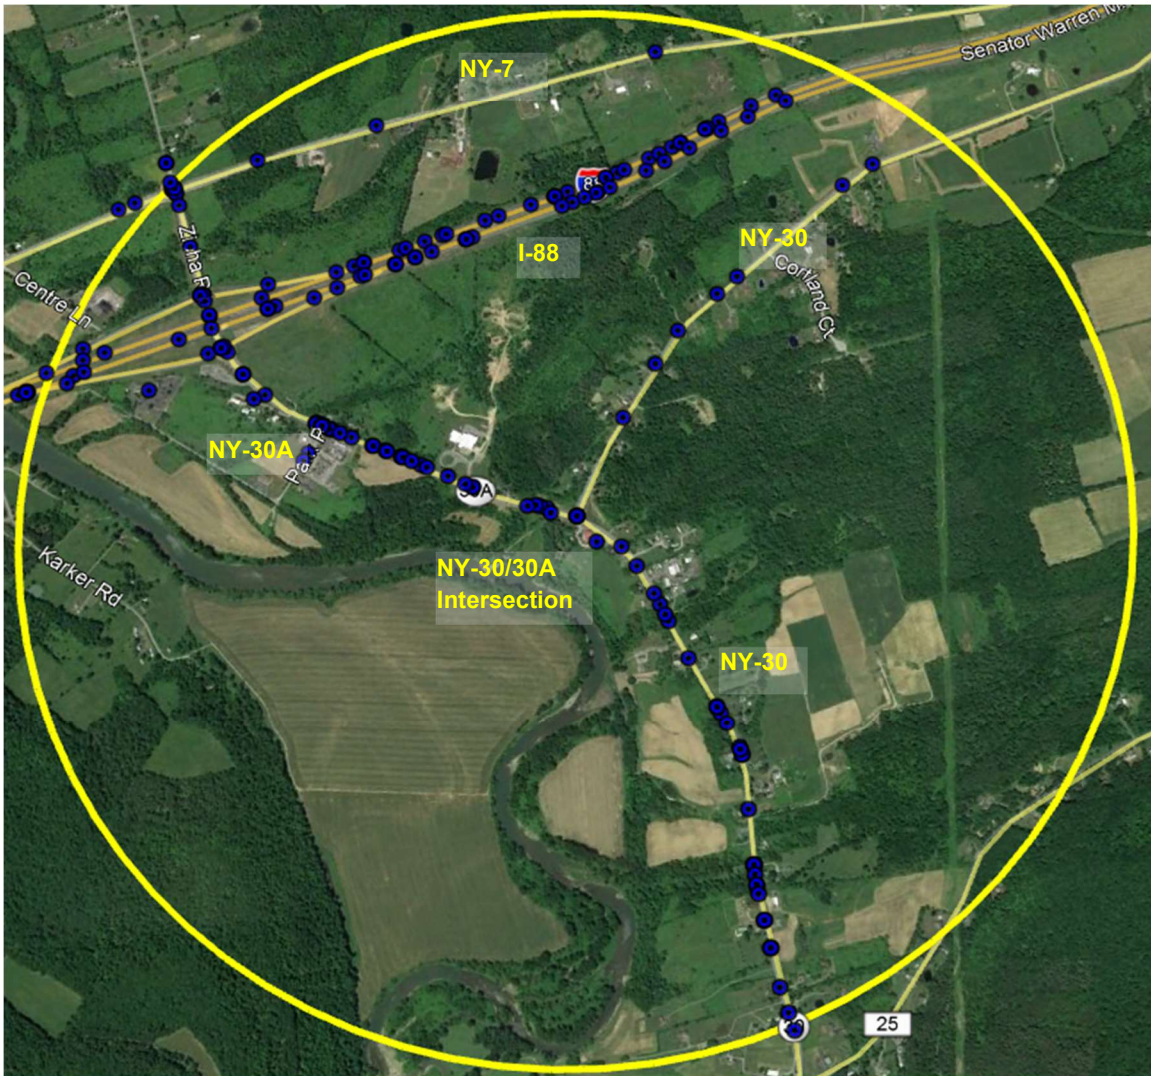
Figure 9: Historical crash locations reported by NYSDOT within a one-mile radius of the NY-30/30A intersection for 2013-2018. Multiple crashes at a single location may be covered by a single icon.

NYSDOT provided a 5-year crash history covering a one-mile radius around the NY-30/30A intersection (**Figure 9**). The history covered January 2013 through October 2018. During this period a total of 196 crashes were tallied, with about 31% classified as non-reportable. As conveyed by NYSDOT *“accidents are classified as either reportable or non-reportable. All accidents involving either a death, personal injury or if the reported property damage to any single motor vehicle meets a threshold of at least one thousand dollars will be considered a reportable accident. Reportable accidents always have event, vehicle and contributing factor information. Non-reportable accidents usually have only a limited amount of event information coded by DMV. The only event information captured by DMV for a typical non-reportable accident is location (reference marker and intersection number) and date. There usually is no vehicle or contributing factor data for non-reportable accidents. However, vehicle and contributing factor records can exist for nonreportable accidents, but all the data fields will contain code values of not entered or not available.*

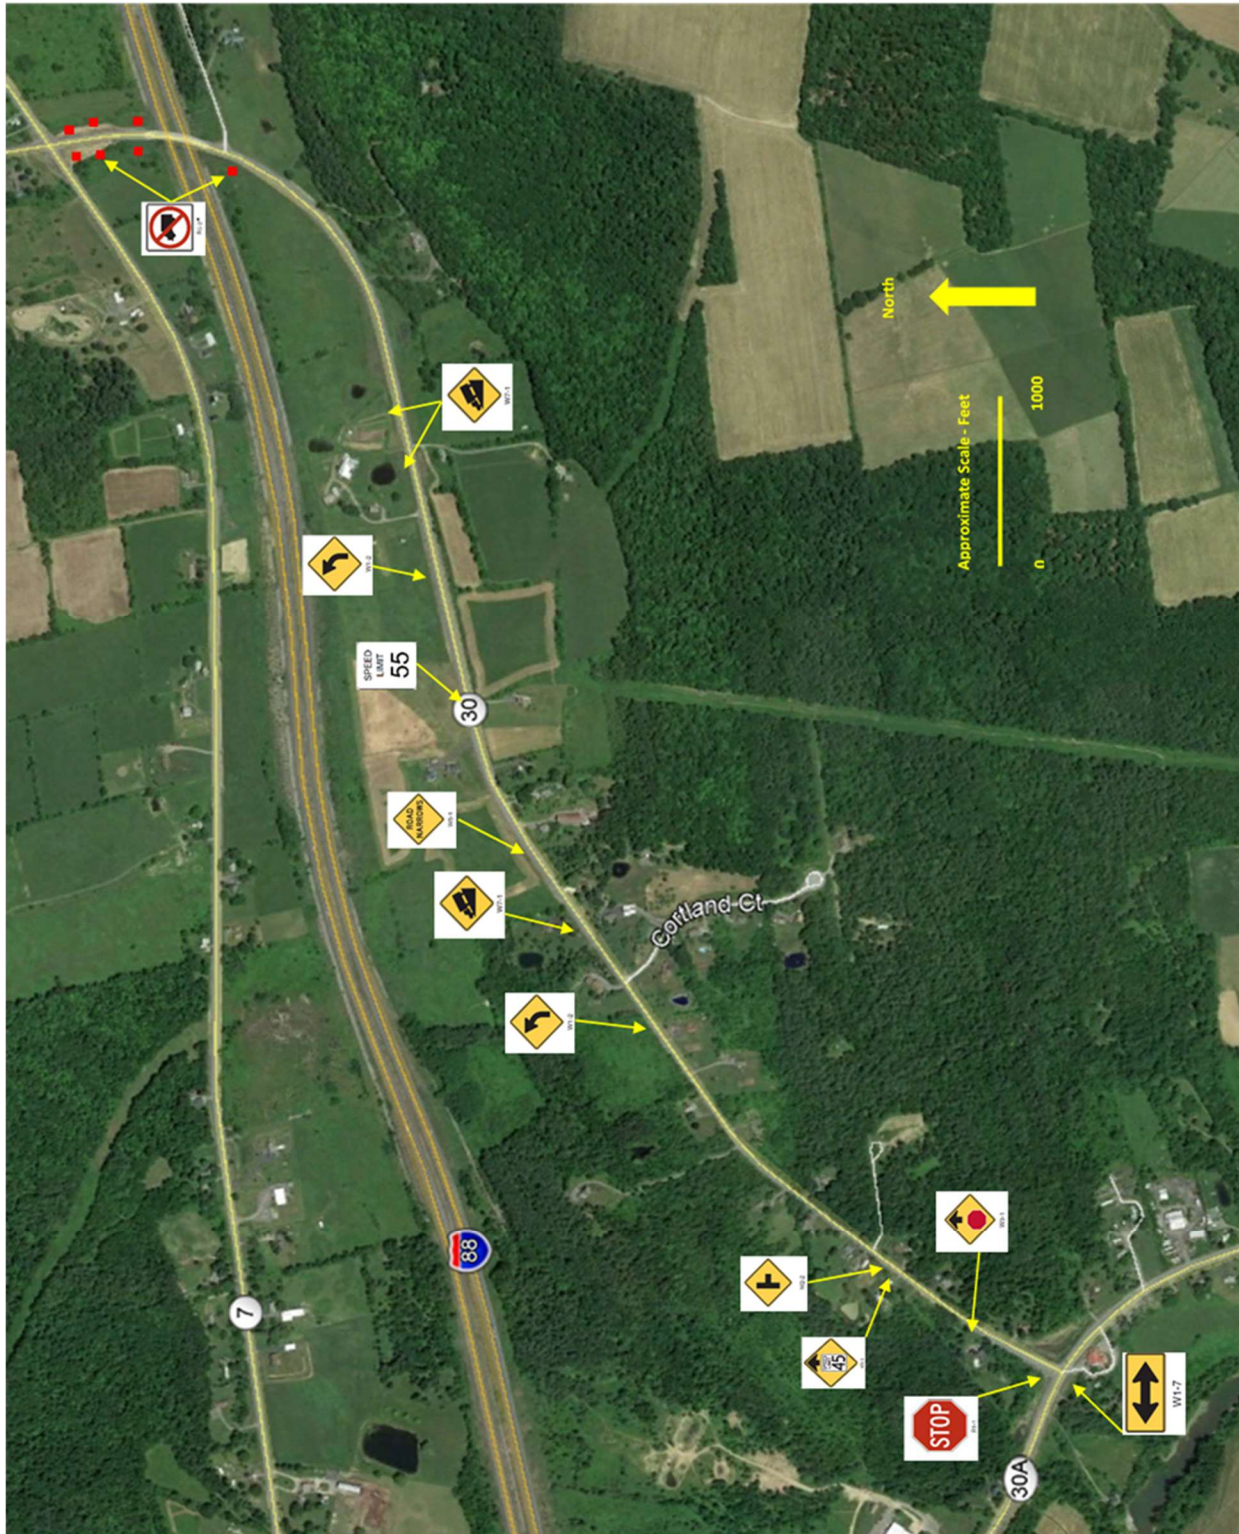
Appendix A: Signage depicted southbound direction of travel along NY-30 between NY-7 and NY-30A.

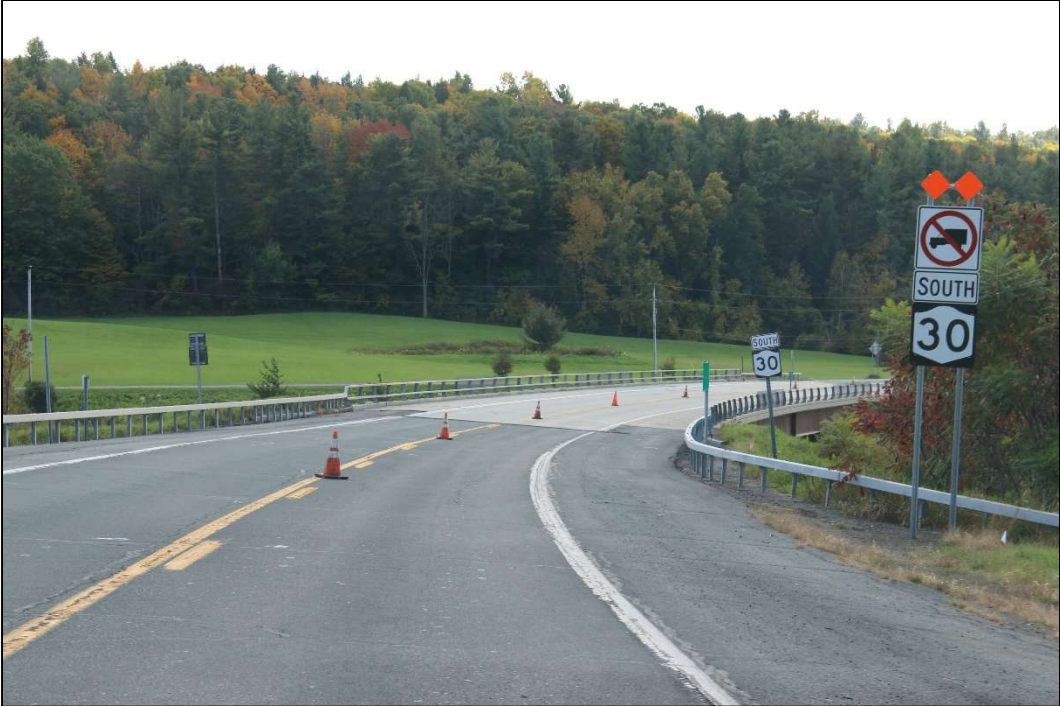
Southbound view along NY-30 through Curve #1 approaching the I-88 overpass. One of the six “No Trucks” is also visible.

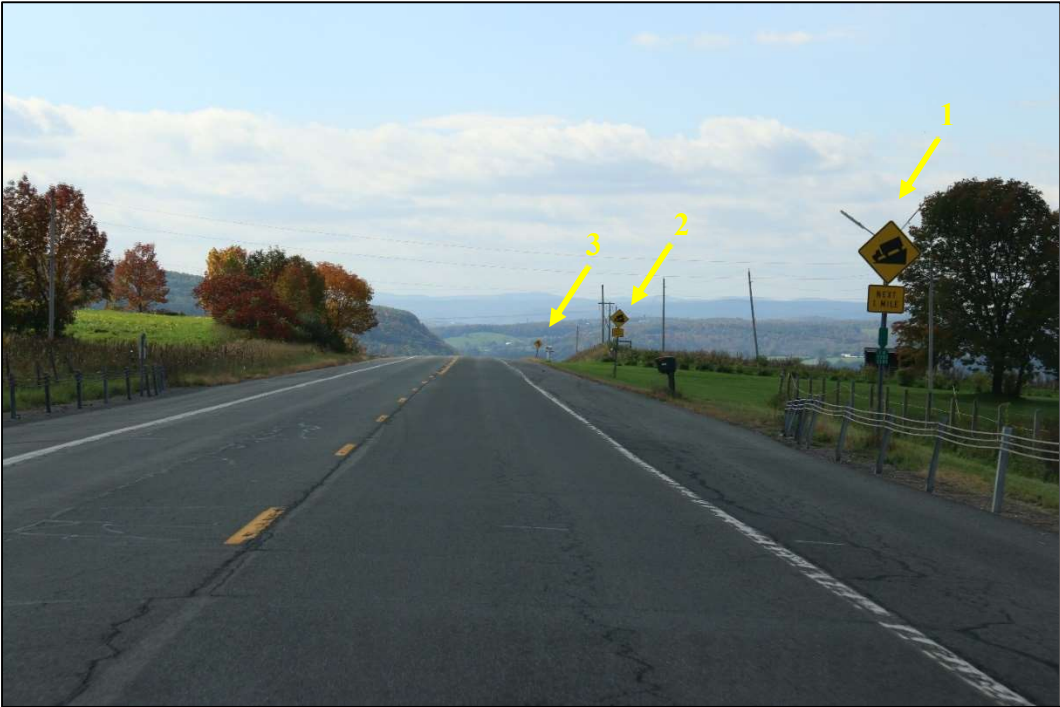
Southbound view after exiting Curve #1 into the tangent segment. The signs indicated by yellow arrows include the first and second “Hill” warning signs (#1 and #2) and the “Curve” warning sign (#3).

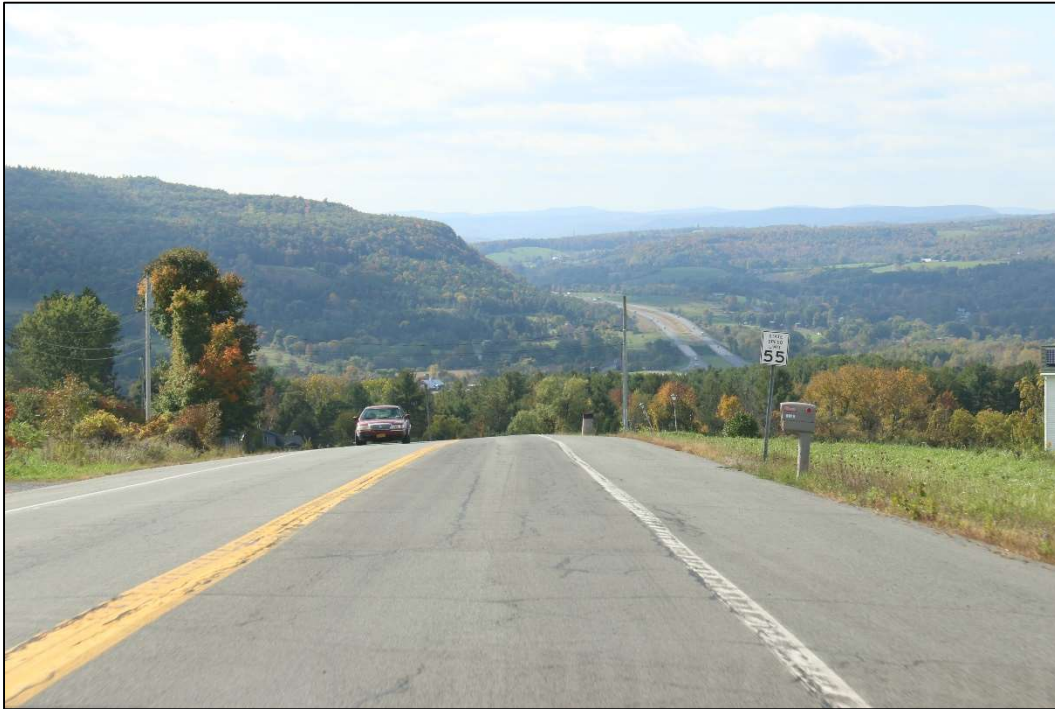
Southbound approach to Curve #2 and onset of descending grade. Speed limit sign (55 MPH) is also depicted.

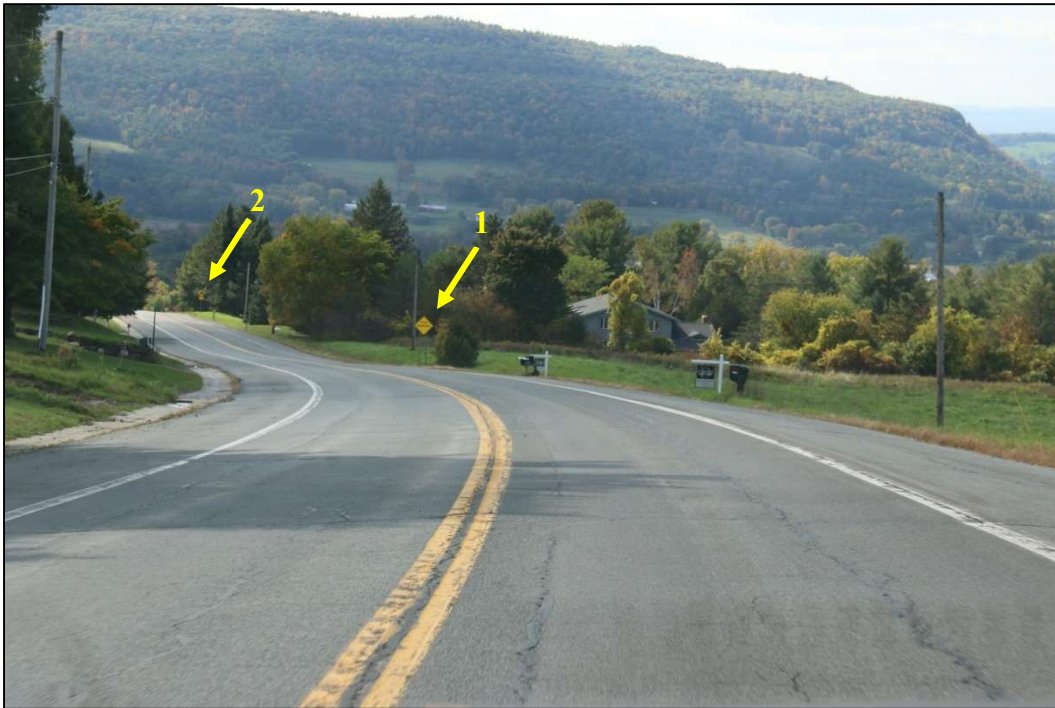
Southbound view toward tangent segment following Curve #2. Signs depicted include "Road Narrows" (#1) and the third "Hill" warning sign (#2).

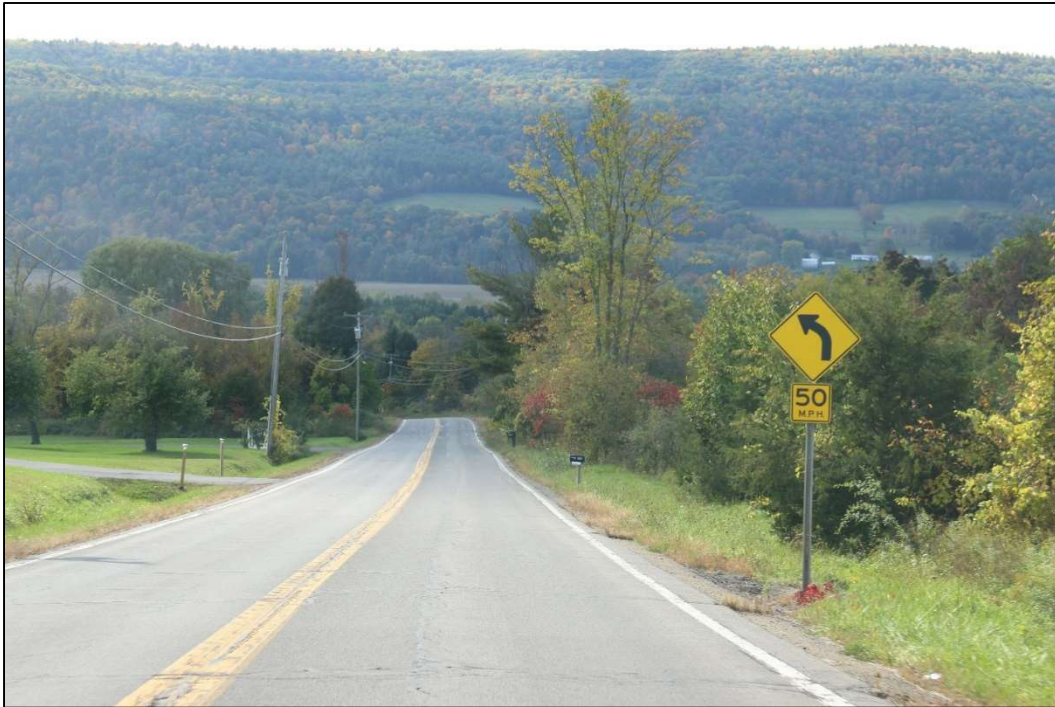
Southbound view along tangent segment approaching curve #3. Image also depicts “Curve” warning sign with reduced speed advisory plaque (50 MPH).

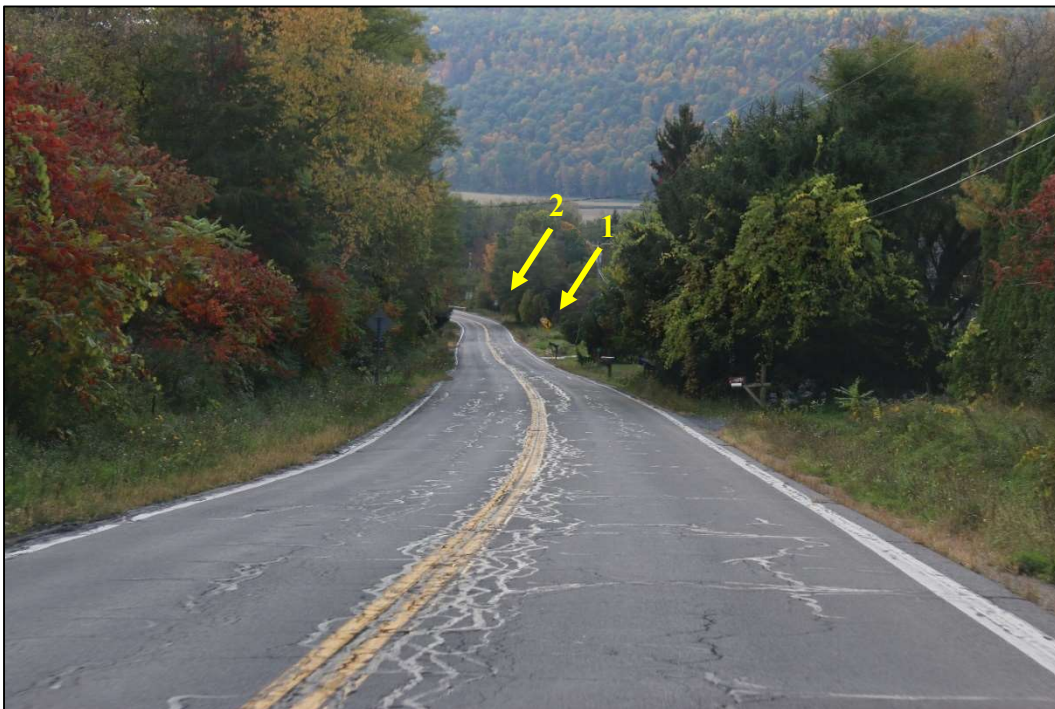
Southbound view of tangent segment following Curve #3 and approaching Curve #4. The signs indicated by yellow arrows include the “Intersection” warning with “Driveways” advisory plaque (#1) and the “Reduced Speed Limit Ahead”, 50-MPH (#2).

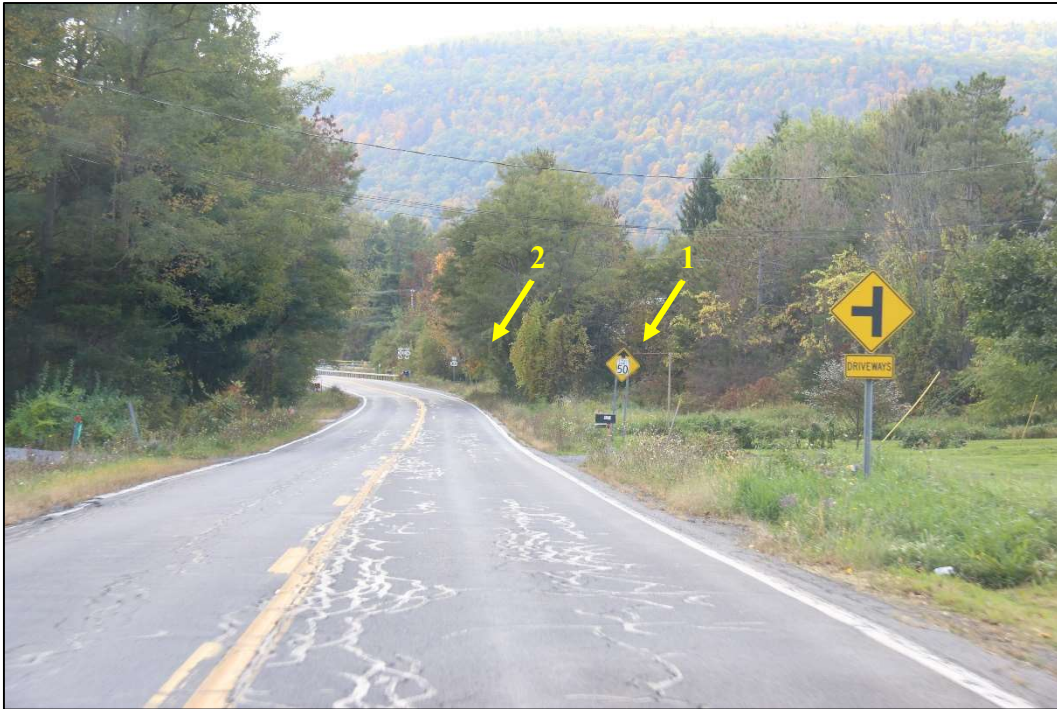
Southbound view approaching Curve #4. Visible signage includes the “Intersection” warning sign, the “Reduced Speed Limit Ahead” sign (#1), and the “Stop Ahead) sign (#2).

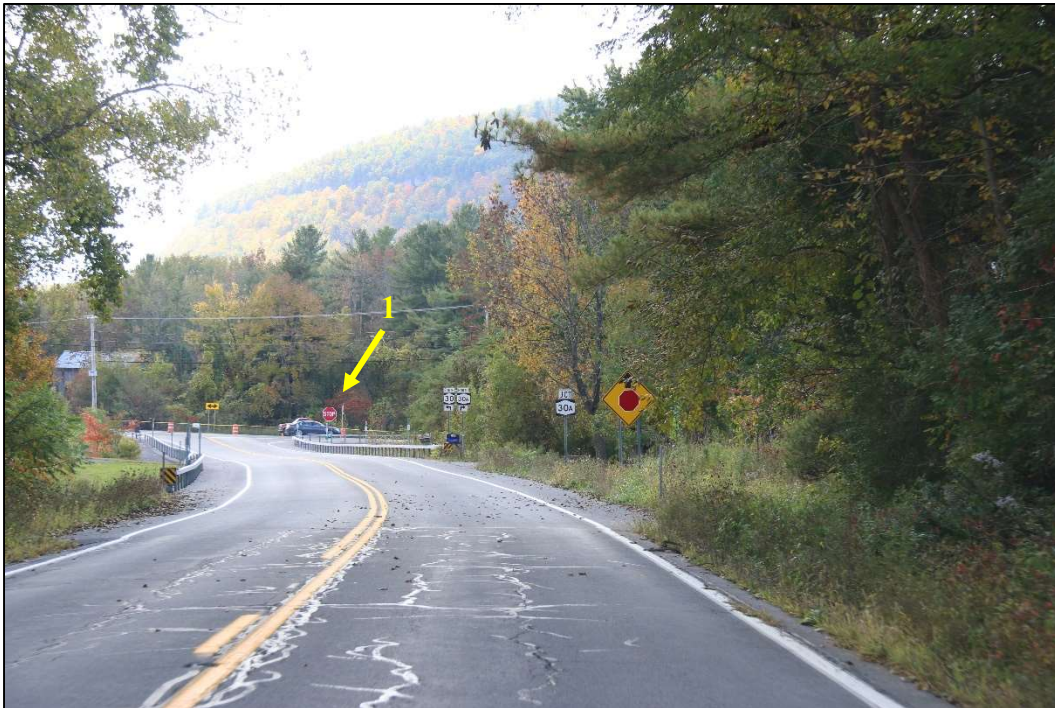
Southbound view approaching Curve #4 and tangent to leading to the NY-30/NY-30A intersection. Visible signs include the “Stop Ahead” sign and intersection “Stop” sign (#1).

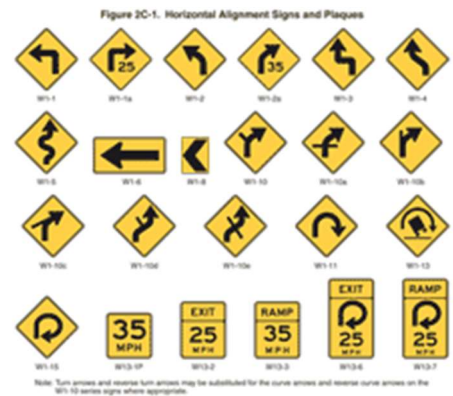
Table 2C-5. Horizontal Alignment Sign Selection

02 In advance of horizontal curves on freeways, on expressways, and on roadways with more than 1,000 AADT that are functionally classified as arterials or collectors, horizontal alignment warning signs shall be used in accordance with [Table 2C-5](#) based on the speed differential between the roadway's posted or statutory speed limit or 85th-percentile speed, whichever is higher, or the prevailing speed on the approach to the curve, and the horizontal curve's advisory speed.

Type of Horizontal Alignment Sign	Difference Between Speed Limit and Advisory Speed				
	5 mph	10 mph	15 mph	20 mph	25 mph or more
Turn (W1-1), Curve (W1-2), Reverse Turn (W1-3), Reverse Curve (W1-4), Winding Road (W1-5), and Combination Horizontal Alignment/Intersection (W1-10) (see Section 2C.07 to determine which sign to use)	Recommended	Required	Required	Required	Required
Advisory Speed Plaque (W13-1P)	Recommended	Required	Required	Required	Required
Chevrons (W1-8) and/or One Direction Large Arrow (W1-6)	Optional	Recommended	Required	Required	Required
Exit Speed (W13-2) and Ramp Speed (W13-3) on exit ramp	Optional	Optional	Recommended	Required	Required

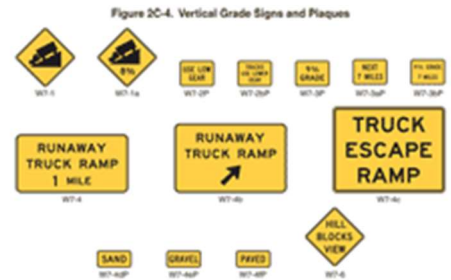
02 The Hill sign and supplemental grade (W7-3P) plaque (see [Section 2C.57](#)) used in combination, or the W7-1a sign used alone, should be installed in advance of downgrades for the following conditions:

- A. 5% grade that is more than 3,000 feet in length,
- B. 6% grade that is more than 2,000 feet in length,
- C. 7% grade that is more than 1,000 feet in length,
- D. 8% grade that is more than 750 feet in length, or
- E. 9% grade that is more than 500 feet in length.

03 These signs should also be installed for steeper grades or where crash experience and field observations indicate a need.

04 Supplemental plaques (see [Section 2C.57](#)) and larger signs should be used for emphasis or where special hill characteristics exist. On longer grades, the use of the Hill sign with a distance (W7-3aP) plaque or the combination distance/grade (W7-3bP) plaque at periodic intervals of approximately 1-mile spacing should be considered.
