Summary: LCU-08 was found to be operational.

Unit Under Test: TLK-LCU-08

Wabtec P/N: 17123P

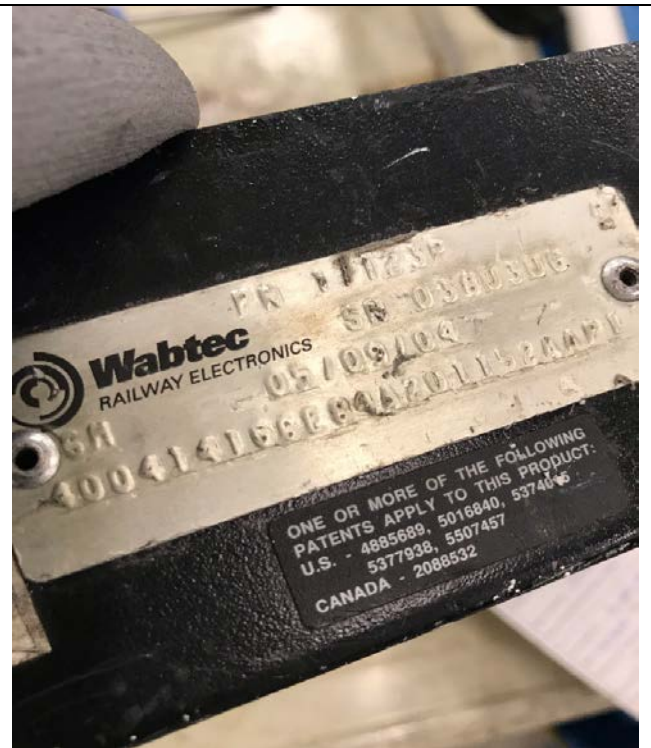
1. Unit has BNSF asset number.
2. Front panel with LSI/Serial connector was severely bent.
3. Internal parts looked okay.
4. Unit has been retrofitted with non-Wabtec radio and RF coax. Radio appears to be packaged by DPS Electronics and contains a Ritron DTX-PLUS DTX-454 radio.
5. Two RE labels were on the LCU enclosure; RE382 and RE470. Both REs were related to the Wabtec radio that was included in the LCU as designed. With the Wabtec radio having been replaced by an unknown party, these are not relevant.
