NATIONAL TRANSPORTATION SAFETY BOARD

**CSX Transportation
Train Derailment
Hyndman Pennsylvania**

NTSB Accident Number: DCA17FR011

Operations Group Factual Report
Tomas Torres, Group Chairman

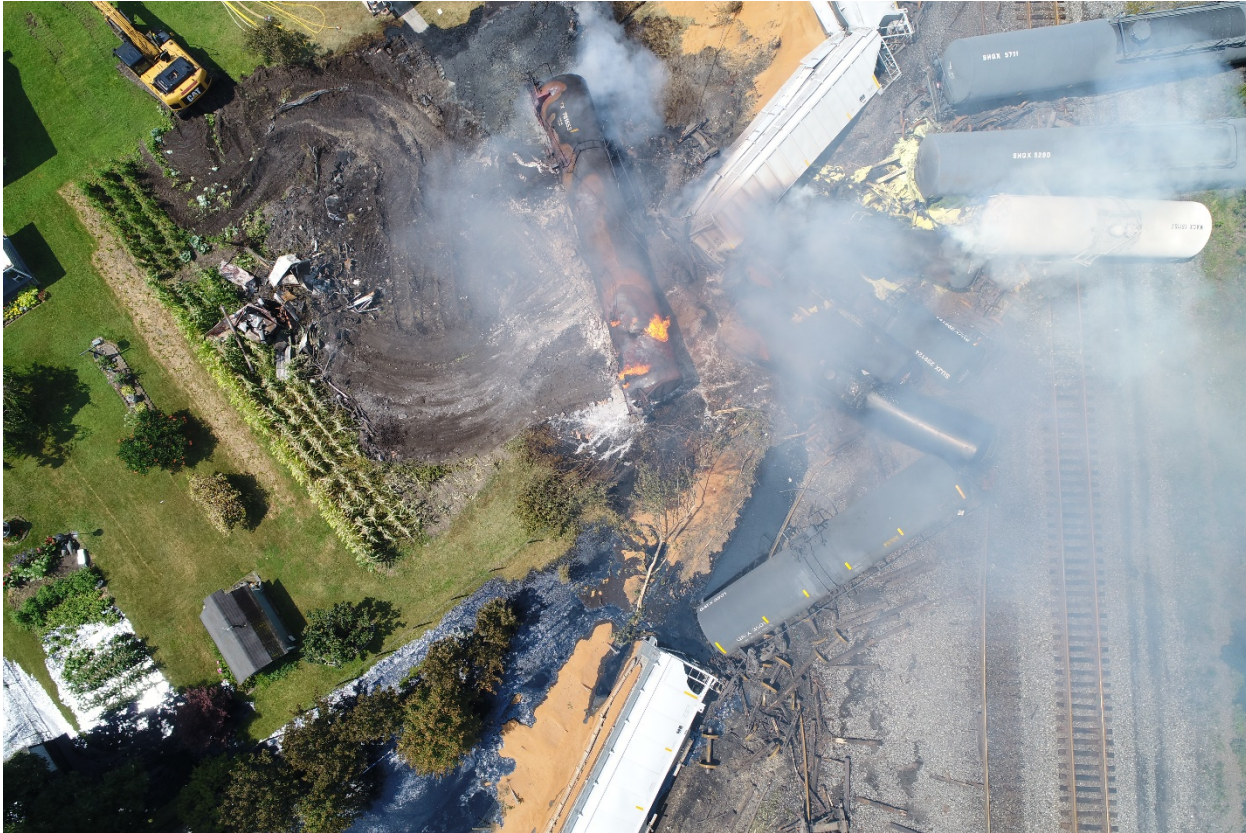
6 *Figure 1Aerial view of the derailment*

10 According to the Train Dispatcher voice recordings, the Engineer reported that cars had
11 derailed, and that one car exploded, and requesting emergency personnel. The first car derailed was
12 the FWTX620150 an asphalt car and it was the 34th from the headend of the train. Some of the
13 following cars contained molten sulfur.
