National Transportation Safety Board

Investigator-in-Charge's Accident Summary

NTSB Accident#: PLD24FR003

Atmos Energy Corporation Natural Gas-Fueled Home Explosions and Fires
January 24, 2024, and January 27, 2024, Jackson, Mississippi

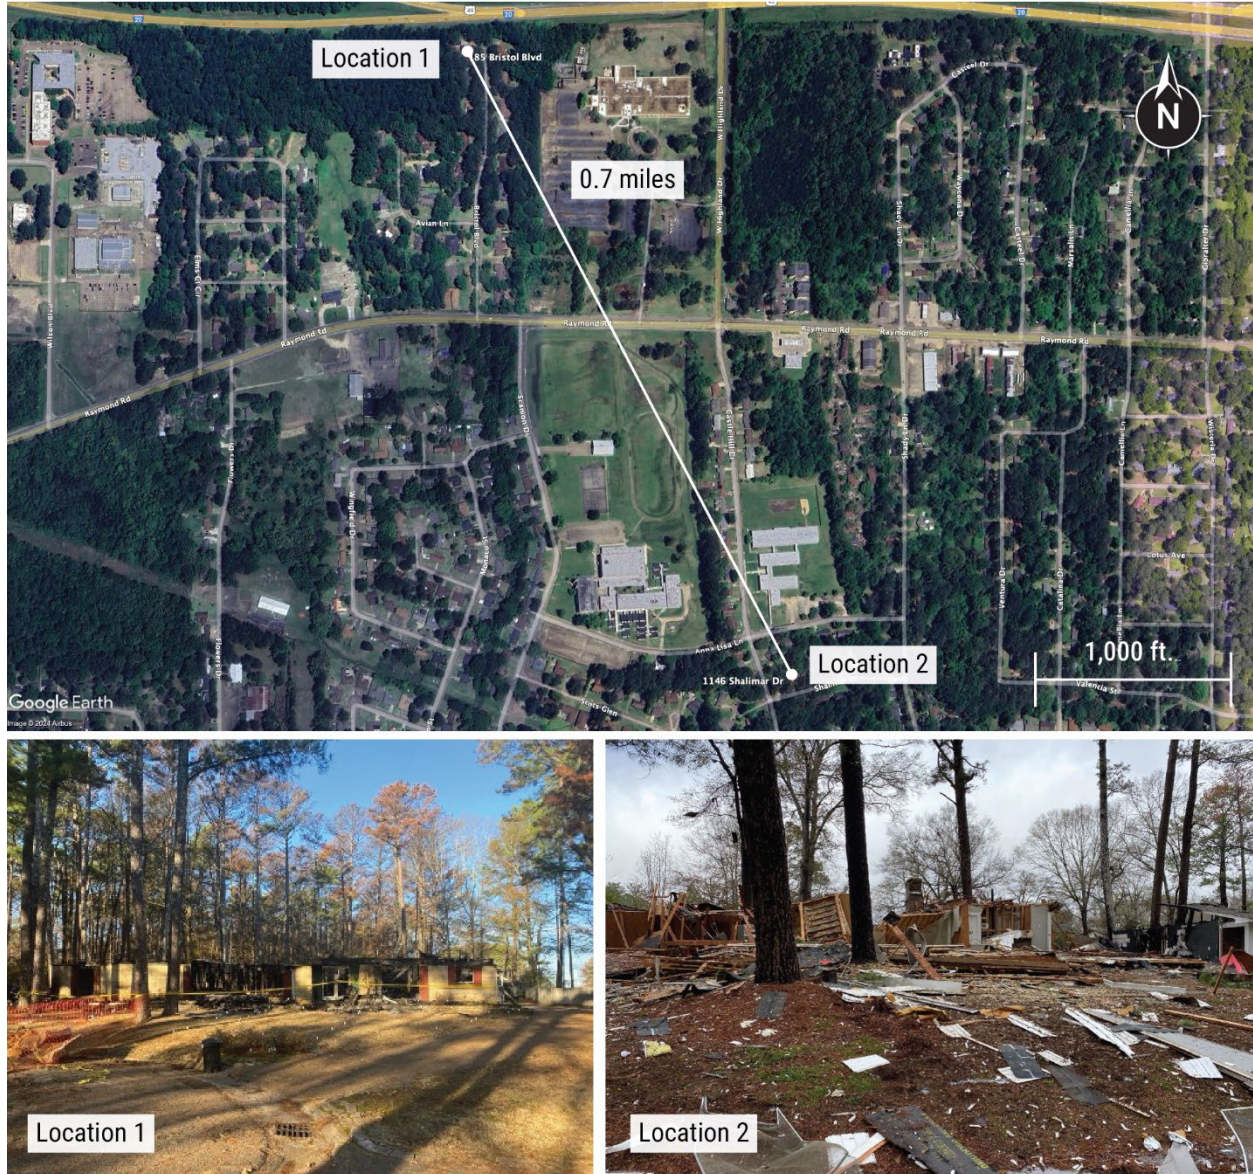
Figure 1. Map and photographs of explosion locations (Courtesy of Google Earth, the Mississippi Public Service Commission [Location 1 inset], and the Pipeline and Hazardous Materials Safety Administration [Location 2 inset].)

On January 24, 2024, about 8:14 a.m., a home explosion and fire occurred at 185 Bristol Blvd. (Location 1) in Jackson, Mississippi, resulting in one fatality and one injury. Three days later, on January 27, 2024, about 4:34 a.m., a second explosion occurred at 1146 Shalimar Drive (Location 2) about 0.7 miles southeast of the first explosion, and fire spread to a neighboring home. (See Figure 1) No fatalities or injuries were reported in relation to the explosion at Location 2. All three homes were destroyed. Light to heavy rain was observed prior to the accidents at both locations.
