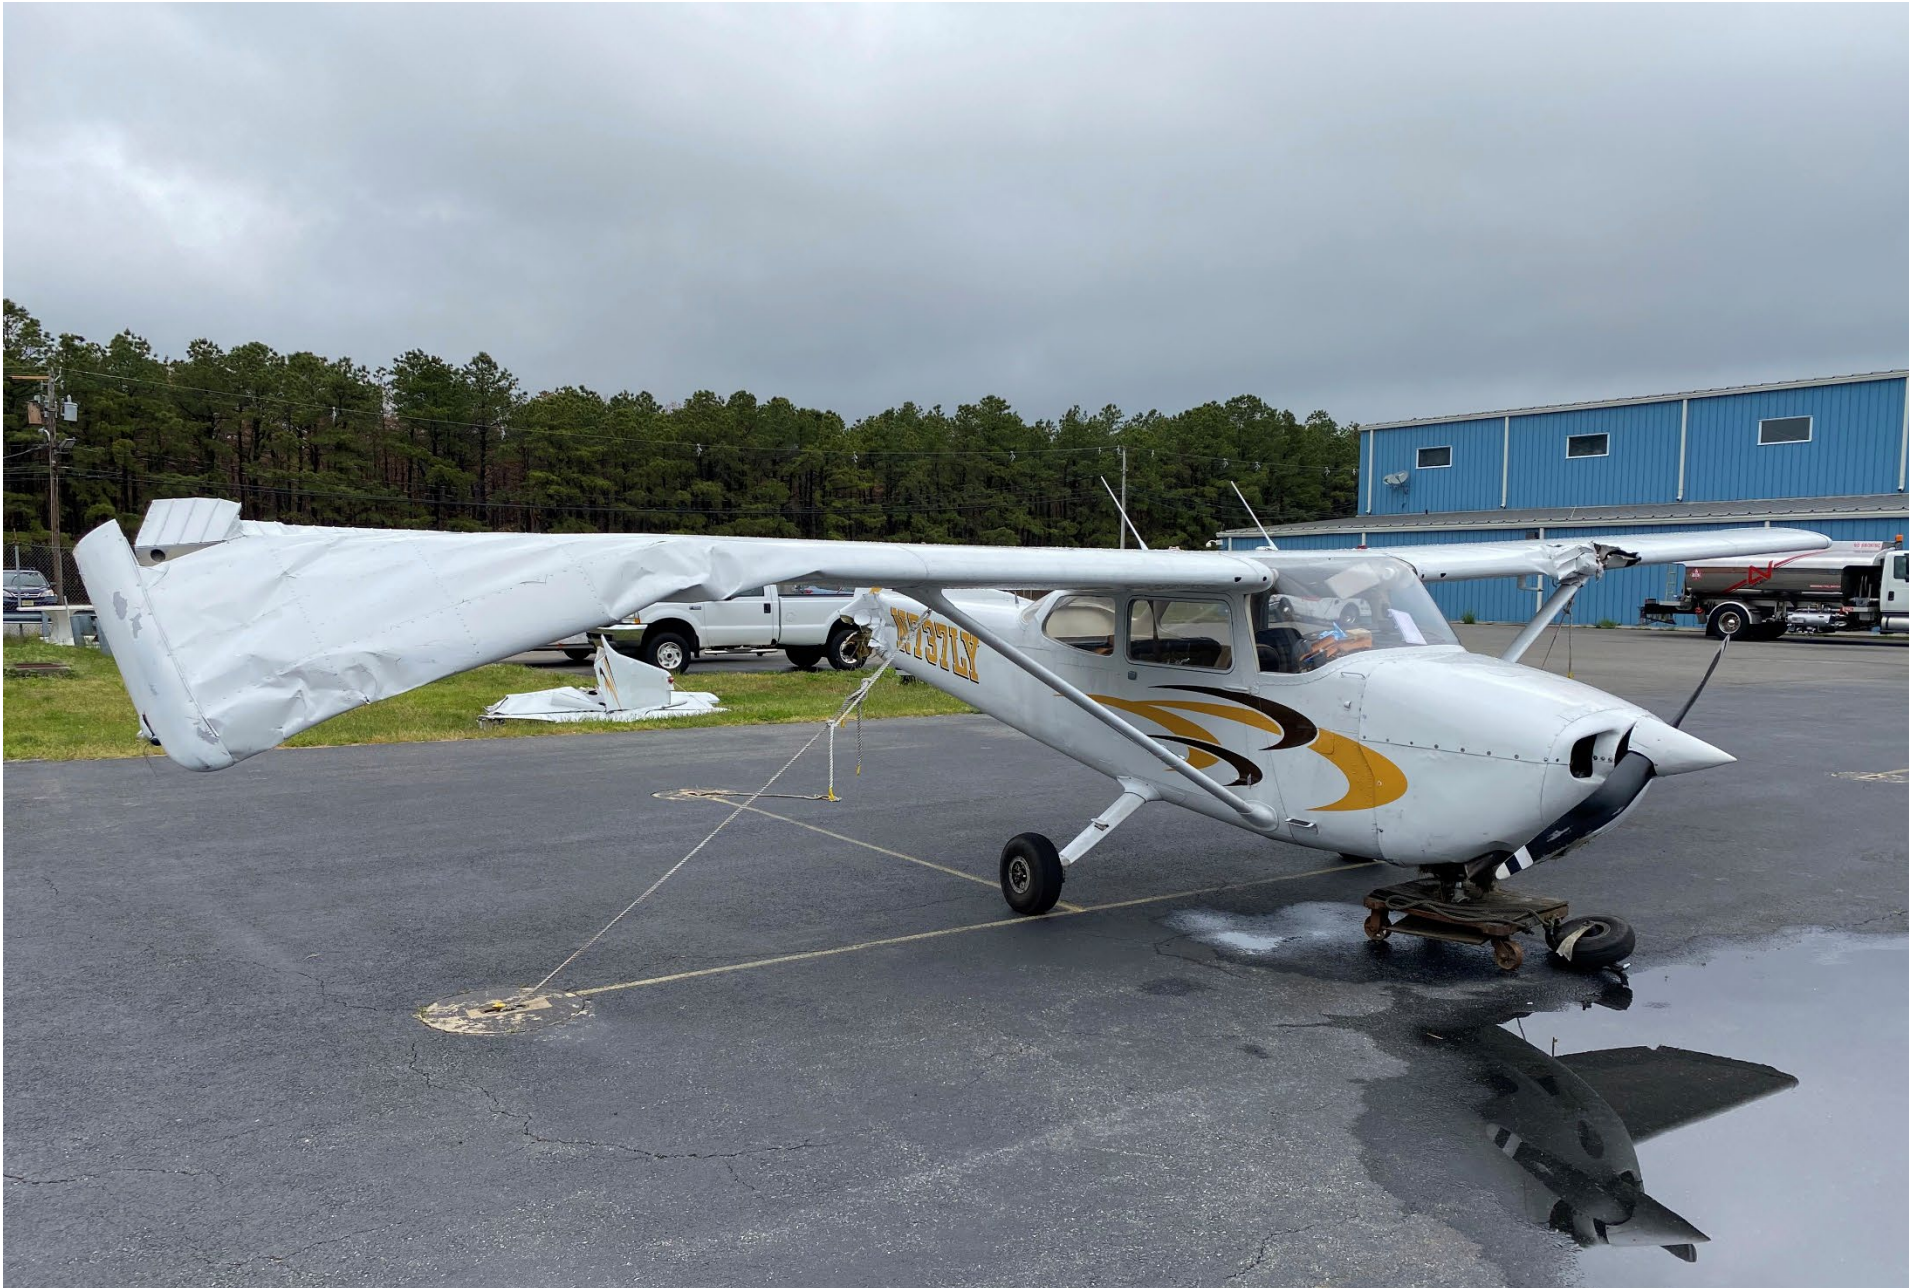
**Photo 1 – main wreckage, front view (FAA)**

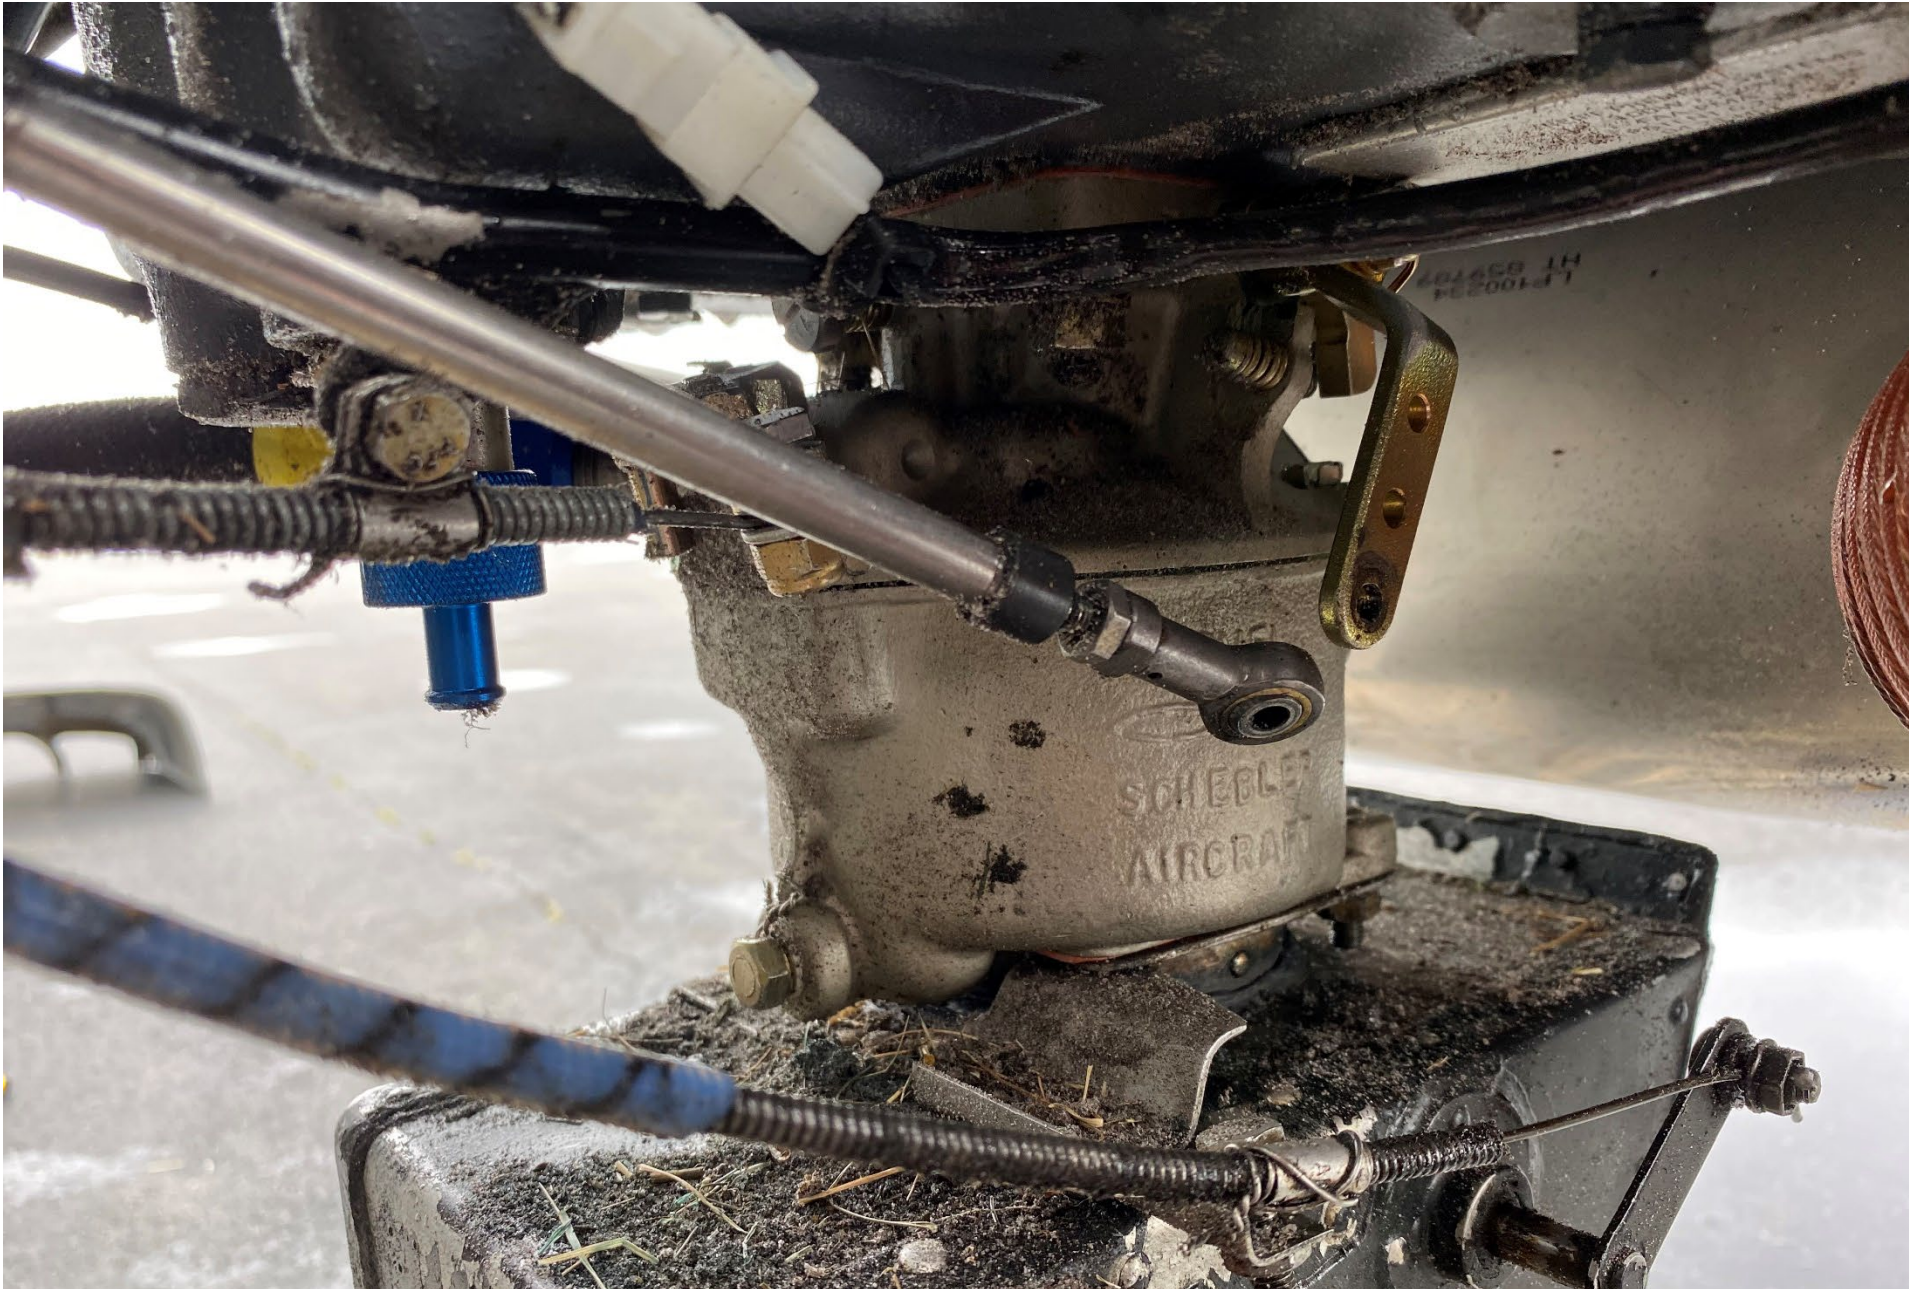
**Photo 2 – throttle cable disconnected, bolt and nut missing (FAA)**
