SERVICE BULLETIN

N° **139-731**

ATA 00 – FORWARD CABIN ROOF CEILING HARNESS INSPECTION

This Service Bulletin is issued in order to prescribe one-off inspections of the Forward Cabin Roof Ceiling Harnesses and their installation in the area between STA 3120 and 3900 to identify potential chafing conditions.

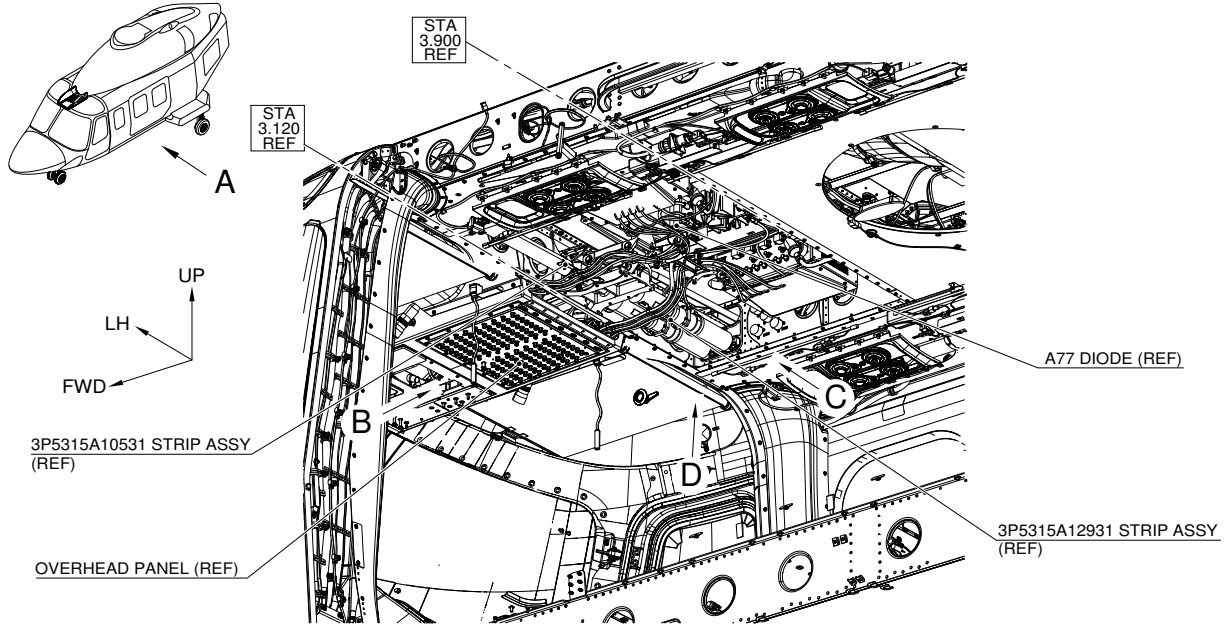
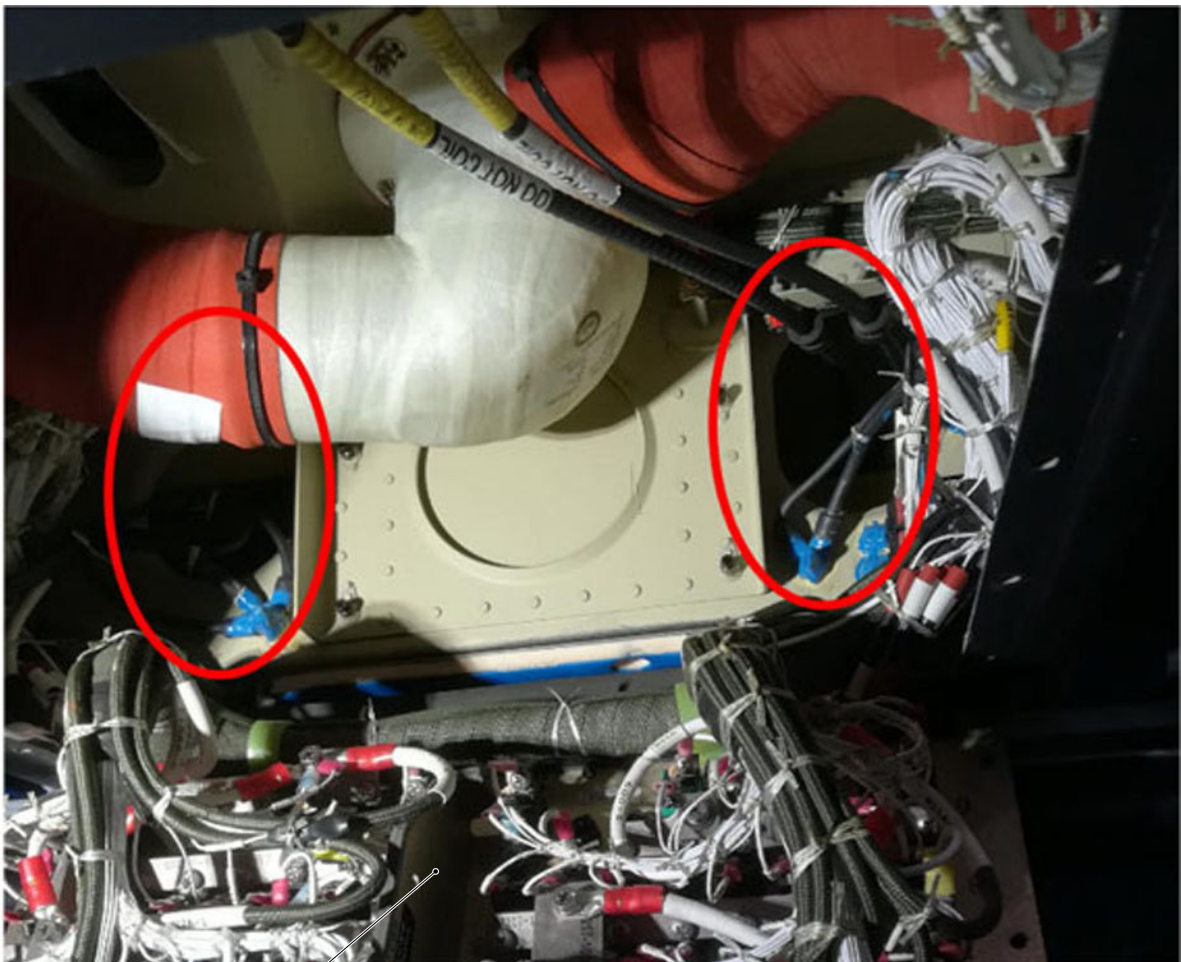
Figure 1

VIEW A
STRUCTURES AND SYSTEMS ARE PARTIALLY OMITTED FOR BETTER CLARITY PURPOSE

VIEW B
STRUCTURES AND SYSTEMS ARE PARTIALLY OMITTED FOR BETTER CLARITY PURPOSE

- 2.1.1 In accordance with the applicable steps of AMP DM 39-A-24-91-01-00A-520A-A and with reference to Figure 1, open the circuit breaker panel assy without removing it.

- 2.1.2 With reference to Figure 1, insert the borescope inside the lightening holes showed to access the area of the inspection.
 - 2.1.3 Perform a visual inspection of the C/As installation.

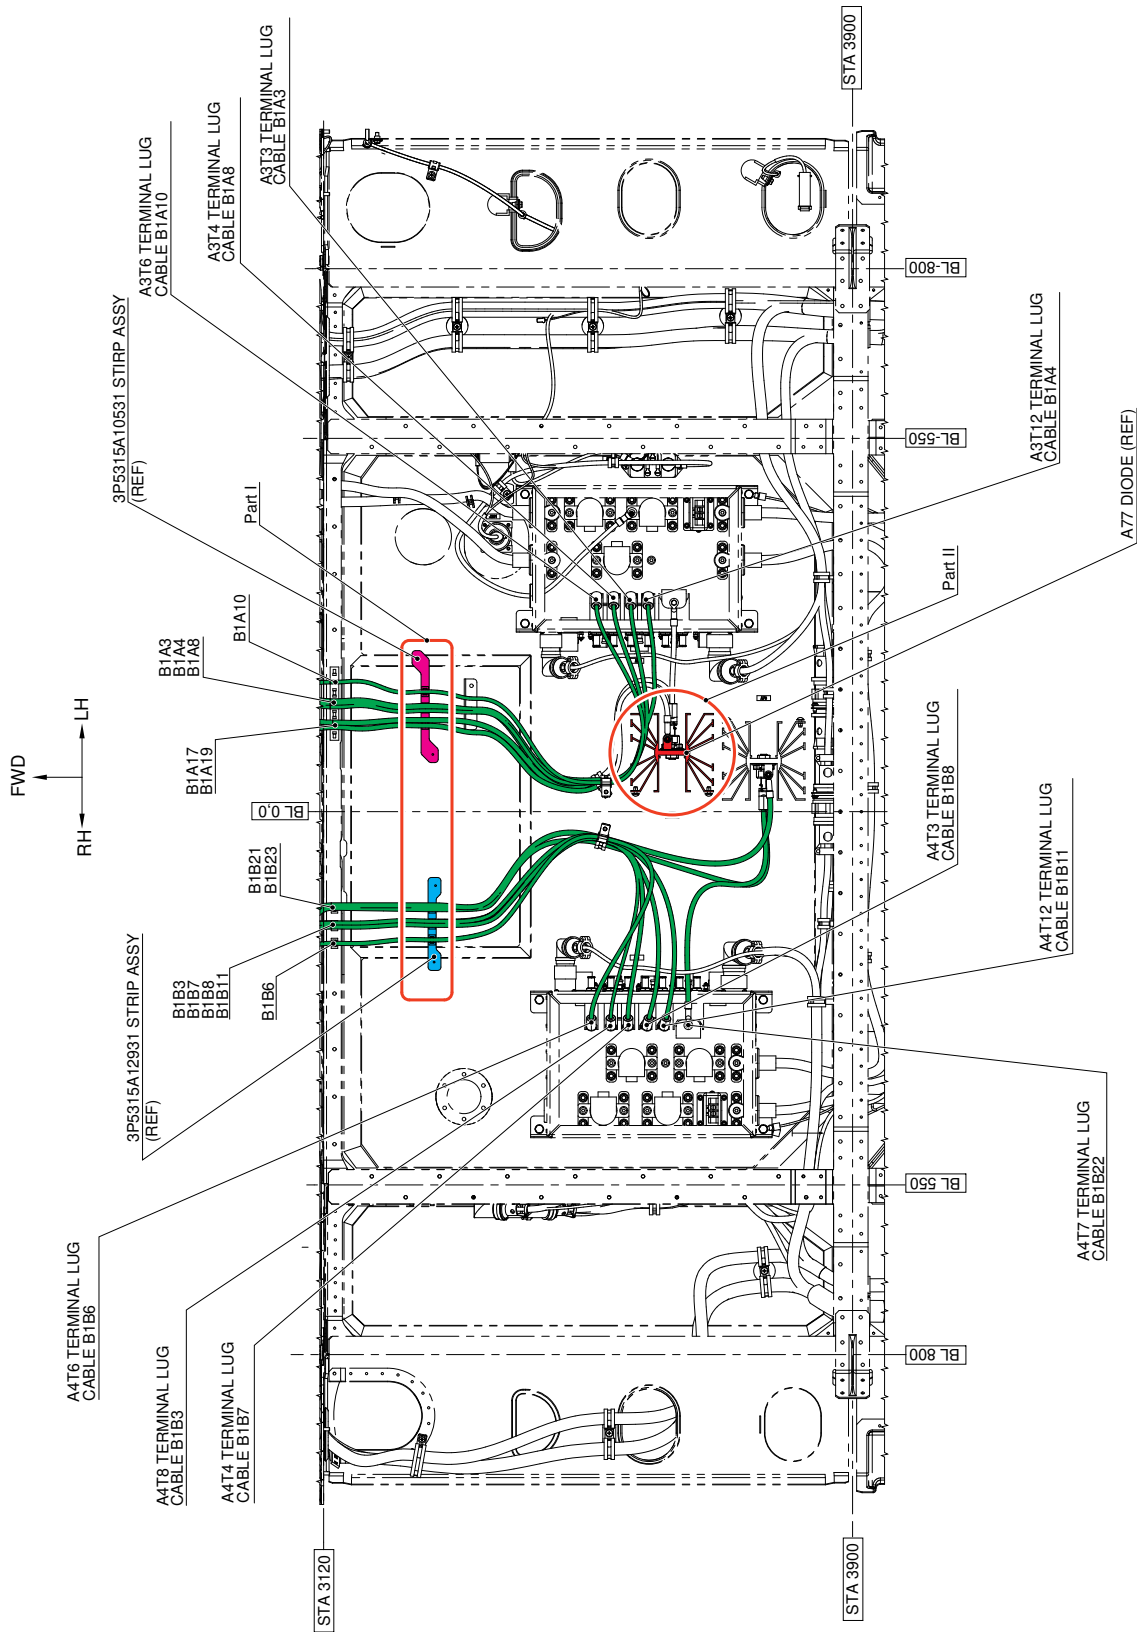
Figure 5

VIEW D
STRUCTURES AND SYSTEMS ARE PARTIALLY OMITTED FOR BETTER CLARITY PURPOSE

2. In accordance with AMP DM 39-A-06-41-00-00A-010A-A and with reference to Figure 5, Figure 10 and Figure 11, remove all external panels, internal panels and internal liners as required to gain access to the area affected by the installation and perform the diode A77 harness installation inspection in the area between STA 3400 and 3900 as described in the following procedure:

- 2.1 With reference to Figure 5, Figure 10 and Figure 11, perform a visual inspection of the C/As installation next to the Diode A77 P/N 3G2430V00352 according to the following steps:

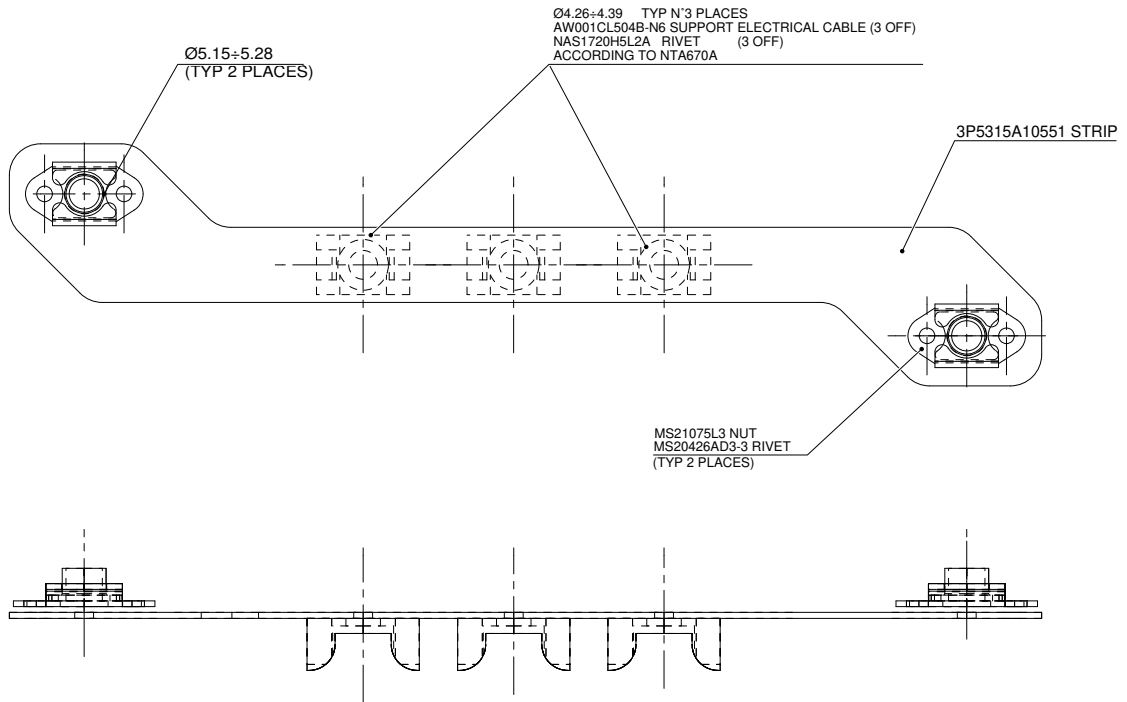
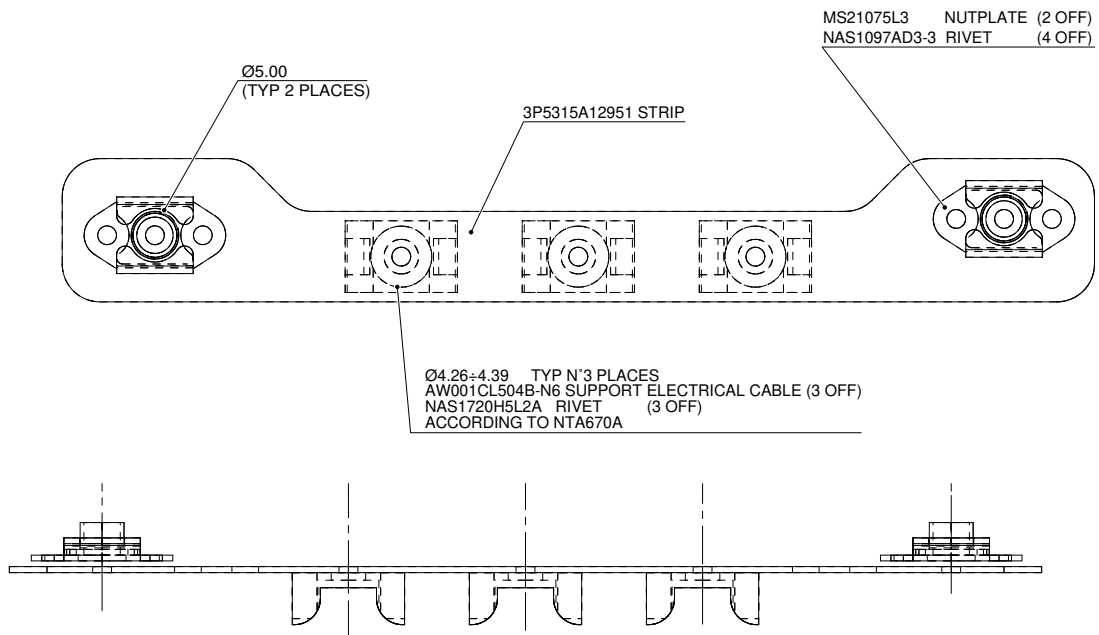
3P5315A10531 STRIP ASSY

3P5315A12931 STRIP ASSY

- 3.3.3 With reference to Figure 7, remove n° 3 supports AW001CL504B-N6 from P/N 3P5315A10531 and/or P/N 3P5315A12931.

- 3.3.4.4 With reference to Figure 7 install n°2 nut plates P/N MS21075L3N by means of n°4 rivet P/N NAS1097AD3-3 or P/N MS20426AD3-3 (as applicable) on strips P/N 3P5315A10551 and/or 3P5315A12951.

- 3.3.4.5 With Reference to Figure 7, install n° 3 new supports AW001CL504B-N6 by means of n° 3 rivets NAS1720H5L2A on strips P/N 3P5315A10551 and/or 3P5315A12951. Make sure they are oriented opposite with respect to nut plates MS21075L3N.

- 3.3.4.6 With reference to Figure 7, countermark the obtained components as P/N 3P5315A10531 and/or 3P5315A12931.

- 3.3.5 With Reference to Figure 7, install n° 3 supports P/N AW001CL504B-N6 by means of n° 3 rivets NAS1720H5L2A on bracket P/N 3P5315A10531 and/or 3P5315A12931. Make sure they are oriented opposite with respect to nut plates MS21075L3N.
- 3.3.6 With reference to Figure 9, fix C/As on strips P/N 3P5315A10531 and/or 3P5315A12931 by means of tie wraps.

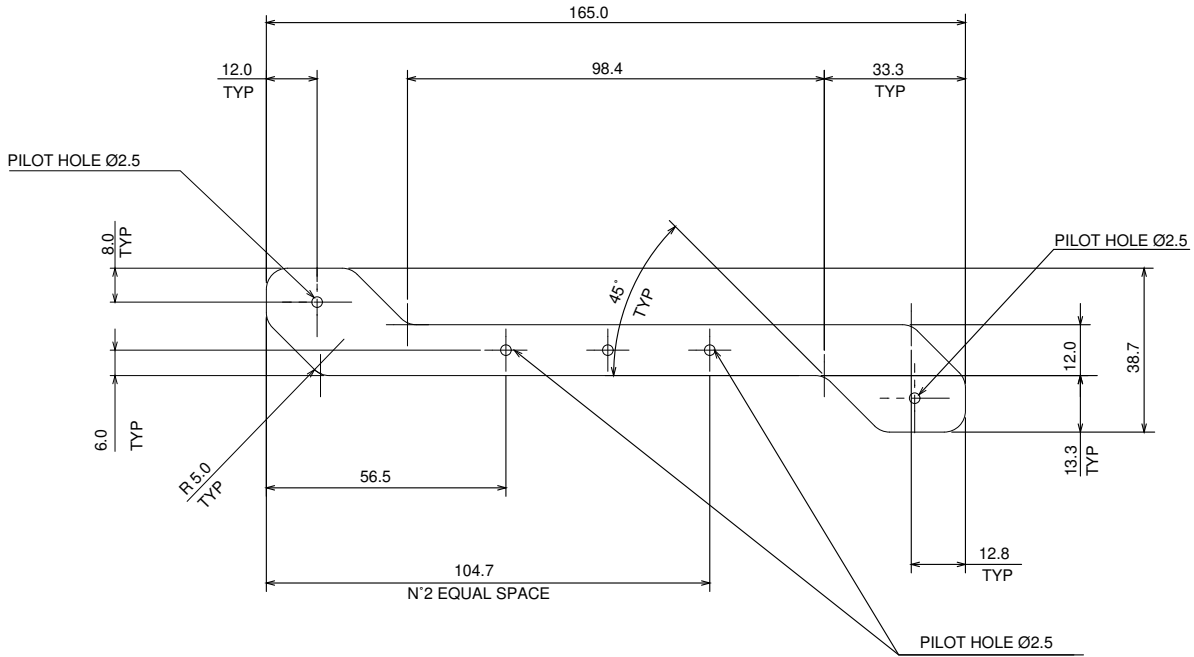
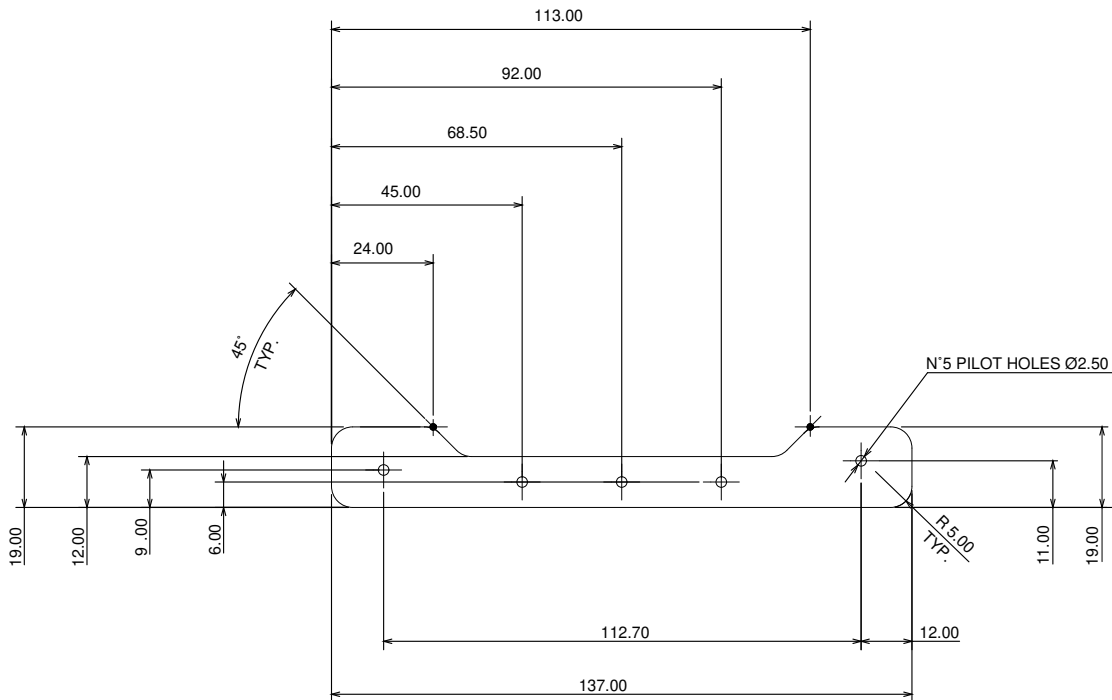
3P5315A10551 STRIP

MATERIAL AL-ALY 2024 T3
AMS-QQ-A-250/5, TH 0.81

3P5315A12951 STRIP

- 3.3.4 With reference to Figure 7, assemble strips P/N 3P5315A10531 and/or 3P5315A12931 with reference to the following procedure:
- 3.3.4.1 With reference to Figure 8, manufacture strips P/N 3P5315A10551 and/or 3P5315A12951 using Aluminium Sheet AL-ALY 2024.

- 3.3.4.2 In accordance to CSRP DM CSRP-A-51-21-06-00A-644A-D apply Chromate Conversion Treatment.
 - 3.3.4.3 With reference to Figure 8 and in accordance with CSRP DM CSRP-A-51-21-02-02A-257A-D apply a layer of primer on strips P/N 3P5315A10551 and/or 3P5315A12951.
