National Transportation Safety Board

HWY23FH005

MOTOR CARRIER GROUP

Group Chair's Factual Report

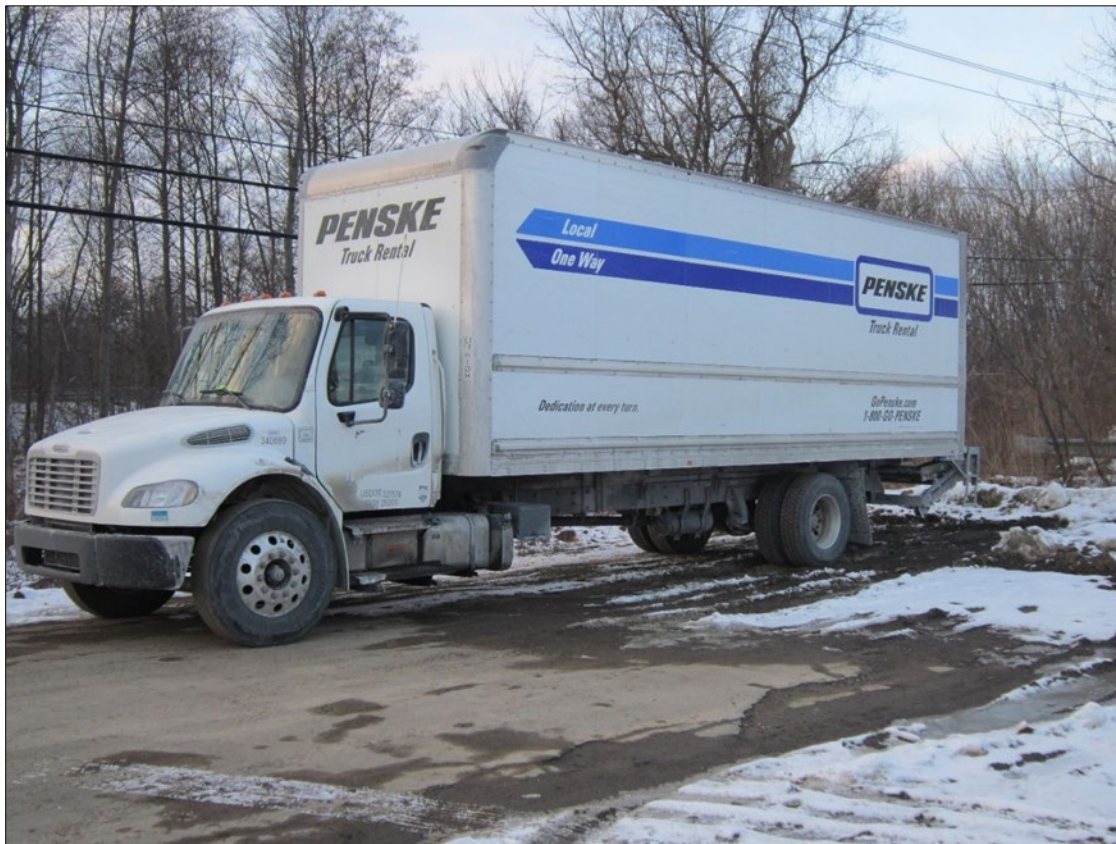
Photograph 2. Exemplar AGL straight truck at pickup location.

On February 4, 2023, NTSB investigators visited the 190 Mohawk Street location and interviewed the owner of the excavating company located at that location. The owner told the NTSB that he rented the parking spot to AGL. The owner of the excavating company stated that the AGL had been operating this slip-seat operation for quite a while and noticed that the truck did not return to the yard the day of the crash. While the NTSB investigators were conducting the site visit a substitute AGL straight truck was observed at the rented parking space. See Photograph 2 for additional details.

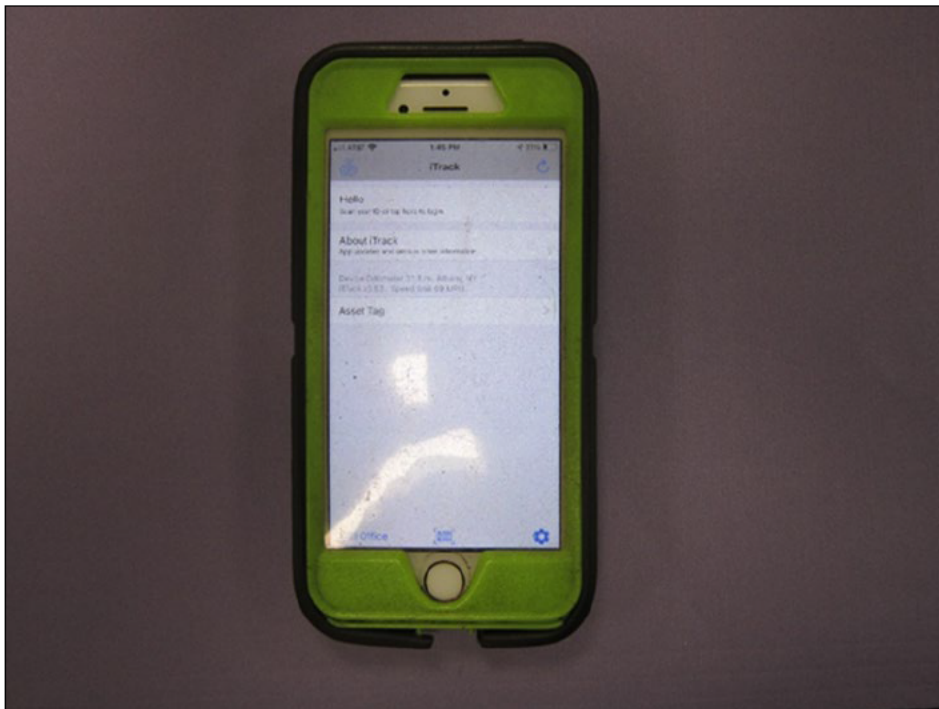
Photograph 3. Exemplar AGL company cell phone with iTracker app.

AGL provided their delivery drivers with a company cell phone. The cell phone had limited features and was restricted to outbound calls and the company applications. The cell phone contained an app called “iTracker” for drivers to record proof of their deliveries for the routes they ran. For more details see Photograph 3.

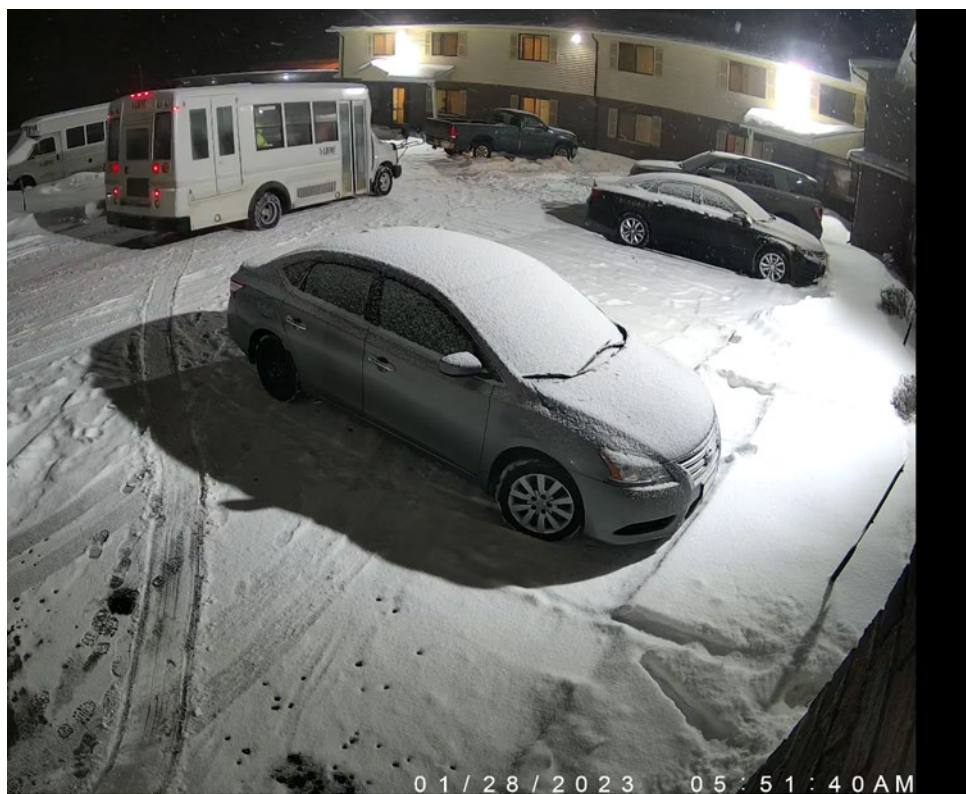
Figure 16. Security video of LBFNY bus at motel day of crash. (Source NYSP)

The driver did not maintain any timesheet, logbook, or ELD for HOS requirements. The bus driver, as well as the rest of the passengers on the bus (solar panel installers) were staying at the Econo Lodge, in Massena, New York. The NTSB obtained approximately 45 minutes of video from the security camera from the motel that documented the events before the LBFNY bus departed the motel. The video indicated that the bus driver did not perform a pre-trip inspection of the bus. The video also indicated the headlights and taillights on the bus were illuminated. The video indicates the LBFNY bus departed the motel parking lot at 05:51 hours. See Figure 16.

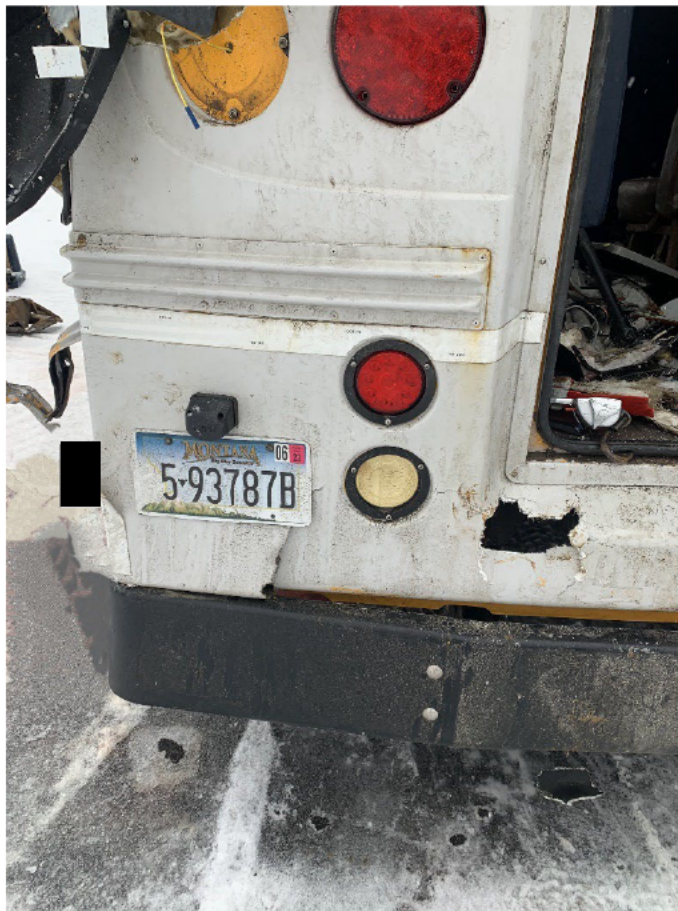
Photograph 5. LBFNY bus with Montana plate.

The crash-involved bus, as well as the rest of LBFNY's fleet, had state of Montana license plates. See Photograph 5.

The owner was questioned why their vehicles were registered in Montana and he stated that it was for tax purposes. The Montana Vehicle Registration for the crash-involved bus (Montana tag 5-93787B) showed an issue date of June 14, 2022, and an expiration date of June 14, 2023. The carrier stated that the company did not have any brick-and-mortar building or any offices or fleet in Montana and used a third-party service to become an LLC in Montana. The carrier further stated that he used a mail forwarding service to receive related company mail and correspondence from the Montana PO Box address.
