# National Transportation Safety Board

## HWY23FH013 Group Chair's Factual Report Motor Carrier Factors

Location: Millersburg, Marion County, Oregon  
Date: May 18, 2023  
Time: 2:45 P.M Pacific Daylight Time.

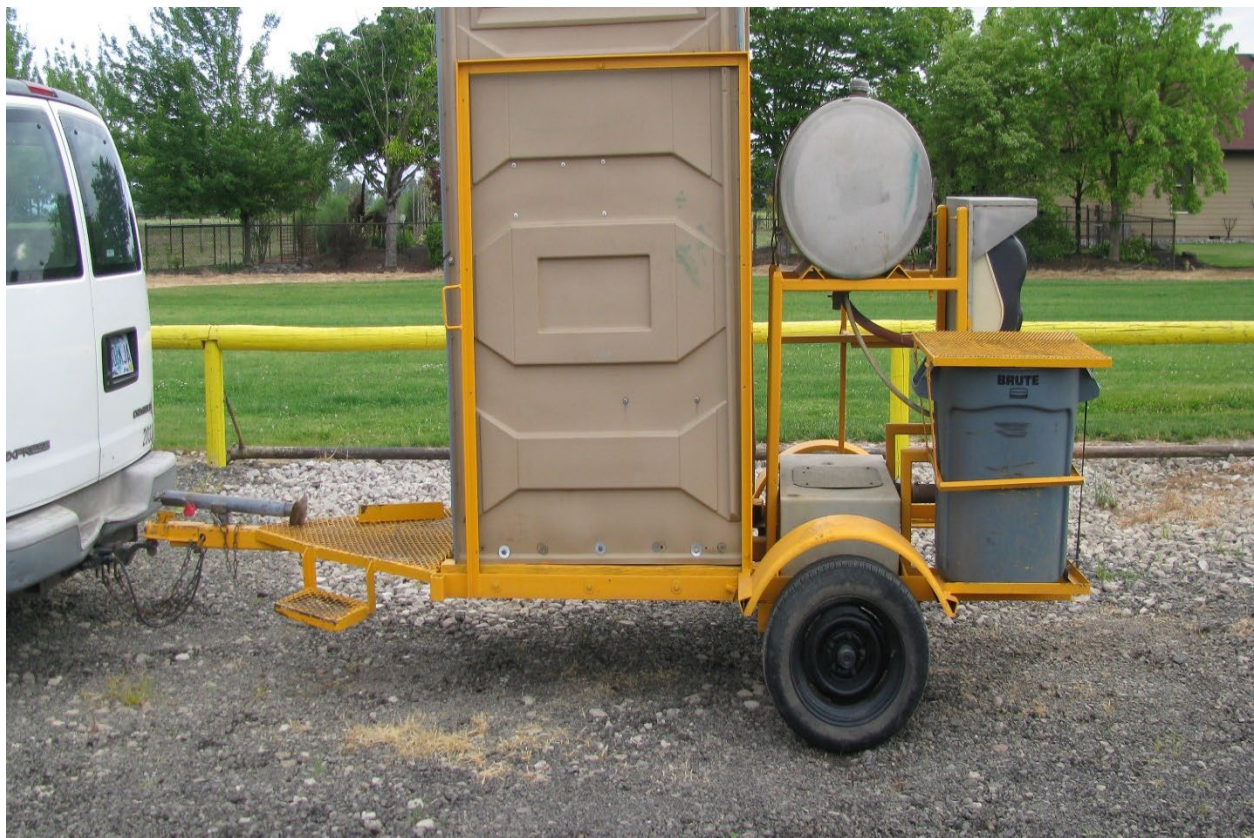
**Figure 1: Photo of exemplar porta-potty trailer used by the contractor when on a job site.**

Ruiz utilities company owned vans to transport the employees to and from the job sites. The carrier often tows a small utility trailer with a mounted Porta-Potty to the job sites if sanitation facilities are not provided by the farm owner.

The van involved in the crash was towing a similar trailer at the time of the crash.

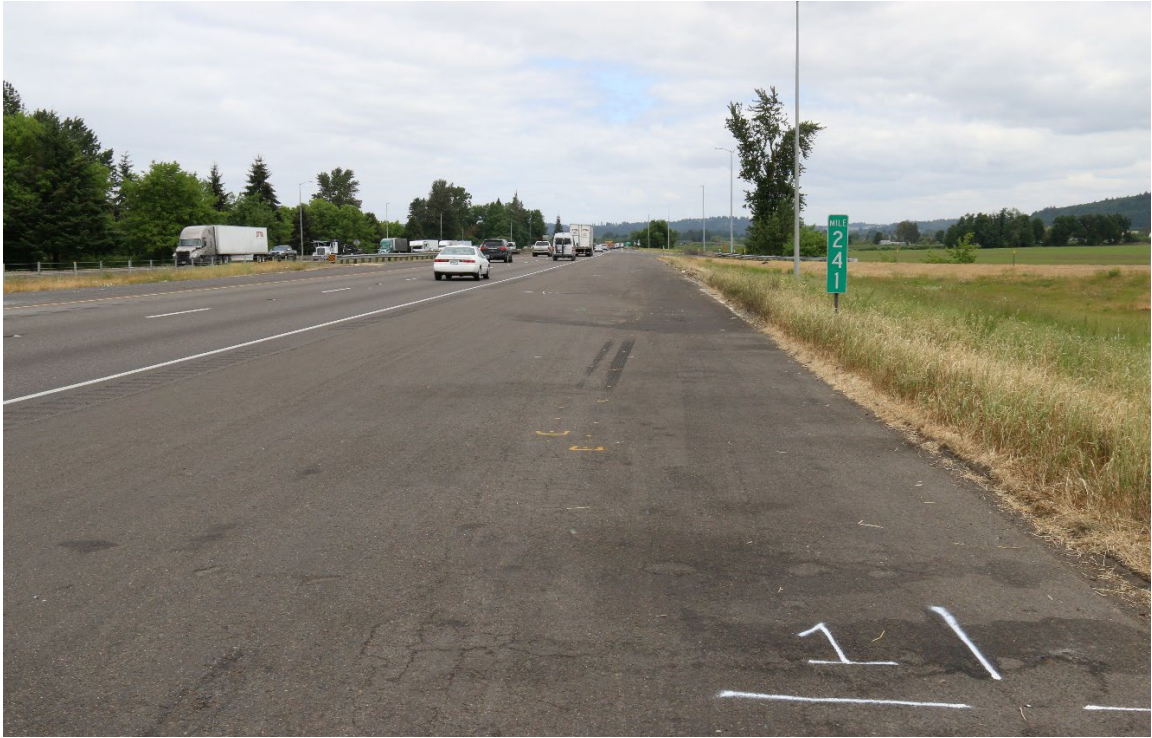
**Figure 2: Photo of the shoulder looking North at the Santiam Rest Area on I-5.**

The Ruiz vehicle had stopped to repair a mechanical issue with the porta-potty trailer and was parked next to the grass shoulder of the shoulder. The C.R. England truck was ahead of the van. The driver was taking his DOT mandated 30 minuet break.
