May 7, 2024

MIR-24-12

Contact of *Queen City* Tow with Vane Dike

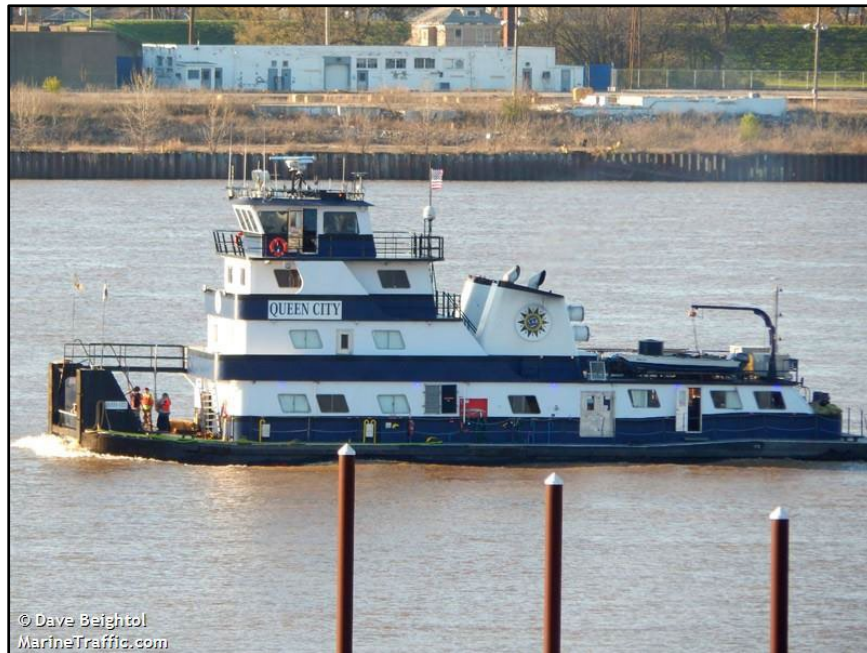
Figure 1. *Queen City* underway before the contact. (Source: Dave Beightol)

Owned and operated by C&B Marine Equipment, LLC, the *Queen City*, built in 1974, was a 103-foot-long, steel-hulled towing vessel (see figure 1). The vessel had two steering and four flanking rudders, and two 1,500-hp diesel engines each driving a propeller.

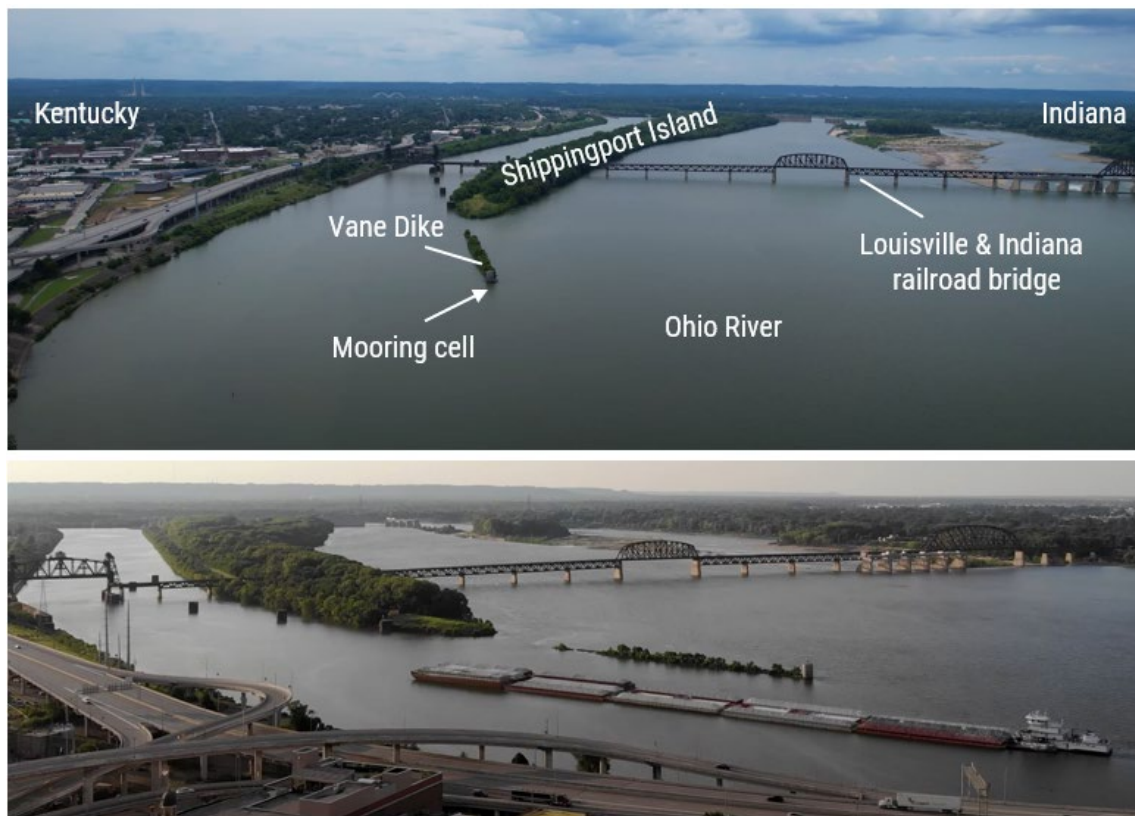
Figure 3. McAlpine Locks and Dam. Shown in the bottom image is a similar-size towing vessel and tow configuration (three across) as that of the *Queen City* at the time of the contact. (Sources: [Top] Nimbusphere, YouTube; [Bottom] TAPP Channel, YouTube)

The Vane Dike is located in a river bend just off the eastern end of the entrance to Portland Channel, which leads to the McAlpine Locks (see figures 2 and 3). The dike, measuring 200 yards by 10 yards, extends eastward from the end of Shippingport Island, the northern land boundary of the Portland Channel. A mooring cell is at the end of the dike. The US Coast Guard Lifesaver Memorial Light sits on top of the cell.

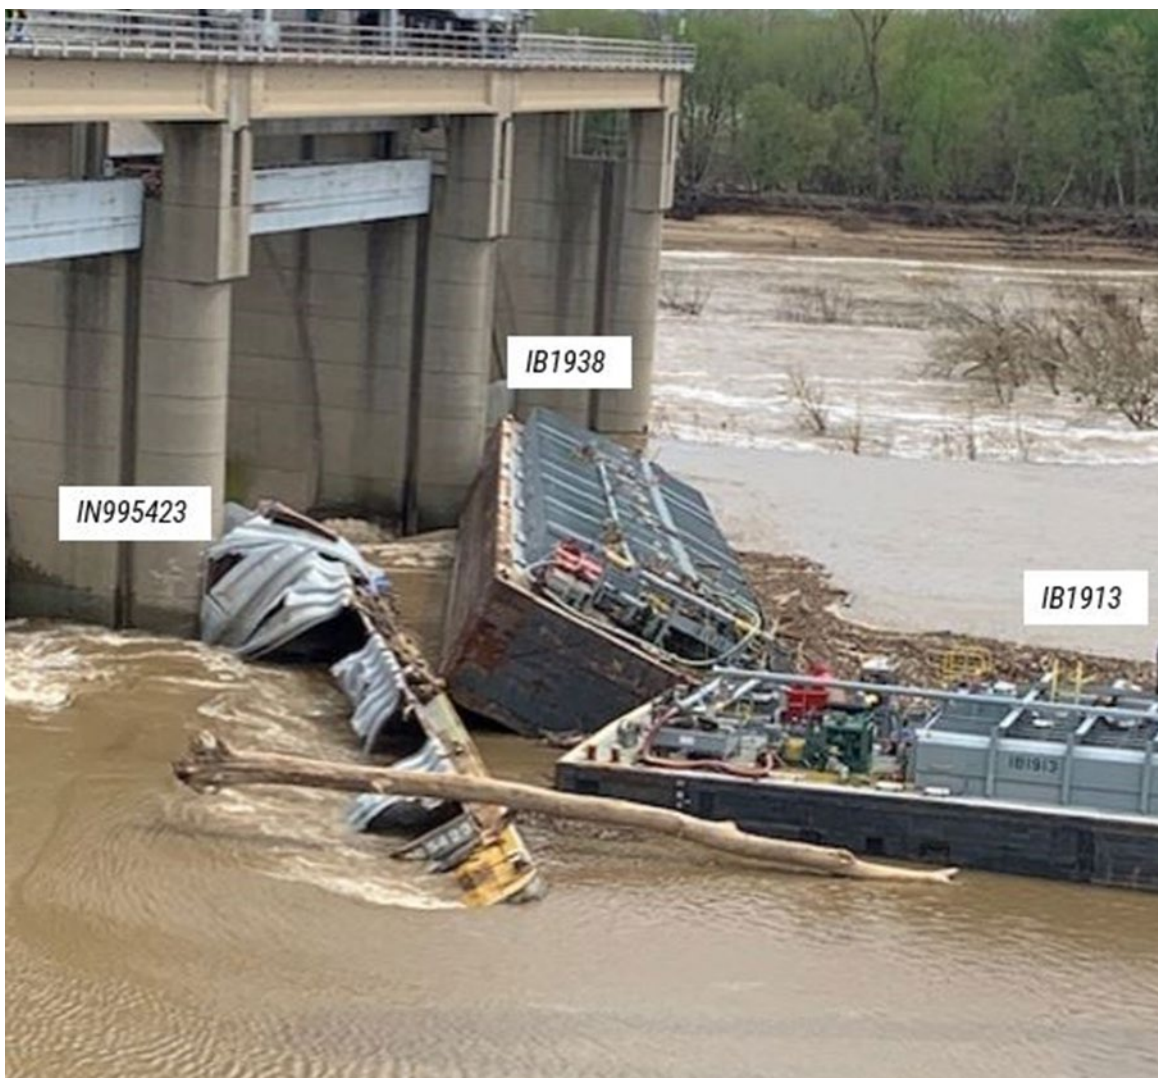
The tow broke apart after striking the Vane Dike mooring cell. The *Queen City* crew retrieved one barge, the *IB1961*, and tied it off in a nearby fleeting area. Another towing vessel crew retrieved the *IN085041* and tied it off to the same fleeting area. Six barges went through the lower dam gates; three were pinned against the lower dam gates: *IN995423*, *T13925*, and the only barge loaded with hazardous material (methanol), *IB1938*.

Figure 6. Barges *IN995423* and *IB1938* against the lower dam gates. *IB1913* is receiving methanol from *IB1938* through a cargo transfer hose. (Background source: Coast Guard)

Due to the immediate threat to public safety associated with the flammability of methanol, air and water monitoring began, and the river was closed. A unified command was established that included local, state, and federal agencies, as well as representatives of the vessel owner/operator. The vessel’s owner/operator activated the vessel response plan. The designated salvor responded on scene, completed water and air monitoring, conducted vessel surveys, developed lightering and salvage plans, lightered the methanol barge while it was pinned against the dam, and salvaged all damaged barges from the waterway (see figure 6).

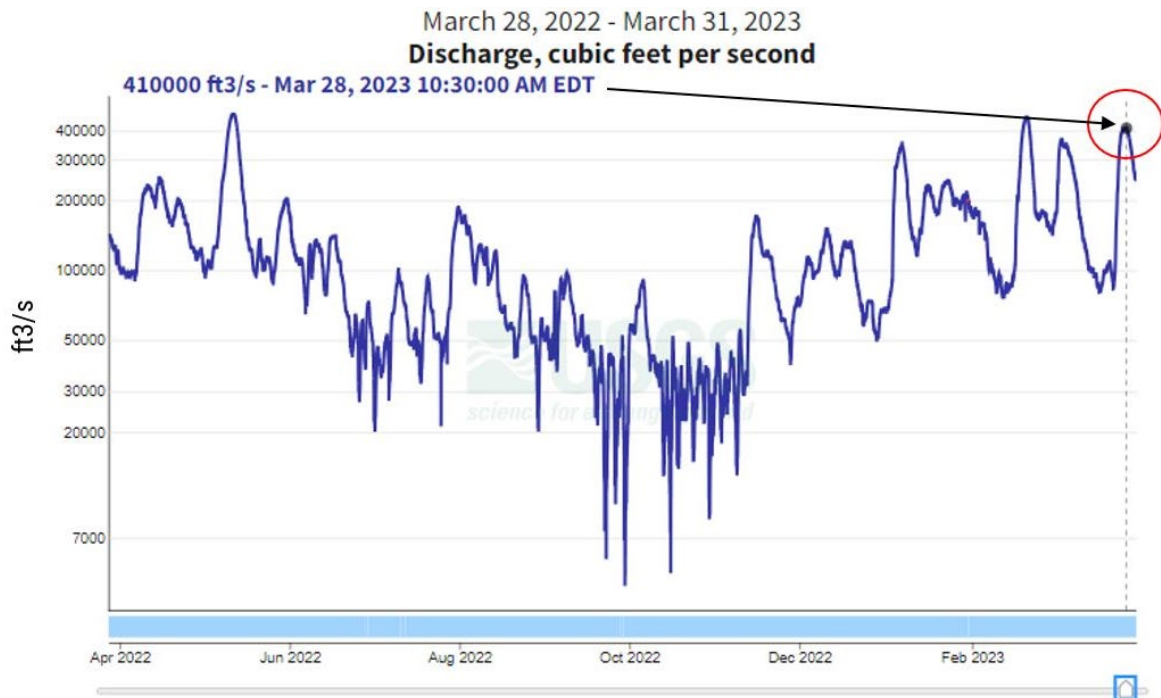
At the time of the casualty, the upper gage at the McAlpine Locks measured river height at 17.5 feet, and the lower streamgage measured water flow at over 400,000 cubic feet per second. These measurements were nearly the highest compared to readings during the previous 12 months (see figures 7 and 8).

Figure 7. Discharge of water on the Ohio River (lower streamgage) at Louisville, Kentucky, from March 28, 2022, to March 31, 2023. (Background source: US Geological Survey)

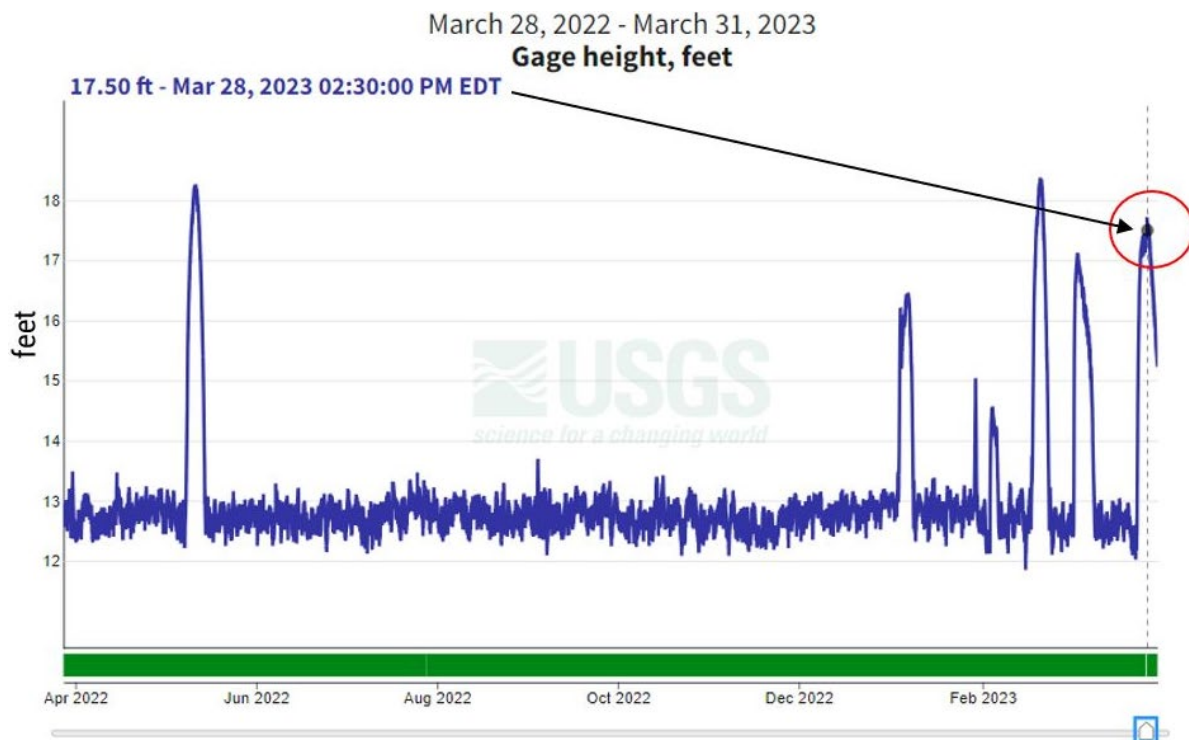
Figure 8. Gage height (upper gage) of the Ohio River at the McAlpine Dam from March 28, 2022, to March 31, 2023. (Background source: US Geological Survey)
