National Transportation Safety Board
Office of Railroad, Pipeline and Hazardous Materials Investigations
Washington, D.C., 20594

Derailment of X41518
CSX Transportation Key Train with Commodities

Alexandria, VA

Mechanical Group Factual

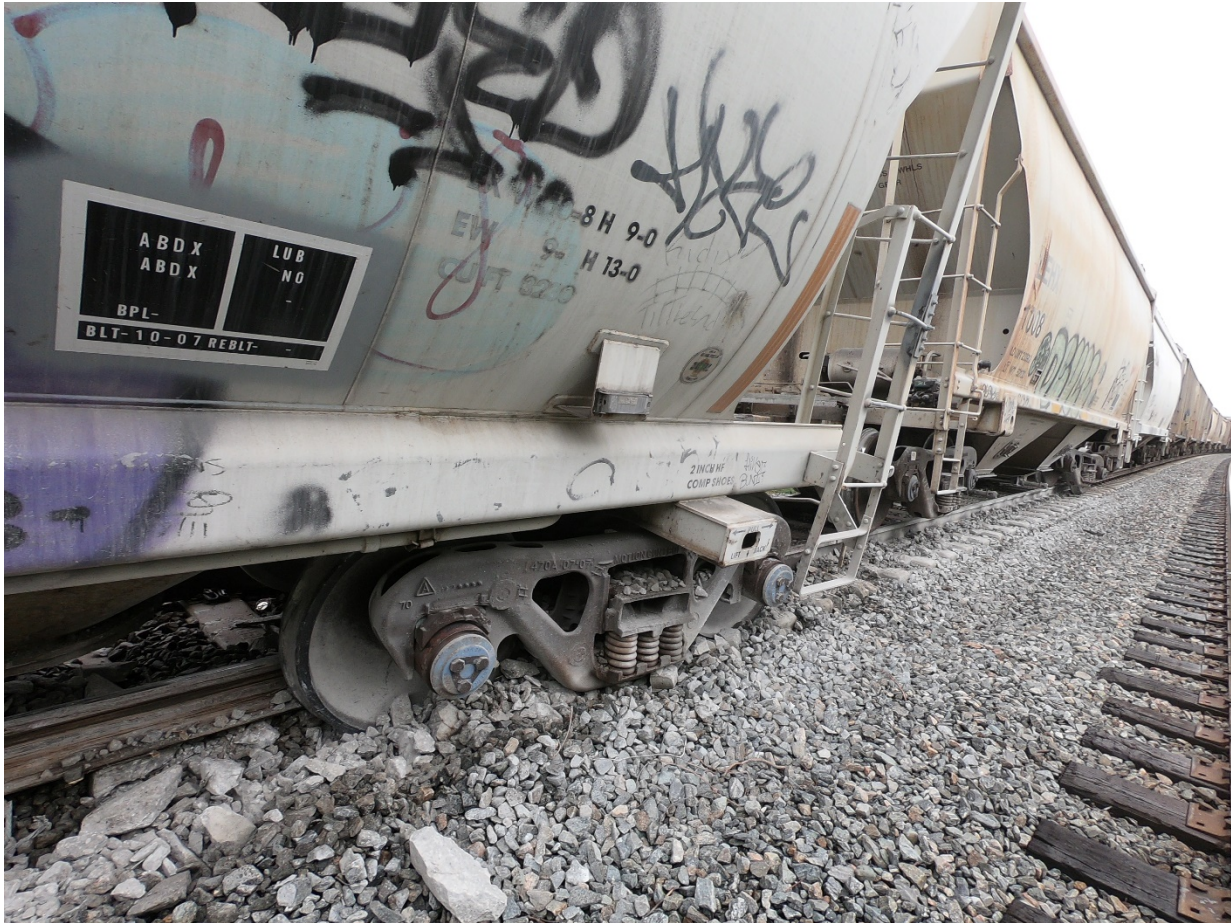
A review of the leading locomotive's event recorder showed the train was traveling at about 31 MPH and throttle in position 8 immediately before the derailment. At about 7:02 a.m., an un-commanded emergency brake was initiated. Investigators determined that the first car to derail in the consist was LEHX 1008, a covered hopper hauling concrete. It was the 42nd car in the consist.

Figure 1. LEHX 1008-first car to derail.

Investigators examined the three cars involved in this derailment that came to rest upright and to the south of the derailment after they were re-railed (LEHX 1000, PRMX 20035 and LEHX 1008). All wheels were observed to have full flanges and normal wheel tread wear with no apparent indication of a wheel break. All brake rigging appeared intact and tread brake pads were within tolerances.

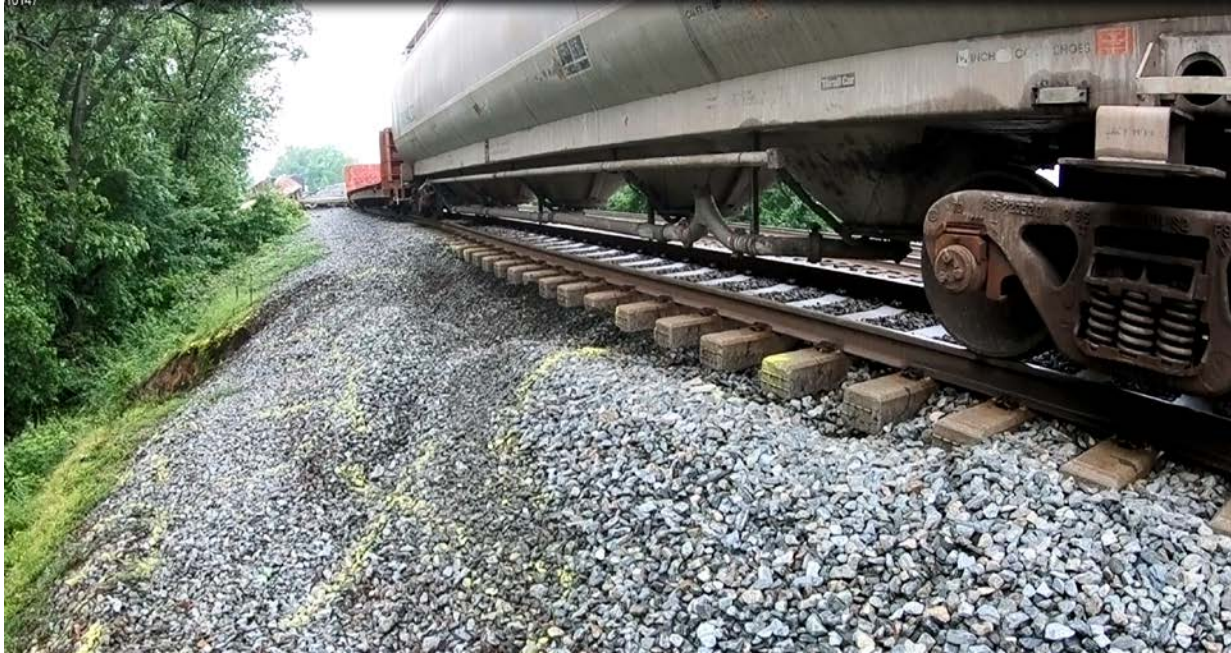
The train derailed at a failed roadbed on main track number 1 at mile post 102.85. As the train continued to pull south, derailed cars were damaging the concrete ties on the eastern or field side of the track.

Figure 2. Failed roadbed at MP 102.85

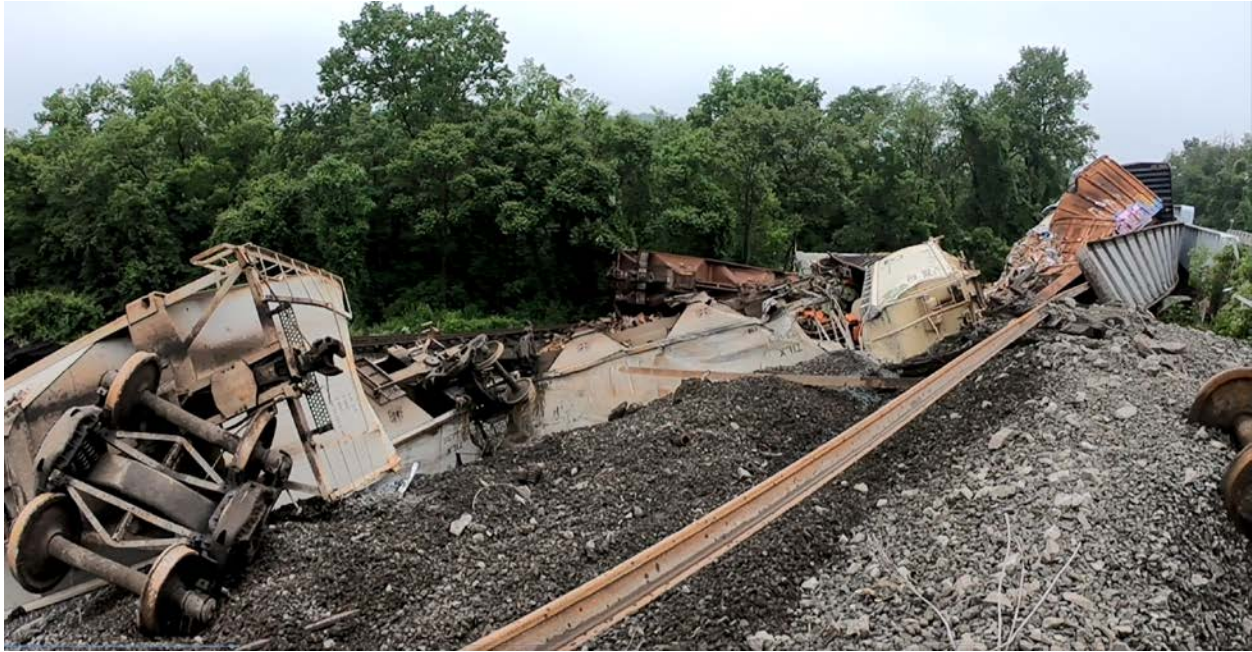
Run in forces caused at least one car to derail to the west of the track and as a result, MWCX 463382-the 56th car, wherein it collided with a bridge abutment north of one span of a two-span open deck through plate girder bridge causing it to collapse onto Norfolk Southern tracks running below.

Figure 3. Derailed cars on the north side of the destroyed bridge.

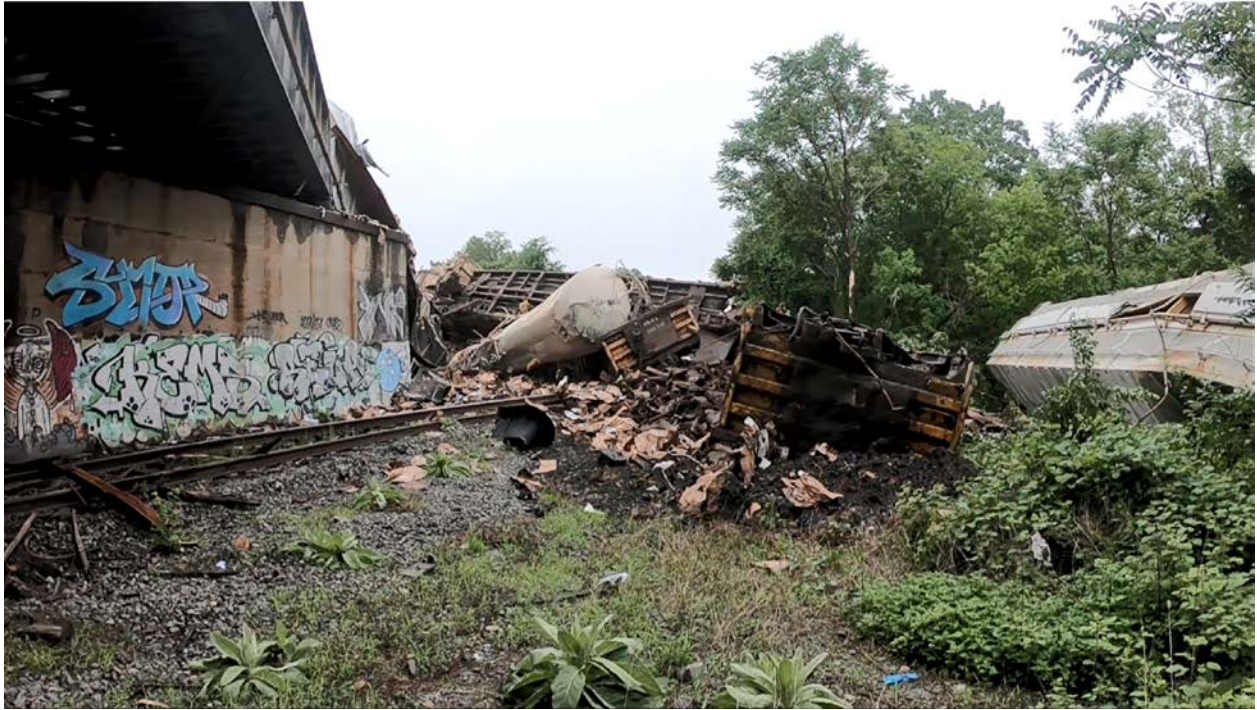
Figure 4. Derailed cars on the Norfolk Southern tracks.

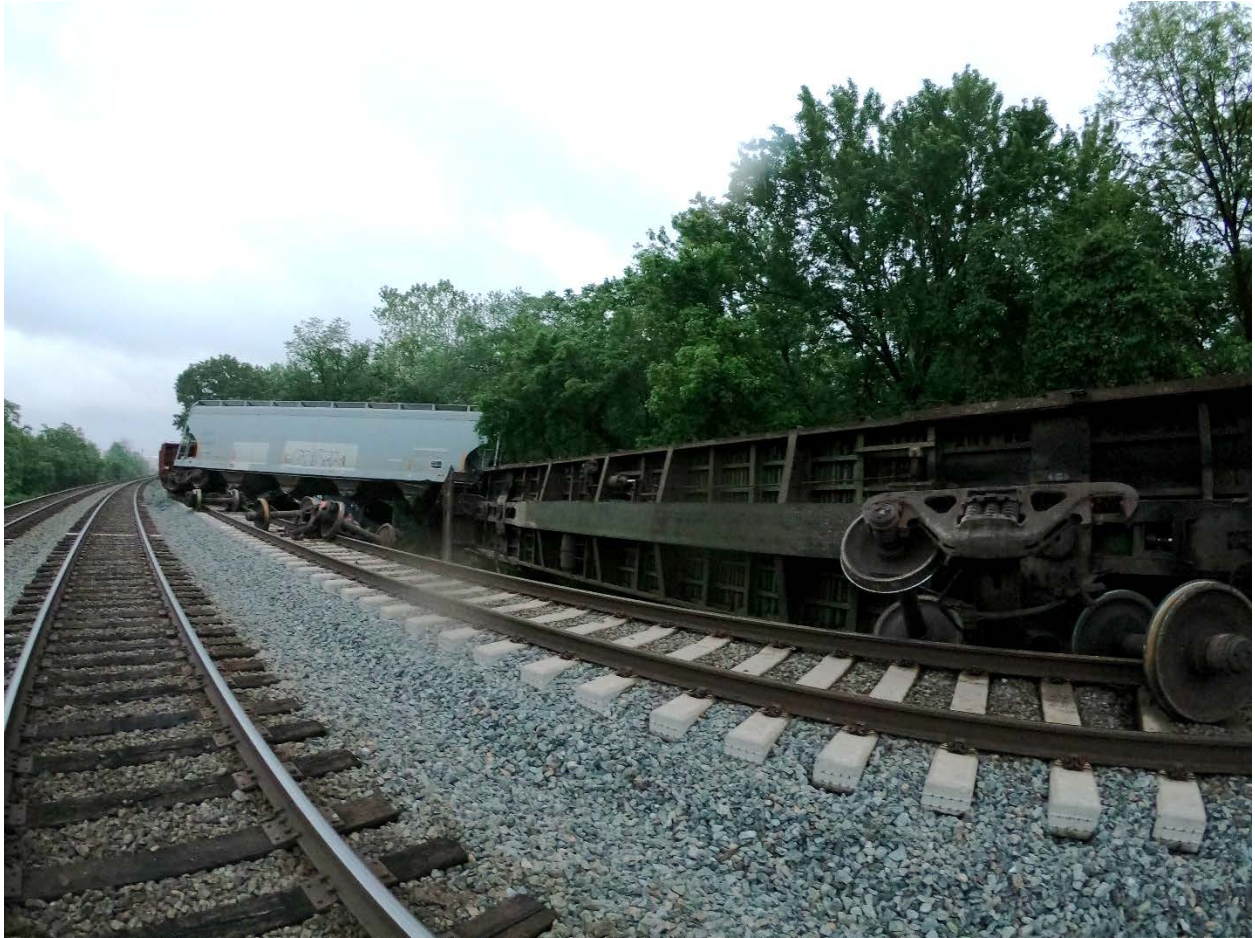
A total of 31 cars derailed, the 42nd through the 66th (25 cars) and an additional 6-cars in positions 89 through 94 also derailed. The later derailment was a result of run in forces associated with the deceleration of the train and the fact that these cars were unloaded.

Figure 5. Photograph of secondary derailment.

On May 20, 2018, investigators coordinated with CSX to re-rail two of the six cars involved in the secondary derailment. Once completed, a consist of 91-cars was assembled so investigators could complete an FRA Class I brake test. Brakes did not function as designed on two of the 91-cars. CSX was notified of the condition.

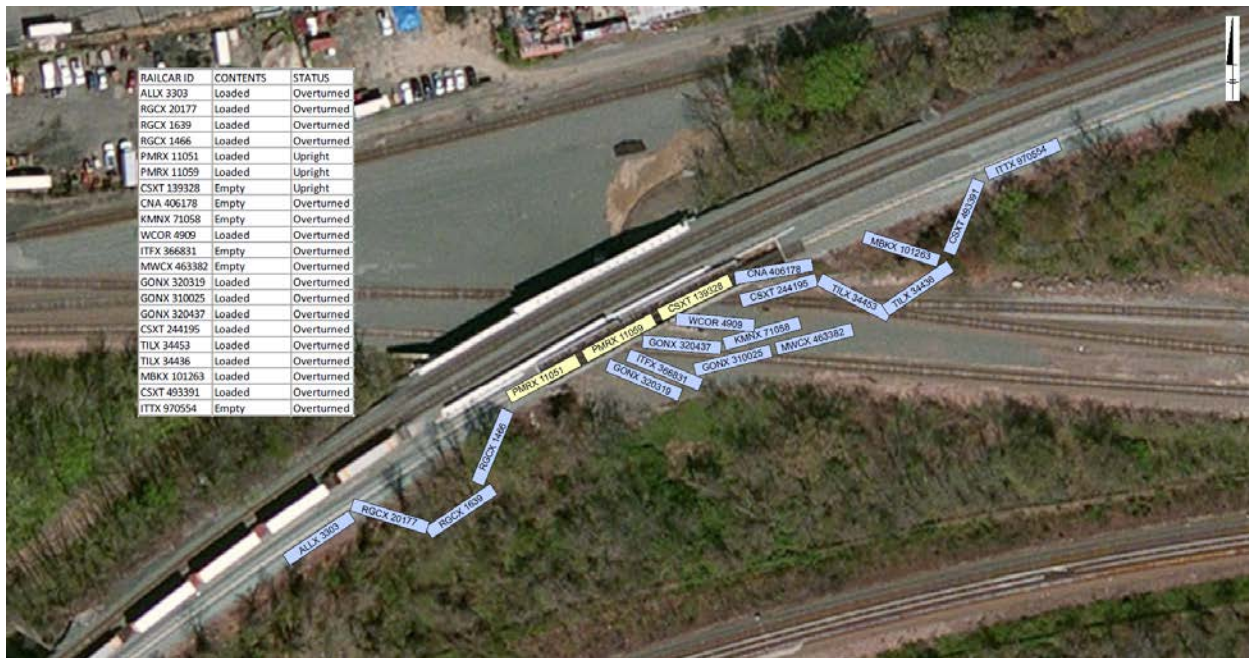
Figure 7. Derailment diagram - central area.
