National Transportation Safety Board

RRD24FR009

MECHANICAL

Group Chair's Factual Report

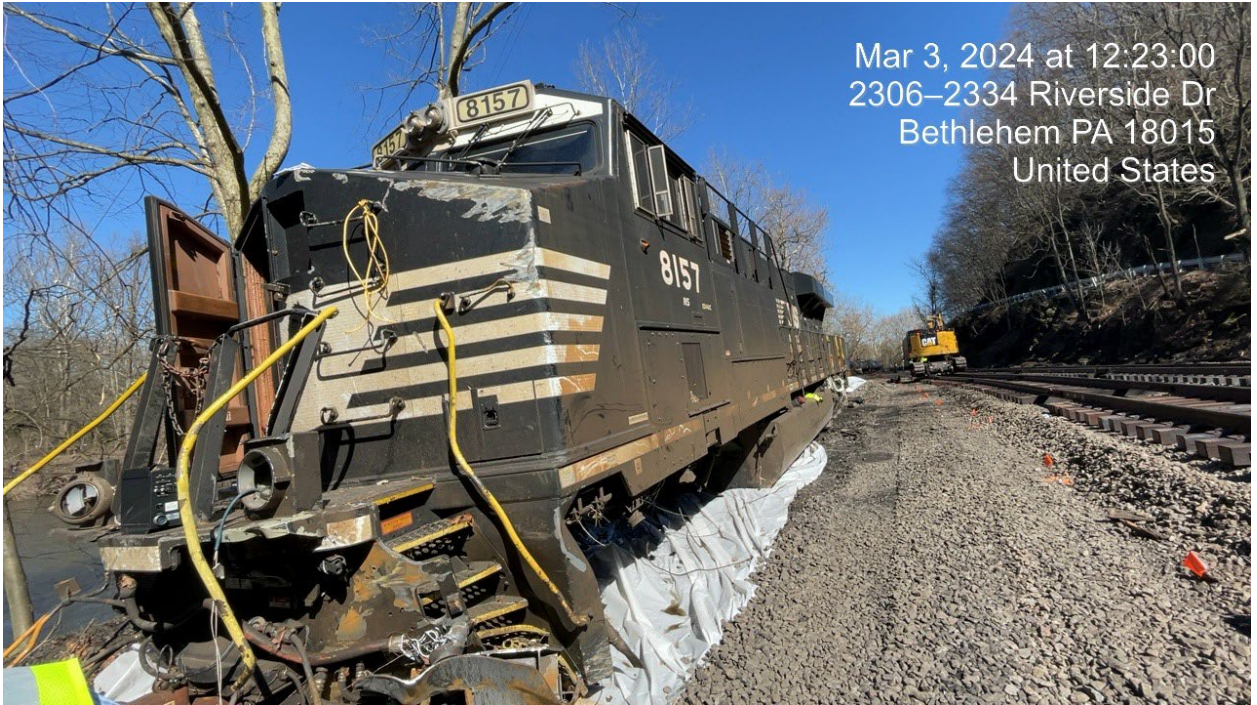
Figure 1 - Lead locomotive NS 8157 from NS Train 19GH501.

The lead locomotive NS 8157 was built in 2013, is 73'2" feet in length, 15'11" tall, weighing 432,000 pounds with a GE Evolution 4400 horsepower engine. The trailing locomotive NS 9891 was built in 2004, is 73'2" feet in length, 15'11" tall, weighing 410,000 pounds with a 7FDL 4400 horsepower engine. The mid train DPU NS 4467 was remanufactured in 2021, is 73'2" feet in length, 16'1" tall, weighing 432,000 pounds with a GE 7FDL 4400 horsepower engine.

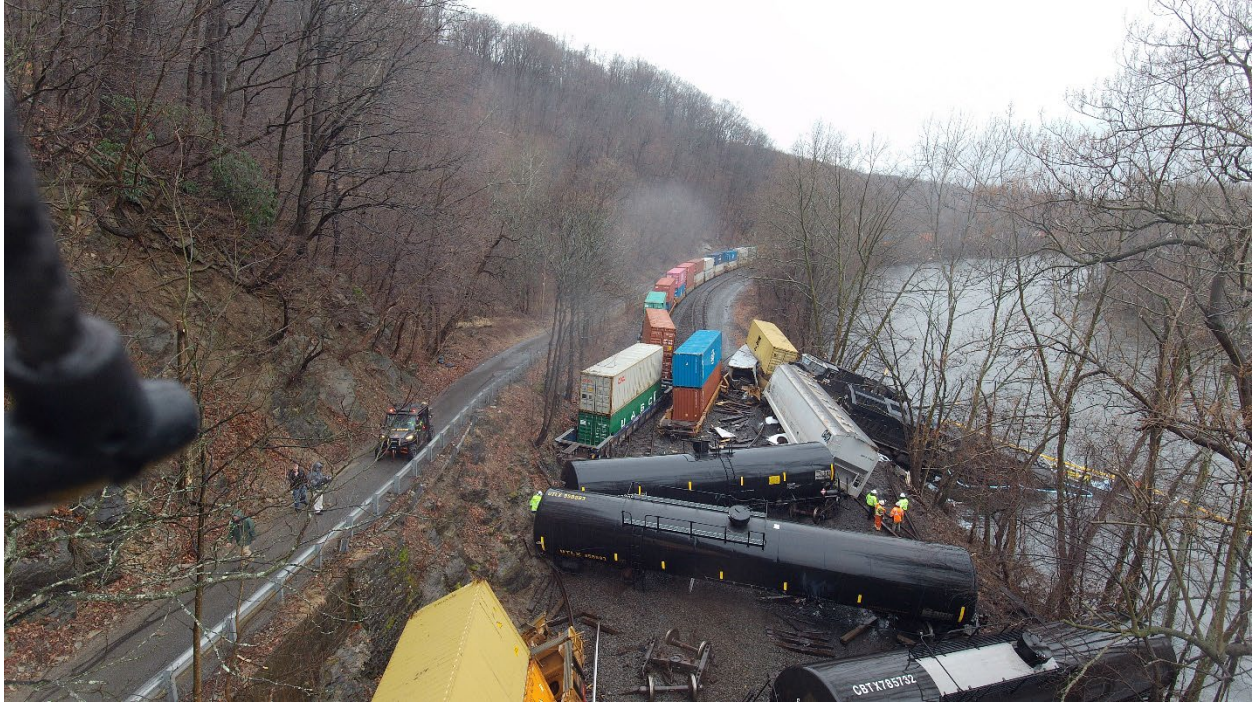
Figure 2 - Drone image of derailment site (provided by NS).
