Amtrak Train 501(18) Derailment

Dupont, WA

Mechanical Factual Report

Accident #: RRD18MR001 **Accident Type:** Derailment with Fatalities and Injuries **Location:** Dupont, WA December 18, 2017 **Date of Accident: Train Operator:** Amtrak **Fatalities:** 3 Total preliminary estimated mechanical damages are \$40 million **Damages: Mechanical Group Members** National Transportation Safety Board-Group Chairman Joey Rhine 490 L'Enfant Plaza East, SW Washington, D.C. 20594 Cell: Email: **FRA** Matt Thompson Cell: E-Mail: **FRA** Chris Lewis Cell: E-Mail: Washington UTC Matt Arnold Cell: E-Mail:

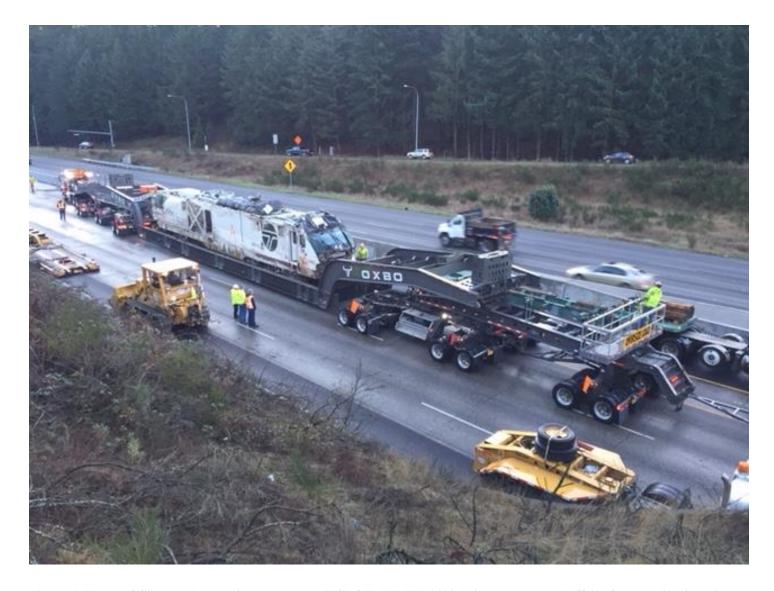
Figure 1 Photo of Siemens locomotive, owned by WSDOT, WDTX 1402 being transported offsite for examination. (Photo provided by Paul Aichholzer, Siemens)

On February 23-24, 2018 the FRA, Siemens, and Amtrak representatives met at the Joint Base Lewis-McChord military base to examine the air brake systems of the WDTX 1402. Upon examination it was noted that most of the trainline pneumatic connections on the front and rear were bent, partially damaged or torn off. Some of them upstream of their exterior cut-out valves. Those connections, specifically the brake pipe, could not be easily closed and used for testing via the exterior glad-hand connections. The locomotive central computer unit (CCU), traction control unit (TCU) and operator displays were removed, and the locomotive right-side battery box was missing. An external air compressor was connected to feed the main reservoir and supply regulated pressure through a split feed into the brake rack at 110 psi. A single car test device was connected to imitate the locomotive brake handle. Due to the system being unpowered and the CCU and TCU being removed, only the brake cylinder (BC) pressure and the emergency bypass function in the computer-controlled brake (CCB2) were tested. An emergency brake application was initiated, and a gradual automatic brake application and release were conducted. All the locomotive disk brake units applied and released as designed.
