National Transportation Safety Board

New York City Transit – Worker Fatality
Manhattan, New York
34th Street
November 29, 2023

NTSB Accident Number RRD24FR003

Mechanical Group Factual Report
Joey Rhine, Mechanical Group Chairman

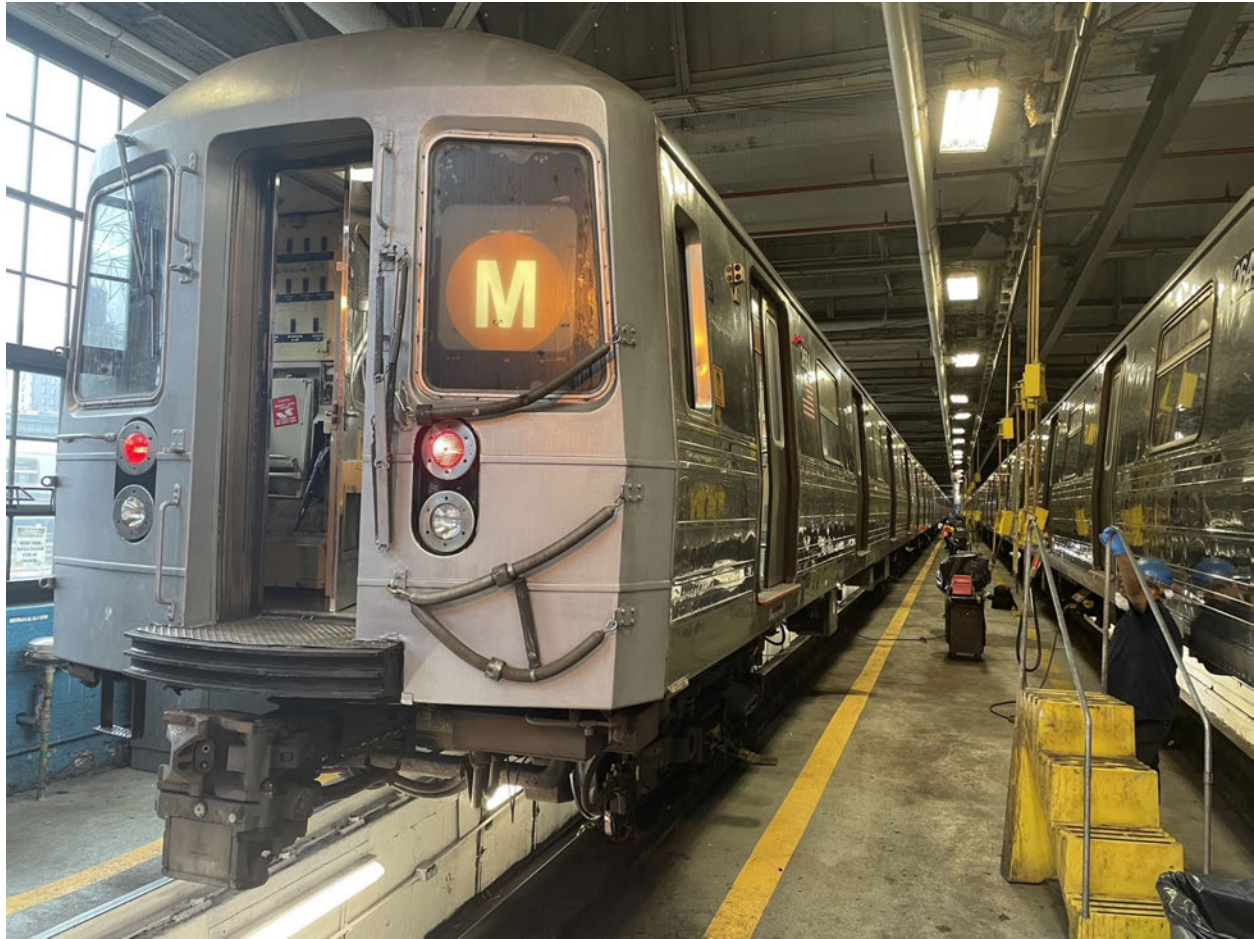
Figure 1. *2317-D at Concourse Yard for Inspection.*

On December 2, 2023, investigators met with NYCT personnel at Concourse Yard for an examination of the equipment involved. An overall review of the equipment did not reveal any conditions that may have attributed to the incident. Brakes, lighting, and controls operated as intended. Trip cocks are used in conjunction with the signal system to assist in train movements. Each R68 car is equipped with 2 trip cocks under the car (one on each end) and are designed to apply a brake application to stop the train if designed limits are exceeded. The trip cocks functioned as intended when tested.
