National Transportation Safety Board  
Office of Railroad, Pipeline and Hazardous Materials Investigations  
Washington, D.C. 20594

CP collision with UP and BNSF

St. Paul, MN

Mechanical Group Factual Report

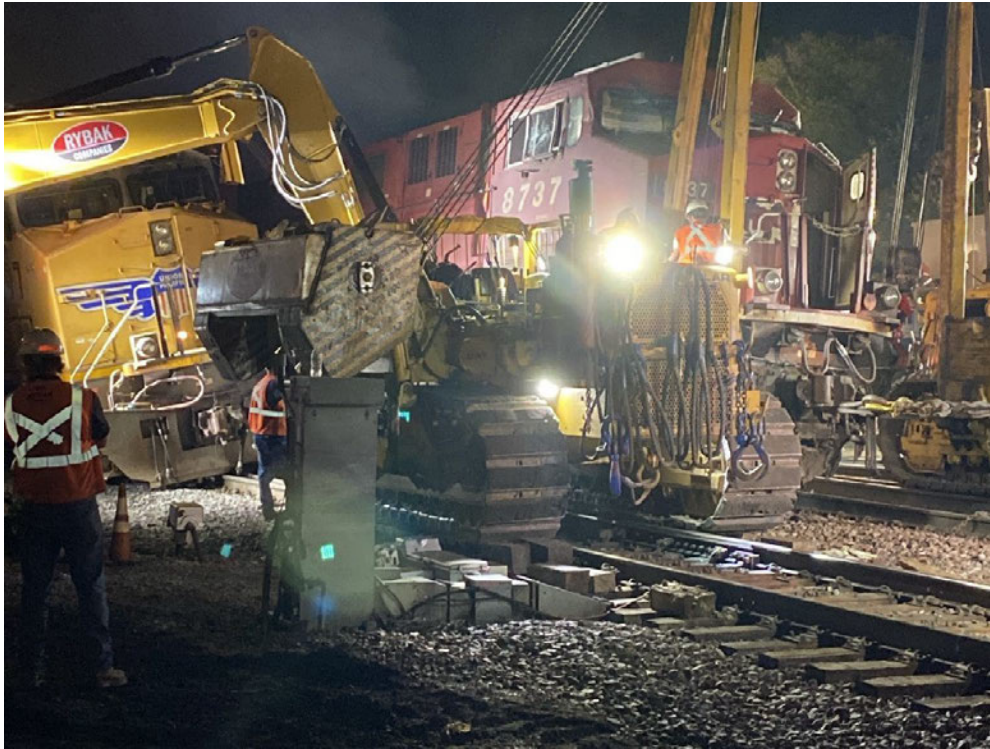
Figure 1 Photograph of the Union Pacific train (left) and the Canadian Pacific train (right) during rerailling operations. (Courtesy of FRA)

The CP striking train damage consisted of the head locomotive CP 8737 with the conductor side front handrailing and steps broken/bent, brake rigging disconnected, all brake cylinders broken/missing, rear handrailing and steps broken/missing, engineer front handrailing and steps broken, rear handrailing and steps broken. Side handrails on engineer side collapsed over/broken. The second unit in the CP consist, UP 5525, had damage at the engineer side rear handrailing and steps. CP mechanical damage was approximately \$289,302.

The Stationary Union Pacific locomotives UP 8264, UP 5497, and UP 793 sustained similar damage to handrails, brake equipment, and running gear. Union Pacific mechanical damage was approximately \$300,000.

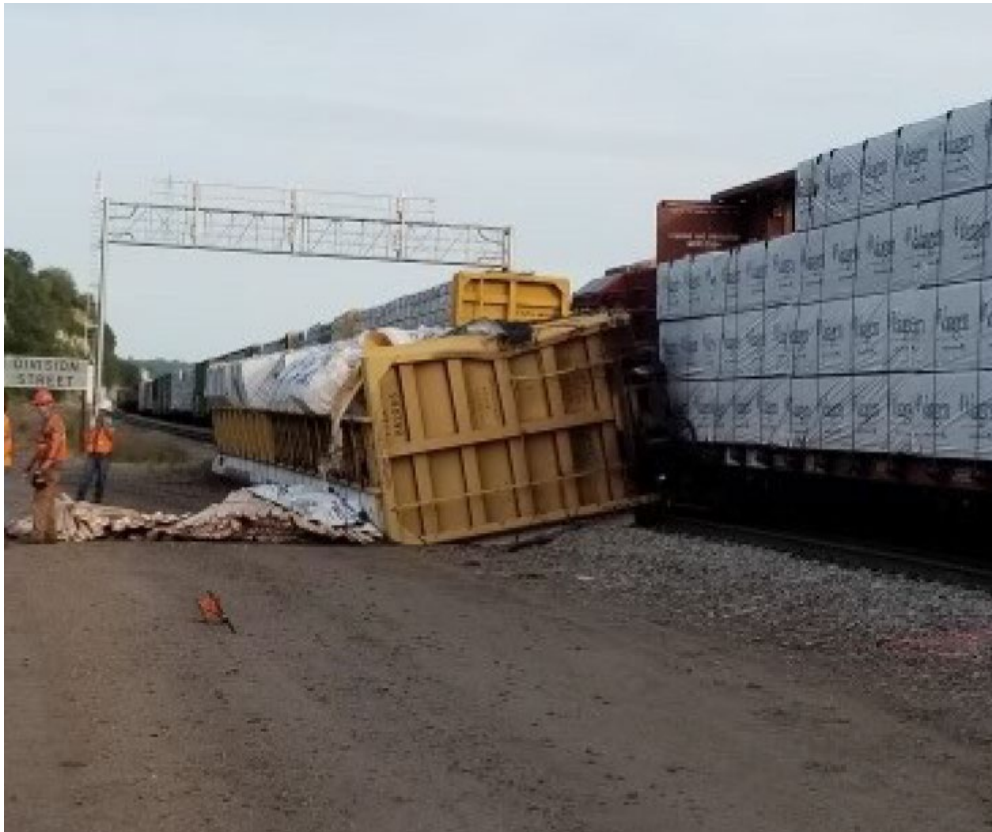
Figure 2 Photograph of the BNSF lumber car on its side after being struck and derailed. (Courtesy of FRA)

During the derailment, the CP head locomotive also side swiped a stationary BNSF lumber car TTZX 862066 on an adjacent track derailing it and knocking it on its side. BNSF damage was approximately \$85,000.
