What follows is an explanation of how investigators at Beech Grove on May 11, 2022 determined the orientation of wheels from Wheelset Nos. 1 and 2 on car AMT 32050.

## ATK 32050

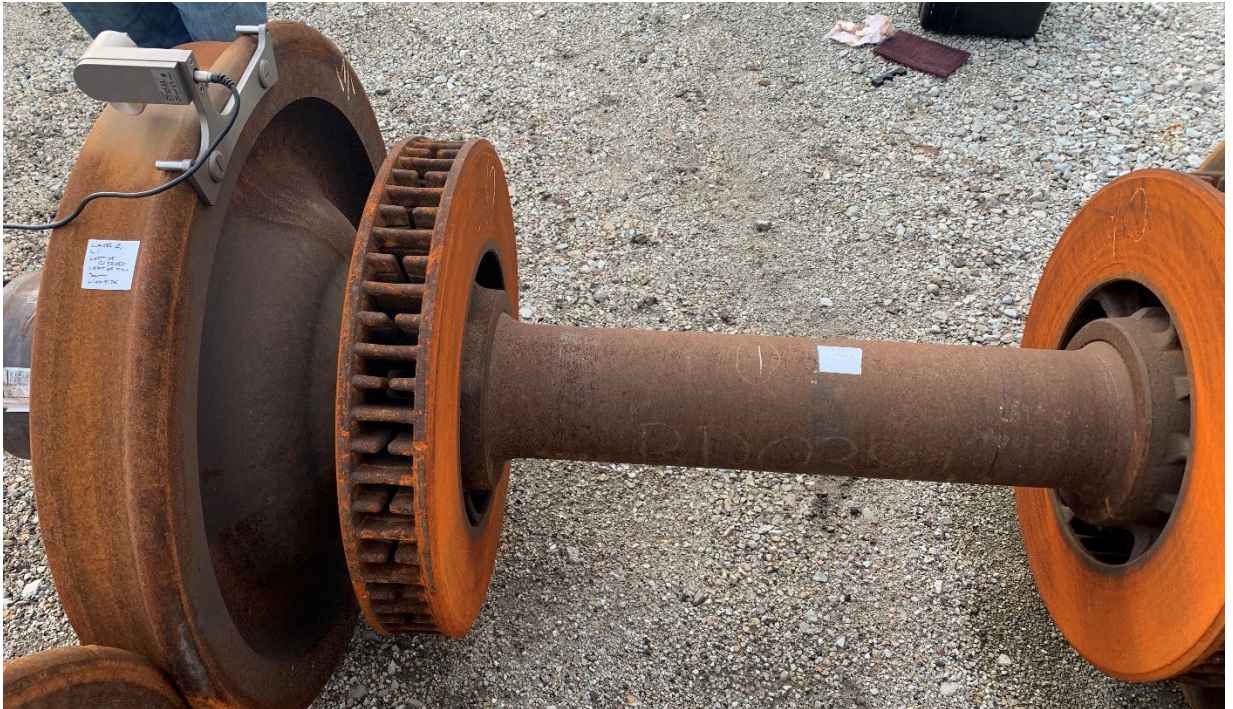
2. Wheelset No. 1 was identified as having serial number BDO3821 using Amtrak records.

Figure 1. Car 32050 Wheelset No. 1 showing ID No. BDO 3821 and tags placed by investigators at Beech Grove on May 11, 2022

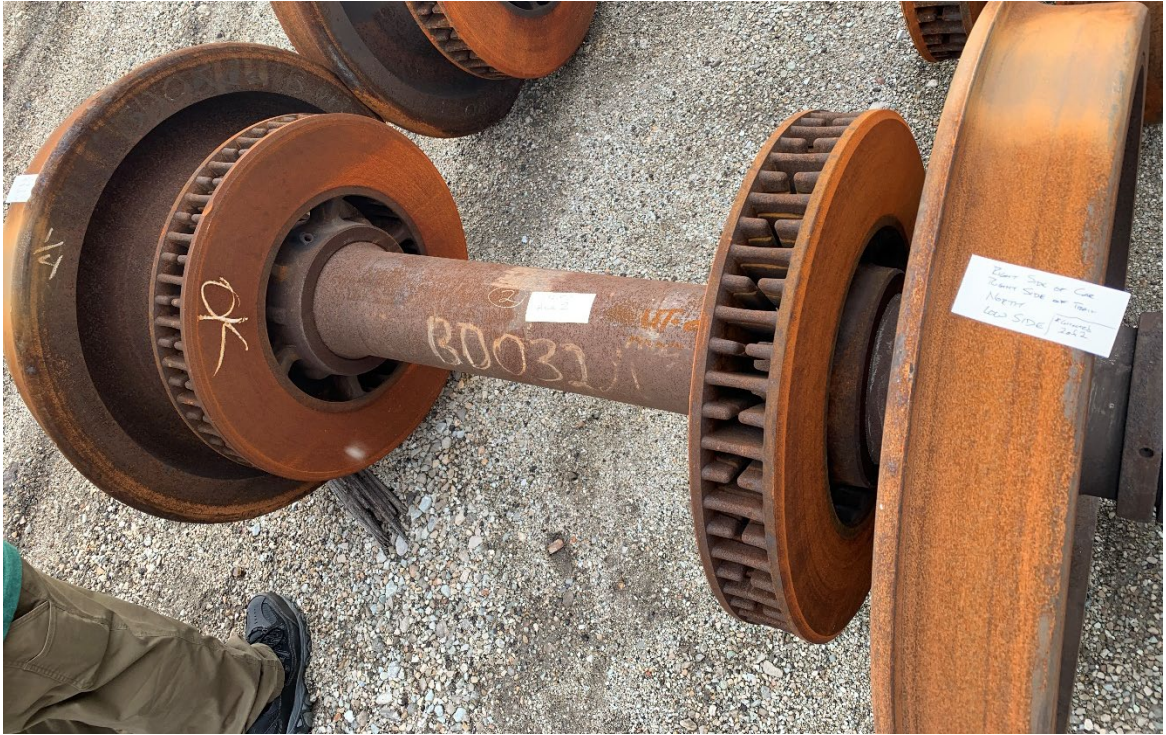
3. Wheelset No. 2 was identified as having serial number BDO3221 using Amtrak records.

Figure 2. Car 32050 Wheelset No. 2 showing ID No. BDO3221 and tags placed by investigators at Beech Grove May 11, 2022

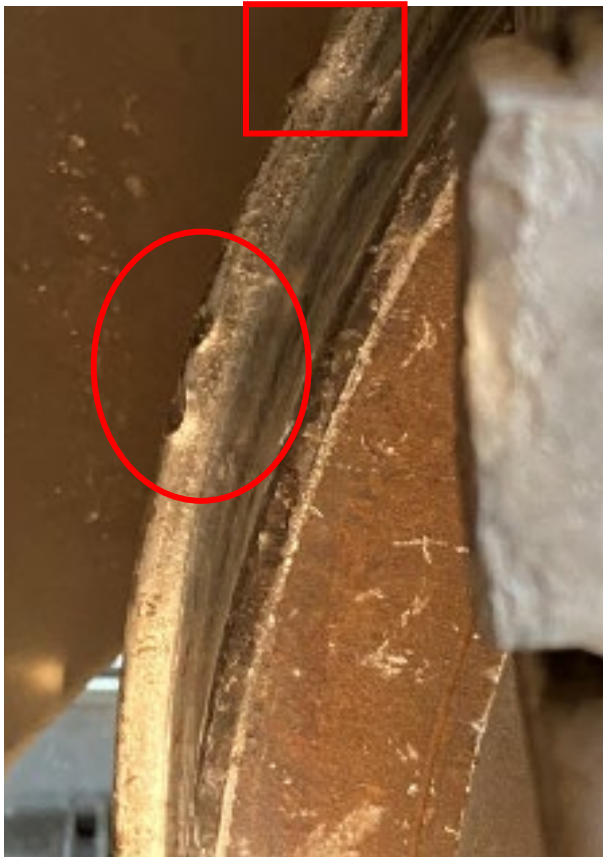
The B-end of the passenger car rear trailing axle showed signs of all four wheels were off the rail. The left number two wheel had evidence of heavy impact marks on the wheel flange as noted in the photos. The left number one brake rotor showed evidence of dragging. The B-end stabilizer bars were bent and damaged. The B-end coupler right side bump stop was broken and impact marks on the top of the coupler shank from the buffer casting. The B-end right side truck frame had signs of dragging. The B-end right side spring saddle had signs of dragging.

Figure 3. Excerpt from FRA field notes from Joplin, MT on-scene phase. Highlighted portion describes damage to the L2 wheel, consistent with one of the wheels profiled in Beech Grove.

4. Investigators used FRA Field Notes to orient Wheelset No. 2 first.
  - a. FRA Field Notes indicate that the Left No. 2 wheel had evidence of impact marks in the wheel flange.
  - b. Investigators located the impact marks in the wheel flange in the FRA field note photographs.
  - c. Investigators then located the impact marks on the wheel at Beech Grove that had matching flange impact marks.
  - d. This was determined to be the wheel on the left side of Wheelset No. 2. This wheel is defined as wheel location number 4. It was positioned on the left side of the train prior to the derailment, on the high side of the accident curve, the south side.

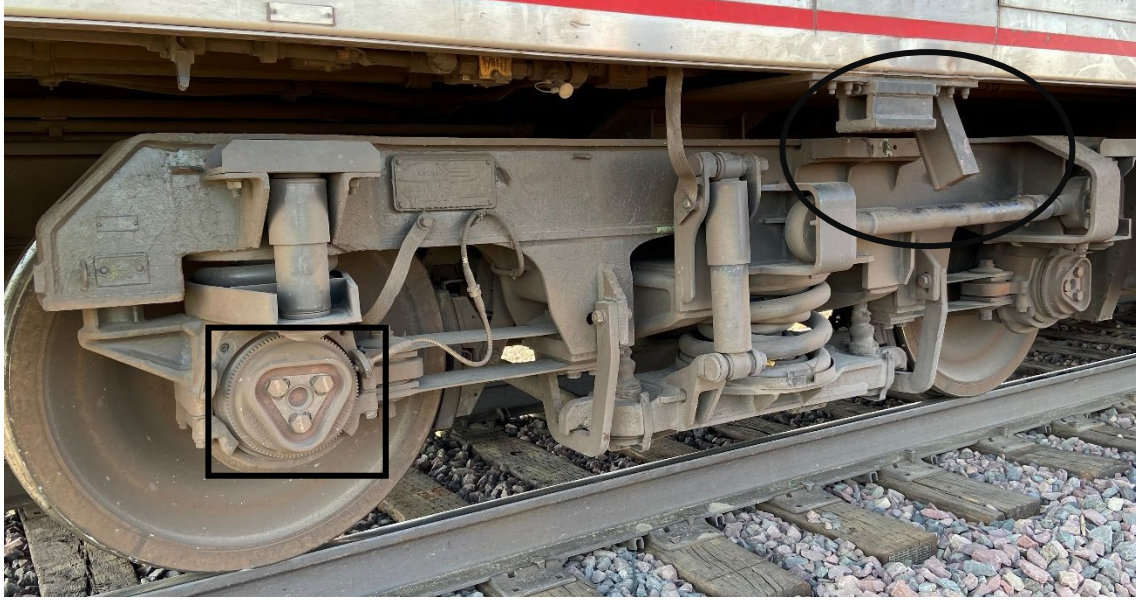
5. Next investigators turned to determining the orientation of Wheelset No. 1.
6. Investigators noted that Volpe Staff took two photographs of the right side, B-end of Car 32050 that clearly showed a broken car side frame bump stop. These photos were labeled in the field by Volpe staff and could be confirmed to be oriented accurately by investigators who had been on scene.
7. A close examination of this photo showed distinct and unique markings on the Wheelset No. 1, right side, roller bearing cap bolts.
8. These distinct marks were found on bearing end cap bolts on Wheelset No. 1 in Beech Grove.
9. Therefore, the wheel with the bearing displaying those unique markings was determined to be the Axle No. 1, Right Side wheel. This is the Amtrak Position 1. The right side of the train, low side of the curve, north side geographically.

*Figure 6. Photograph of the 32050 north side truck, showing bump stop damage. This photograph was taken by and annotated by Volpe staff while on scene. The north side corresponds to the right side of the train and the right side of the car. (Low rail)*

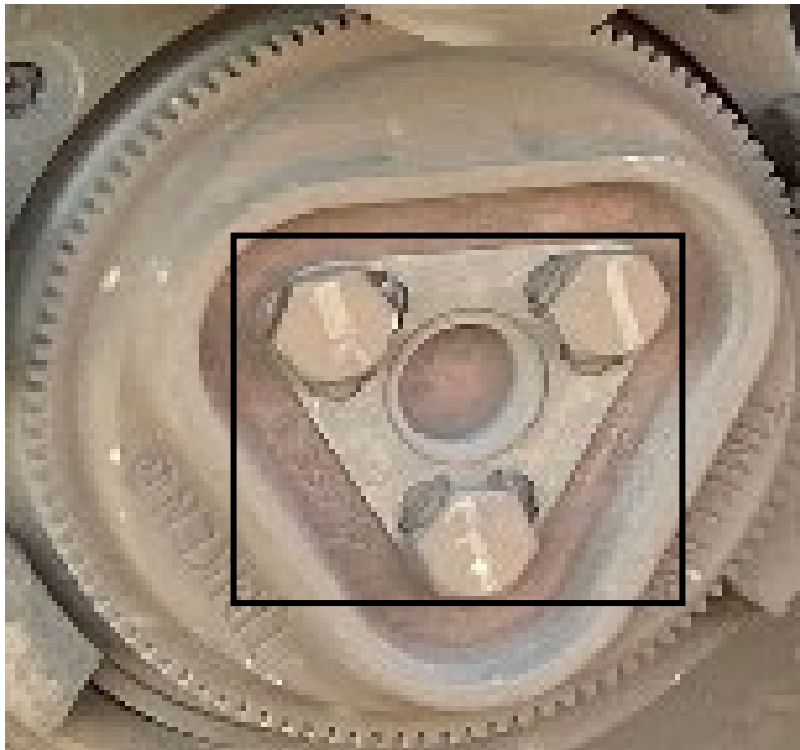
Figure 7. Photograph of the same 32050 truck with bump stop damage, taken by a different Volpe investigator.
