# NTSB MEMORANDUM FOR RECORD

**Date: 4/28/2020**  
**Person Contacted: See Below**  
**NTSB Accident Number: ERA20LA160**

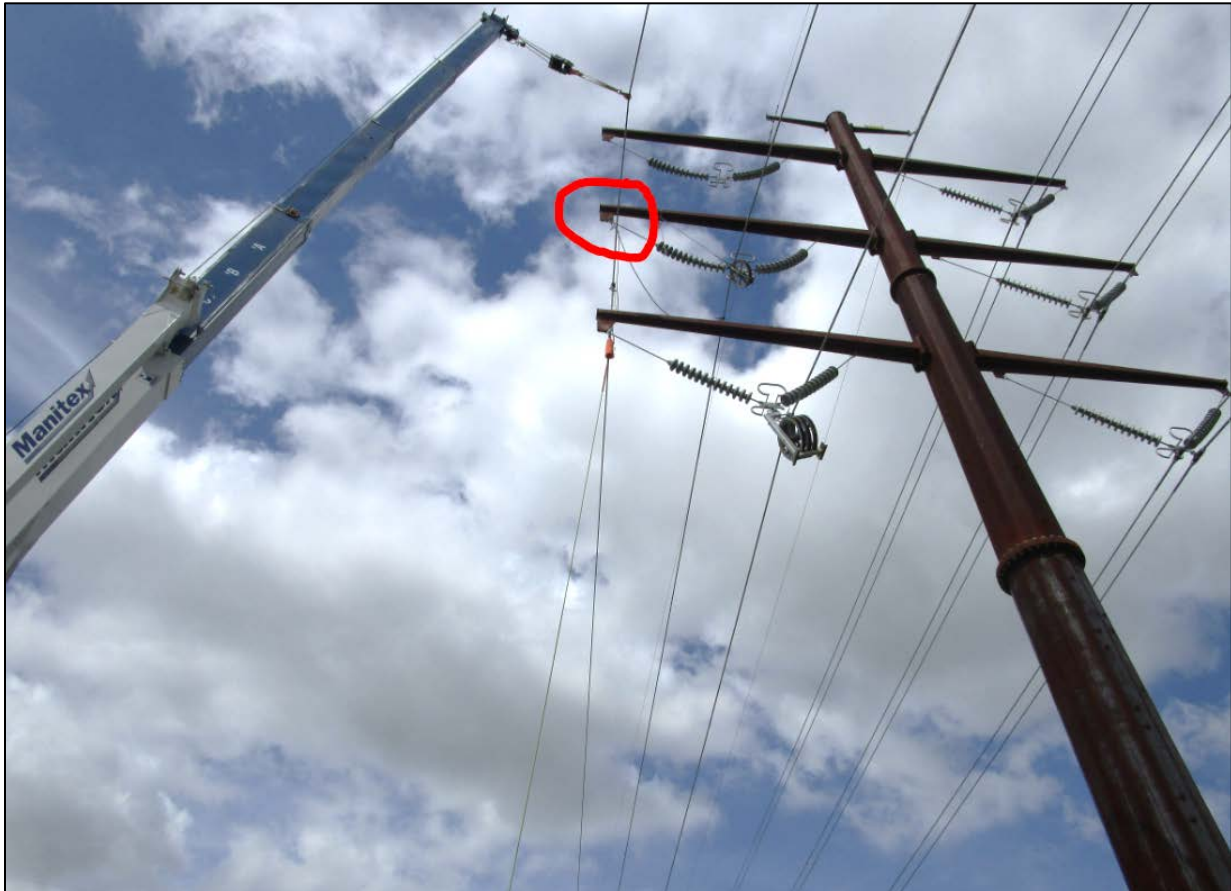
The purpose of the Part 133 operation was to move a conductor powerline from the top tier area to the middle area. Figure 1 shows the middle beam the conductor powerline was being moved to and is circled in red.

Figure 1: View of the conductor powerline that was moved by the helicopter

The purpose of the crane, which is visible in Figure 1, was to support the weight of the wire. The helicopter's job was to move the wire laterally, toward the helicopter. Referencing Figure 1, the helicopter would have been located near the crane during its hover and maneuvering. During the moving of the powerline, a loss of engine power occurred at an estimated height of 140 ft.

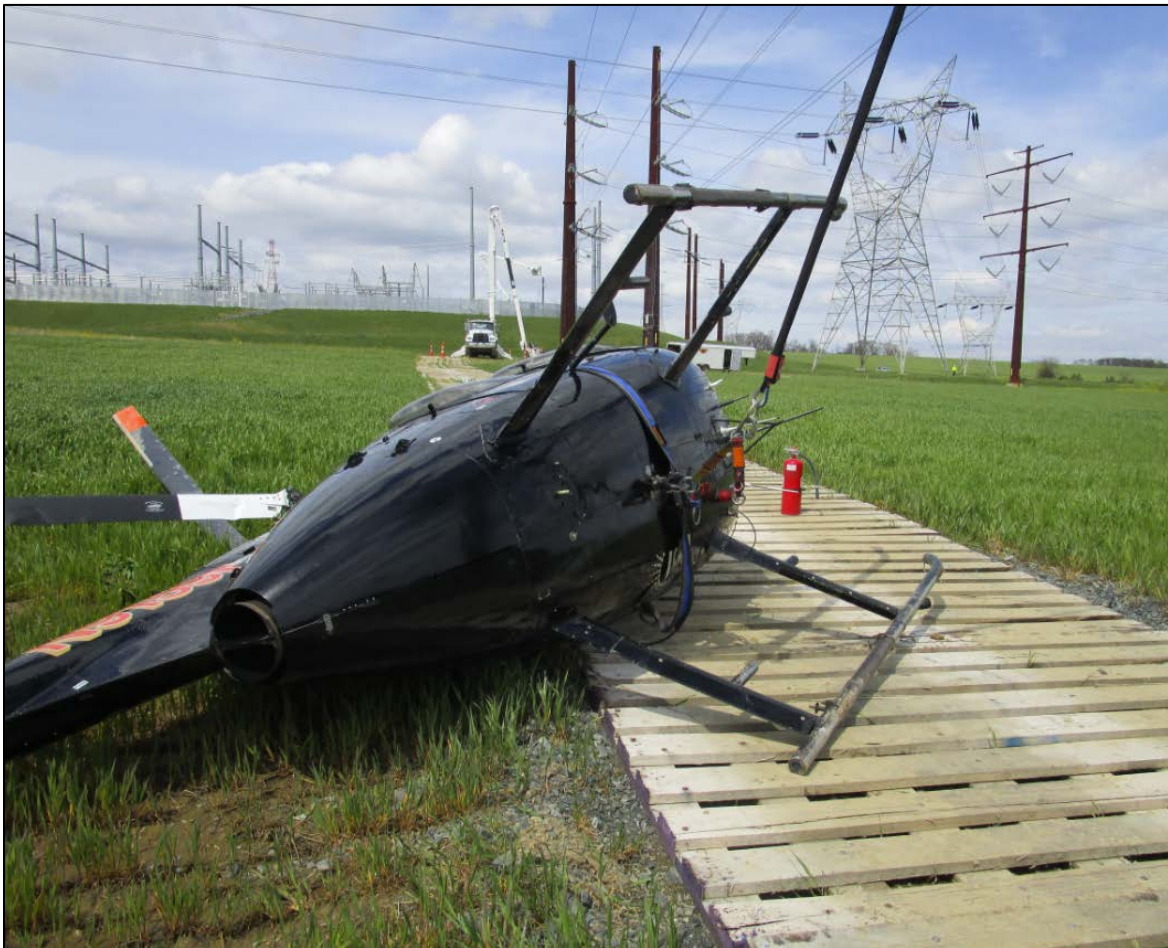
Figure 2 shows the helicopter at the accident site, with the belly band and long line in view. The belly band is the blue strap on the bottom of the fuselage. The belly band serves as a secondary safety measure, to catch the long line, should it become inadvertently released. This is critical during Human External Cargo (HEC) operations,

where a human is attached to the end of the long line. During the accident flight, HEC operations were not being performed, however, immediately prior to the accident, HEC operations were being performed.

The long line, which has orange markings on its line, is still attached to the power line and the bottom of the fuselage and the main hook.

Figure 2: View of the helicopter with the belly band and the long line in view

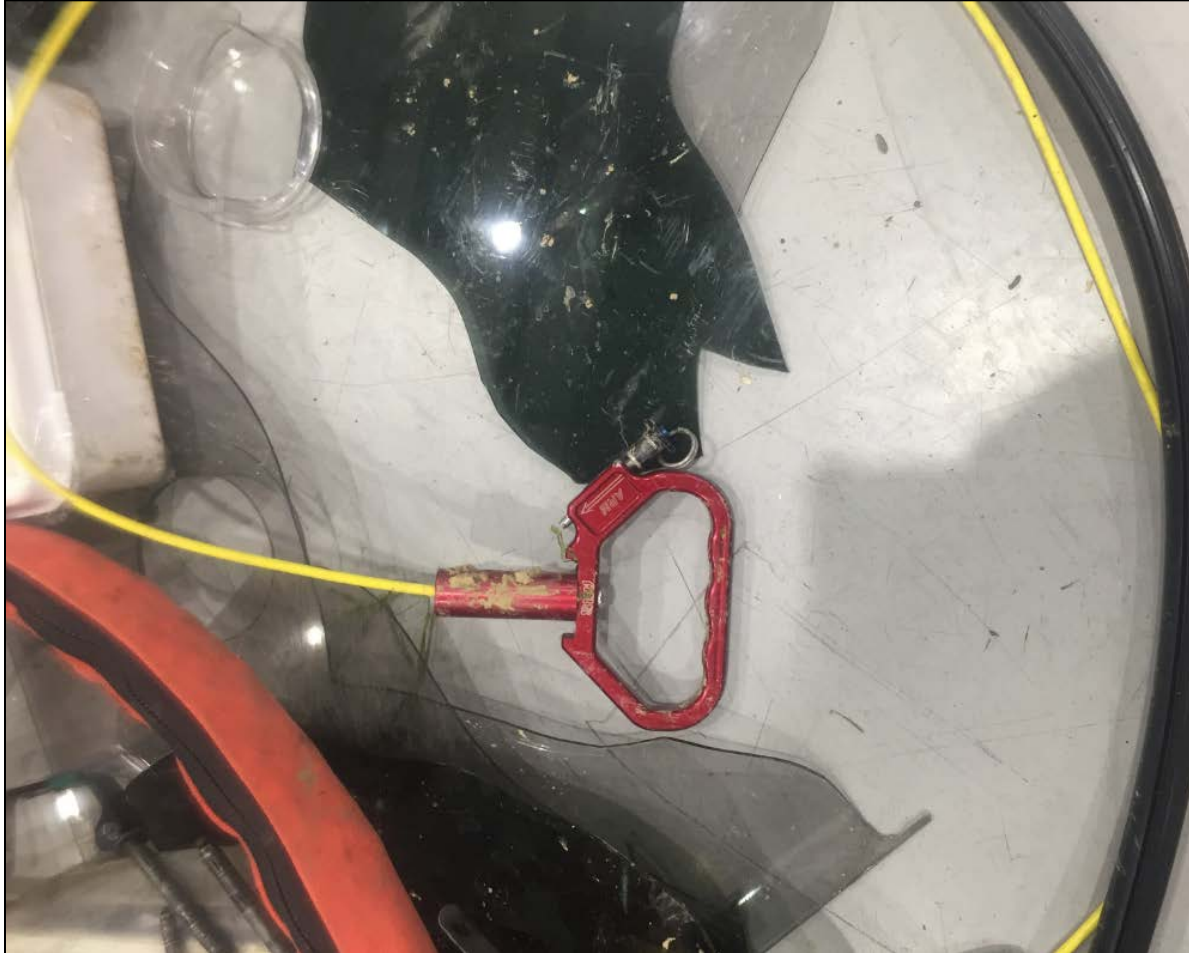
To release the belly band, the pilot would need to pull an estimated 8 to 12 inches. The handle is located near the pilots left hand, and the pilot would need to remove their left hand from the collective to pull the handle the 8-12 inches. The handle from the accident airplane had been pulled under the fuselage during the impact sequence and was not photographed at the accident site. Figure 3 is an image of the belly band from the accident airplane.

Figure 3: View of the belly band release handle from the accident airplane

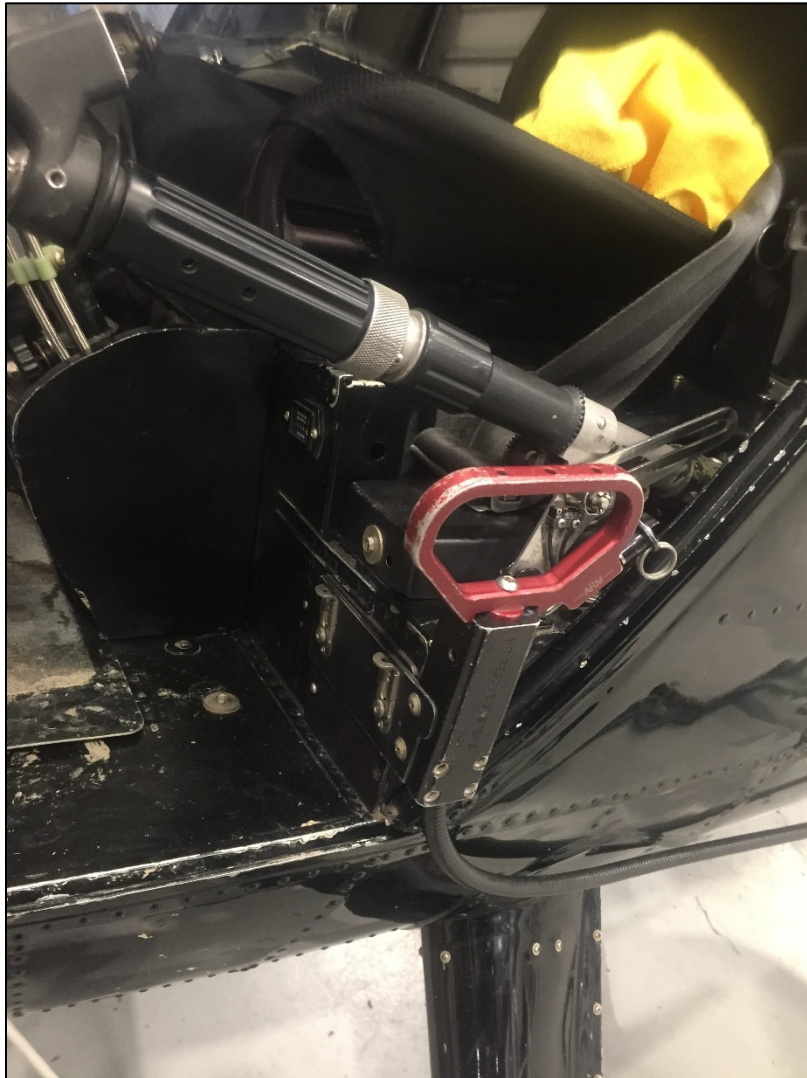
Figure 4: Exemplar belly band release handle from another Haverfield Aviation MD369D Helicopter

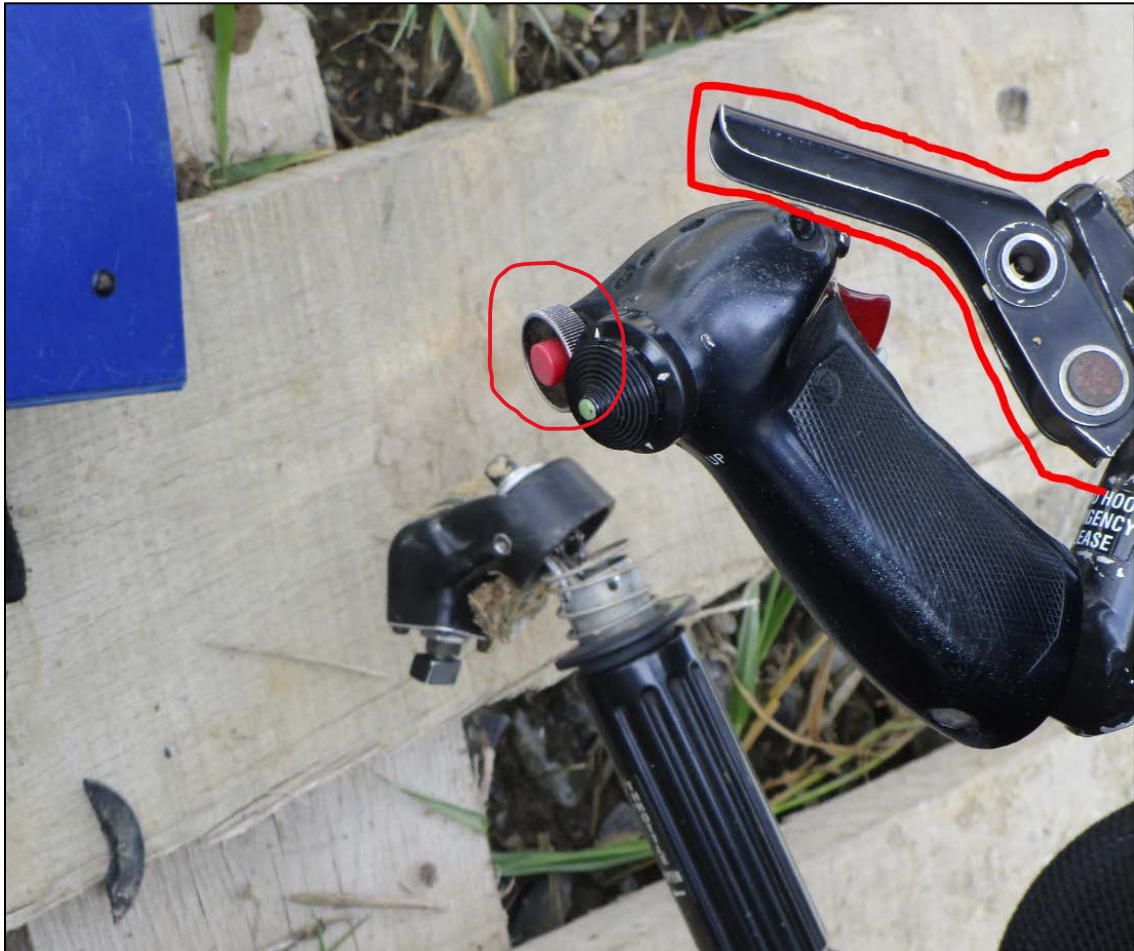
The long line also had an emergency release handle on the cyclic. Figure 5 shows the handle that was required to be pulled with the pilot's right hand (the handle is outlined in red). In addition, within Figure 5, a red button is visible and circled. This button is an emergency release for the long line and serves the same function as the release handle located on the cyclic handle. This electrically driven button, however, was deactivated due to the circuit breaker being pulled by the pilot prior to the accident. It was explained that pulling this circuit breaker is common when HEC operations are being performed.

Figure 5: View of the two emergency release mechanisms for the long line main hook

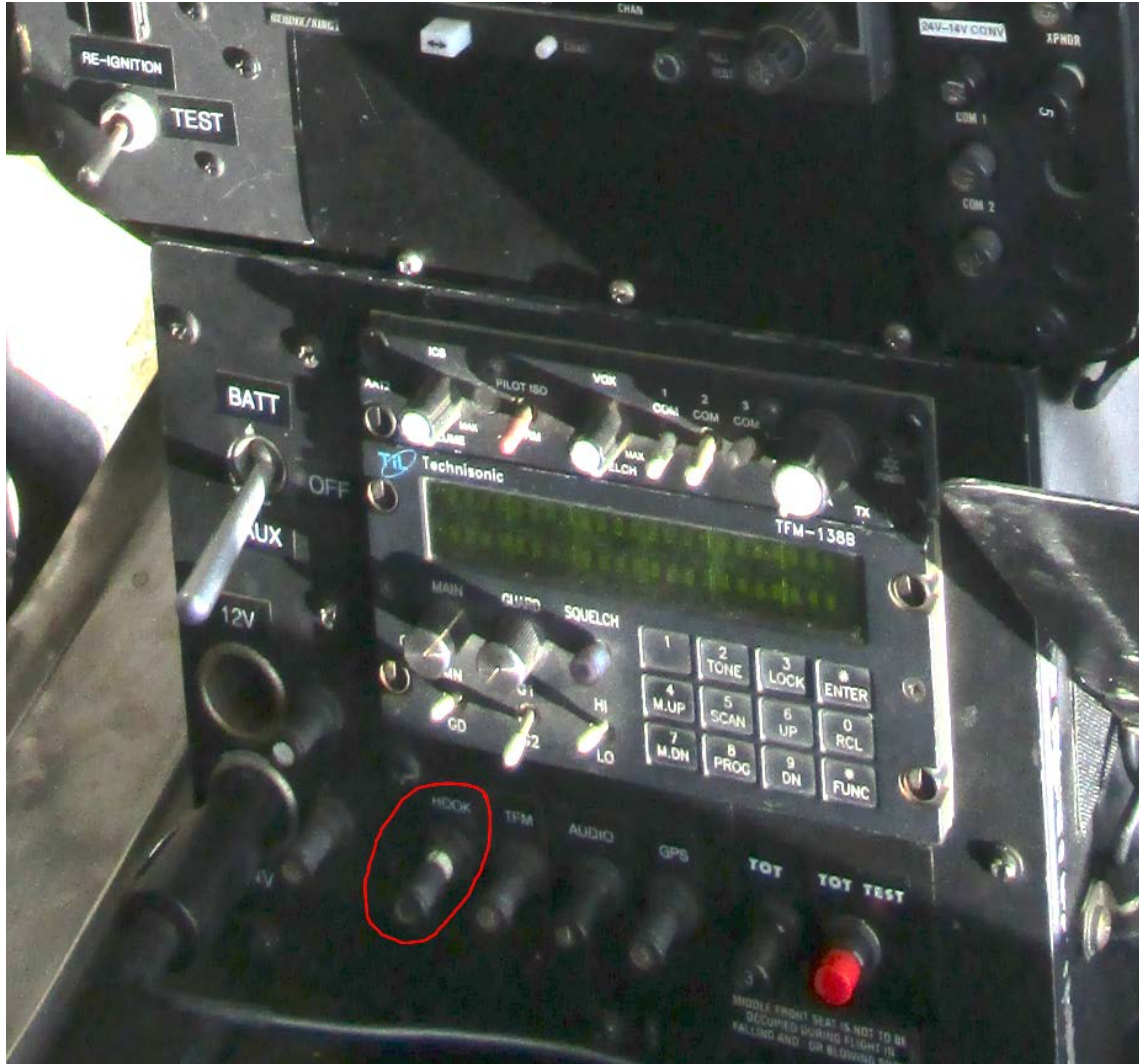
Figure 6: View of the pulled circuit breaker that controls the hook release button located on the cyclic

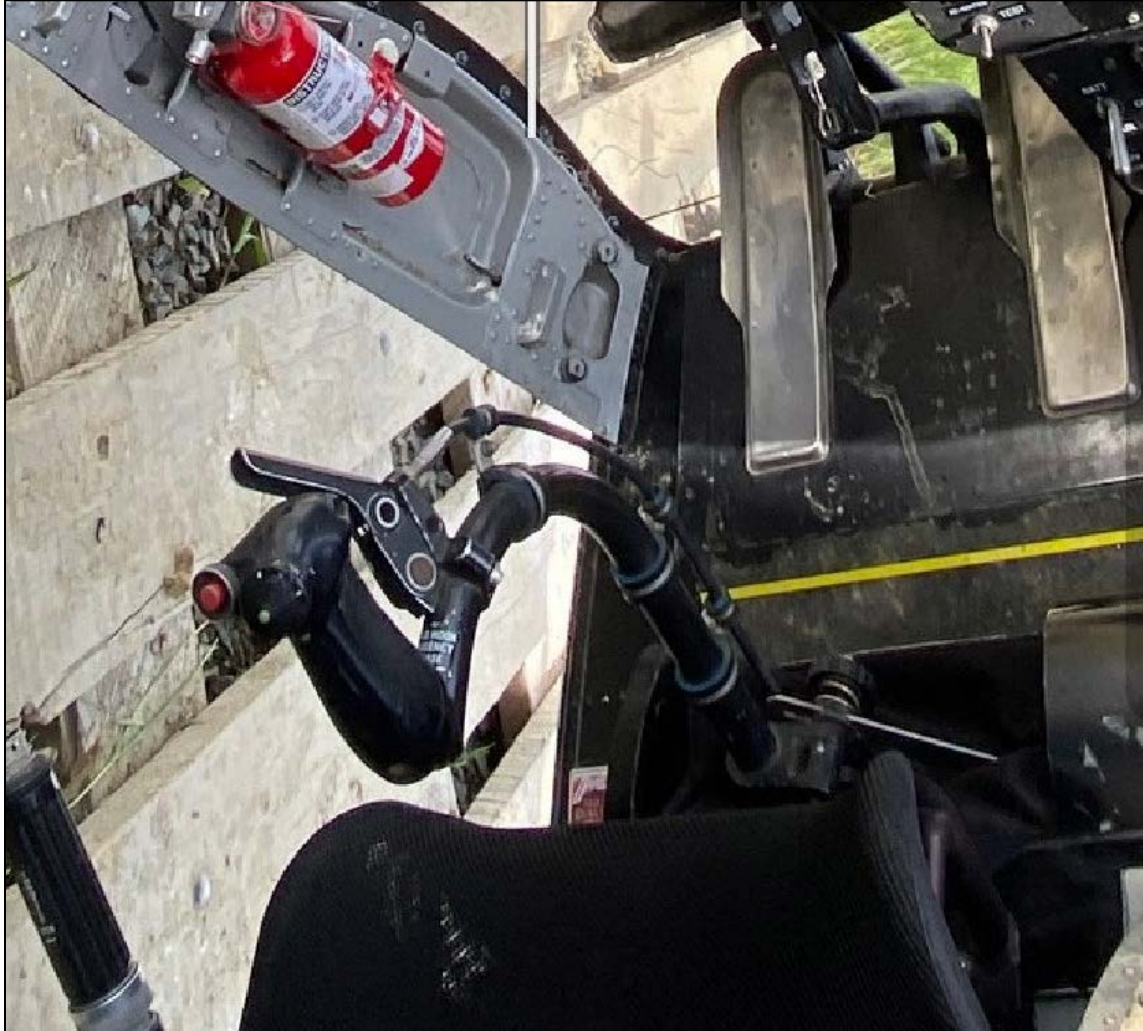
Figure 7: Additional view of the cyclic and the emergency release handle and red button
