# **Analysis of Samples Removed from a Damaged Pipeline**

**Analysis of Samples Removed from a Damaged Pipeline**

Paul E. Stutzman

April 2001

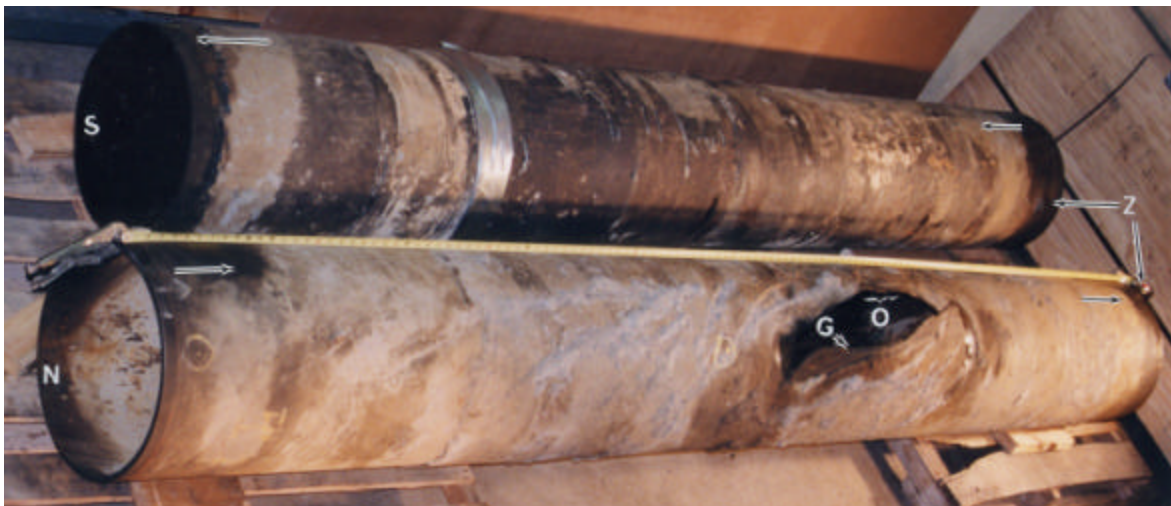
Figure 1. Pipe section showing the location of the gaping crack (G) and crack origin (O) after removal from the field. North and south ends are indicated by “N” and “S”, respectively. Pipe was cut in the field in the area indicated by arrows “Z”.

A section of a 40.6 cm (16 in) diameter gasoline pipeline showed signs of mechanical gouging and had experienced a rupture in service (Figs. 1-3). The gouges were partly filled with a partially indurated material of undetermined origin. The National Safety Transportation Board (NTSB) provided a set of specimens that were adhered to a pipe for microstructure evaluation. NTSB staff contacted the Building Materials Division of the National Institute of Standards and Technology to assist in characterizing the material and to determine if it was a portland cement-based material. If these materials were determined to be portland cement based, they would be characterized to see if they were related to concrete used in any construction subsequent to the installation of the gasoline pipeline.

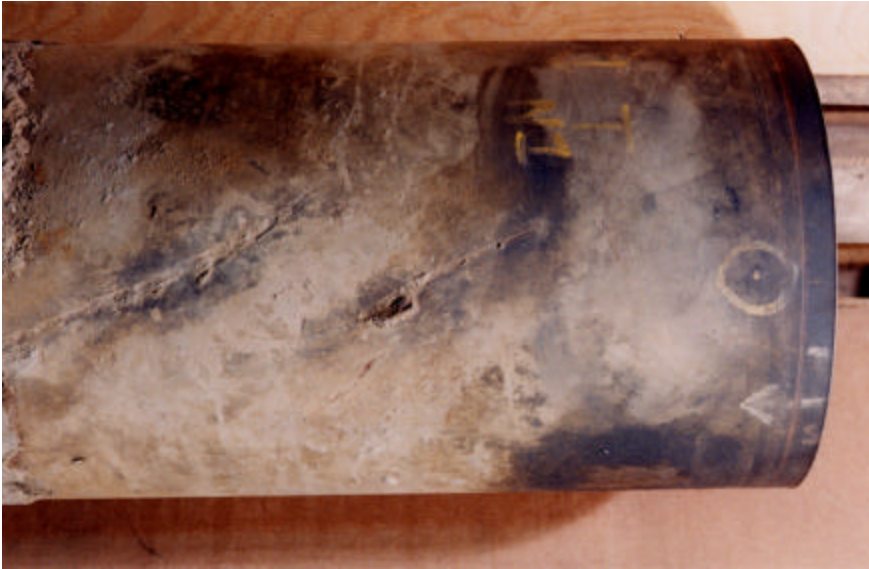
Figure 2. Close-up photograph (left) of the north end of the pipe showing two exposed diagonal gouge marks. Specimen labeled “E” was removed from the gouge mark located at the upper left corner of the photograph.

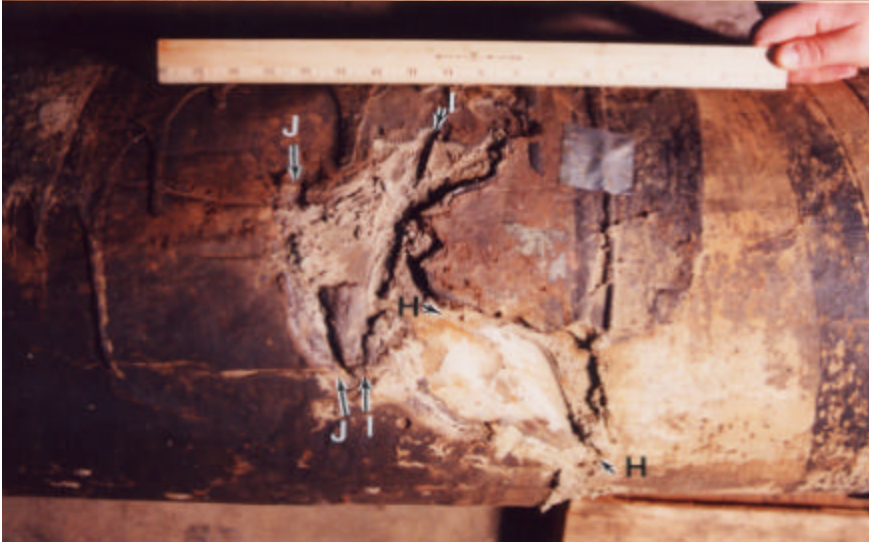
Figure 3. Close-up photograph of three gouge marks between arrows “H”, “I” and “J”. Samples removed from these gouge marks were labeled with the same letter designation, respectively.

- Figure 3. Close-up photograph of three gouge marks between arrows “H”, “I” and “J”. Samples removed from these gouge marks were labeled with the same letter designation, respectively..... 3

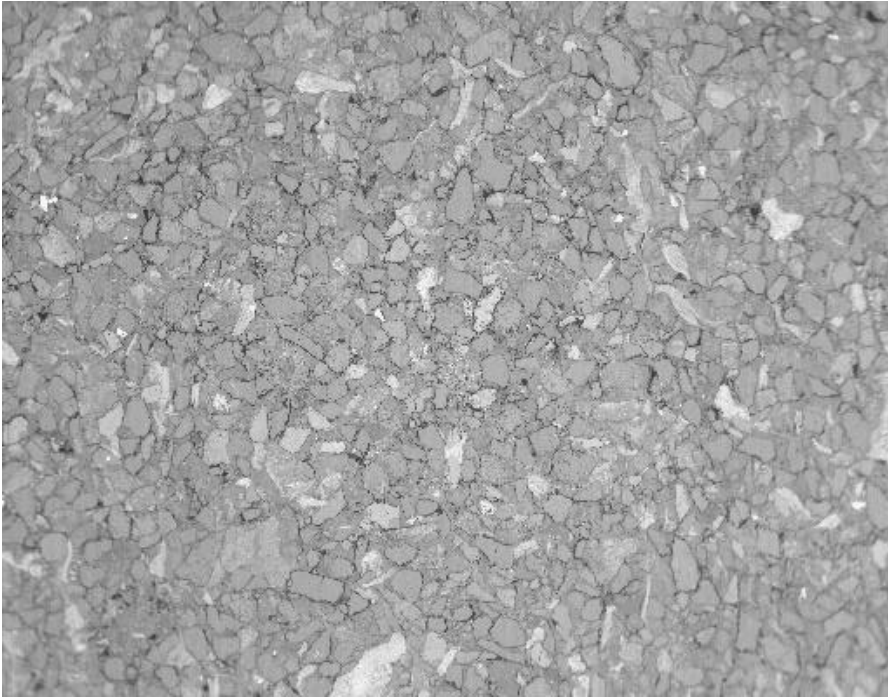
Figure 11. Scanning electron microscope backscattered electron image of an epoxy-impregnated, polished cross section of the back fill with uniform sand grading. Field Width: 4.9 mm

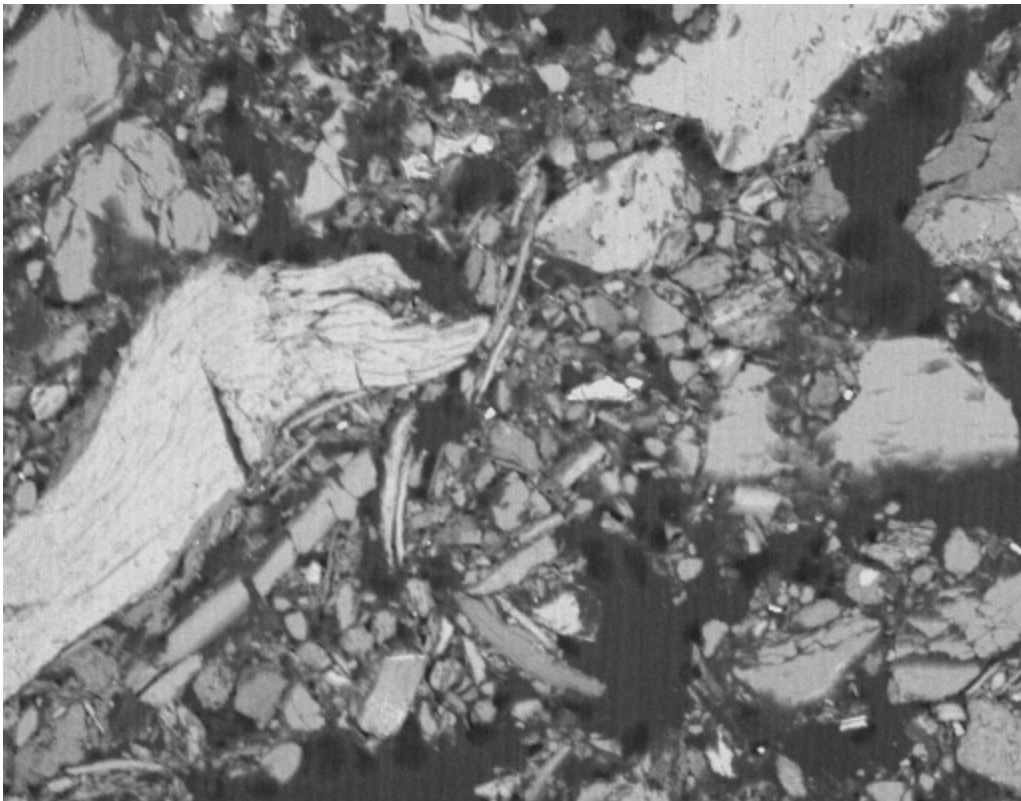
Figure 16. E-soil specimen exhibits a heterogeneous matrix with the upper image field width of 475  $\mu\text{m}$ , and the lower 144  $\mu\text{m}$ . The platy grains showing apparently good basal cleavage are probably a mica, or micaceous mineral.

Specimen E was provided as a reference for local soils. SEM images show an abundance of coarse and fine-sized multi-phase aggregates (see Figs. 15 and 16). These aggregates are probably shale, given their fine texture. The matrix is fine-grained and heterogeneous and exhibits irregular-shaped voids, distinct from the hardened cement paste and the entrained air voids found in the concrete. The X-ray powder diffraction patterns in Fig. 17 indicated the presence of quartz, calcite, feldspar, mica, and clays. The HCL spot test was positive, indicating the presence of calcite (calcium carbonate).

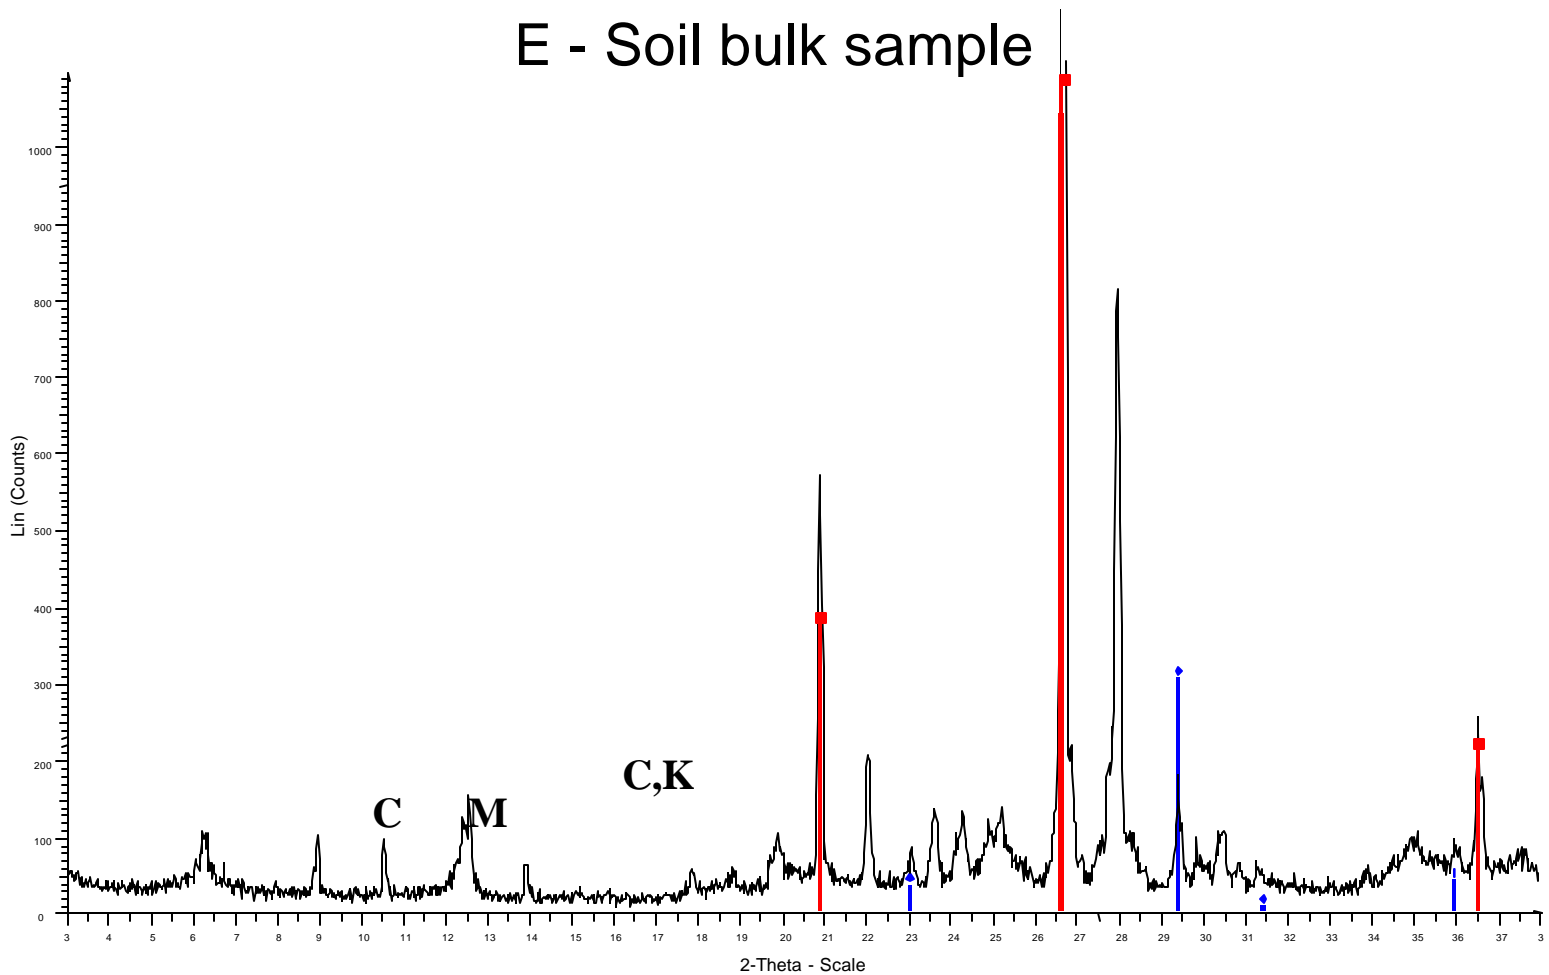
# E - Soil bulk sample

E - Soil bulk sample - File: ebulk.RAW - Type: 2Th/Th locked - Start: 3.000 ° - End: 38.000 ° - Step: 0.020 ° - Step time: 2. s - Temp.: 25 °C (Room) - Time Started: 0 s - 2-Th Operations: Import  
 46-1045 (\*) - Quartz, syn - SiO<sub>2</sub> - Y: 95.83 % - d x by: 1. - WL: 1.5406 - Hexagonal - a 4.91344 - b 4.91344 - c 5.40524 - alpha 90.000 - beta 90.000 - gamma 120.000 - Prim  
 05-0586 (\*) - Calcite, syn - CaCO<sub>3</sub> - Y: 12.50 % - d x by: 1. - WL: 1.5406 - Hexagonal (Rh) - a 4.989 - b 4.98900 - c 17.062 - alpha 90.000 - beta 90.000 - gamma 120.000 - F

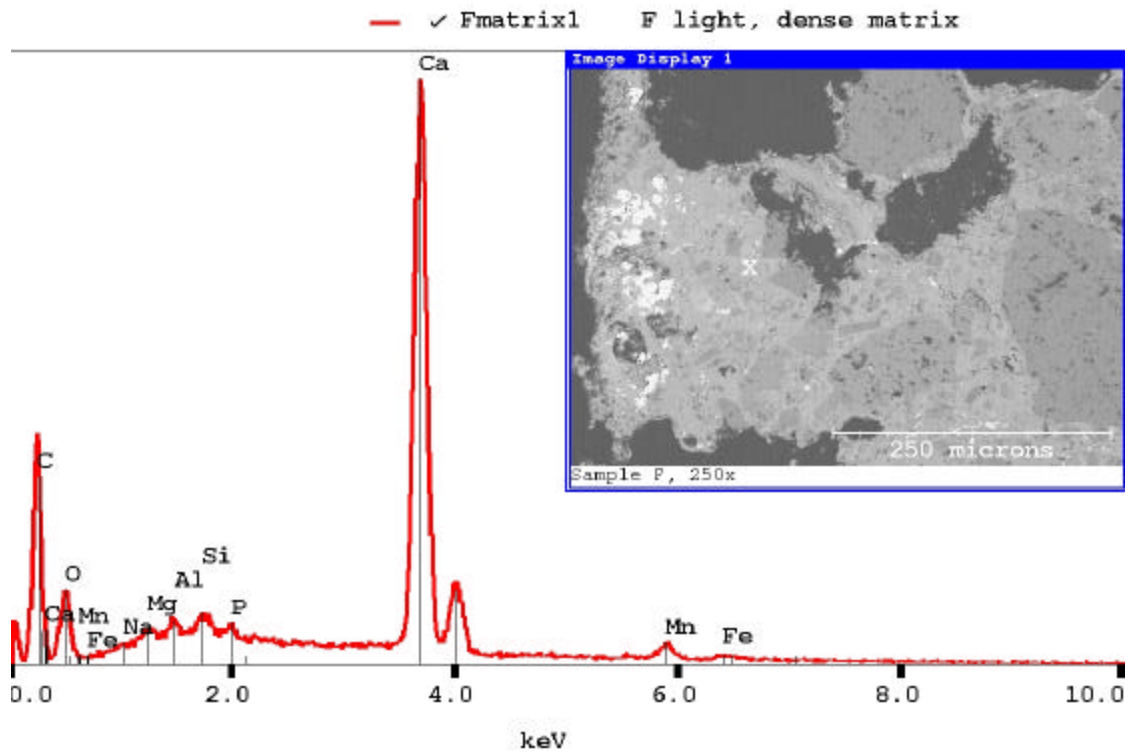
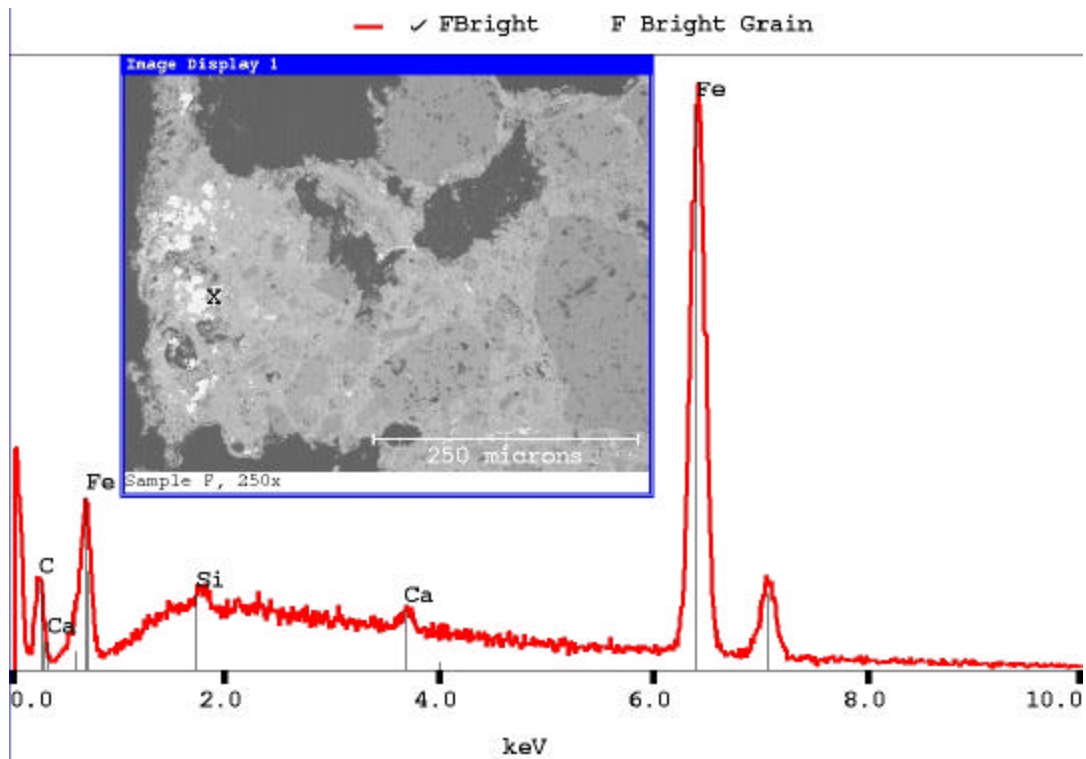
Figure 23. X-ray microanalysis of the dense material (upper spectra) indicates that it probably is calcite, with high calcium and relatively strong carbon peaks. The bright inclusions (lower spectra) show strong iron spectra.

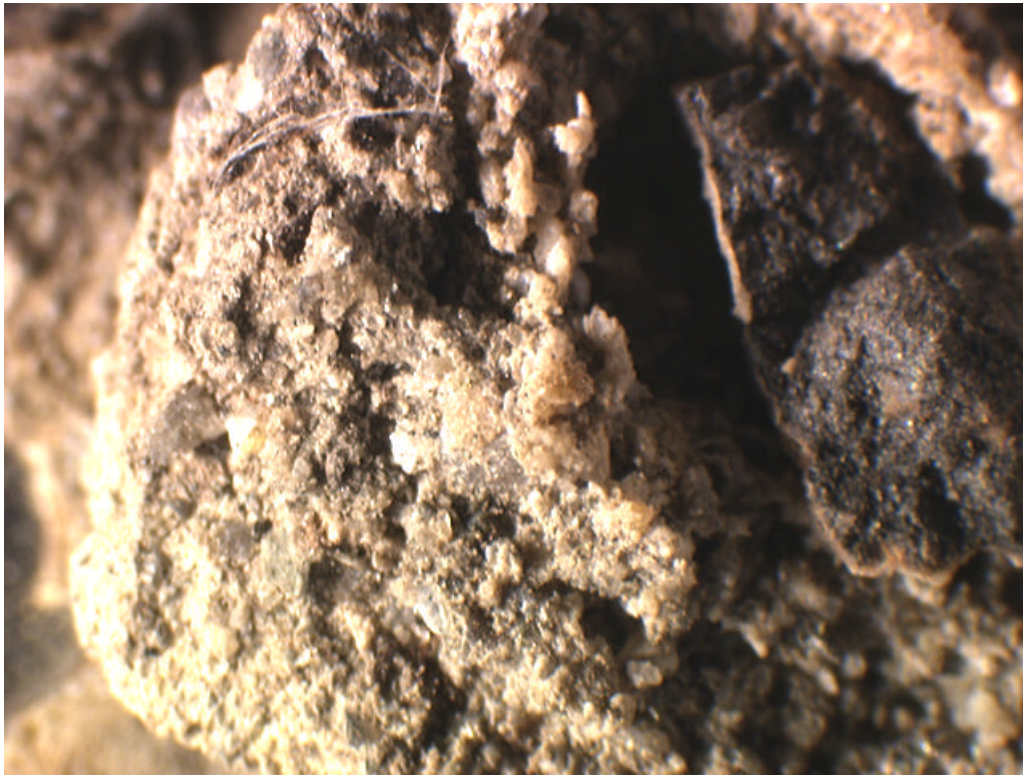
Figure 25. Specimen H at 7 mm (upper) and 2 mm (lower) field width is a brown to yellow, sandy, friable material.

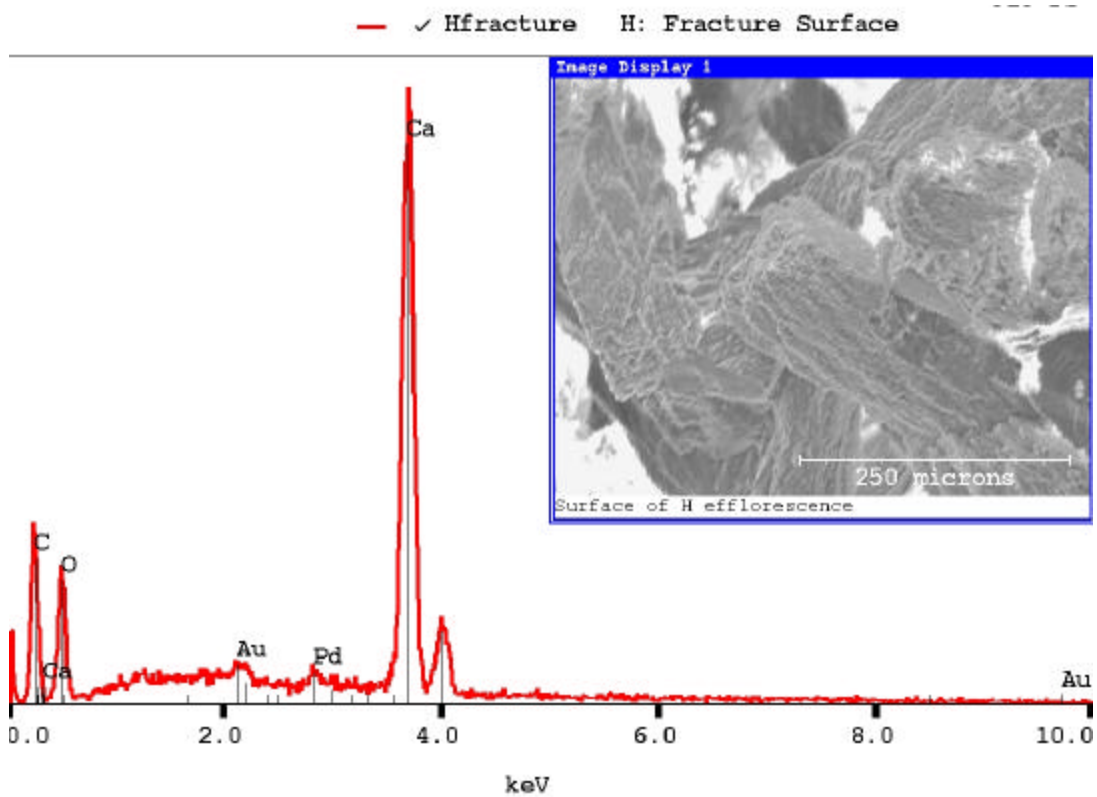
Figure 28. Secondary electron image of the surface texture and spot x-ray microanalysis of the surface of a specimen of sample H show it is composed of calcium and carbon and is probably the calcite, as observed in the XRD and HCL tests. The gold and palladium peaks are from the conductive coating necessary for imaging insulating specimens.

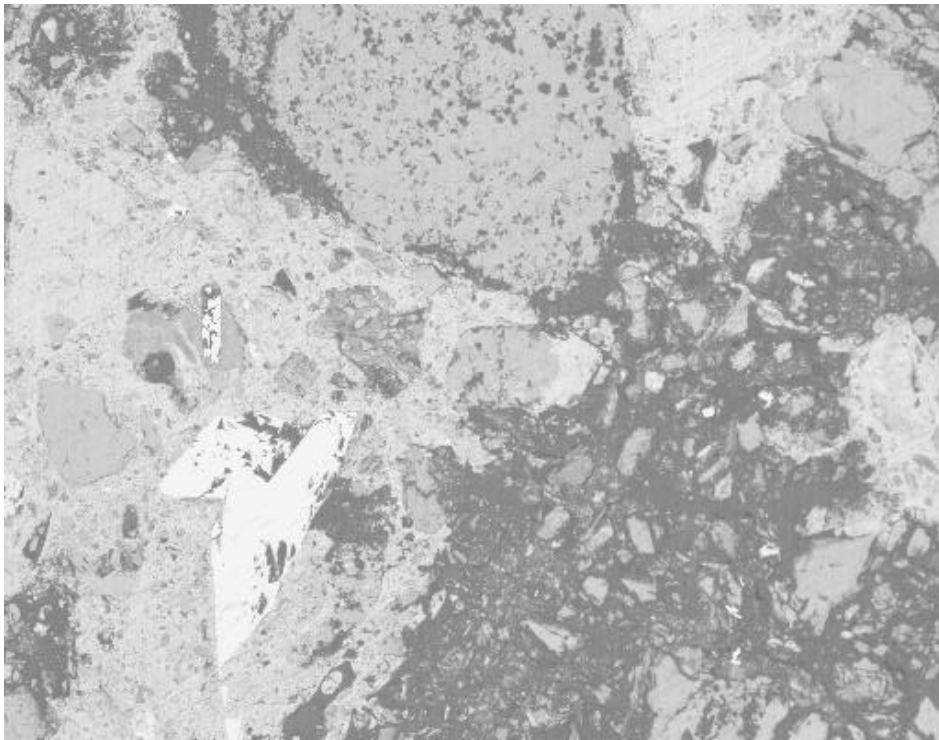
Figure 34. Another specimen from sample location I at 6 mm (upper) and 475  $\mu\text{m}$  (lower) field width shows the heterogeneous phase distribution and microstructure distinctly different from that of the concretes.

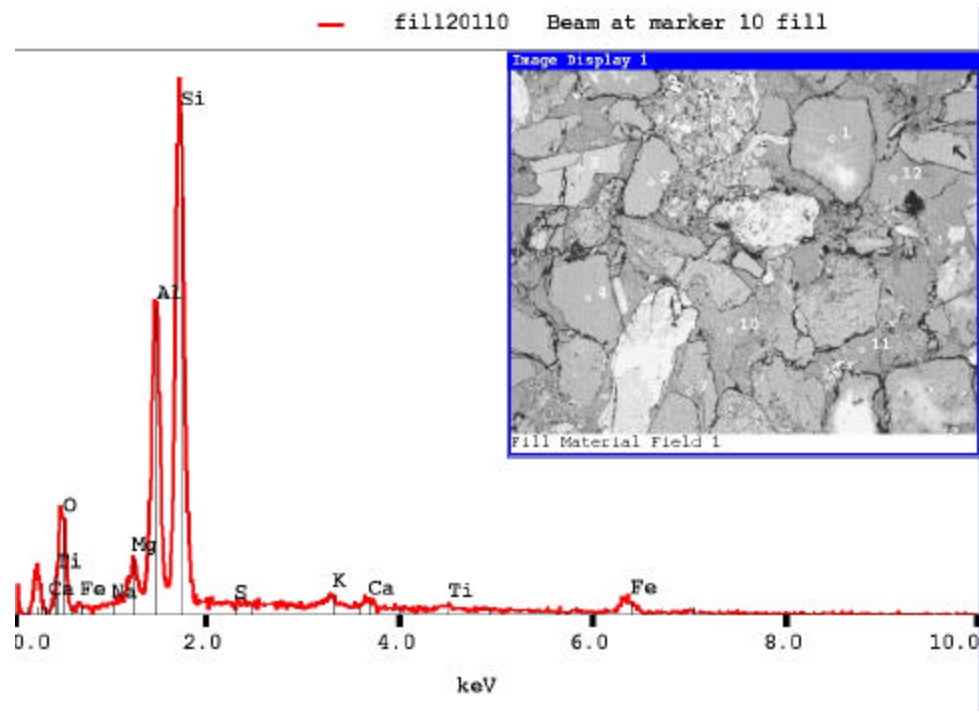
Figure 46. Spot X-ray microanalysis of the matrix indicates a magnesium - aluminum - silicate composition with minor iron, calcium, sodium, and potassium. A set of three spectra provided the following peak intensities that will be used for comparison. The ratio of the magnesium and aluminum peaks to silicon were about 0.10 and 0.57, respectively. The values of the replicate spectra were Mg : 0.11, 0.09, 0.11 and Al: 0.57, 0.56, and 0.59.
