Moisture Seal Position Description

NTSB Investigation Number: DCA22MA193

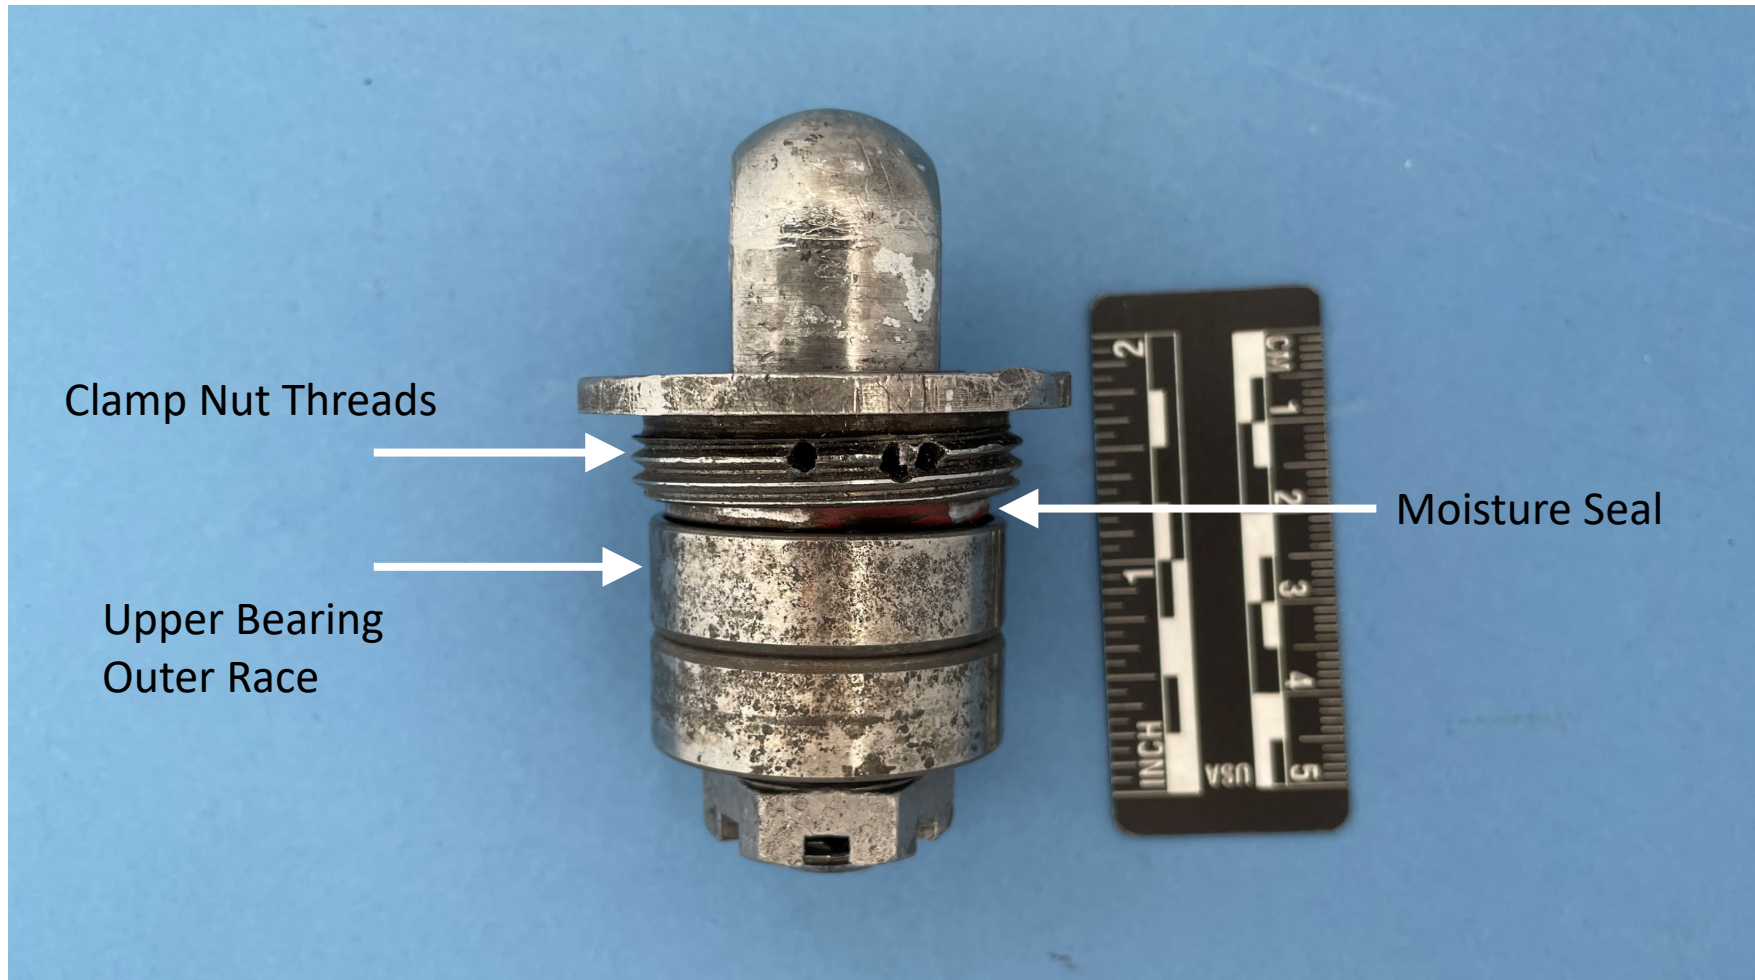
The picture is of the top eye end and bearing assembly with the moisture seal. The assembly and moisture seal had previously been disassembled and reassembled for other examination/testing prior to the pictures in this document. For the pictures in this document, the moisture seal was similarly positioned to the as-received condition where the moisture seal protruded approximately 0.07 inch from the bottom of the clamp nut.

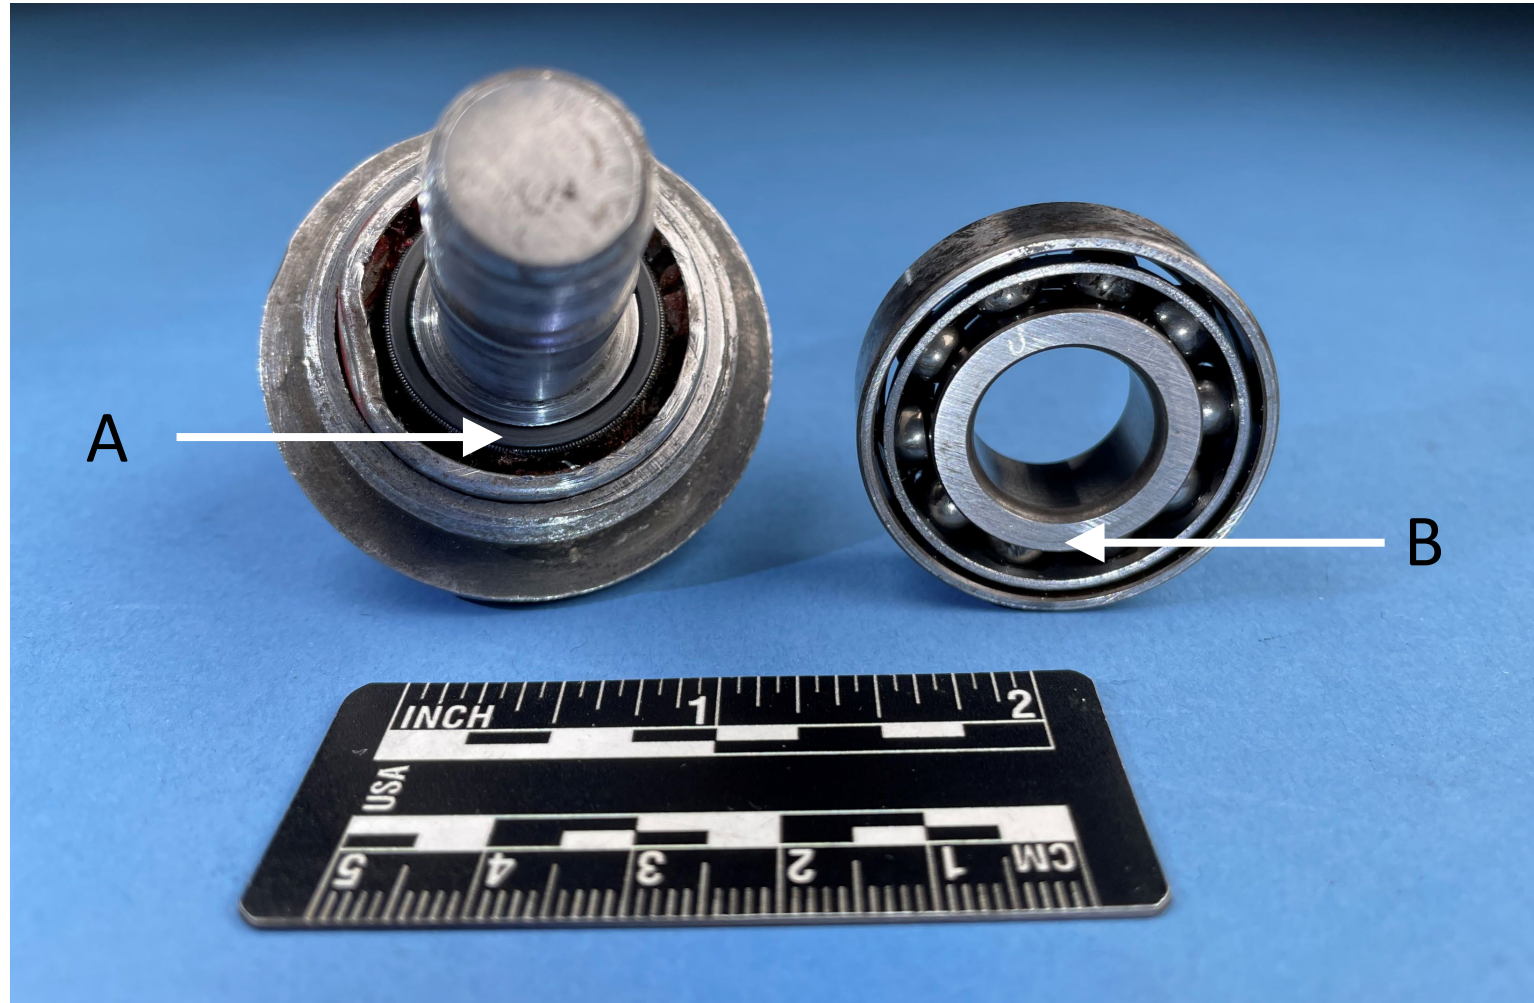
The arrows point to the surfaces that contacted each other when the moisture seal was placed against the bearing. Arrow A points to the elastomer seal of the moisture seal. Arrow B points to the inner race of the bearing.

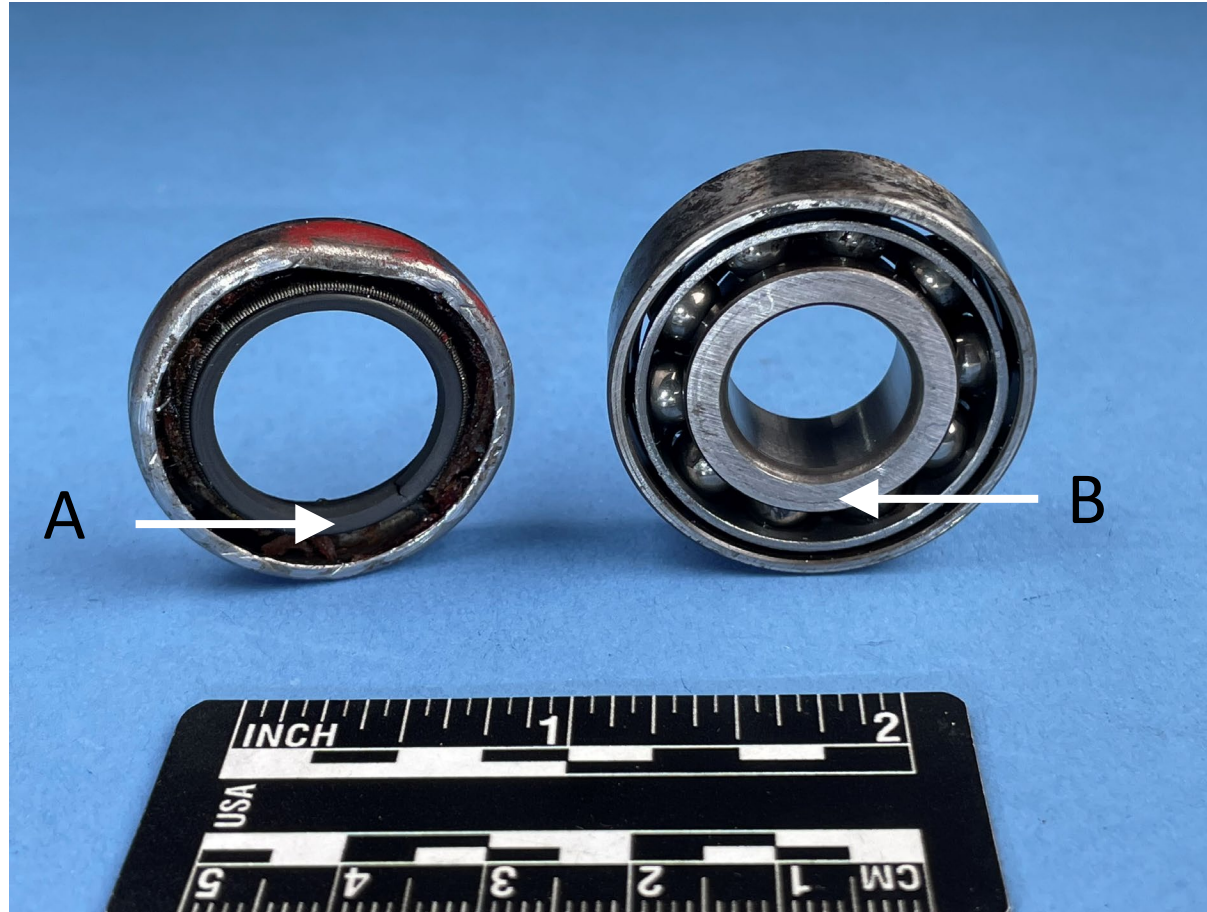
This picture is of the moisture seal removed from the eye bolt (left) and the upper bearing (right). Arrow A points to the elastomer seal of the moisture seal. Arrow B points to the inner race of the upper bearing.

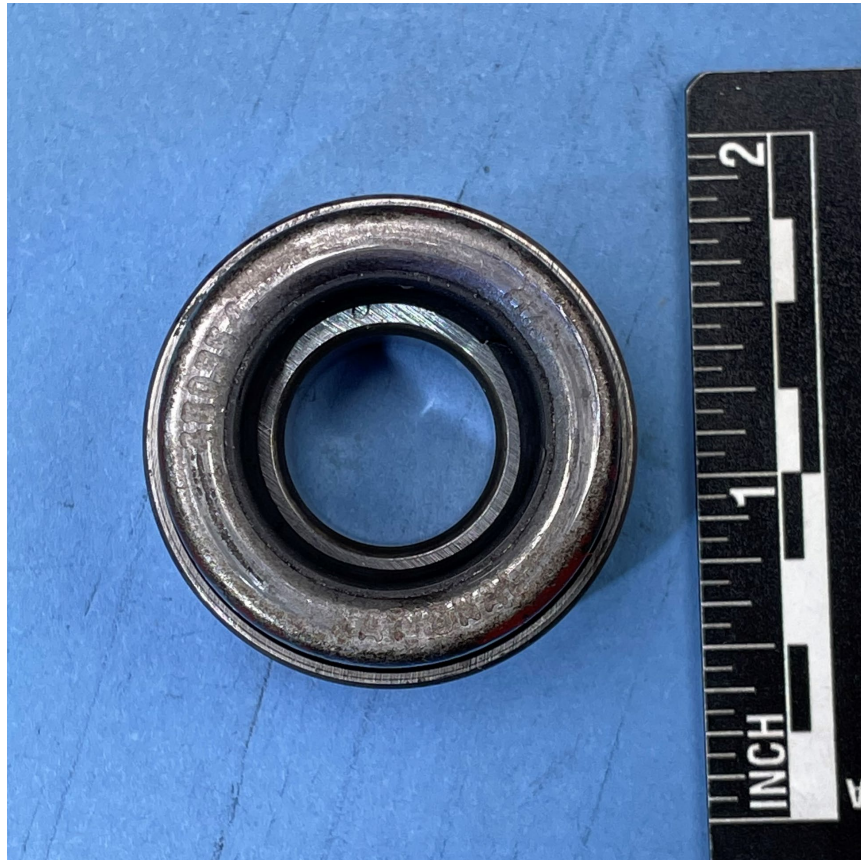
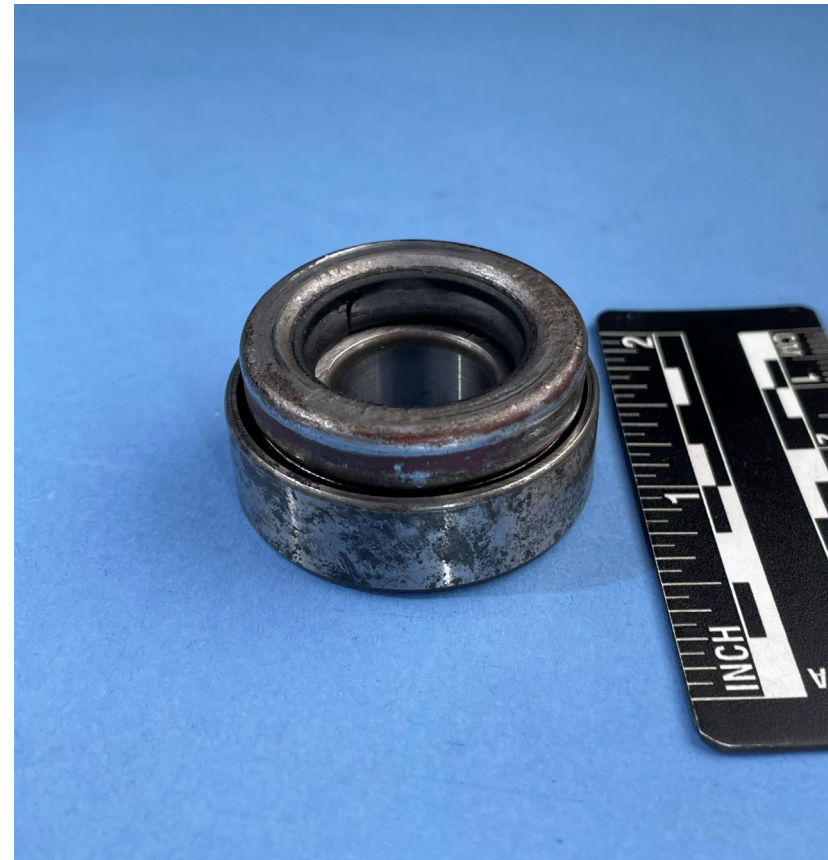
Two views showing how the moisture seal and upper bearing contacted each other. Note the moisture seal is resting on the inner race of the upper bearing, and the moisture seal sits just inside of the outer race of the upper bearing.

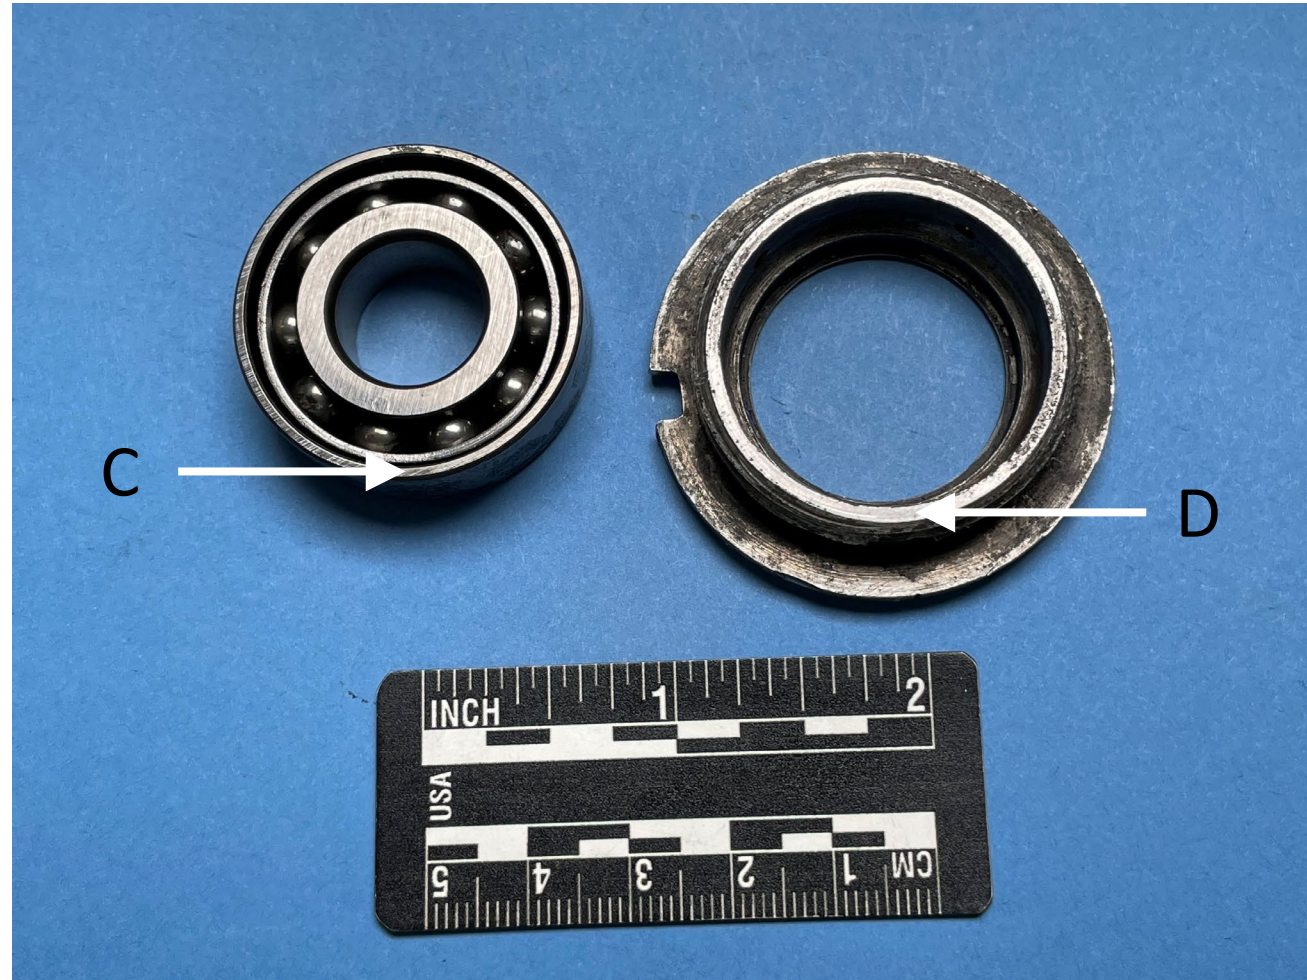
The arrows point to the surfaces that contacted each other when the moisture seal was not present, as per design. The upper bearing is on the left and the clamp nut is on the right. Arrow C points to the outer race of the upper bearing. Arrow D points to the bottom of the clamp nut, just below the threads.

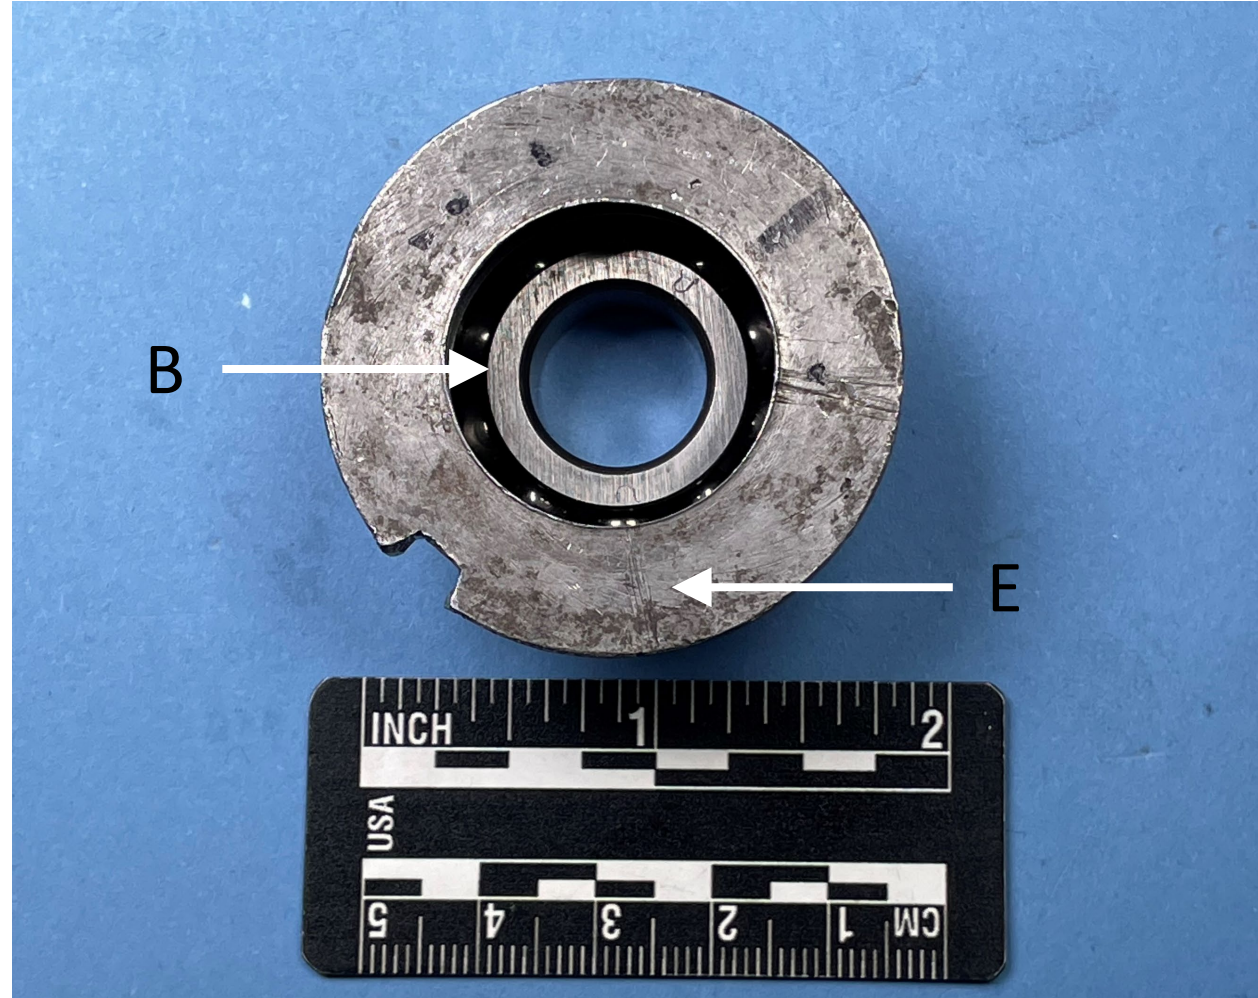
View looking down at the clamp nut resting on the outer race of the upper bearing. Note the inner race of the bearing is not contacted. Arrow B points to inner race of upper bearing. Arrow E points to the top side of the clamp nut.

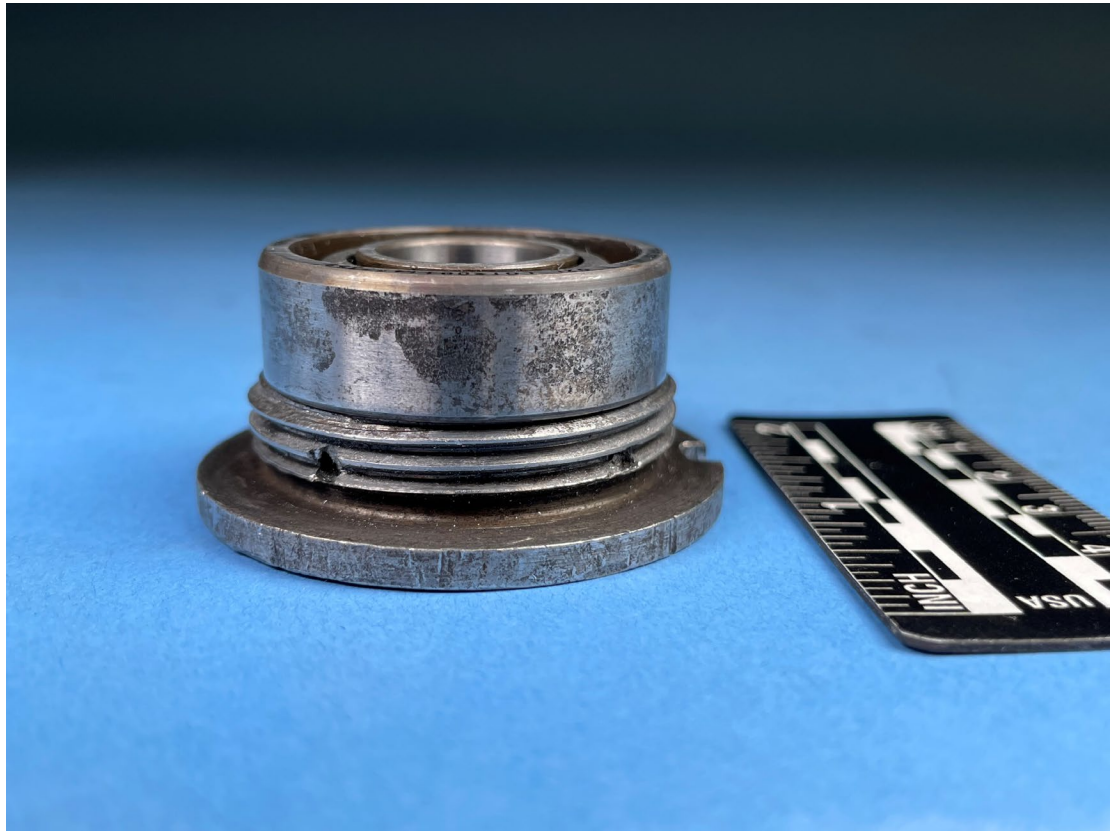
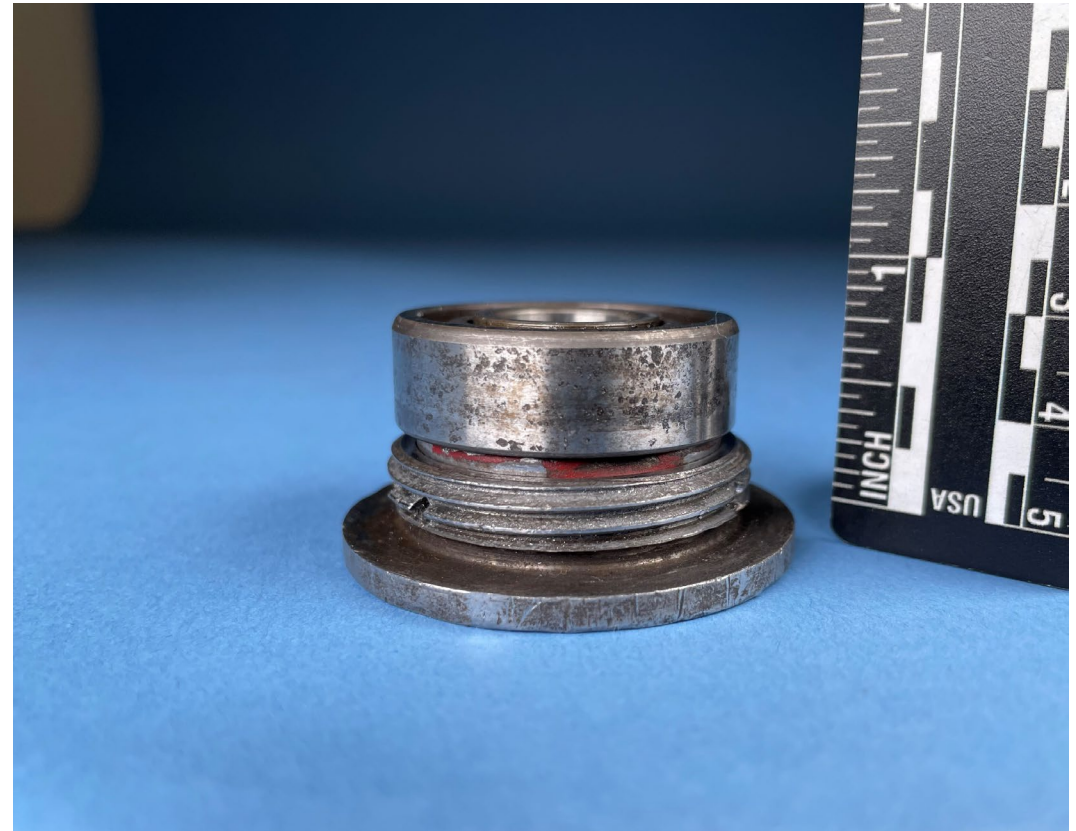
Comparison of contacting surfaces. The left picture is of the outer race of the upper bearing contacting the clamp nut as per design. The right picture is of the inner race of the upper bearing contacting the moisture seal.
