**NATIONAL TRANSPORTATION SAFETY BOARD
OFFICE OF HIGHWAY SAFETY
WASHINGTON, D.C.**

**MOTOR CARRIER FACTORS GROUP CHAIRMAN'S
FACTUAL REPORT**

Operator #9: 45-year-old male (deceased)
Passenger #9: 45-year-old female (deceased)
Vehicle #10: 2015 Harley Davidson FLST
Operator #10: 52-year-old-female (not injured)
Vehicle #11: 2007 Harley Davidson FLHRSE3
Operator #11: 51-year-old male (injured)
Date: Friday, June 21, 2019
Time: 6:26 p.m. local time
NTSB #: **HWY19MH010**

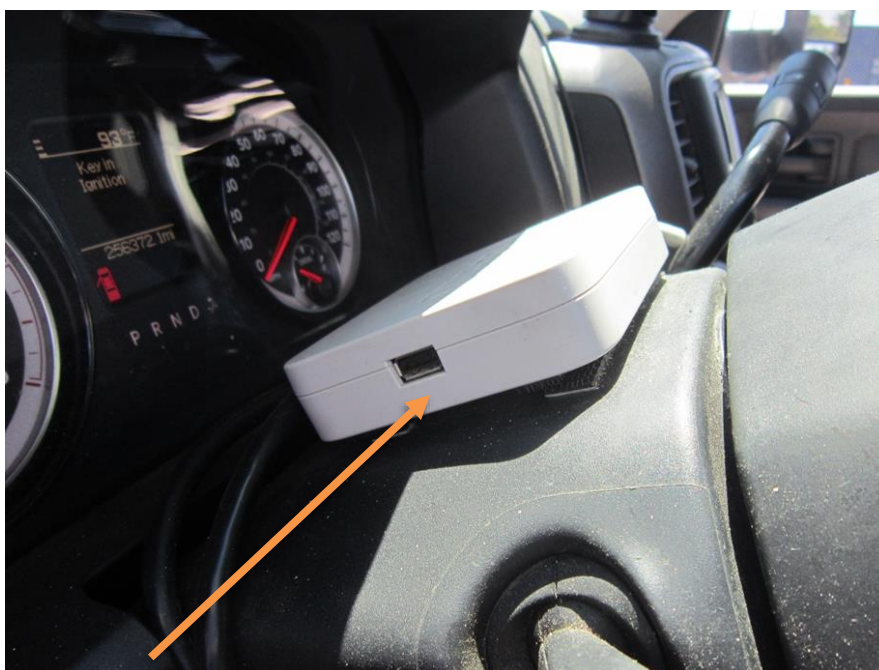
Photo 1. ABORD transmitter box. Orange arrow shows box disconnected.

Investigators asked how it was possible for the log to reflect a location that was different from the actual location of the truck, and the owner stated: “I disconnected the smart phone cable from the transmitter box. When you do this, it is unable to transmit data so the log shows the last destination which was Dunkirk, New York, but in fact the driver was back here in West

Springfield.”¹⁶ The carrier further elaborated and stated to investigators “we can’t make the trips because of the rules.” The carrier showed investigators on his app on his smart phone how he was able to manipulate and edit the duty status on his logs. Additional logs provided by the carrier showed similar issues of falsification and that the logs had been manipulated with the KeepTrucking software. The carrier demonstrated to investigators how to disconnect the smart phone from the transmitter in an exemplar vehicle which prevented the device from transmitting data to the iCloud. **Photo 1** documents the exemplar vehicle and the KeepTrucking ABORD transmitter box.

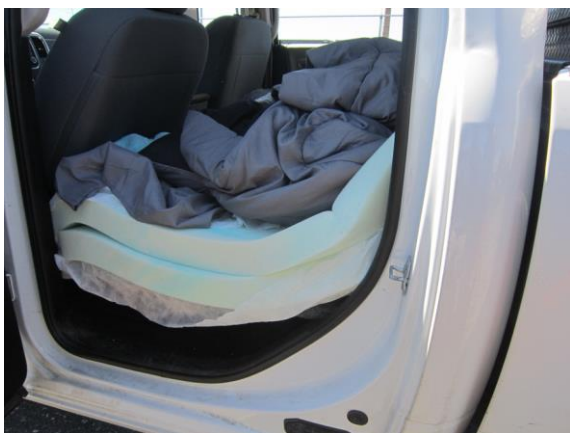
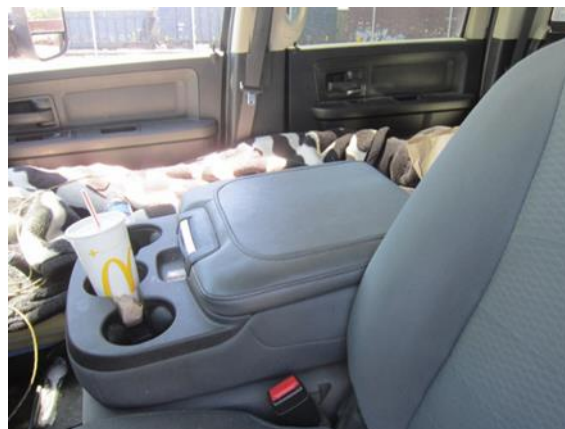
Images 2-3 Exemplar Vehicle with non-compliant sleeper berth.¹⁹

The Massachusetts State Police (MSP), the NTSB and the FMCSA inspected the carrier's fleet. All of the carrier's vehicles were weighed by MSP to verify the combination weight ratings and to determine what vehicles required CDLs.¹⁸ The entire Westfield fleet including the accident vehicle had been modified with the rear seats had been removed and a mattress had been placed to create a makeshift sleeping area. **Images 2-3** document the sleeper berth for the exemplar vehicle.

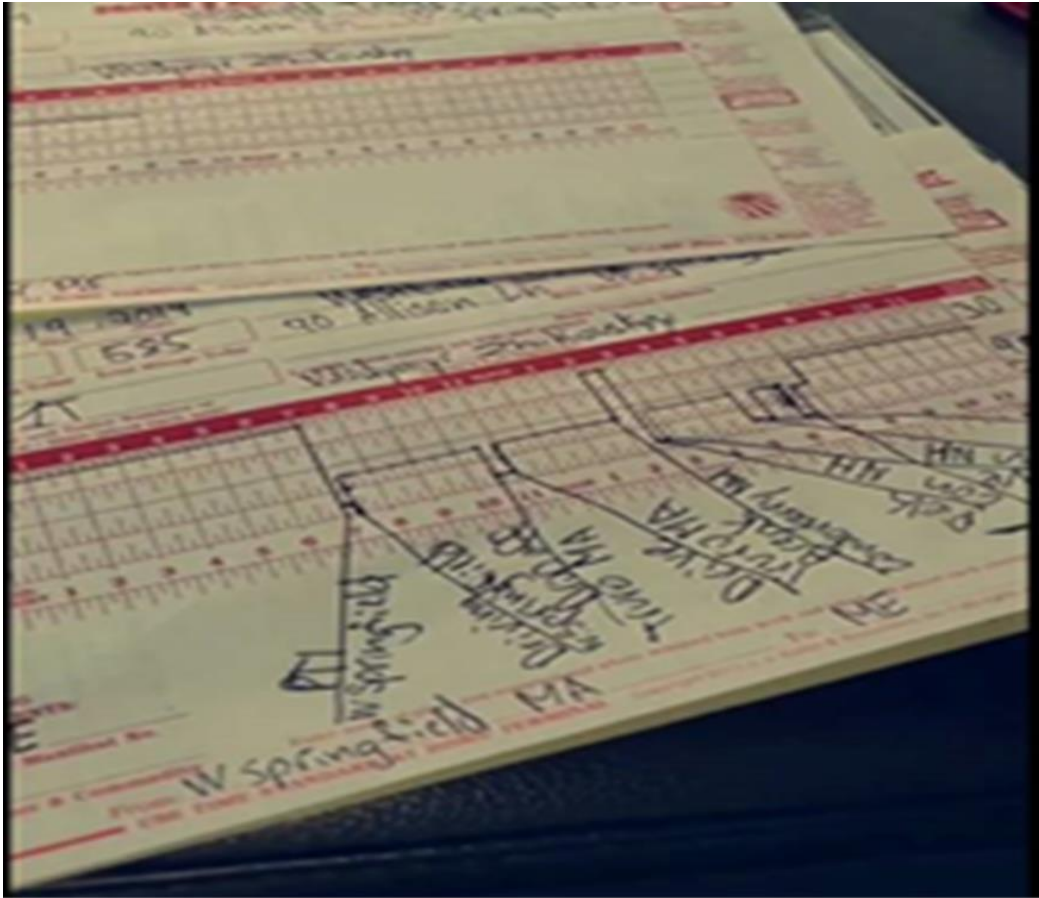
Image 1. Cell Phone Photo of Accident Driver’s Logbook for June 19, 2019.

NTSB investigators determined that the accident driver falsified his log on June 19, 2019. According to the EZ Pass the driver was on-duty driving in Maine at 5:09 p.m. however the driver recorded that he was in his sleeper berth from 5:00 p.m. until 11:59 p.m. in New Hampshire. Furthermore, interviews conducted by the NTSB indicated the driver was on-duty driving when he made a pickup order at Thomaston, Maine at 9:00 p.m.³⁹ With the exception of the June 19th log, investigators did not have any additional logs to determine any other HOS violations.

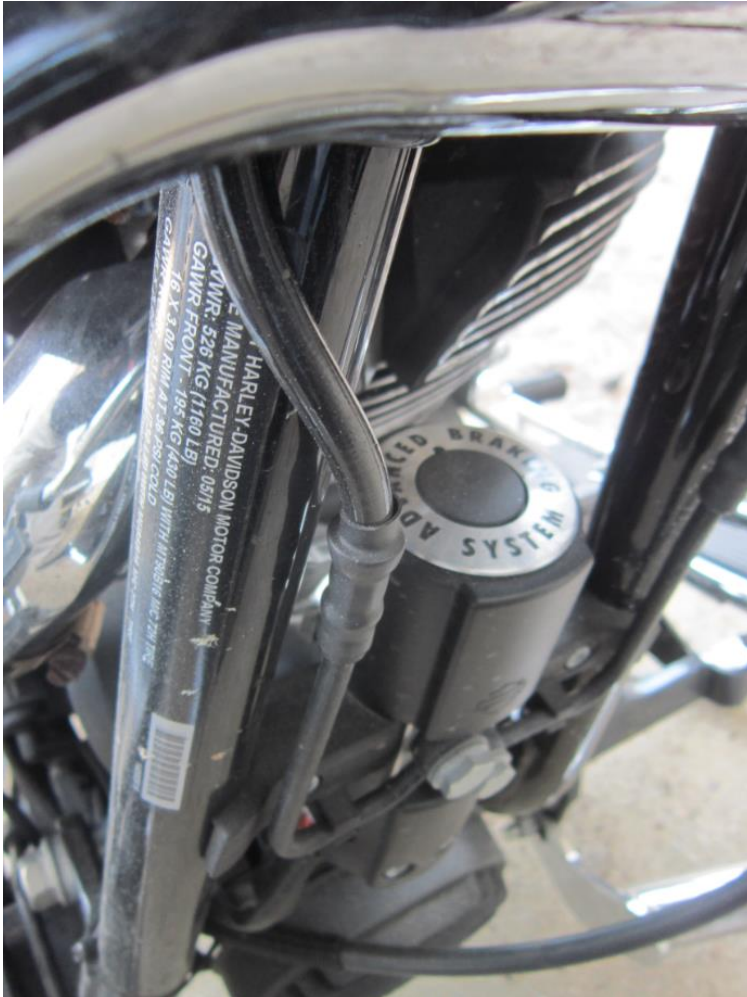
Image 3. Crash Involved Motorcycle equipped with ABS.

noted that the operators of two of the motorcycles involved in this crash were operating motorcycles with automatic braking systems (ABS). See **Image 3** for additional information. The operator located in position 3 was equipped with ABS see the *Survival Factors Group Chairman Report* for additional information. According to statements from the operators of these motorcycles, that during the crash sequence they were able to maneuver out of the path of the oncoming truck and bring their motorcycles to emergency stop without turning over their motorcycles. These two operators were uninjured.
