National Transportation Safety Board

RRD24FR003

VIDEO STUDY

Location: New York, New York
Date: November 29, 2023
Time: 12:13 a.m.
Train: New York City Transit passenger train No. 2317-D

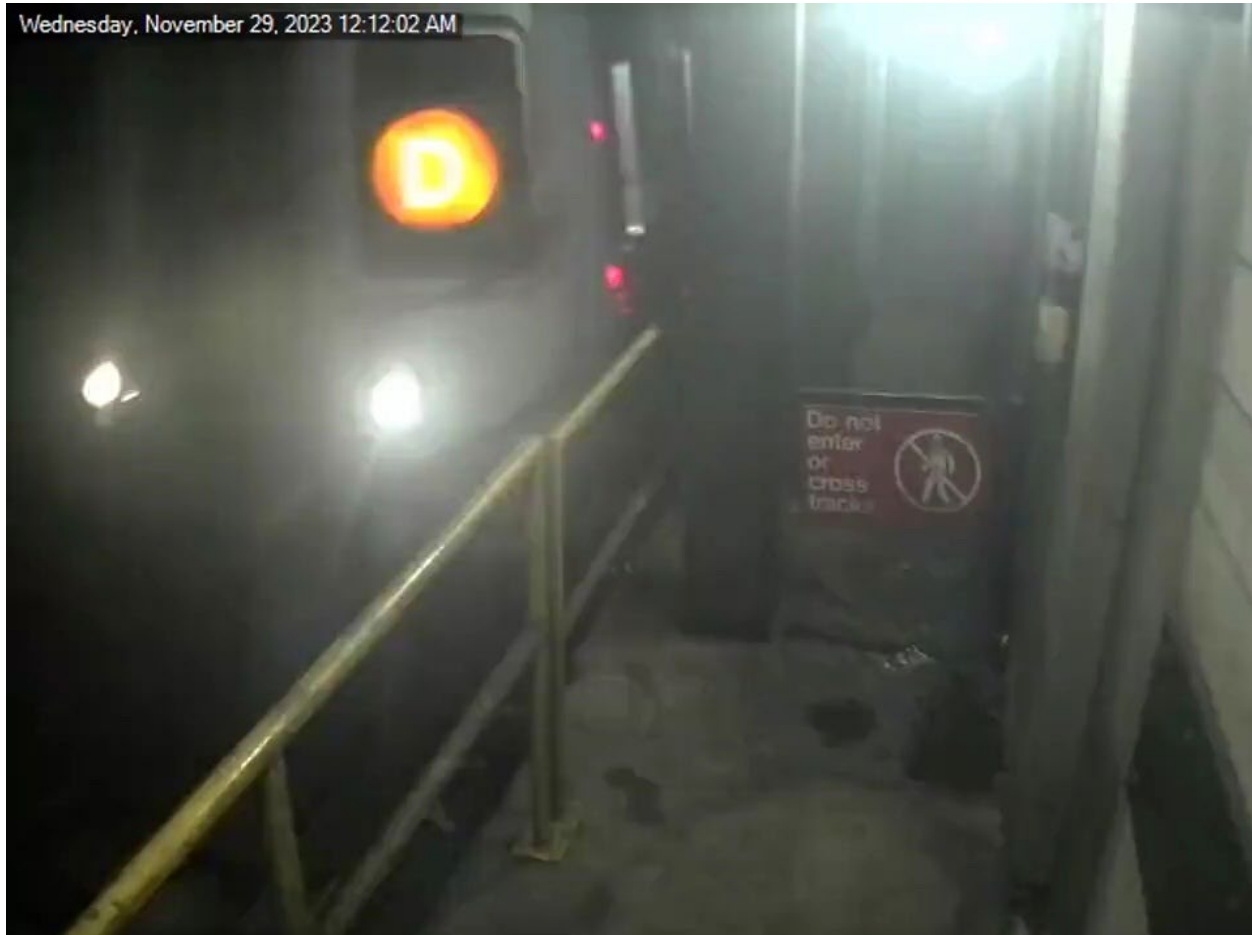
Figure 1. Video frame at time 12:12:02.00 AM

The moving train appeared in the video at time 12:11:57 AM based on the time stamp in the video. The video time stamps had resolution of one second. The train motion stopped at time 12:12:18 AM. Estimating the location of the train became

possible at time 12:12:02 AM. Figure 1 shows a frame of the video at time 12:12:02 AM.

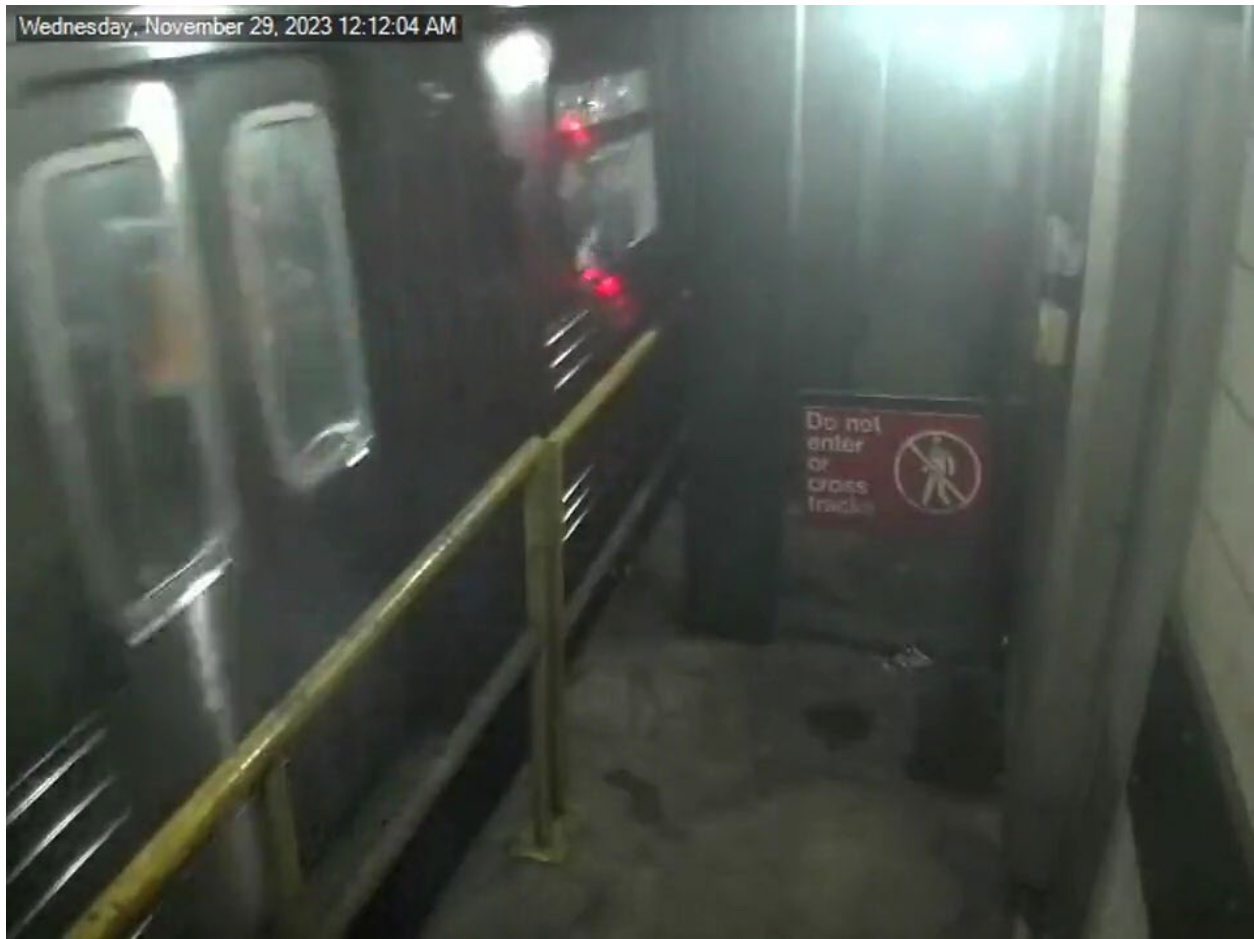
Figure 3. Video frame at time 12:12:04.80 AM (first car, second door)

Figure 3 shows the video frame at the time when the leading edge of the second door of the first car touched the left edge of the video frame. Figure 4 shows the video frame at the time when the leading edge of the third door of the first car touched the left edge of the video frame. Since the door-to-door distance was known, the distance traveled by the train between these video frames was known.

The seven measured door-to-door times were 1.53 seconds, 1.67 seconds, 1.53 seconds, 1.26 seconds, 1.27 seconds, 1.33 seconds and 1.47 seconds. The seven door-to-door distances traveled during these seven times were 18.1875 feet, 17.625 feet, 18.1875 feet, 18.1875 feet, 17.625 feet, 18.1875 feet and 18.1875 feet. Figure 5 shows the seven estimated train speeds, computed by dividing traveled distances by the times to travel them, in units of miles per hour. The figure shows a speed estimate at the time of the video frame corresponding to the end of a measurement door-to-door distance. For example, the speed estimated based on the frames shown in Figure 3 and in Figure 4 is placed at 12:12:06.47, the time corresponding to the video frame in Figure 4.

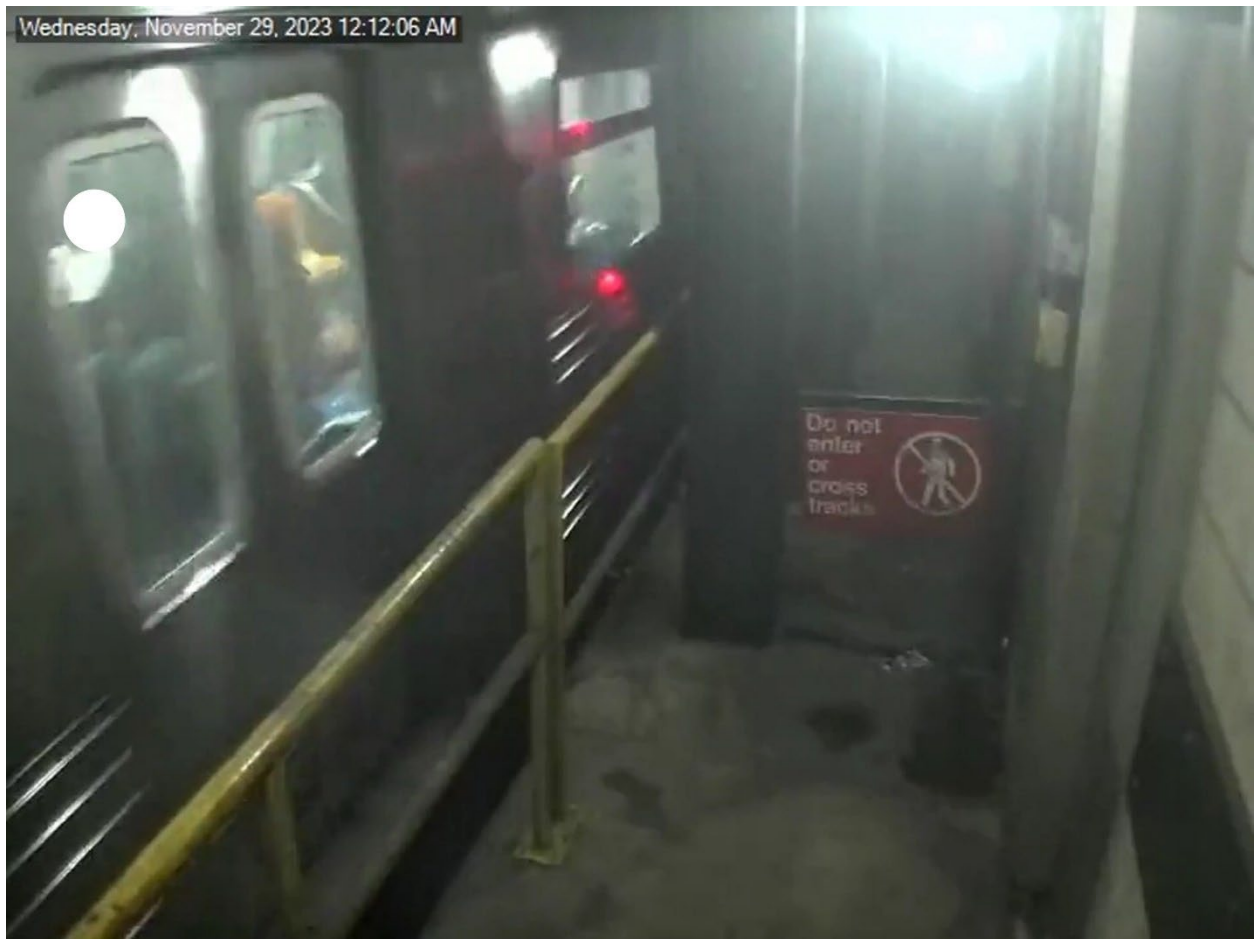
Figure 4. Video frame at time 12:12:06.47 AM (first car, third door)

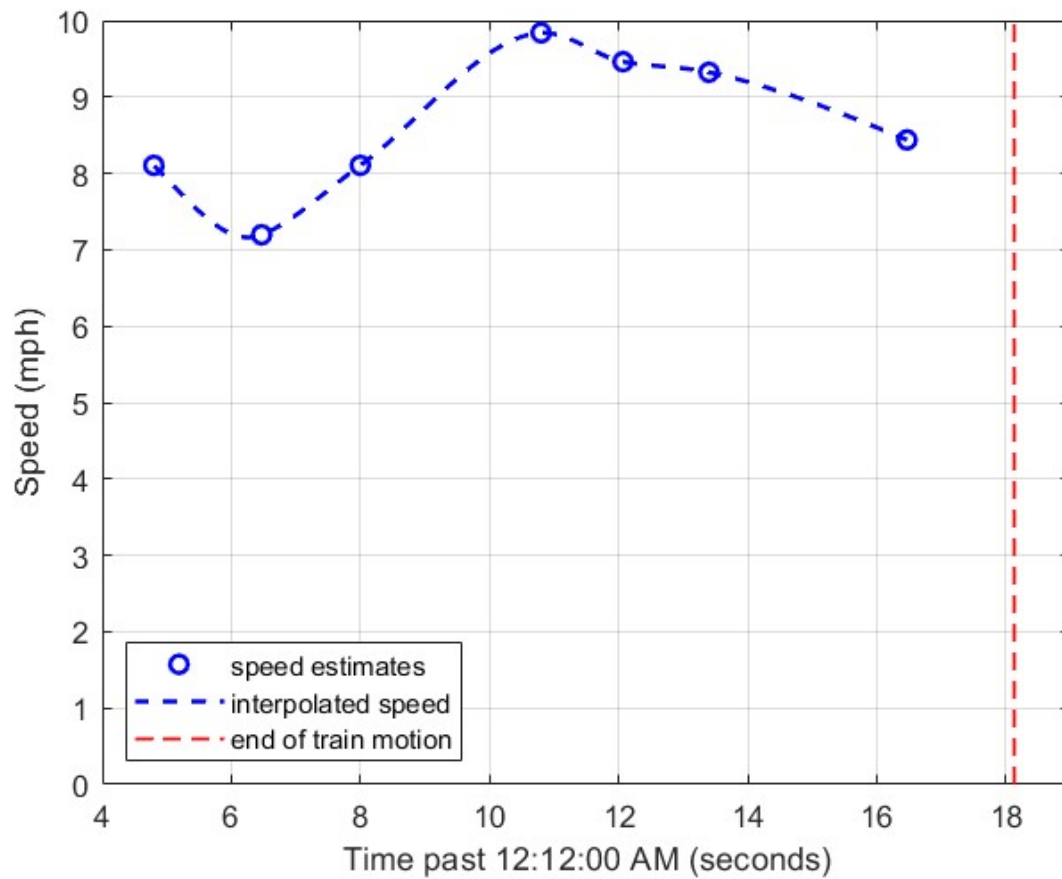
Figure 5. Estimated train speed

The seven estimated speeds shown in Figure 5 are in the range between 7.2 mph and 9.8 mph. The average of the seven estimated speeds is 8.6 mph. The figure shows a period of about four seconds when the train was accelerating. The acceleration during this period was small, less than 0.03 g. Possible reasons for this acceleration include heating of brakes, change in slope of the track, and change in aerodynamic drag on the train.

Speed can also be estimated based on the time it took a subway car to travel the distance from the first door to the fourth door, which is 54 feet according to Figure 2. The estimated speed of the first car is 7.78 mph, and the estimated speed of the second car is 9.51 mph. This increasing speed is in agreement with the more detailed speed estimates shown in Figure 5.

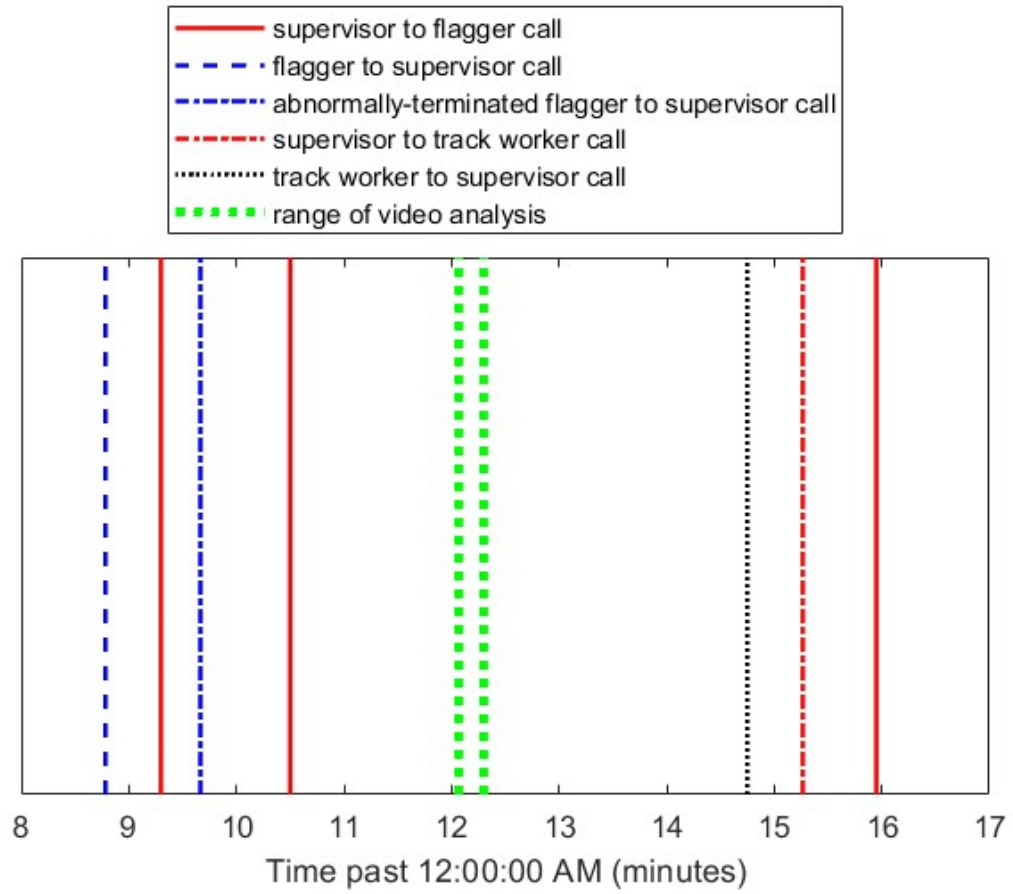
Figure 6. Graphical representation of phone call times

Phone carrier records were used to document the timing of phone calls involving a supervisor, the flagger and a track worker that occurred shortly before and shortly after the time period during which the train speed was estimated. Figure 6 is a graphical representation of the phone calls. The dotted green lines represent the time period during which the train speed was estimated.
