# National Transportation Safety Board

ERA23FA024

## **NAVIGATION DEVICE**

Location: Marietta, Ohio  
Date: October 18, 2022  
Time: 0709 eastern daylight time (EDT)  
Airplane: Beech E90, N515GK

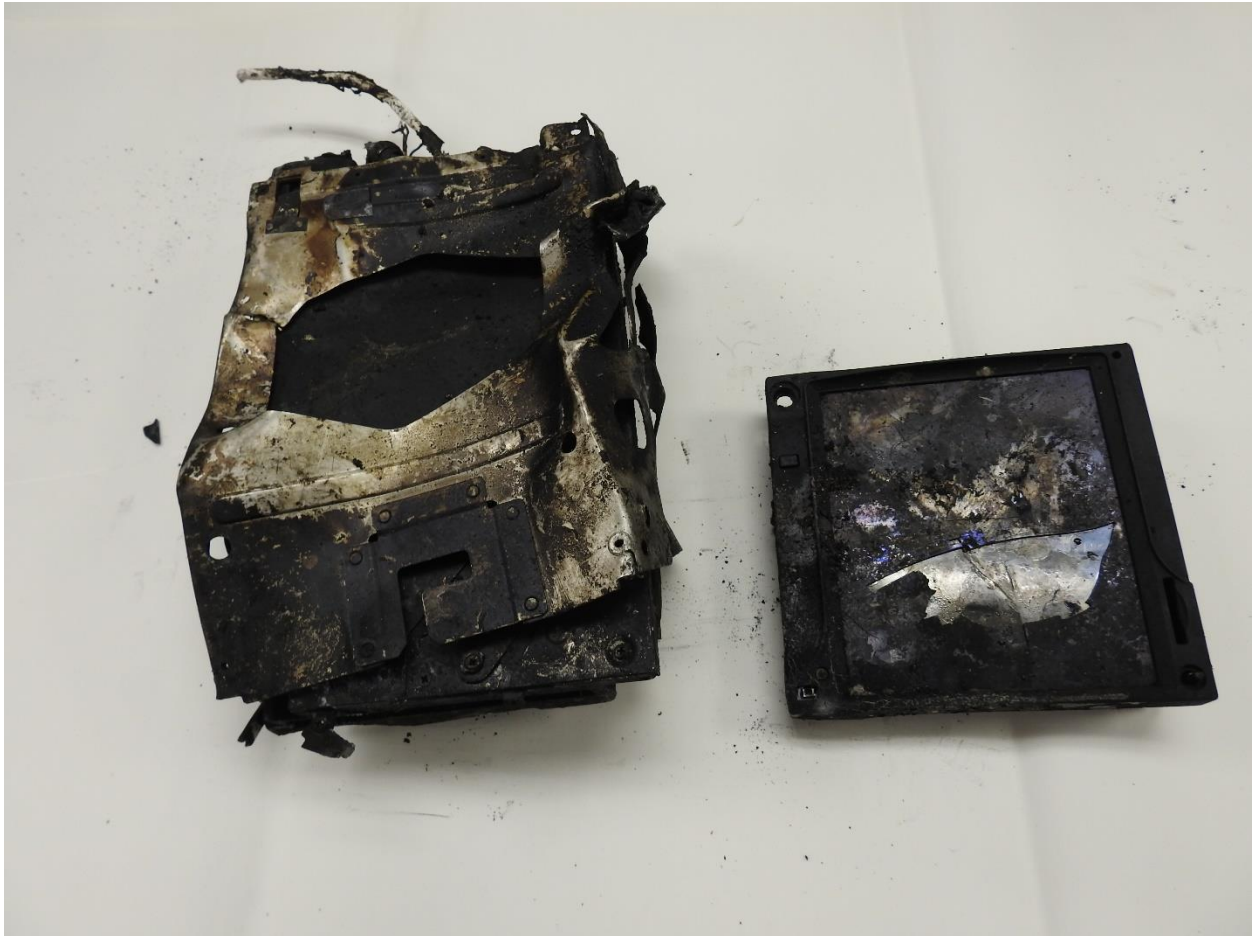
**Figure 1.** The Garmin GTN 750 as received, the main body on the left and the screen on the right.

Upon arrival at the Vehicle Recorder Division, the Garmin GTN 750 exhibited severe impact and fire damage, as shown in figure 1. The unit's internal circuit boards were fire damaged, as shown in figure 2. A SD card's internal chip, which had been broken down into two pieces, was located. This device is shown in figure 3. The two pieces of the SD card had sustained severe fire damage. The extent of the damage precluded normal and advanced recovery procedures and additional attempts were unsuccessful in yielding usable data. Therefore, no data pertinent to the accident were recovered.

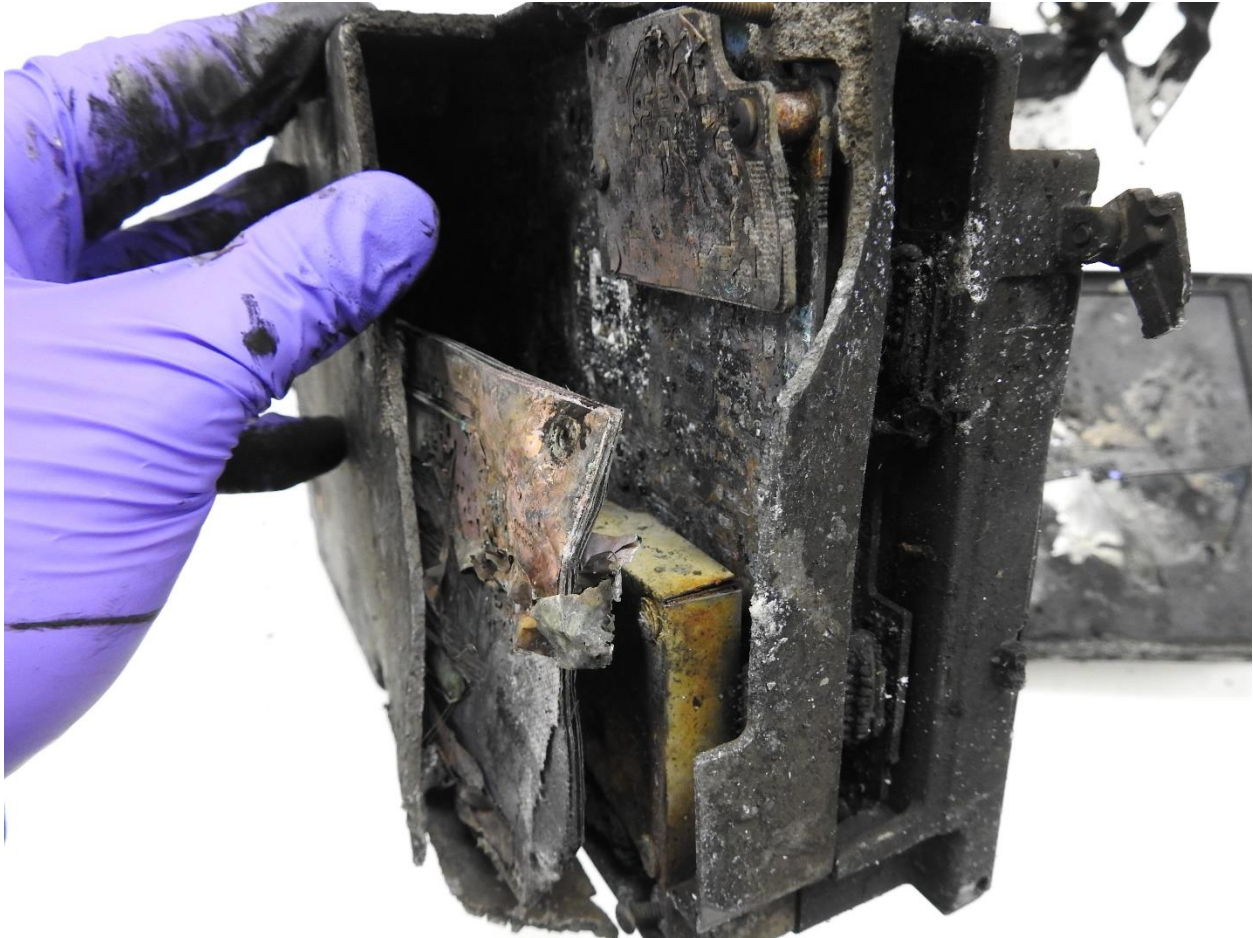
**Figure 2.** A view of the internal circuit boards of the Garmin GTN 750.

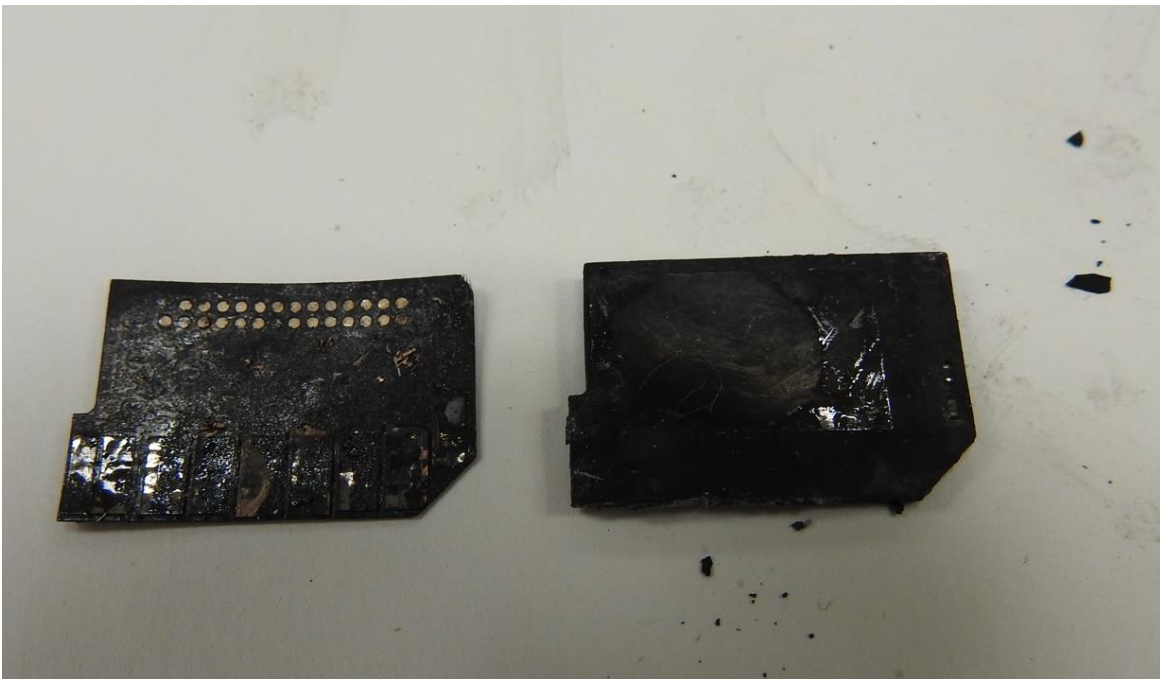
**Figure 3.** A fire damaged SD card's internal chip which was broken down into two pieces.
