National Transportation Safety Board

DCA23FM038

VIDEO STUDY

Location: Algiers Lock, New Orleans, Louisiana
Date: July 4, 2023
Time: 1808 Central Daylight Time
Vessel: Barge EMS 317 pushed by towing vessel Kitty

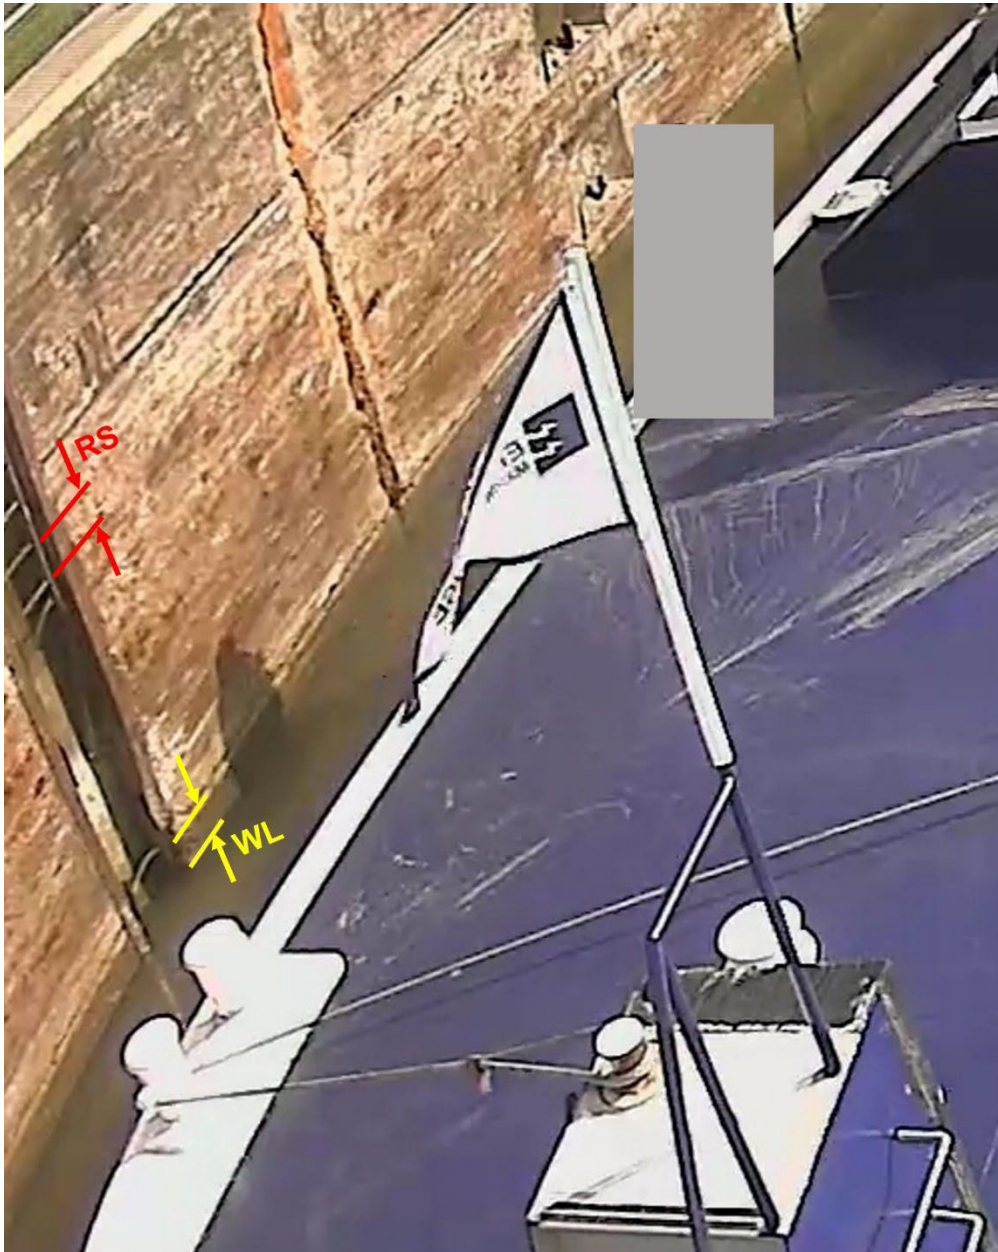
Figure 2 shows a segment of a frame from the CH02 video recorded at video time 13:26.359. The gray rectangle covers the image of a barge worker. Several ladders, such as the one seen in the figure, are installed on the lock walls. The spacing of the rungs of the ladders was used as a gauge for measuring the water level. The spacing of the rungs of the ladders was measured to be 12.0 inches, meaning that one rung spacing equals one foot. The distance W1, marked in Figure 2, from water level to a reference level, is estimated to be 0.9 rung spacings or 0.9 feet. The bent rung seen in the figure was used as the reference level.

Figure 2. Segment of CH02 video frame recorded at video time 13:26.359

Figures 2, 3, 4 and 5 show segments of CH02 video frames recorded at video times 13:26.359, 15:00.024, 15:19.857 and 16:33.557 respectively. The water levels at these times were estimated to be 0.9, 3.25, 1.75 and -0.1 feet. It was estimated based on the CH02 video that barge EMS 317 contacted the lock gate at video time 15:52.190, the time when the forward motion of the towing vessel stopped. This video time was used as a reference time, time zero seconds, for displaying the estimated water levels.

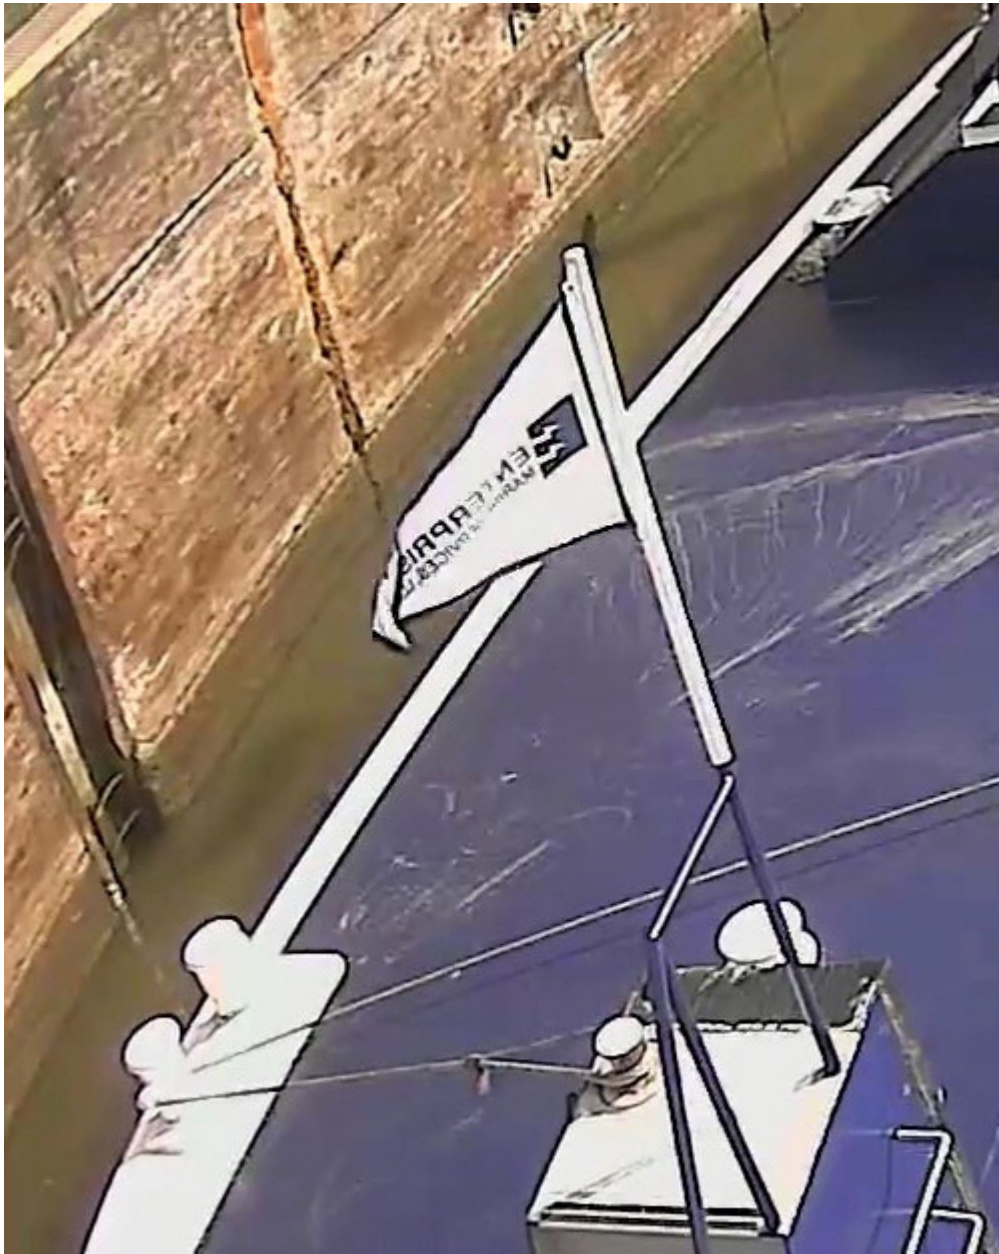
Figure 4. Segment of video CH02 frame recorded at video time 15:19.857

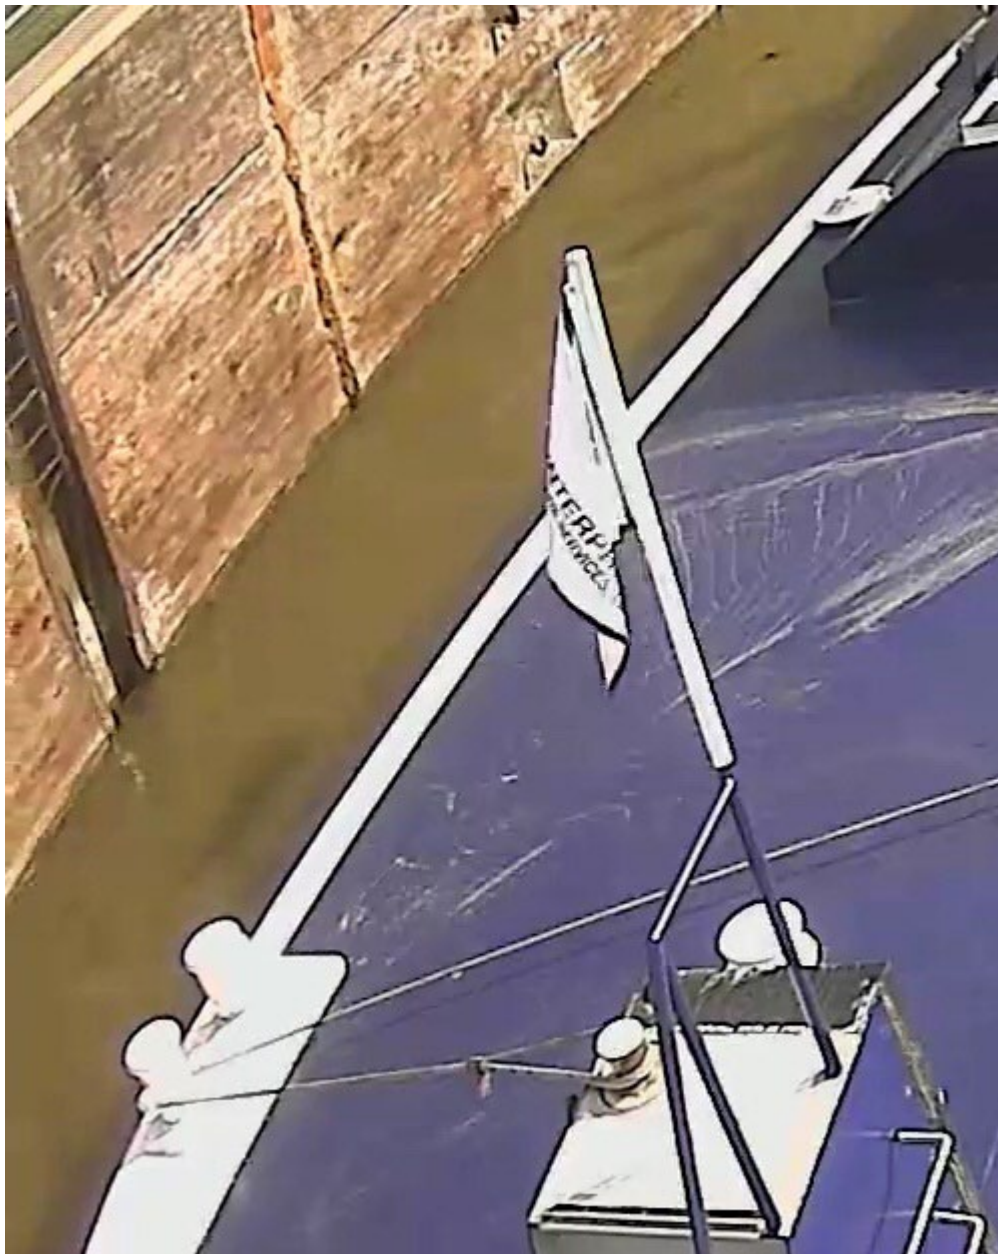
Figure 5. Segment of video CH02 frame recorded at video time 16:33.557

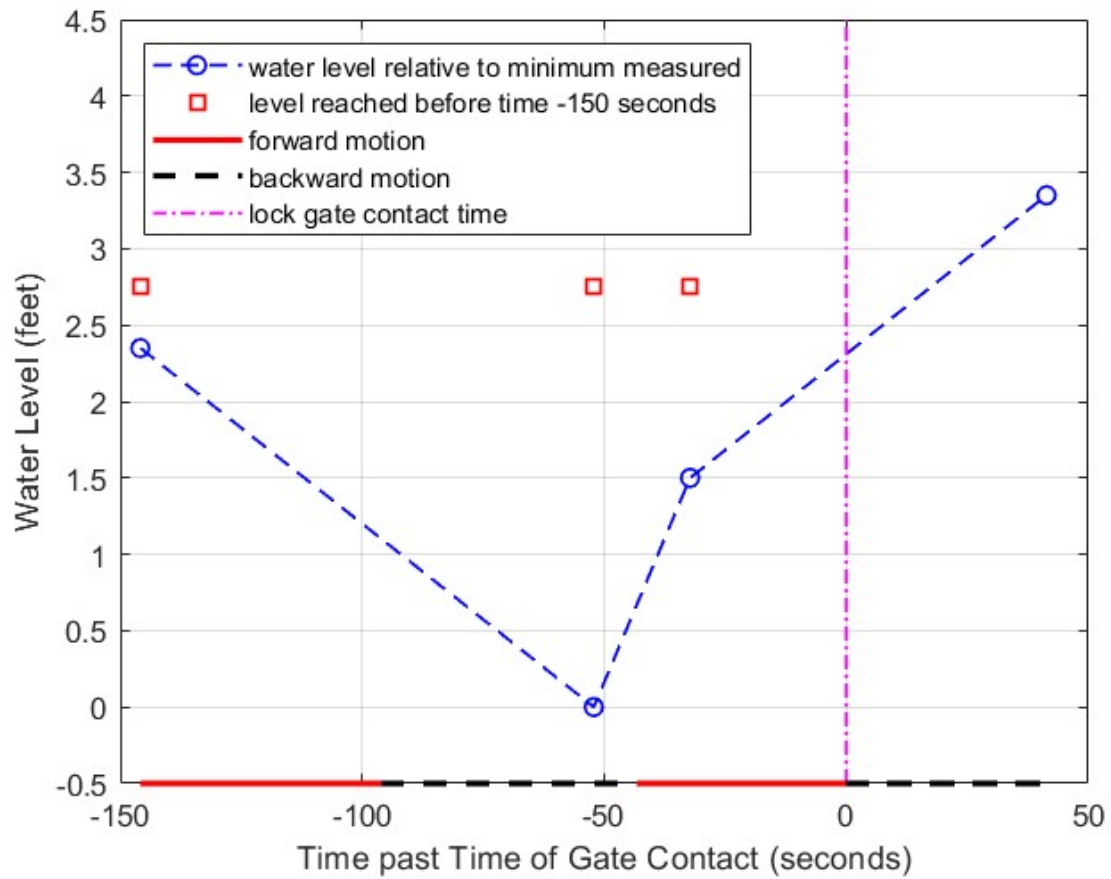
Figure 6 is a plot of the estimated water levels. The lowest measured water level was set to zero in the figure. The highest measured water level was 3.35 feet, measured about 41 seconds after the lock gate contact. The barge was moving sternway at that time, away from the lock gate. Between times -52 seconds and time -32 seconds, the water level was increasing at the highest observed rate. During this time period, the speed of the towing vessel seen in the video was the highest as it was approaching the lock gate.

Only four water level measurements were possible during the analyzed 187.2 seconds. They are marked by the four blue circular markers in Figure 6. The straight blue broken lines interconnect the circular markers. These lines should not be viewed

as accurately interpolated water levels. At any time, the actual water levels could be above or below these lines. Furthermore, the actual water levels at times other than the four times when water level measurements were possible and at locations other than ladder no. 3 could be above or below the blue markers. Therefore, the difference between the highest measured level and the lowest measured level could be higher than 3.35 feet. Consequently, the estimated highest water level variation in the lock, the 3.35 feet seen in Figure 6, should be viewed as a lower limit on the highest water level variation.

Figure 6. Estimated water level over time

Figure 3 shows a wet lock wall area that is above the water level at the time when that video frame was recorded. It means that the water level at that location was higher at an unknown earlier time. Such wet wall areas at the ladder no. 3 location are seen in the video frames recorded at video times 13:26.359, 15:00.024 and 15:19.857. The corresponding water level was 2.75 feet above the lowest measured water level in the video. The red square markers in Figure 6 are at this water level. The water reached this level at some unknown time before time -150 seconds, the earliest time shown in Figure 6.

A video recorded with a camera installed on the towing vessel Kitty was used to estimate the water level variations in the Algiers Lock. The highest estimated water level was 3.35 feet above the lowest estimated water level. Since only four water level estimates were possible during the analyzed 187.2 seconds, the estimated 3.35 feet water level variation should be viewed as a lower limit on the actual water level variations.
